EVALUATION OF HIGH CRASH LOCATIONS (DARK CRITERIA) STUDY

**LOCATION #7:
SR 52 (Kenneth Pike)
MILEPOST 2.40 to 4.29
November 2012**

Prepared for:
Delaware Department of Transportation

By:
Urban Engineers, Inc.

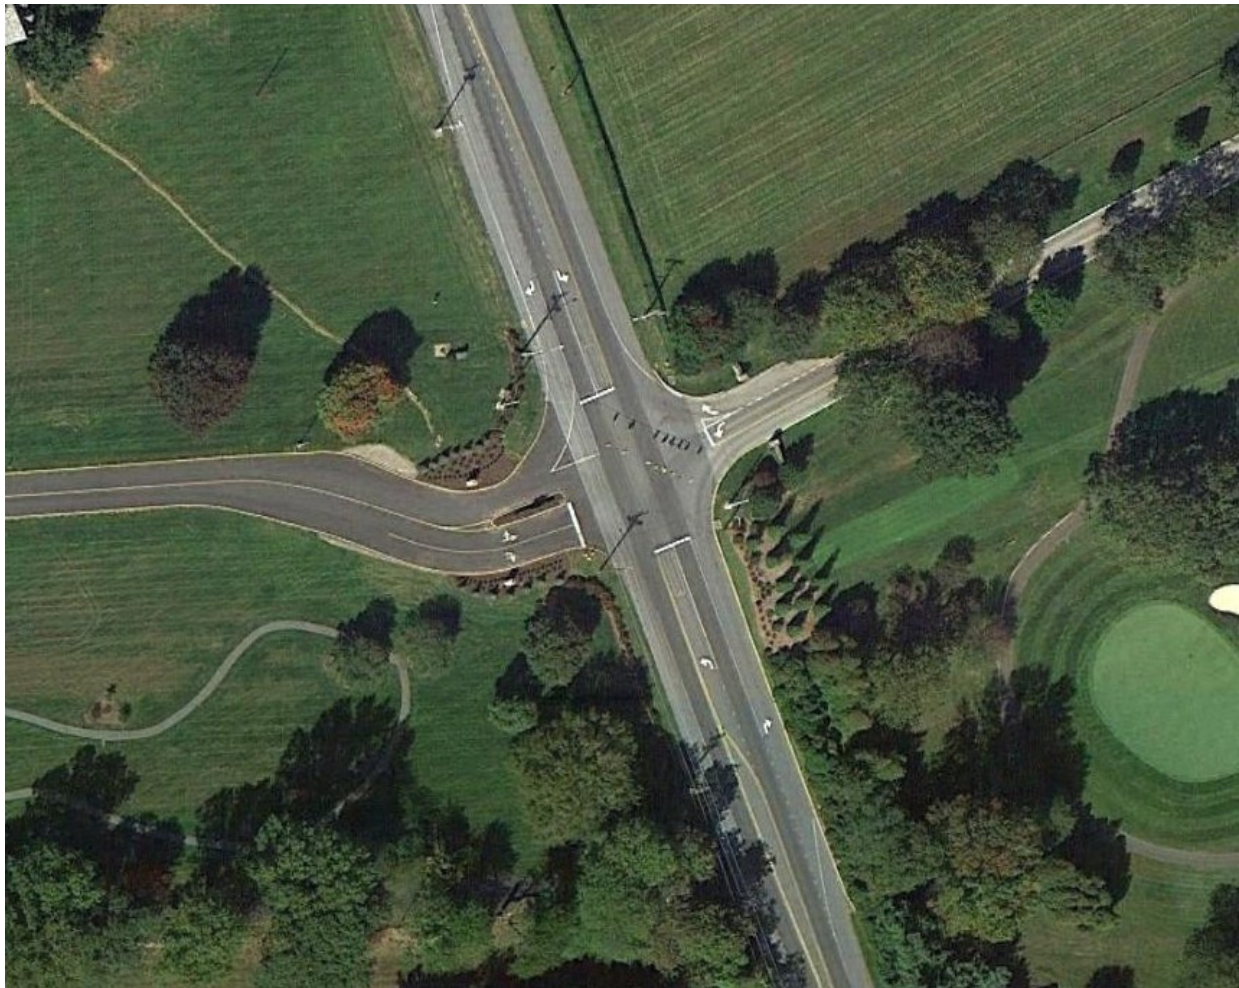
Photo 1: SR 52 @ Private Drive (Methodist Country Home / Golf Club) Intersection

SR 52 northbound has one through lane, a left turn lane and a right turn lane. SR 52 southbound has one through lane, a left turn lane and a right turn lane. Private Drive eastbound from Methodist County Home has a shared left/through lane and a right turn lane. Private Drive westbound from Golf Club has a shared left/through lane and a right turn lane. An aerial showing the intersection layout is shown in **Photo 1**.

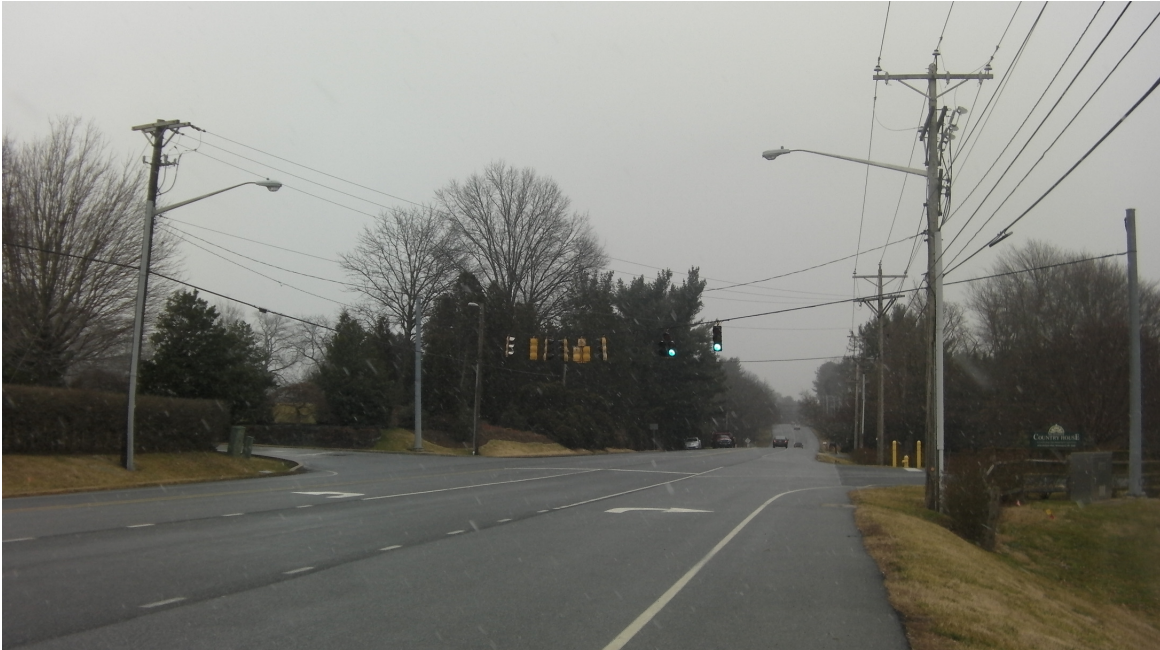
Photo 2: Facing south on SR 52 just north of Private Drive (Day)

One (1) 250 Watt, HPS luminaire is present on utility poles on both sides of SR 52 just north of the intersection. Another 250 Watt, HPS luminaire is present on an utility pole at the southeast corner of the intersection. However, there is no luminaire at the southwest corner of the intersection.

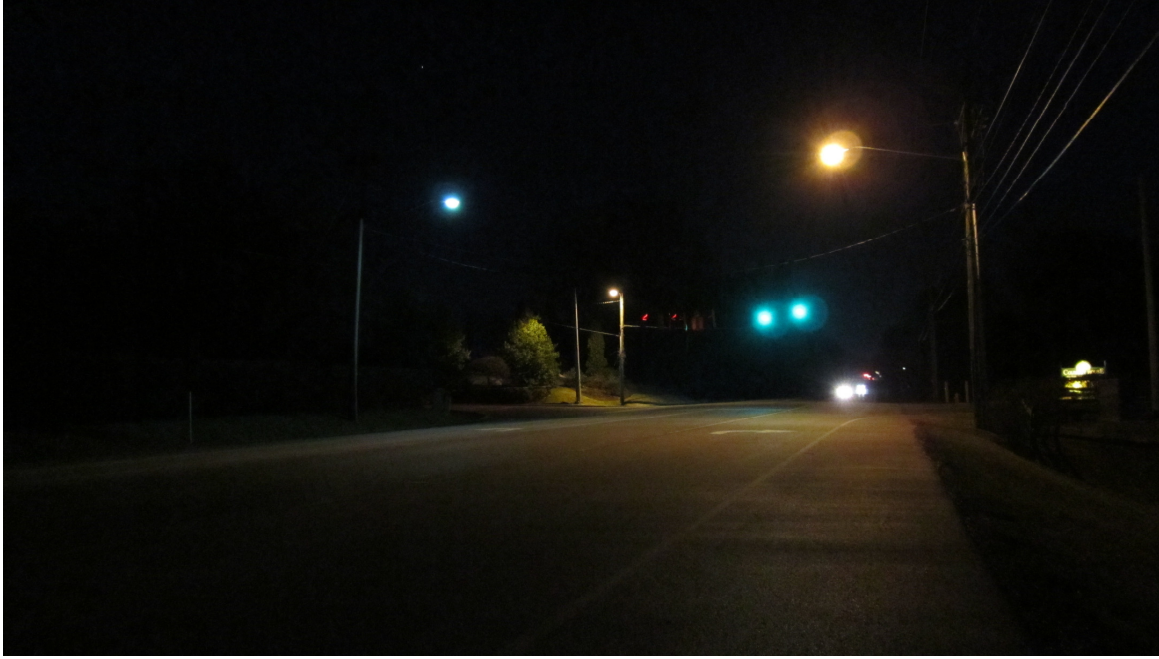
Photo 3-1: Facing south on SR 52 just north of Private Drive (Night)

It was also found in the field visit that the light bulb in the luminaire attached on the utility pole located at the northeast corner (pole number 46991/45199) is getting old and malfunctioning shown in **Photo 3-1** and **Photo 3-2**. The luminaire may have a bulb problem to be replaced or has a ballast problem to be repaired. In either of the cases, the luminaire should receive maintenance attention.

It was also found in the field visit that the light bulb in the luminaire attached on the utility pole located at the northeast corner is getting old and malfunctioning as shown in **Photo 3-1** and

It is also recommended that a utility-owned luminaire on the utility pole located on the northeast corner should receive maintenance attention, as the luminaire is malfunctioning.

Photo 3-2. It is recommended that the light bulb be replaced or the ballast be repaired. At minimum it is recommended that the luminaire should receive the maintenance attention.

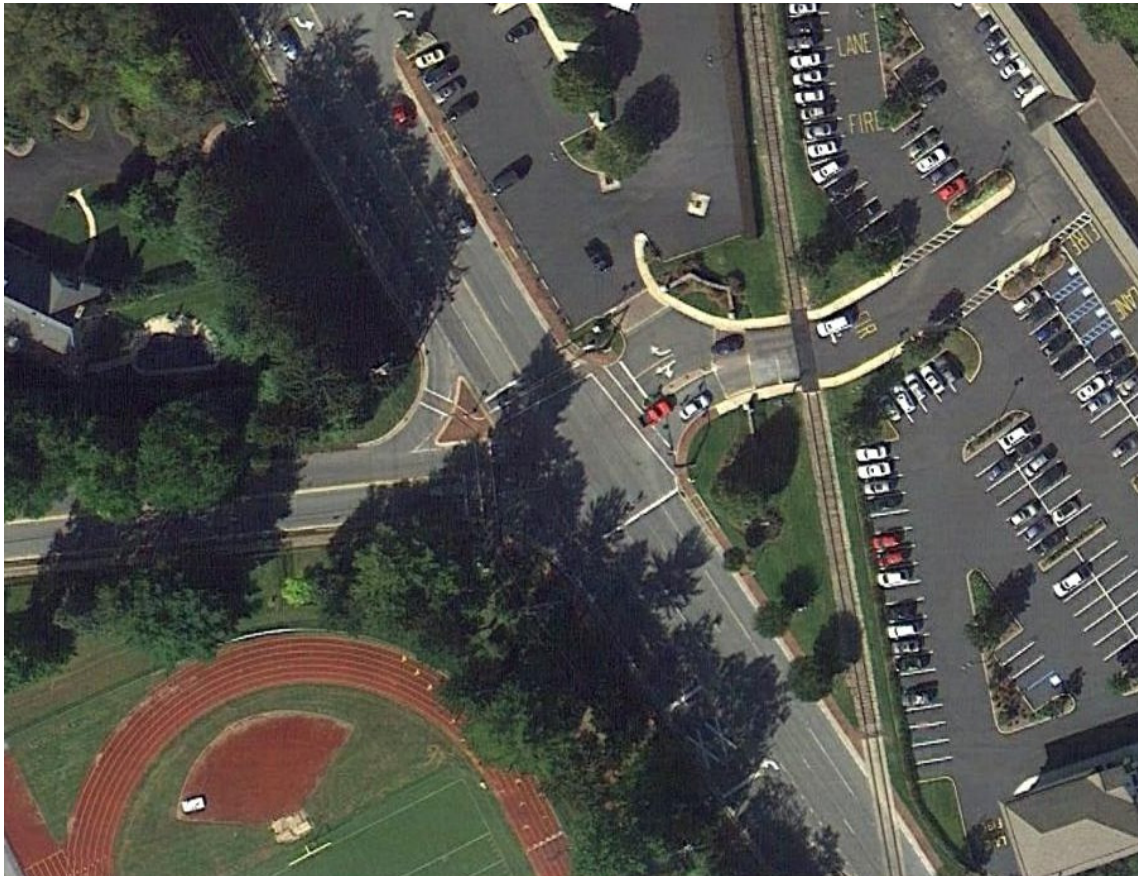
Photo 4: SR 52 @ Hillside Road / Greenville Crossing S.C. Intersection

SR 52 northbound has two through lanes, a left turn lane and a right turn lane. SR 52 southbound has one through lane, a left turn lane and a right turn lane. There is a raised channelized right-turn island on the southbound approach. Hillside Road eastbound has a shared left/through/right lane. There is a painted channelized right-turn island on the eastbound approach. Private Drive westbound from Greenville Crossing Shopping Center has a shared left/through lane and a right turn lane. An aerial showing the intersection layout is shown in **Photo 4**.

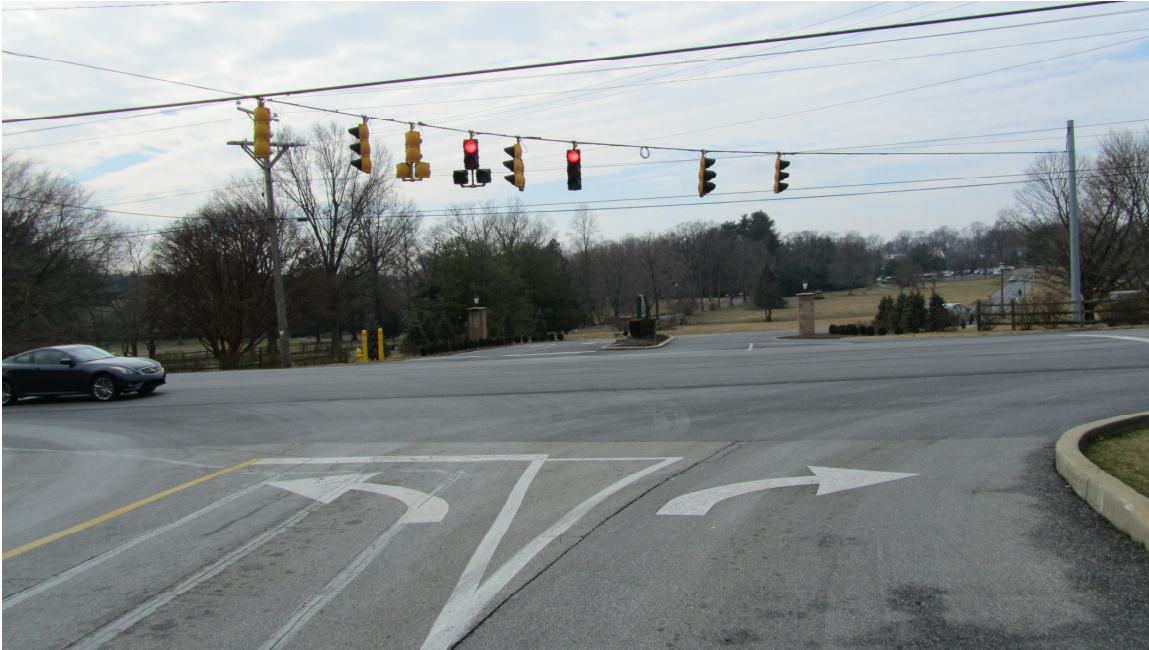
Photo 7: Facing west towards intersection of SR 52 @ Private Drive

In the field visit, it was found that the lane markings on the westbound approach from the Golf Club do not show the lane for through movement shown in **Photo 7**. It is recommended that the lane marking on the left lane on the westbound approach be changed to left/through arrow from left only arrow.

It is recommended to change the lane marking on the left lane of the westbound approach to a left/through arrow from left only arrow.

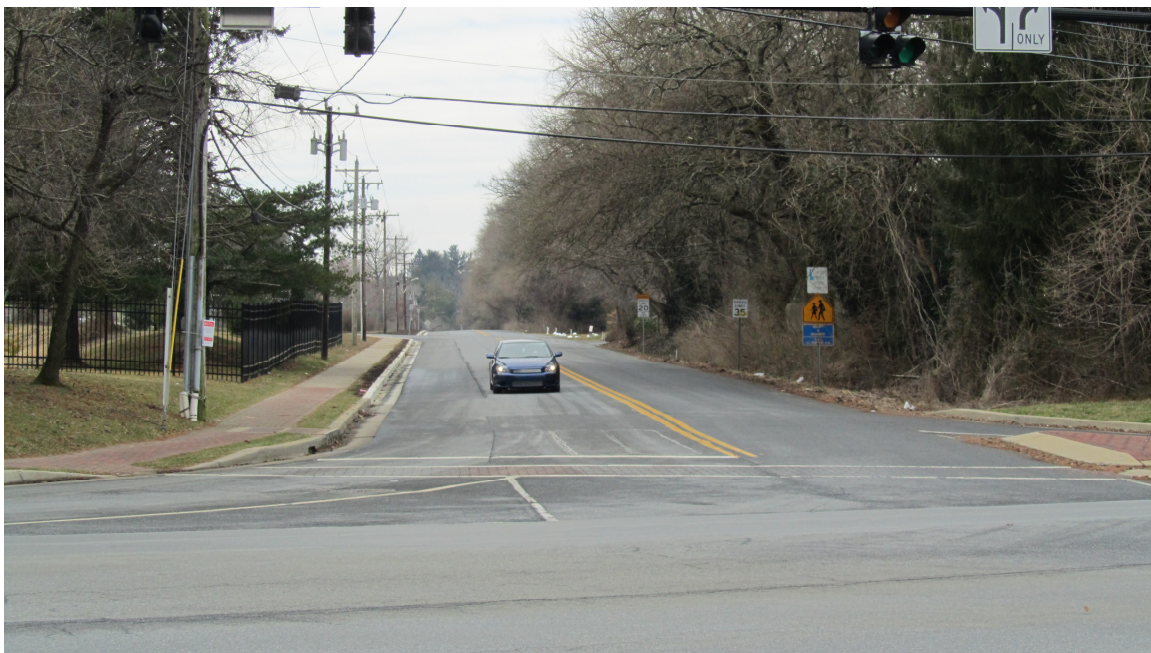
Photo 8: Facing west towards intersection of SR 52 @ Hillside Road / Greenville Crossing Shopping Center

The signal heads for the eastbound approach on Hillside Road indicate the approach has a shared left/through lane and a separate right-turn lane, however the lane striping shows only one lane on the approach although the lane is wide enough for two lanes as seen in **Photo 8**. The combination of the signal heads and lane striping confuses drivers and creates an unsafe condition. It is recommended that pavement markings be restriped with arrows on the eastbound approach.

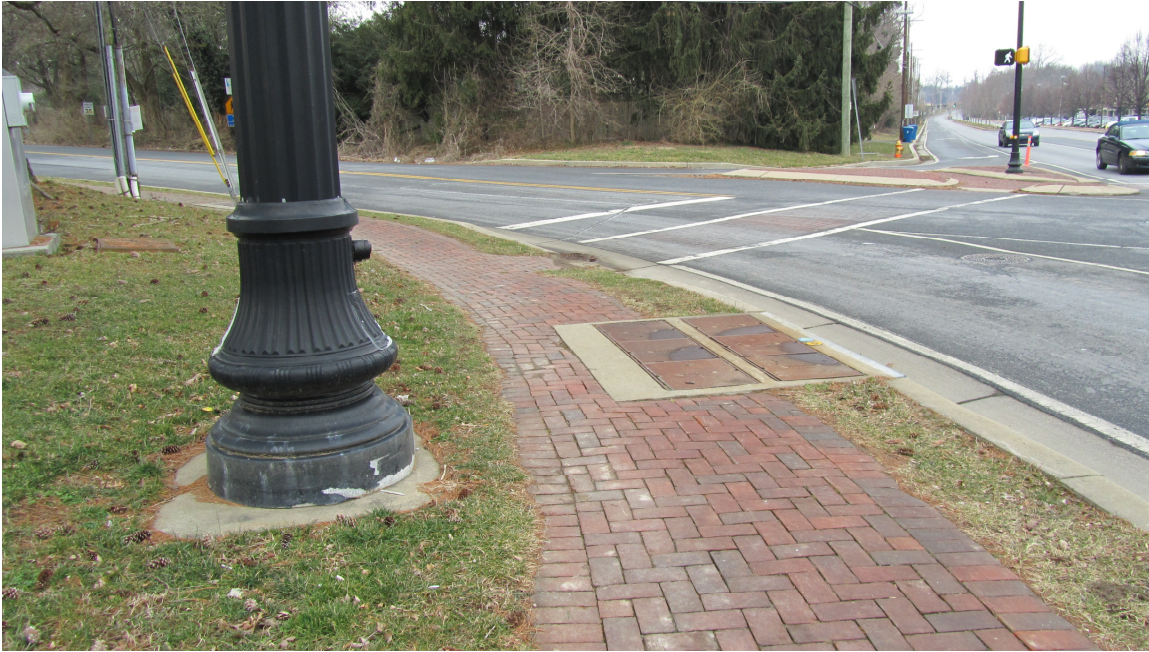
There are pedestrian crosswalks at the northern side of the intersection for crossing SR 52, the western side of the intersection for crossing Hillside Road, and the eastern side of the intersection for crossing Greenville Shopping Center Driveway. There are pedestrian signal heads for all three pedestrian crossings. However, many of the pedestrian push buttons located at corners of the intersection do not meet ADA standards. The existing push buttons are located either too far from the crosswalk landing area or too far from the sidewalk edges seen in **Photo 9-1** and **Photo 9-2**. Therefore, it is recommended that the pedestrian push buttons be

Photo 9-1: Facing north towards the pedestrian push button located at southwest corner of SR 52 @ Hillside Road / Greenville Crossing Shopping Center intersection

relocated to meet the current ADA standards. It may be necessary to install some pedestal poles for the push button relocations. At the time of this report, a Pave & Rehab project is expected to include this intersection which would address the ADA concerns.

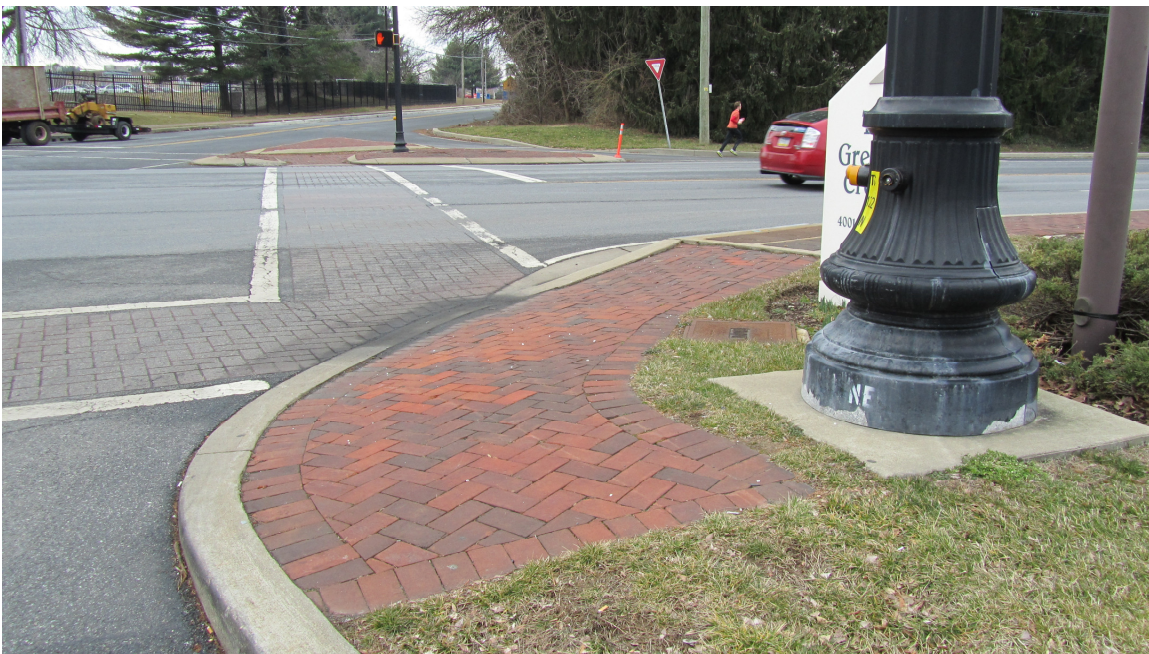
Photo 9-2: Facing west towards the pedestrian push buttons located at northeast corner of SR 52 @ Hillside Road / Greenville Crossing Shopping Center intersection

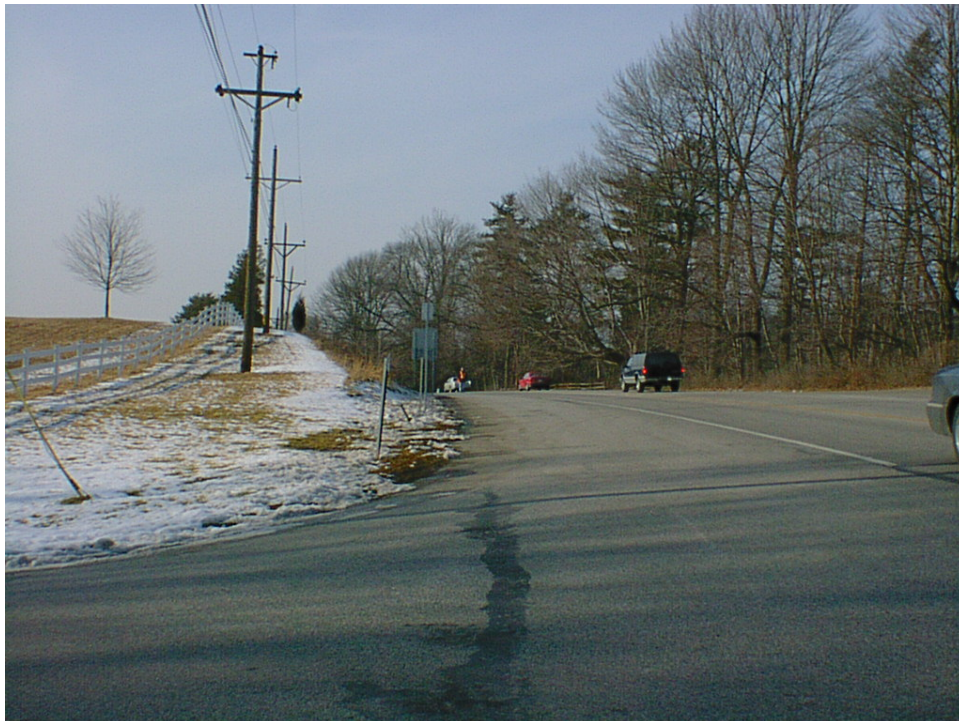
Table 4 summarizes sight distance criteria and available stopping sight distance on Kennett Pike and corner sight distances from Snuff Mill Road. Corner sight distances were measured from the observed vehicle stopping points. Sight distance criteria are shown for passenger vehicles travelling on Kennett Pike at the 45-mph 85th-percentile speed as measured in speed studies. As indicated, sight distance requirements are not met for eastbound Snuff Mill Road motorists looking to the north on Kennett Pike and for southbound SR 52 motorists approaching the intersection. Corner and stopping sight distance are restricted by a horizontal curve and a berm on the west side of the roadway, north of the intersection.

Photo 6: Looking north at SR 52 southbound from Snuff Mill Road, object at 300 feet north

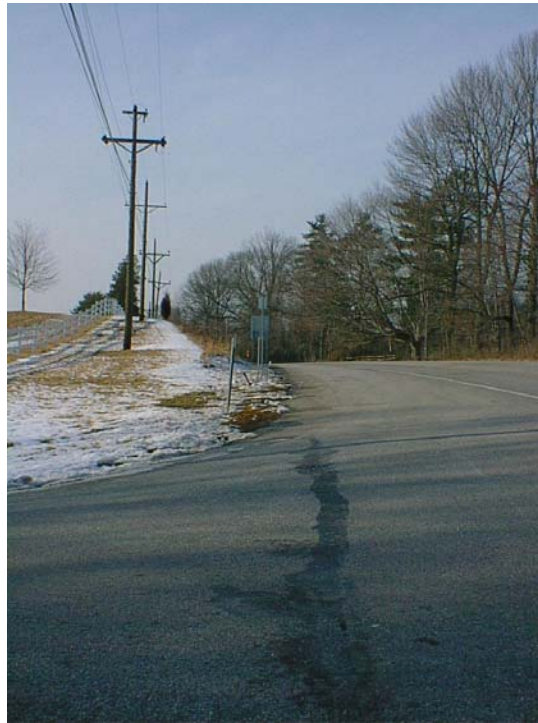
Photo 7: Looking northbound at SR 52 southbound from Snuff Mill Road, object at 400 feet north

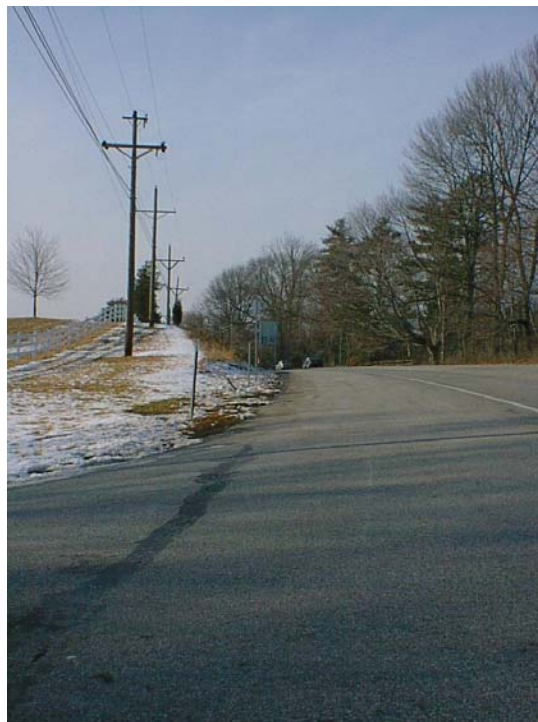
Photo 8: Looking northbound at SR 52 southbound from Snuff Mill Road, object at 425 feet north
