# **Ancillary Resources**

## ANCILLARY RESOURCES

In addition to the thirteen structures, which were intensively documented with measured drawings and detailed photographs, several other structures, objects, and resources were observed on the landscape of Camp Wright. These structures, objects, and resources are:

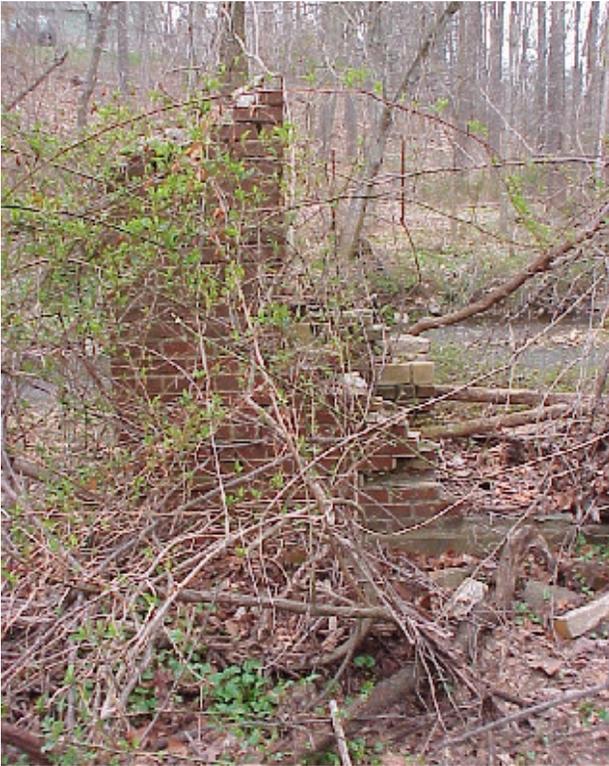
The brick barbeque is northwest of the pool building, near the bank of the stream. The barbecue is heavily damaged and overgrown. The barbeque is built mainly of extrude red bricks on a concrete base. The interior, which was once fully lined, is now only partially lined with refractory bricks (i.e. firebricks) marked WOODLAND. In front of the barbeque, two 3-foot square flagstones lie on the concrete base.

**Plate 01:** View of barbeque facing north. Note the dilapidated state of the barbeque and the shrub/scrub overgrowth.

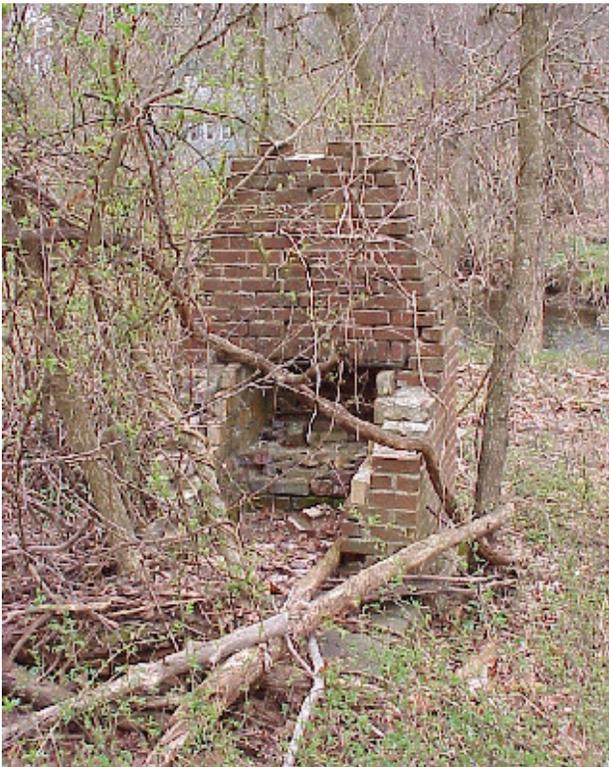
**Plate 02:** View of barbeque facing west. Note dilapidated state of the barbeque and the shrub/scrub overgrowth.

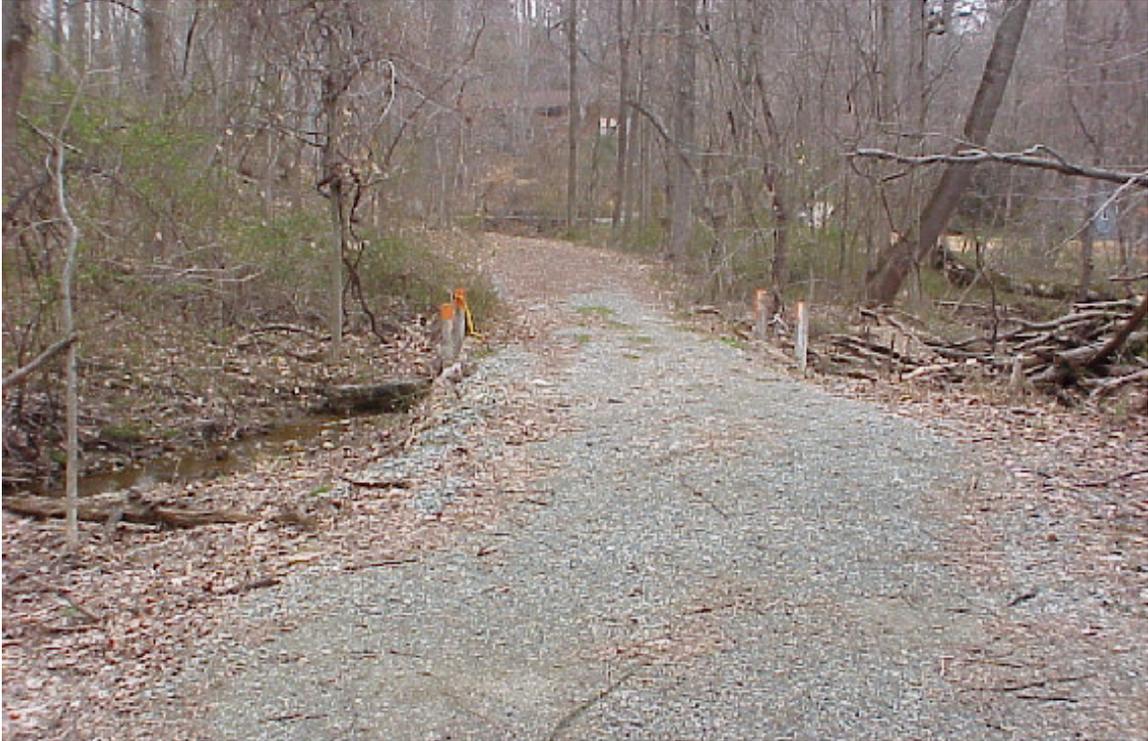
- Each post is attached by two embedded bolts.
- The posts are painted white with orange tops.
- The posts once held 1x4 inch wood side rails.
- The side rails were positioned at the top and middle of posts.

- The side rails were attached by wire nails.
- Fragments of the side rails are still extant.
- The surface of the bridge is covered with grey crush-and-run stone.

**Plate 01: View looking northeast at the old gravel driveway over the bridge.**

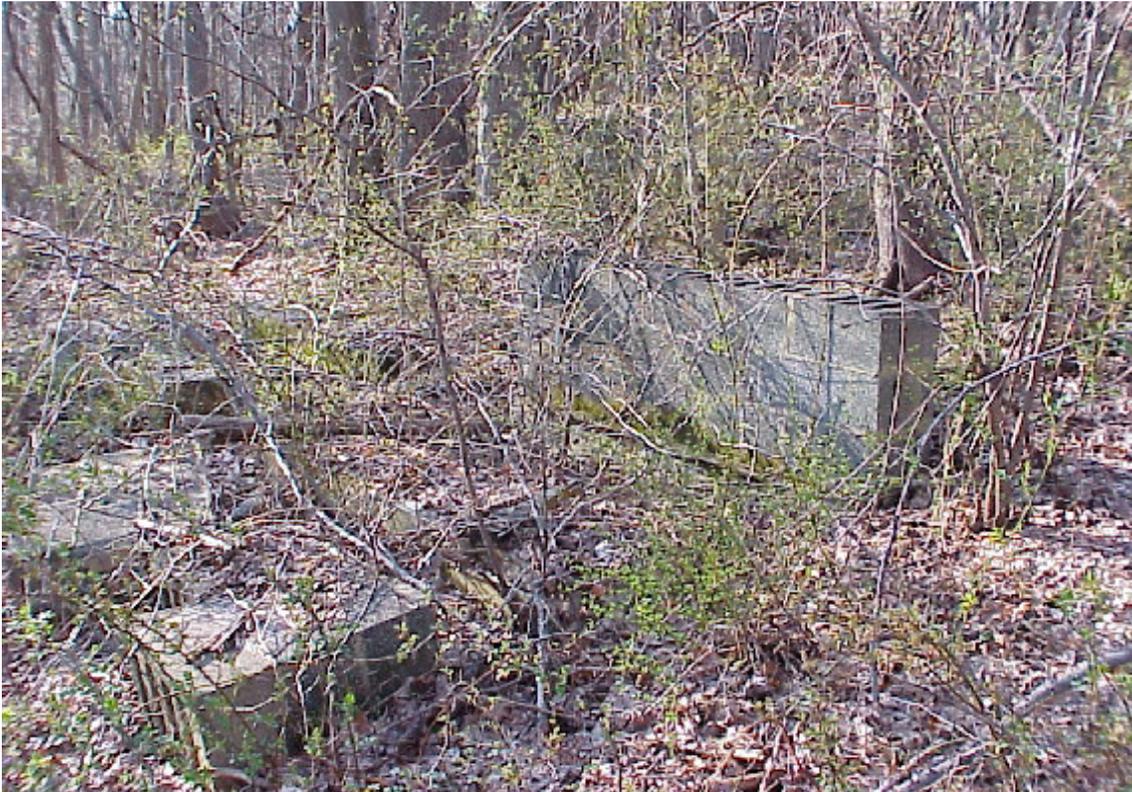
- The walls/piers of the northern pair are set 48 inches apart.
- The northern pair of walls/piers has collapsed.

**Plate 01:** View looking south at the ruins of a concrete foundation. Note the foundation consists of two pairs of supports.

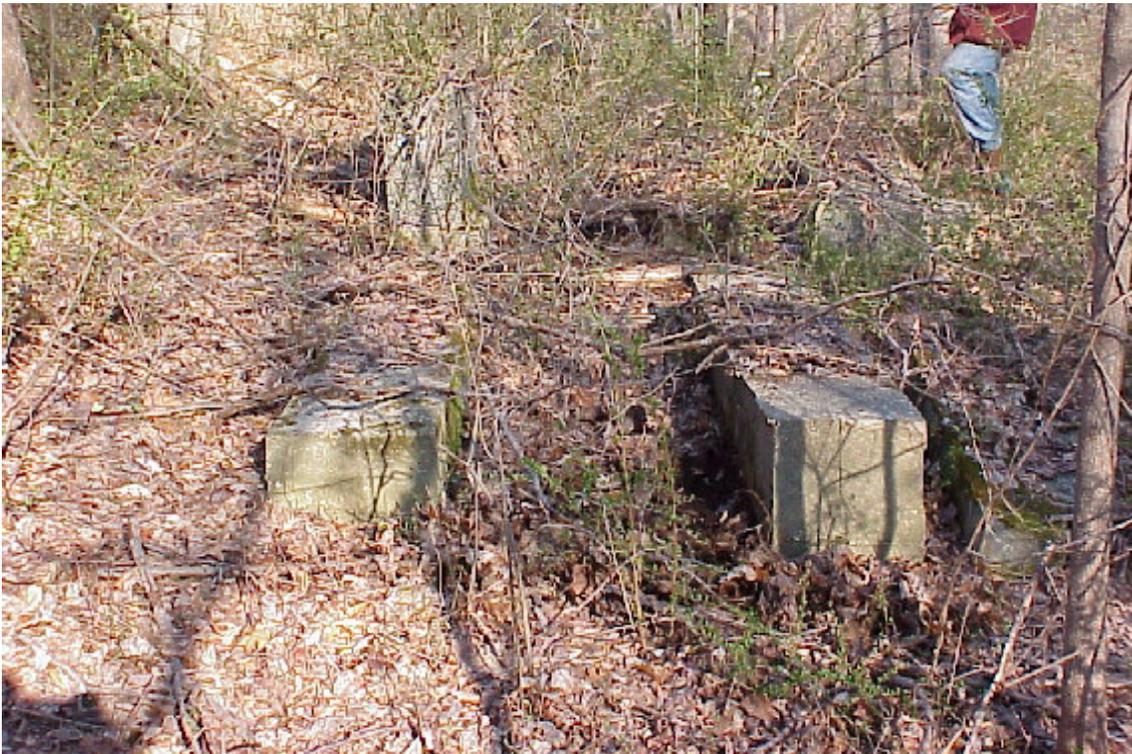
**Plate 02:** View looking northwest at the ruins of a concrete foundation. Note the foundation consists of two pairs of supports.

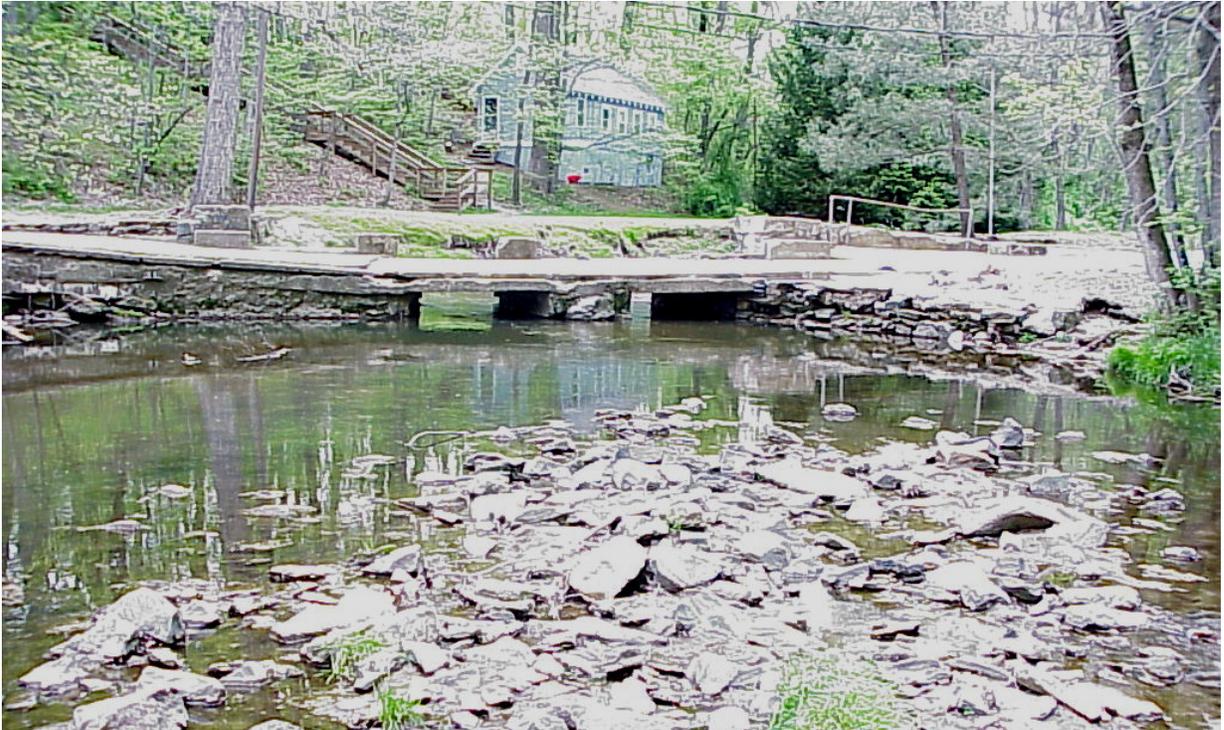
- The concrete along eastern edge of the current bridge is chipped and in many places, an older bridge surface is exposed.
- The current surface layer of concrete is 4.5 inches thick.

- The older bridge surface has two 1.5-inch holes near the edge.
- The heavily-eroded remains of a 15-foot long stone wall extends from the east side of the bridge and along the northern bank Mill Creek.

- There are two areas of roughly poured concrete on top of and behind the eroded stonewall. The concrete appears to overlay a large, highly angular, grey stone. The placement of the concrete and stone appears to have been an attempted erosion control measure.

**Plate 01: View looking west at the Main Access Bridge.**

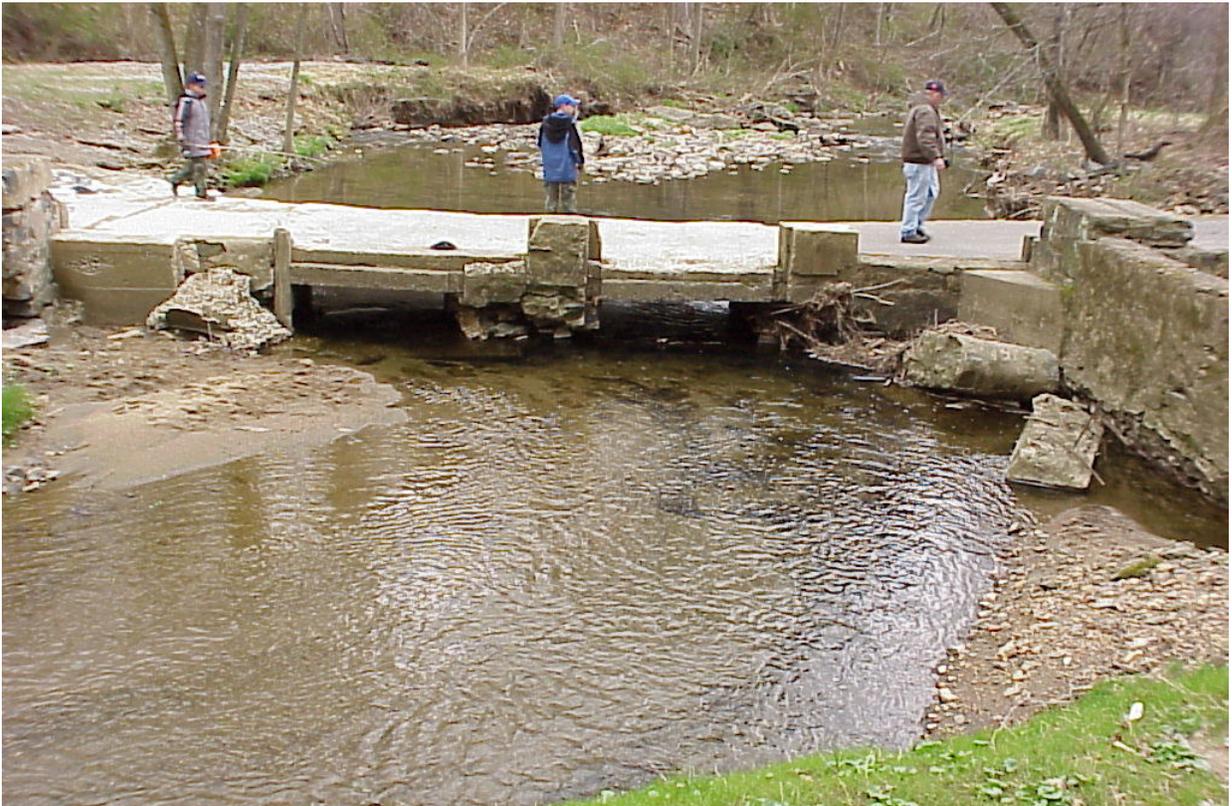
**Plate 02: View looking east at the Main Access Bridge.**

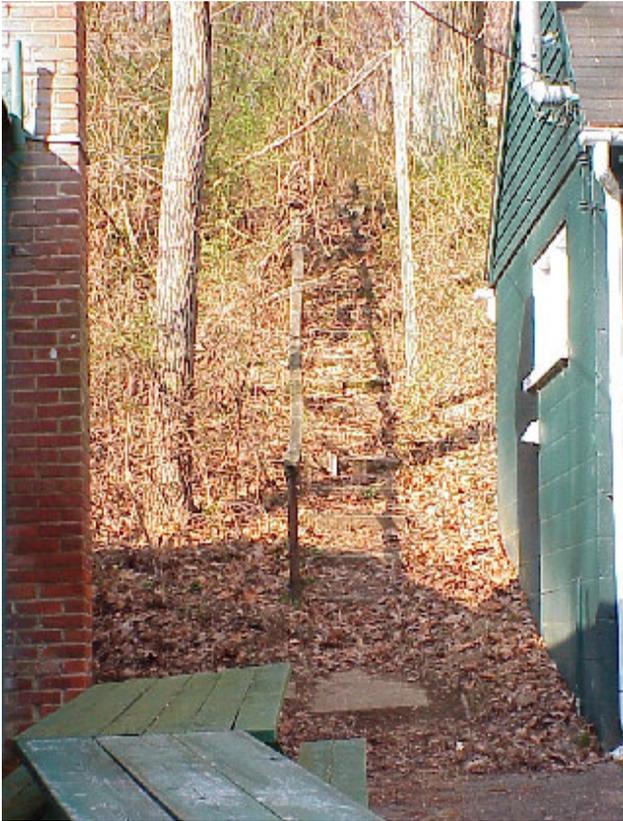
The Old Concrete Stairs have nineteen concrete. The stairs have long been out of use. Several of the steps have been displaced by root activity.

**Plate 01:** View looking southwest at the old concrete stairs.

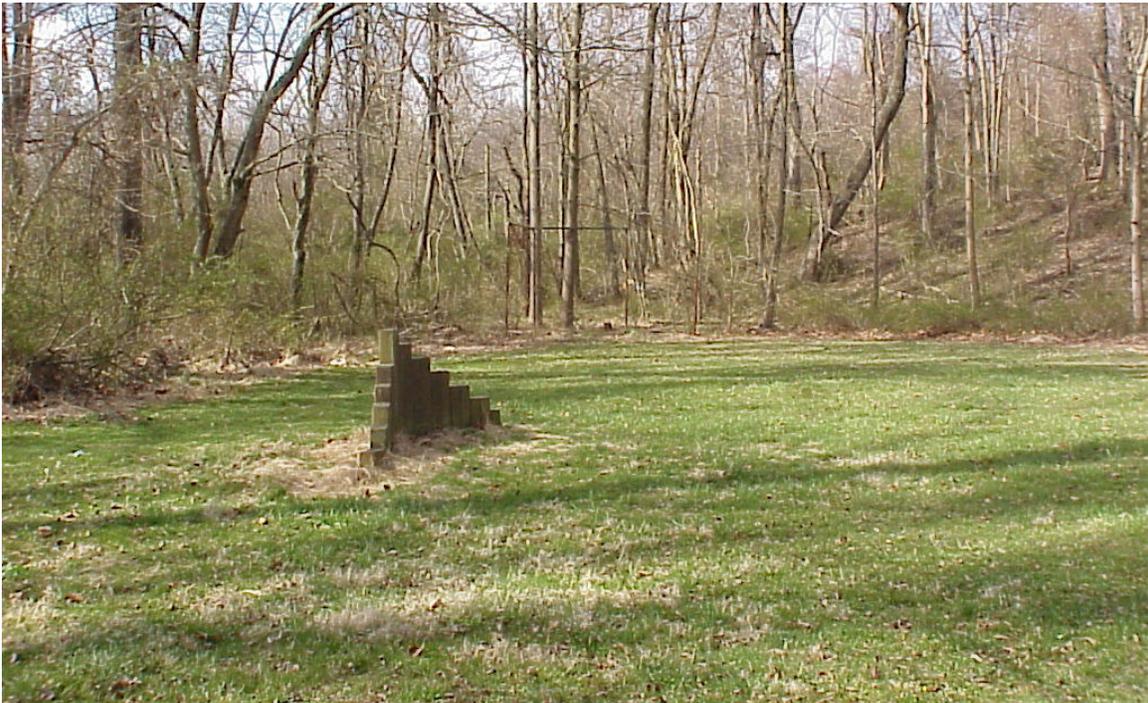
80 feet west of Stepper. The baseball/softball backstop and the area around and in front of it are not maintained. Baseball/Softball has not been played here for many years.

**Plate 02:** View looking southwest at the western most piece of playground equipment (the stepper) and baseball/softball backstop frame.
