HISTORIC AMERICAN BUILDINGS SURVEY

GEORGE MURPHY HOUSE

HABS No. DE-284

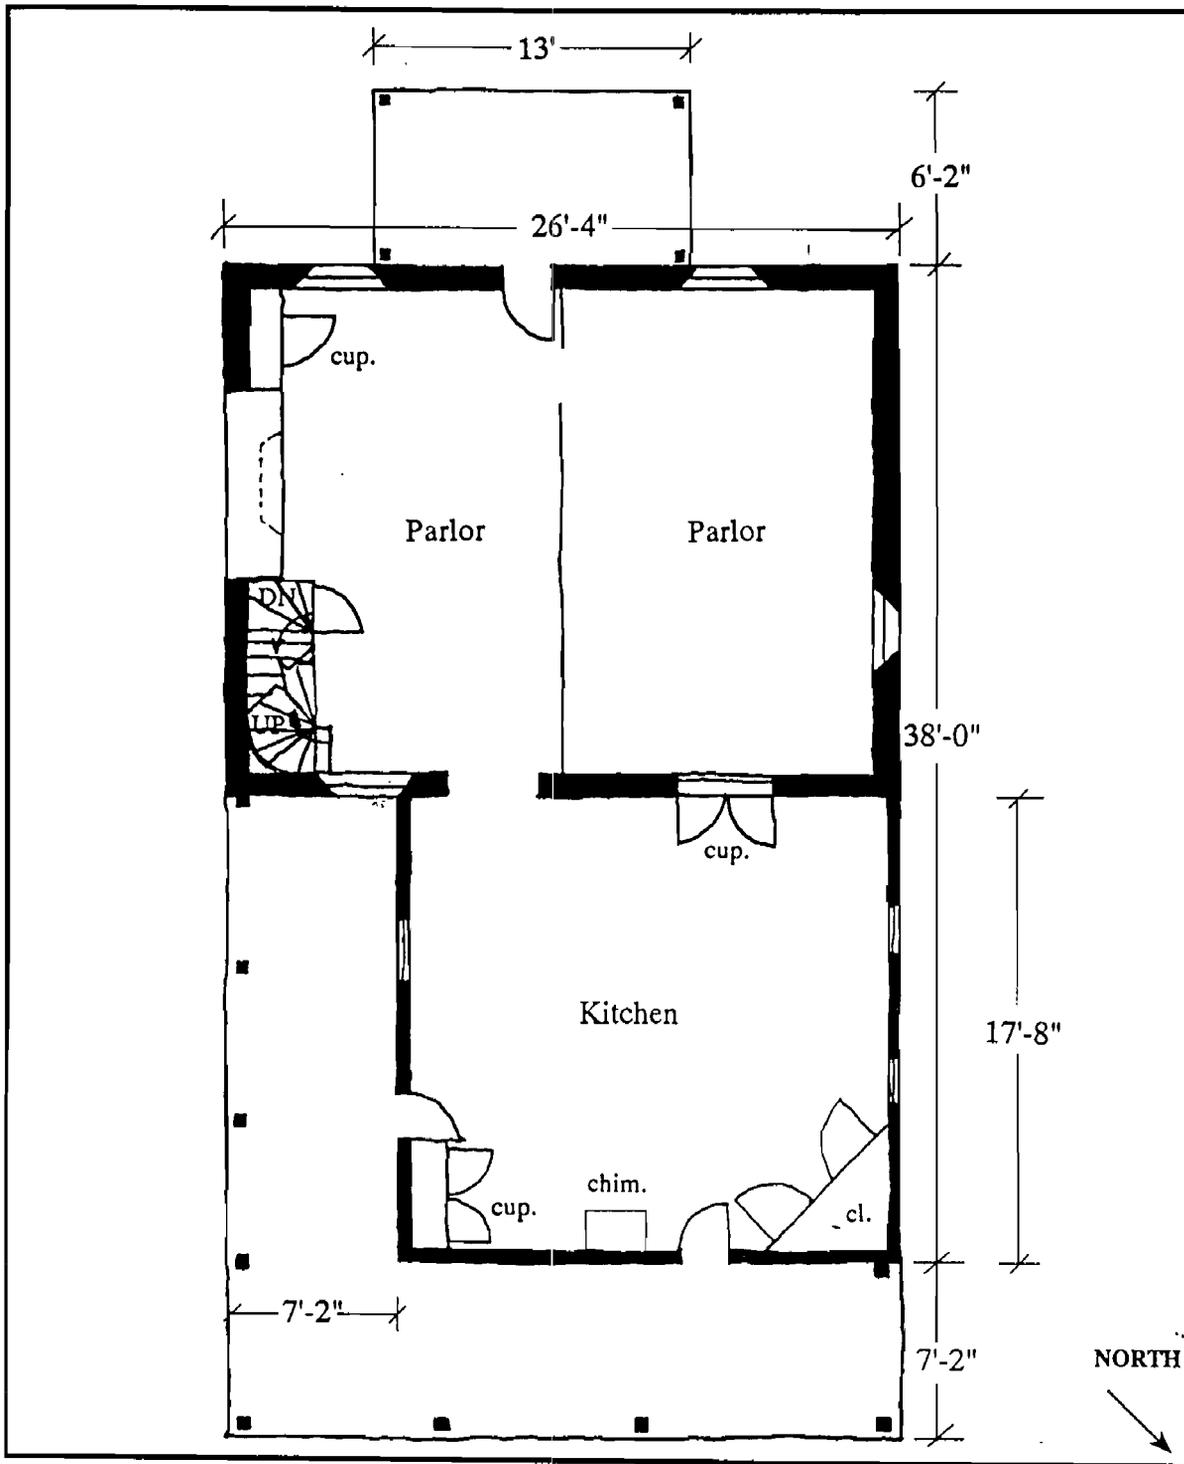
First Floor Plan
Not to Scale
Date Drawn: 1993
Prepared By: Jill Cremer
Source: Physical inspection

The first floor of the house contains two equal-sized parlors within the front section and a large kitchen room within the rear wing. The east parlor contains the main entrance off the front porch, a fireplace, the stairs to the basement, the stairs to the second floor, and the doorway to the rear wing. The west parlor is accessed through a doorway from the east parlor. Evidence of a fireplace or chimney stack in the west parlor has been removed. The rear kitchen room contains numerous built-in cupboards, a chimney stack on the north wall, and two doors leading to the east and north legs of the rear porch.

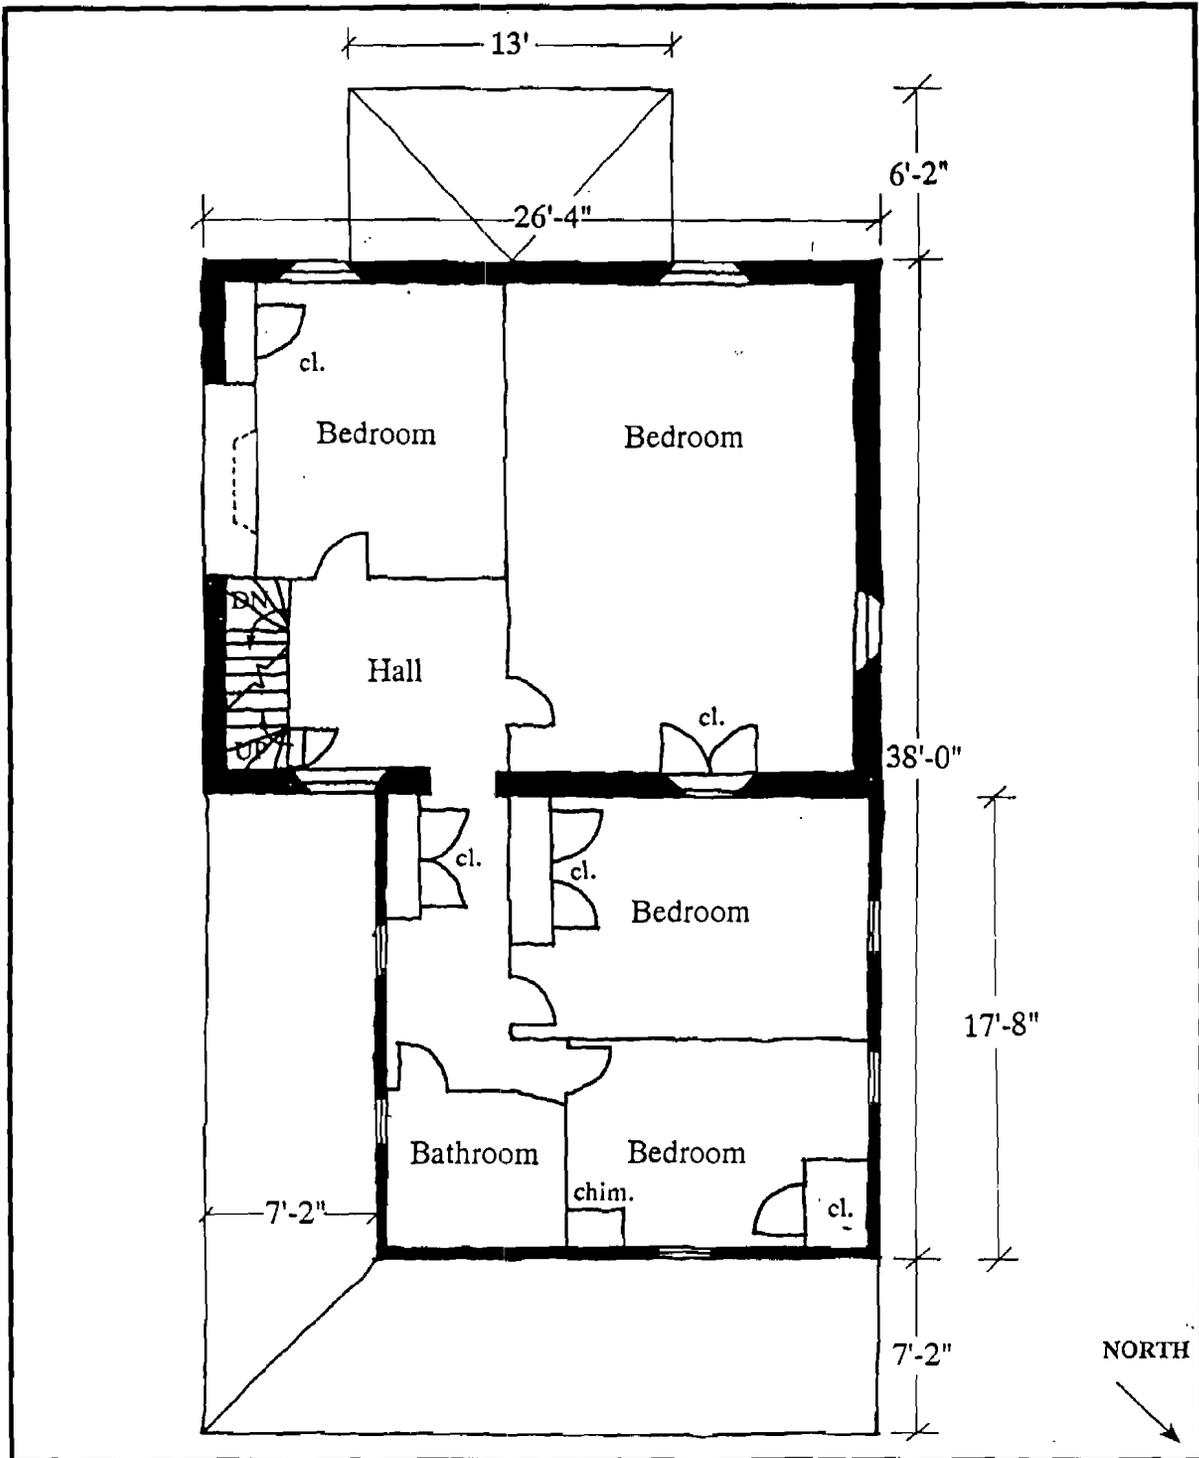
Second Floor Plan
Not to Scale
Date Drawn: 1993
Prepared By: Jill Cremer
Source: Physical inspection

The second floor of the house contains a hall and two bedrooms within the front section, and a hall, two bedrooms, and a bathroom within the rear wing. The front hall is located in the northeast corner of the front section and accesses the two front bedrooms, the rear wing, the stairs to the first floor, and the stairs to the attic. The bedroom to the south of the hall contains a built-in closet and a fireplace. The bedroom to the west corresponds in size to the west parlor beneath it. The rear hall is located in the southeast corner of the rear wing and accesses two bedrooms to the west and a bathroom to the north. The hall and bedrooms contain built-in closets, and a chimney stack is visible in the northwest bedroom. The attic is essentially one large space, while the basement is divided into several sections, separated by load-bearing foundation walls. Further information on floor and room layouts is presented in the attached sketch floor plans.
