CULTURAL RESOURCE SURVEY
MAIN BUILDING FORM

CRS # N05184.01

1. ADDRESS/LOCATION: 551 Boyds Corner Road
2. FUNCTION(S): historic dwelling current dwelling
3. YEAR BUILT: 1800 CIRCA?: X ARCHITECT/BUILDER: unknown
4. STYLE OR FLOOR PLAN: vernacular; side gable with ell

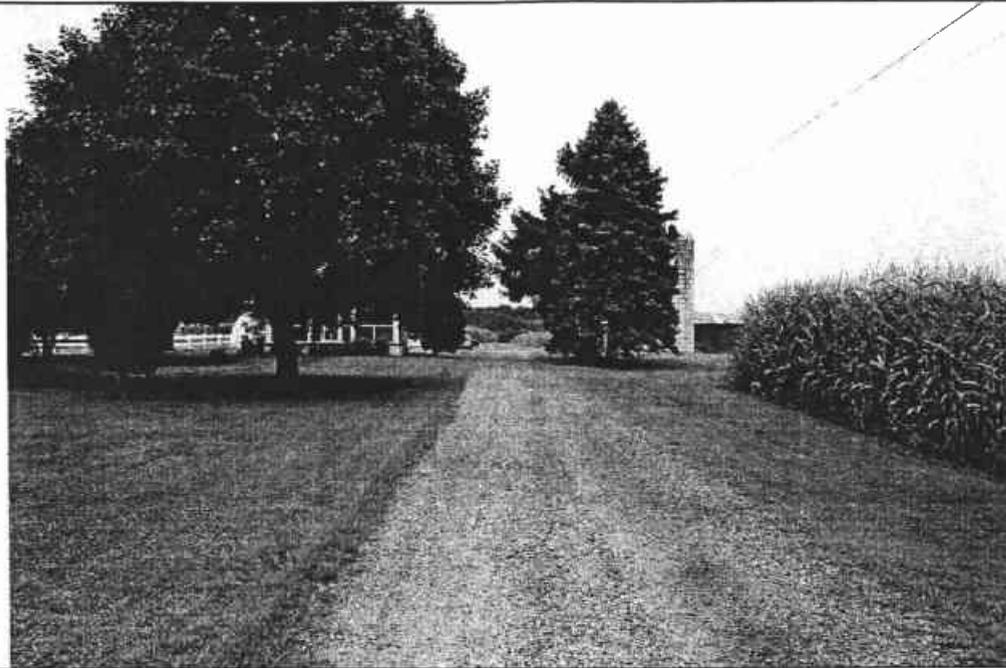
N05185. Photograph 1: Robinson House, view looking south. Note that the dwelling and house lie on the east side of the farm lane, while the agricultural outbuildings are located on the west side. Also note that the farm lane continues south towards the tree line in the far distance and once accessed a farmstead to the southeast.

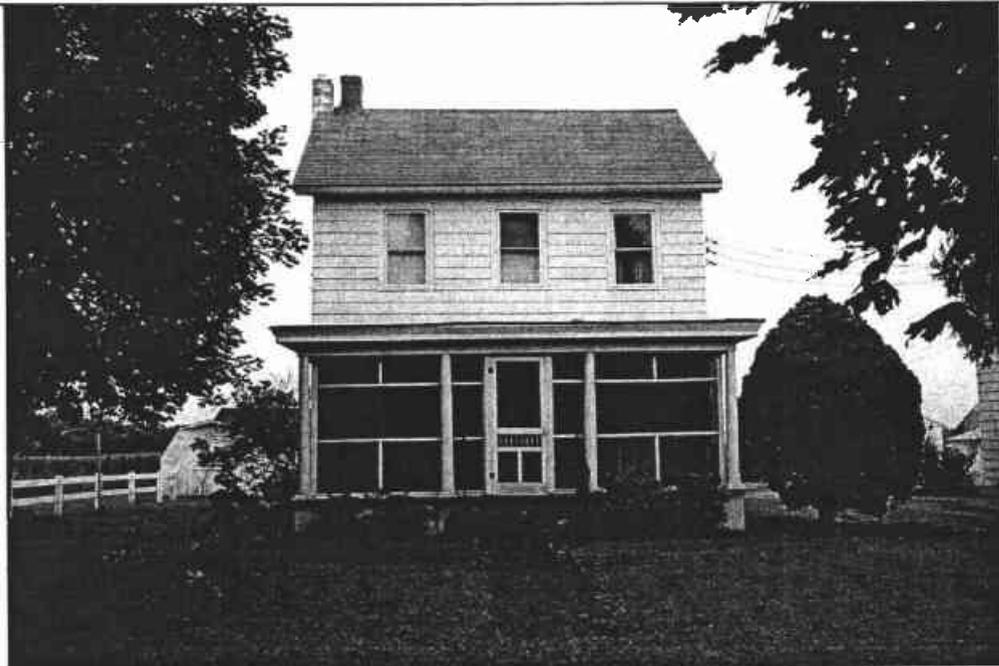
N05185. Photograph 2: Dwelling, north elevation, view looking south. Note the dwelling's three bays, the simple fenestration pattern and the ca. 1920 porch. The post-1962 shed is visible to the left of the dwelling.

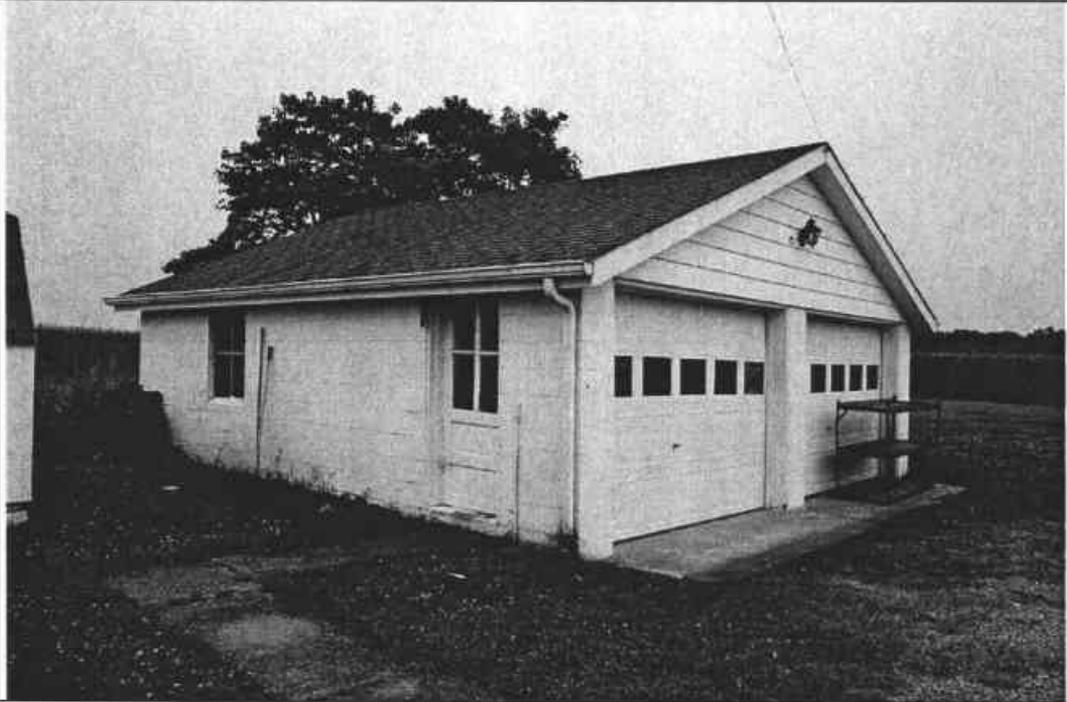
N05185. Photograph 3: Garage, north and west elevations, view looking southeast. Note the modern, overhead garage doors on the west elevation and the pedestrian entry on the north elevation.

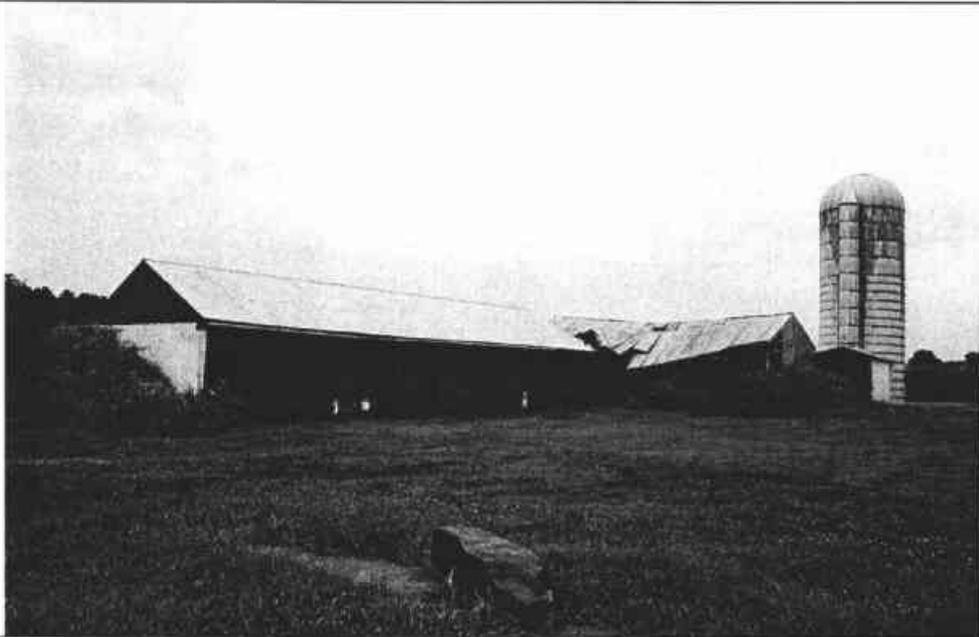
N05185. Photograph 4: Equipment shed/cow barn, south and east elevations, view looking northwest. The cow barn is partially collapsed. Note the silo and attached feed house in the background.

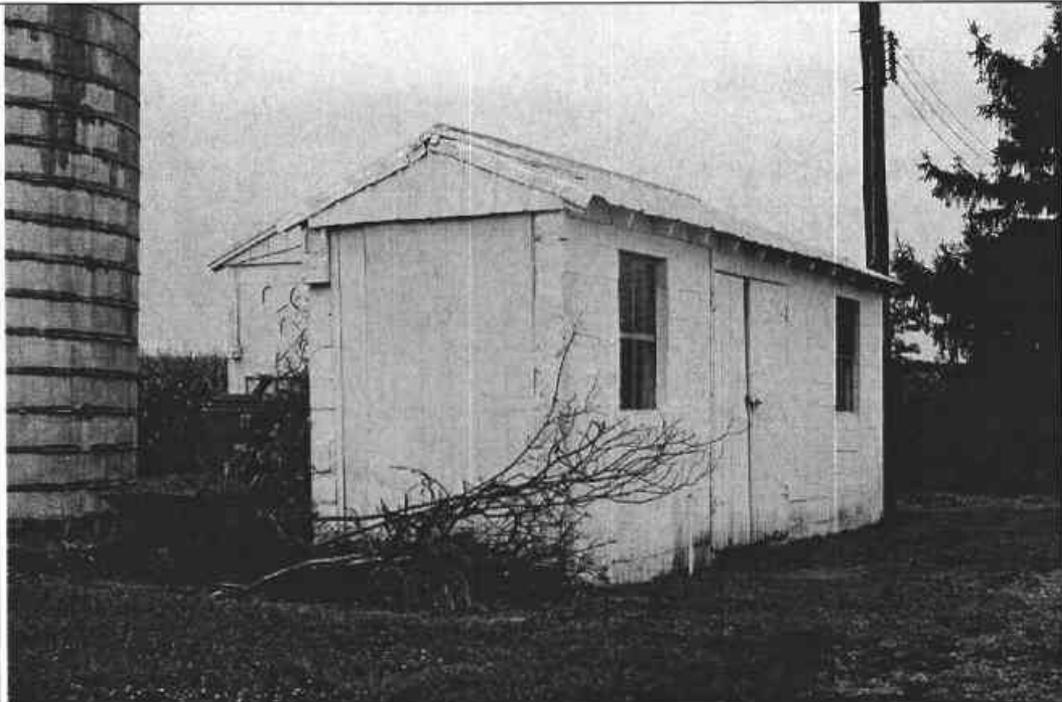
N05185. Photograph 5: Milkhouse, south and east elevations, view looking northwest. Note batten double doors on the east elevation and the closed entry on the south elevation.

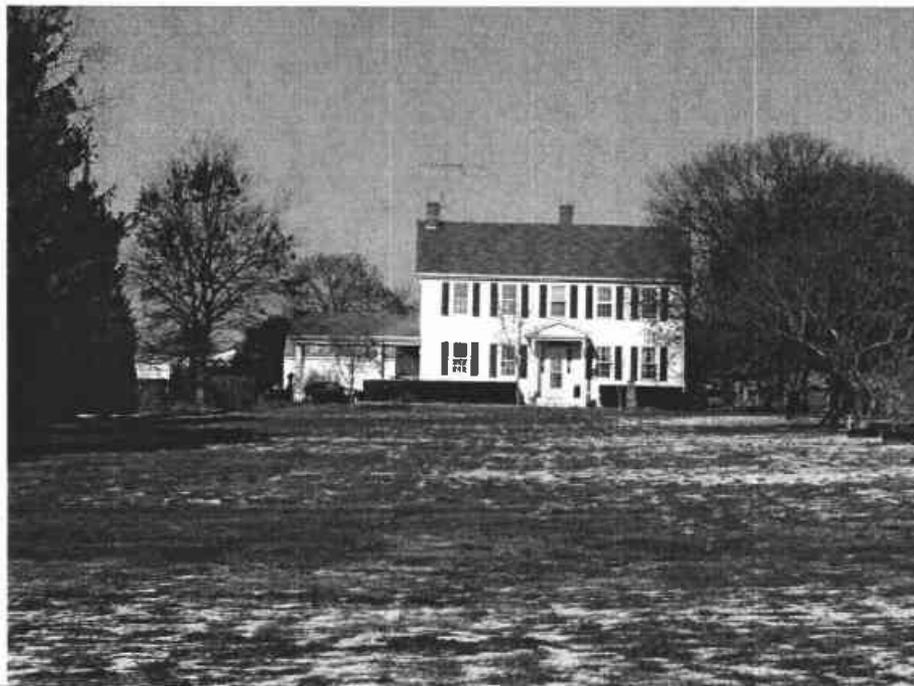
N05186. Photograph 1: Dwelling, south elevation, view looking north (May 2003). Source: New Castle County Department of Land Use.

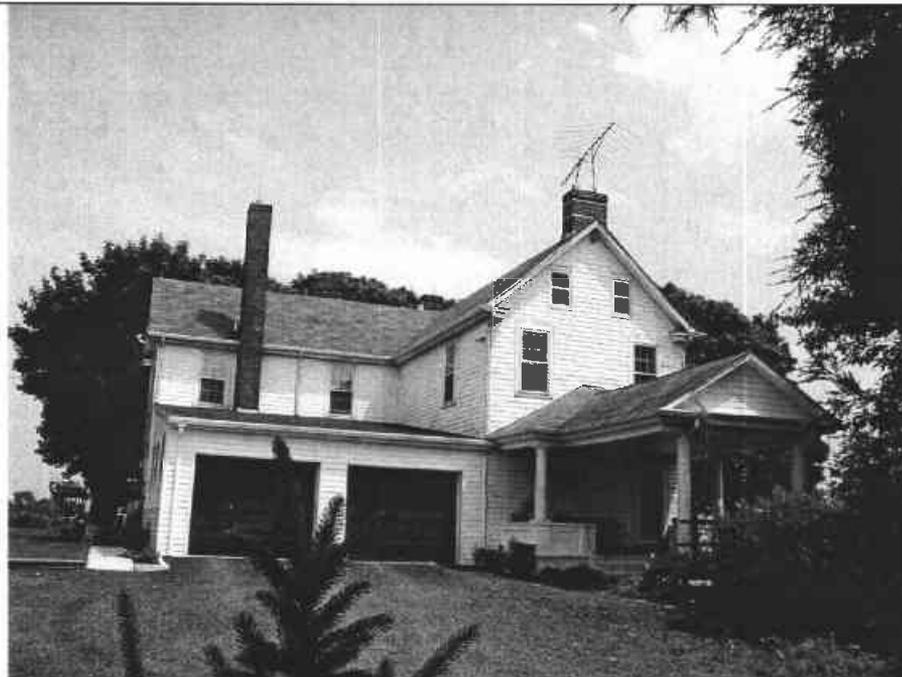
At the time the dwelling was determined eligible in 1988, it retained its six-over-six double hung sash, which has been replaced with vinyl sash. Additionally, the large two-car garage and deck additions to the rear ell were not present in 1985. Thus, due to the encasement of the walls, cornice, and roof in synthetic siding, the replacement of the original windows, addition of vinyl shutters, and the construction of two post-1985 additions on the rear ell of the house, the dwelling does not appear to retain sufficient integrity of design, materials, and workmanship to be considered eligible. These changes to the physical features of the dwelling have also affected the building's ability to present the feeling of a historic farmhouse.

N05186. Photograph 2: Dwelling, west elevation, view looking east. Note large two-car garage addition to rear ell (May 2003). Source: New Castle County Department of Land Use.

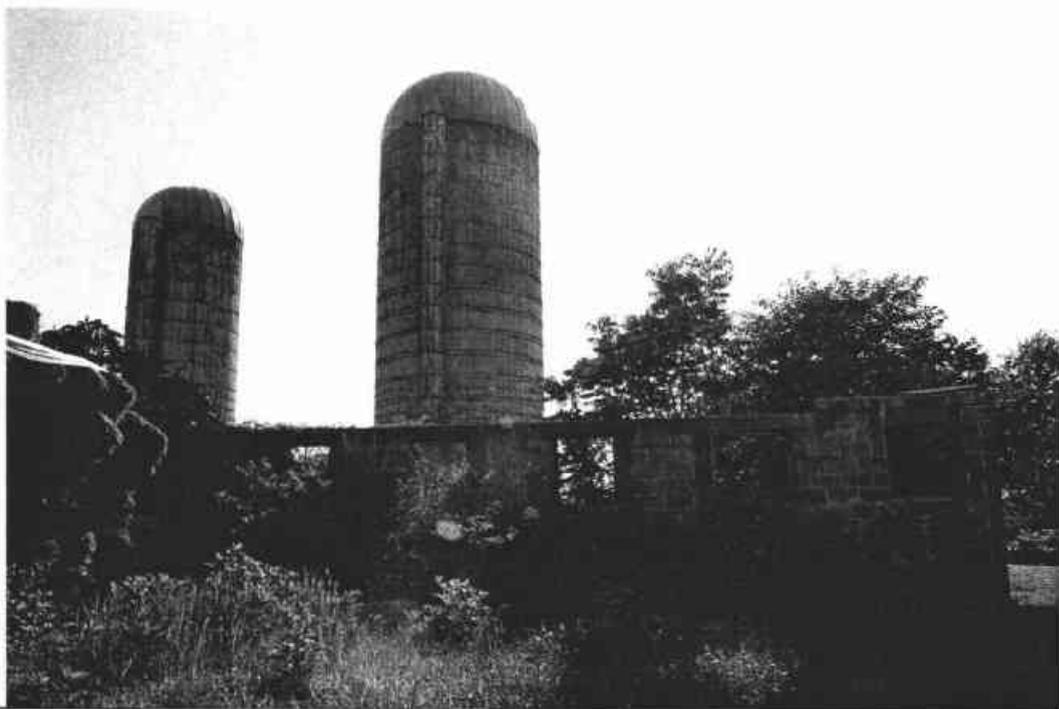
N05186. Photograph 3: Cowshed addition to barn, view looking east. Note only extant wall.

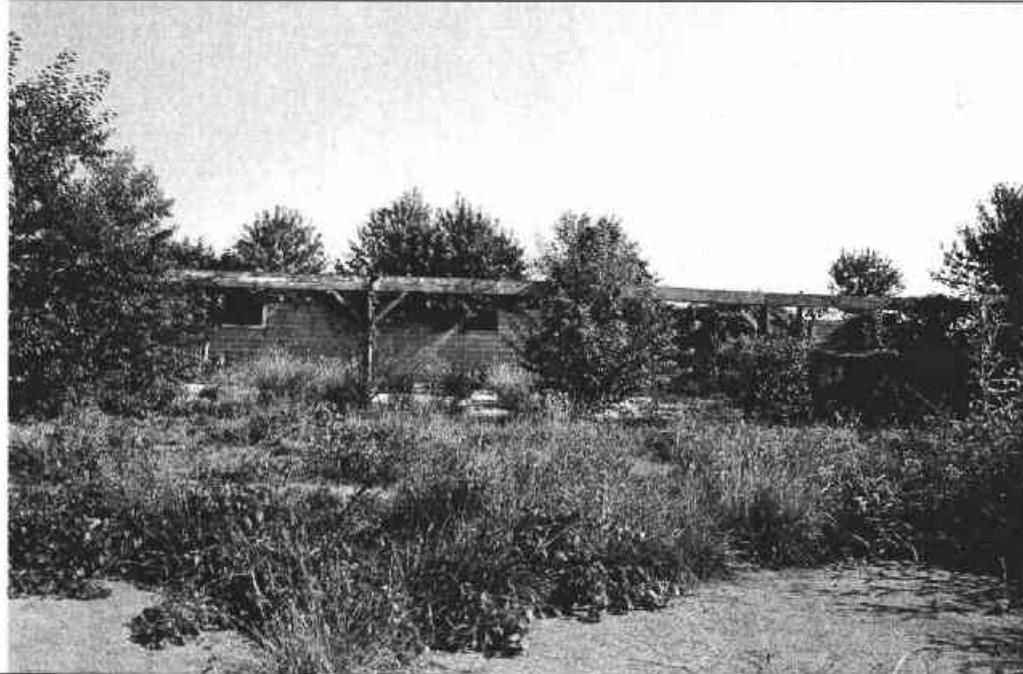
N05186. Photograph 4: Ruins of machine shed 3, view looking north.

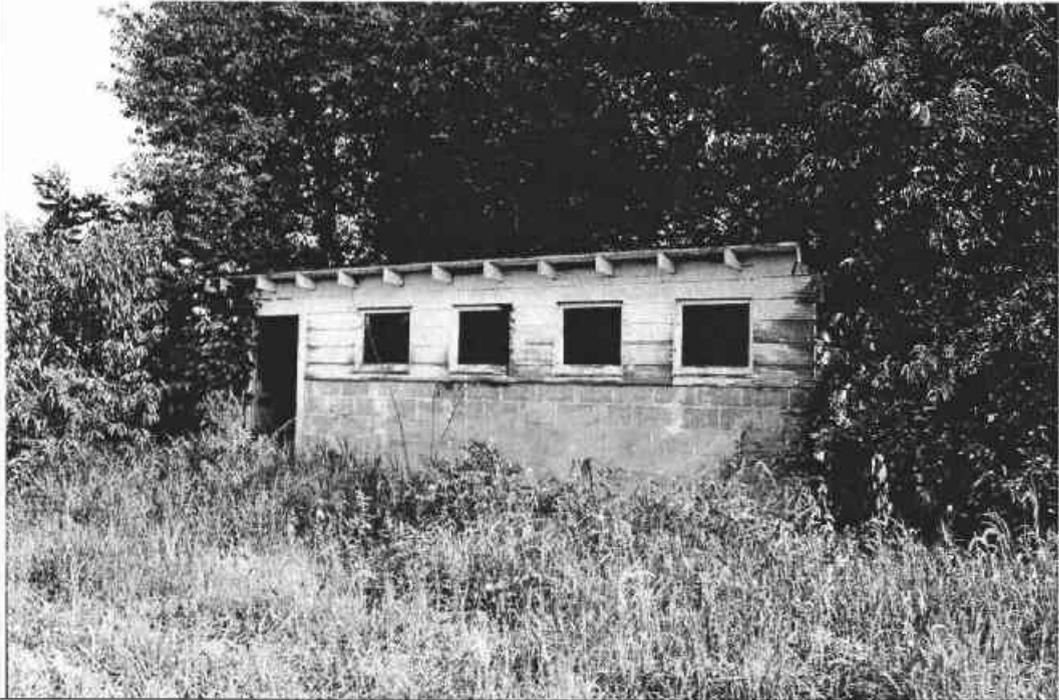
N05186. Photograph 5: Piggery, south elevation, view looking north.

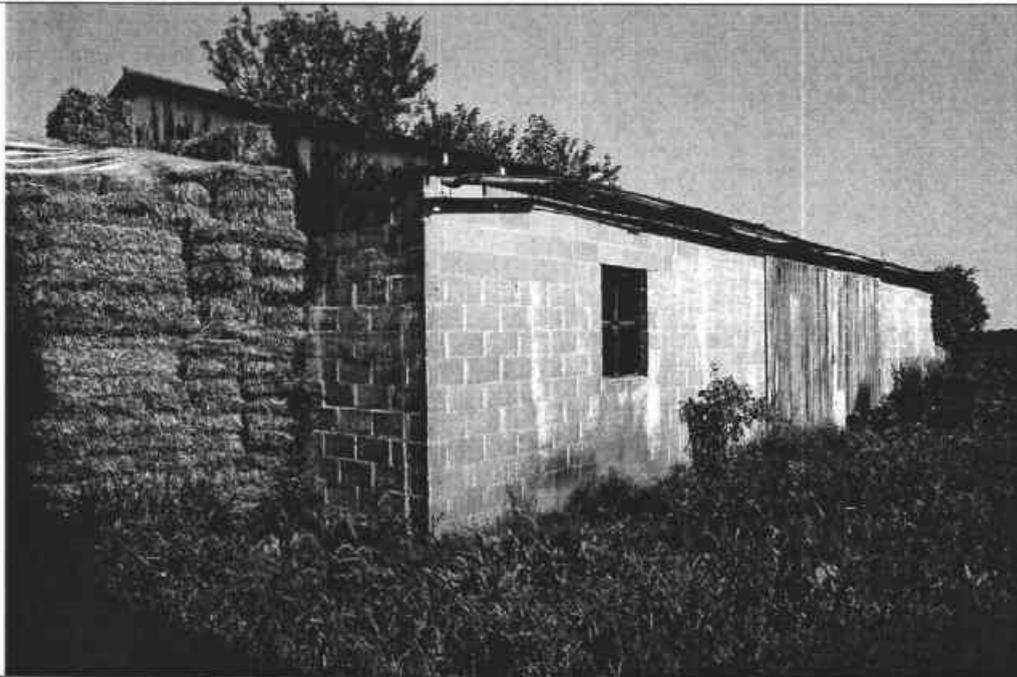
N05186. Photograph 6: Machine shed 2, south and east elevations, view looking northwest.

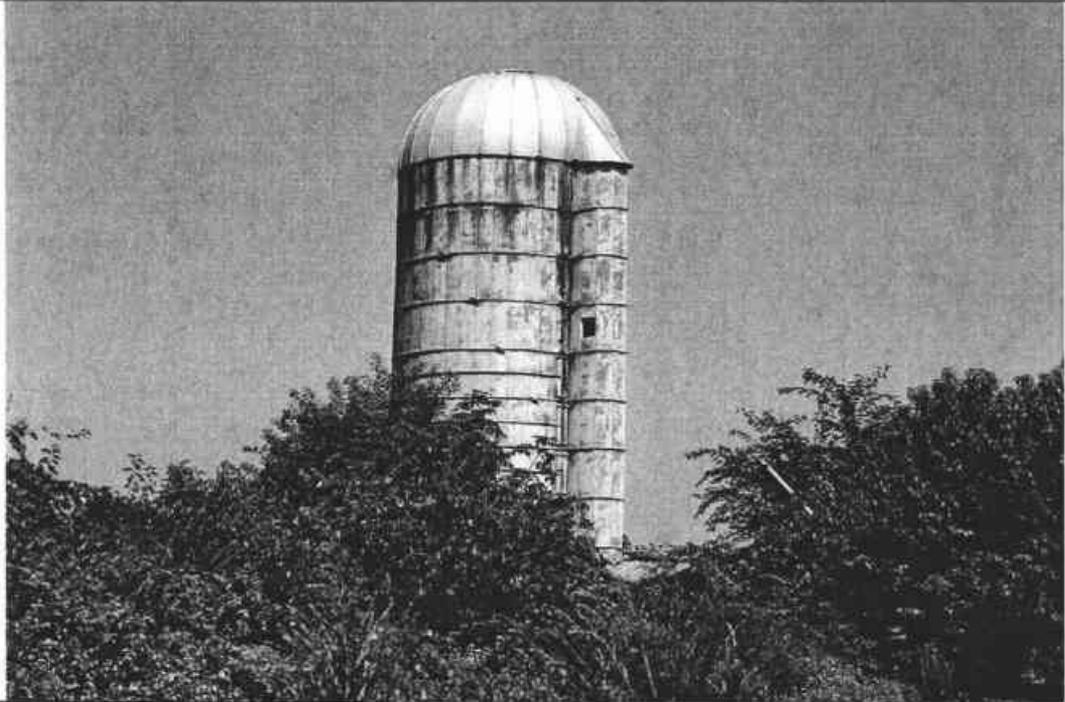
N05189. Photograph 1: View looking north. Photograph of the concrete silo with the remains of the original barn in the foreground. The barn remnants are heavily overgrown.

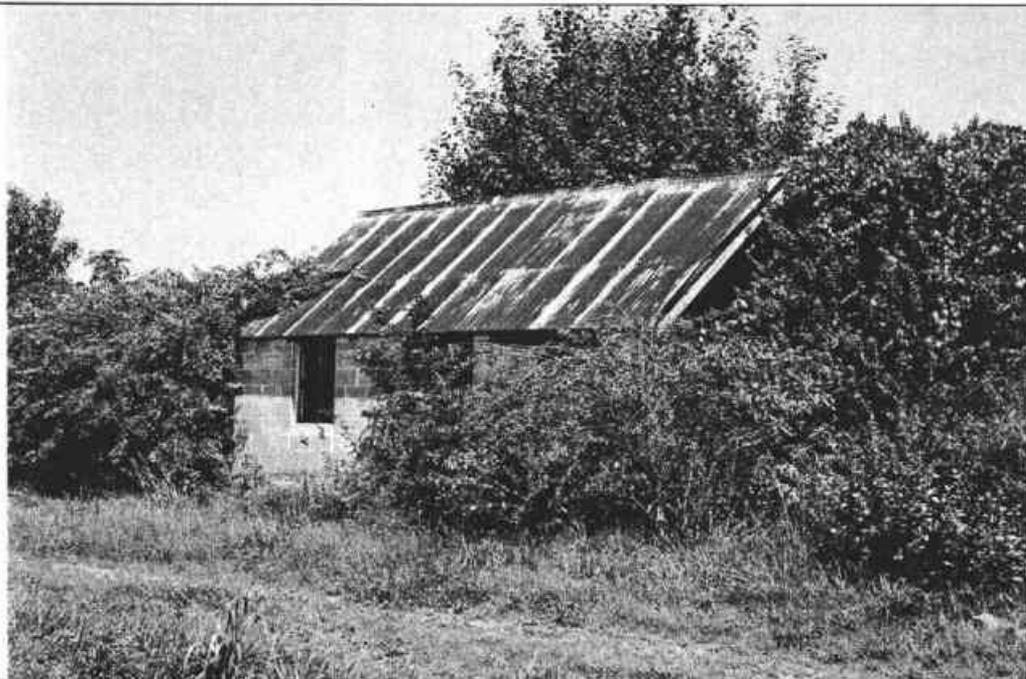
N05189. Photograph 2: View looking northwest. Photograph of the extant milkhouse. This concrete block structure was once connected to the barn which is no longer extant. The building is heavily overgrown with vegetation.

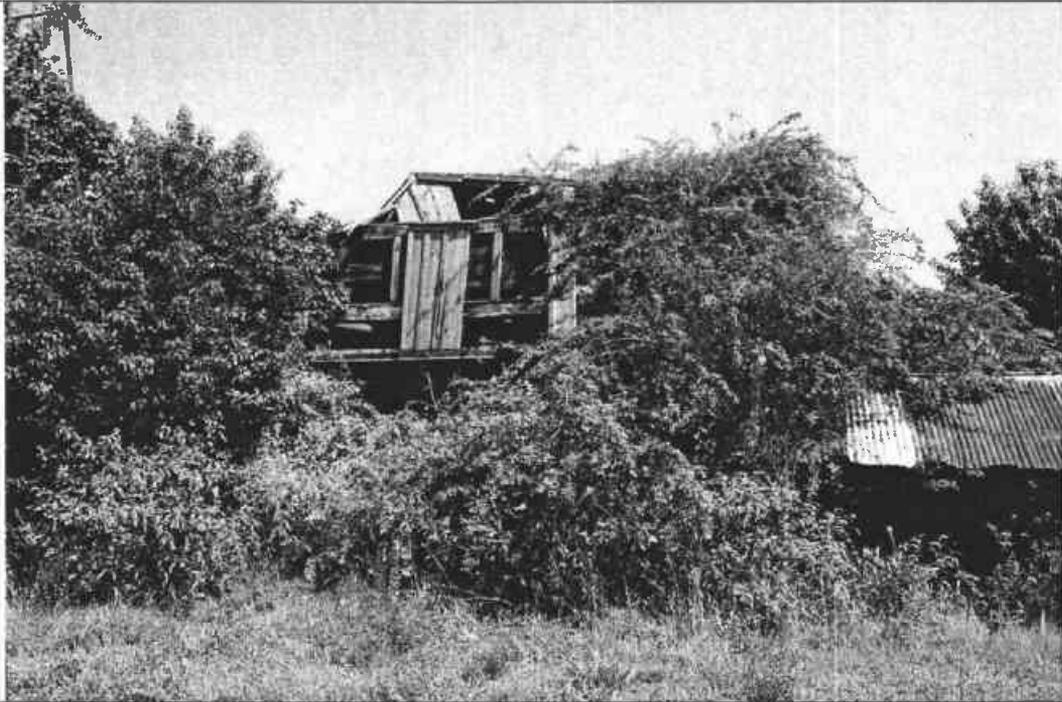
N05189. Photograph 3: View looking north. Photograph showing the remains of the collapsed carriage house. The building is heavily overgrown and is in a state of disrepair.

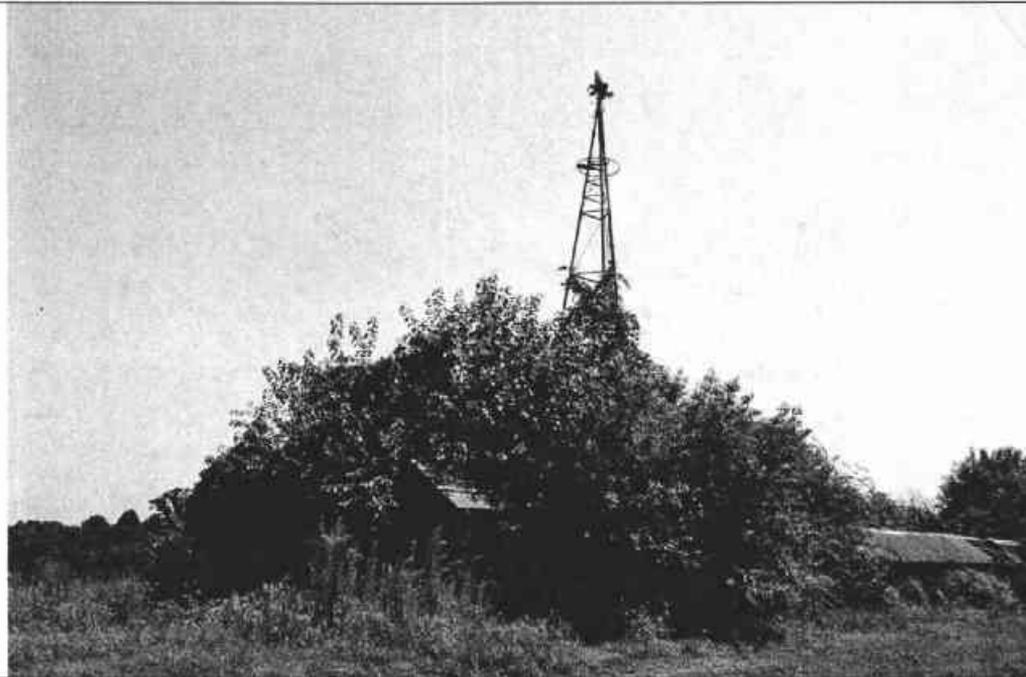
N05189. Photograph 4: View looking northeast. Photograph showing the remnants of the powerhouse/windmill. The windmill is no longer in working order and the powerhouse has fallen into disrepair. The building is heavily overgrown with vegetation.

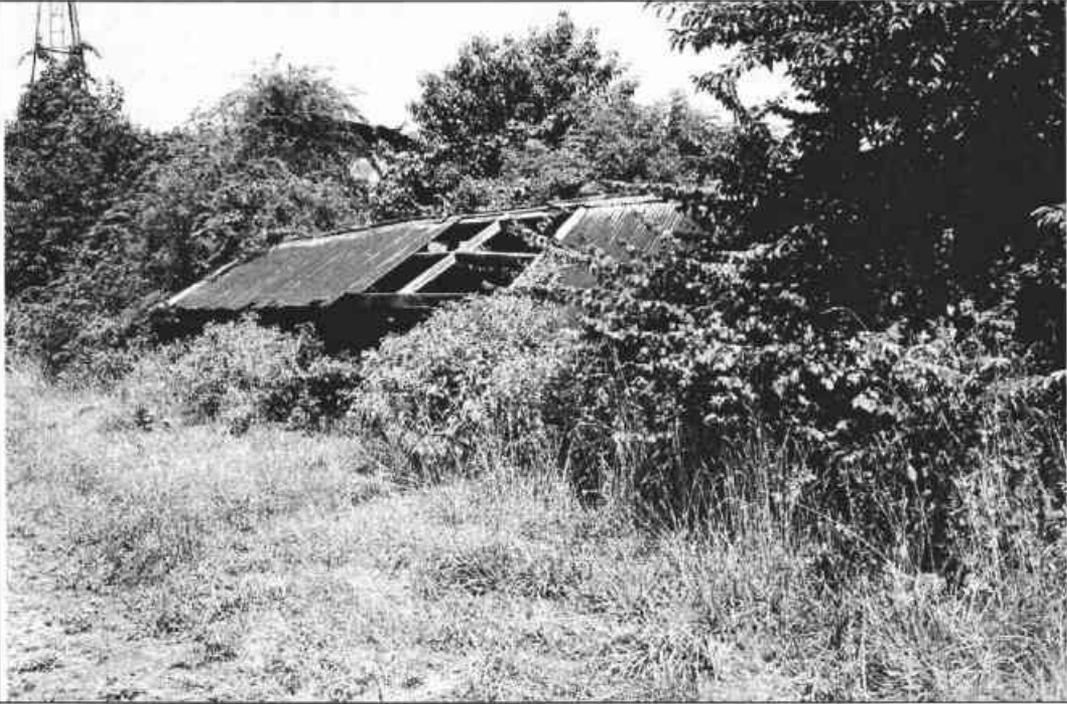
N05189. Photograph 5: View looking northwest. Photograph showing the remains of the equipment shed. This building is heavily overgrown with vegetation and has fallen into a state of disrepair.
