APPENDIX

February 23, 2004

Re: Laurel Train Station
Roofing Condition Assessment Report

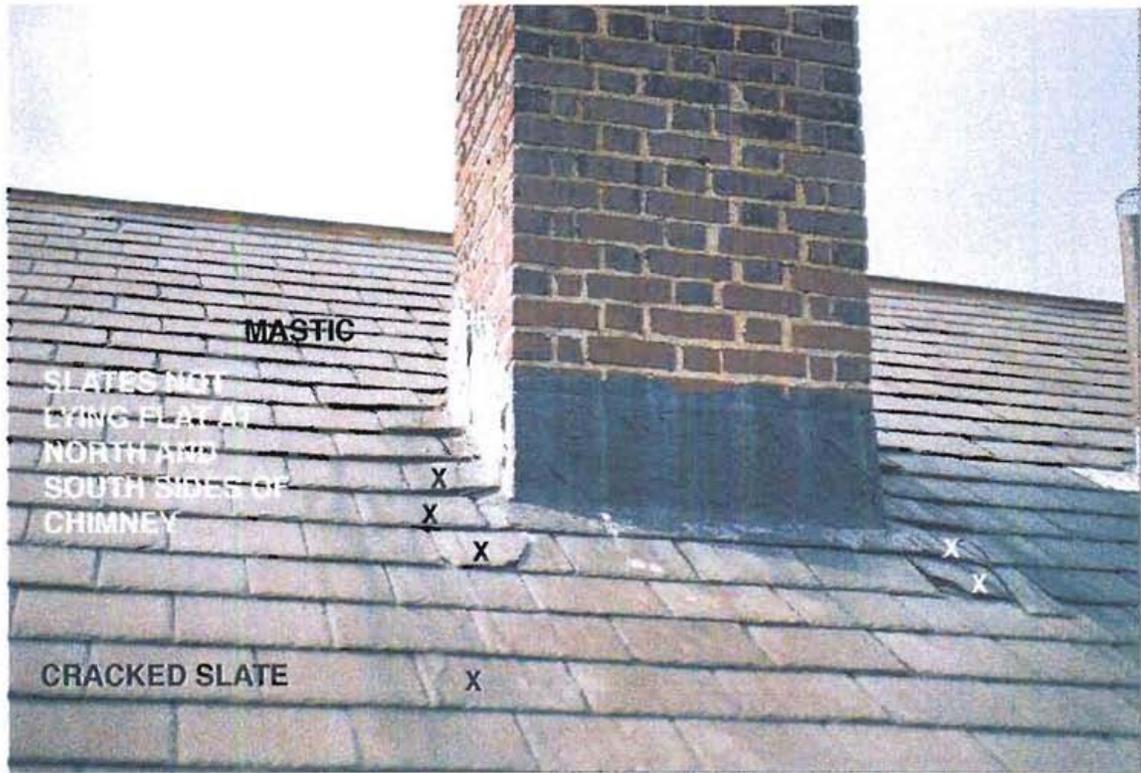
Photo 1

Roof decking and framing consists of solid wood boards measuring 5 to 6 inches in width on wood rafters spaced at approximately 2 feet on center. There is no wood ridge pole. Wood kickers nailed to the rafters create the subtle change in roof slope at the eaves. The wood rafters have sagged slightly, except for those on the east slope located adjacent to the north and south faces of the chimney. As a result, slate shingles abutting the north and south sides of the chimney are no longer laying flat (Photograph No. 1).

Given the simplicity of the roof, flashings are limited to the chimney, a soil pipe, a ridge, rakes, and hips. In short, these flashings are either non-existent or in poor condition. The chimney's north, south, and east base and counterflashings are covered with roofing cement (see Photograph No. 1). The chimney's west cricket is constructed of terne metal that has not been painted in many years and, as a result, is rusting. The lone soil pipe is located immediately north of the chimney. Its flashing is secured to the roof deck with exposed screws and rises only about 6 inches up the pipe, where a sealant joint has failed. The north-south running ridge is covered with a terne metal flashing that is severely corroded (Photograph No. 5). The building's hips and rakes have no flashings. Should a new roof be installed, a copper drip edge should be installed at the rakes. Mastic covers most of the slate hip shingles (Photograph No. 6). In some locations, the roof deck is visible through a gap between the hip slates. These shingles should be removed and replaced and copper or lead flashings interwoven with each course as the new slate is reinstalled.

4. Remove all existing chimney flashings and install new copper base flashings, counterflashings, an apron flashing, and a cricket. Remove, salvage, and reinstall slate shingles as required for the installation of the new flashings. Assume 5% breakage and replacement with new, salvaged slate shingles. Remove existing mastic from face of brick units located adjacent to reglets. Fill reglets with mortar. See also recommendation no. 13 (chimney rebuilding).

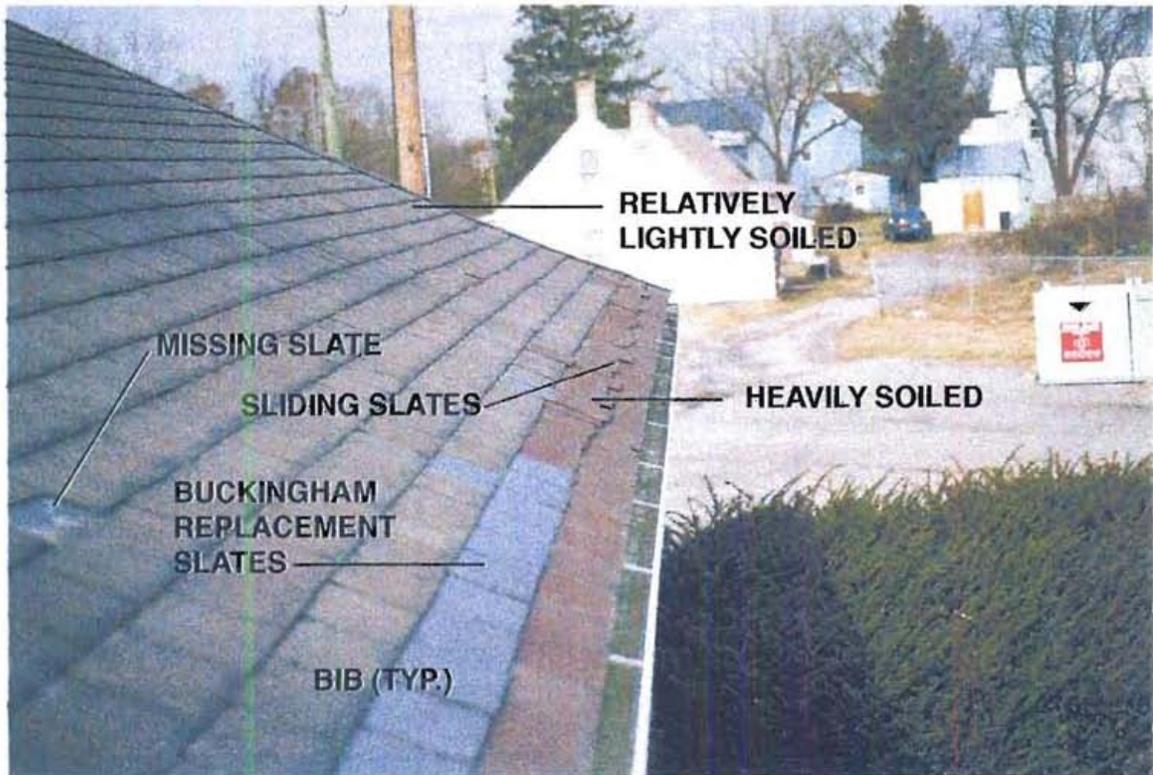
Photo 2

The roof's slate shingles are held in place with 1-1/2 inch long galvanized roofing nails with 3/8 inch diameter heads. The few nails I was able to observe were in good condition and there is no evidence above the first 3 to 4 courses at the eaves to suggest that the nails are failing. Displaced and sliding slates in the first 3 to 4 courses are likely due, not to corroding nails, but rather to poorly executed past repairs. In fact, based on the number of copper bibs present, the presence of mismatched replacement slates, the aluminum gutters, the presence in the field of a slate that was cut to be adjacent to a hip, and the inconsistent mixing of lightly stained and deeply stained original slates, I believe that the bottom 4 or 5 courses of slate were stripped and re-laid some time ago (Photograph Nos. 2 and 3, see also footnote number 3, below).

2. Remove all displaced slates from the first 4 courses at the eaves and reinstall (assume 50%).

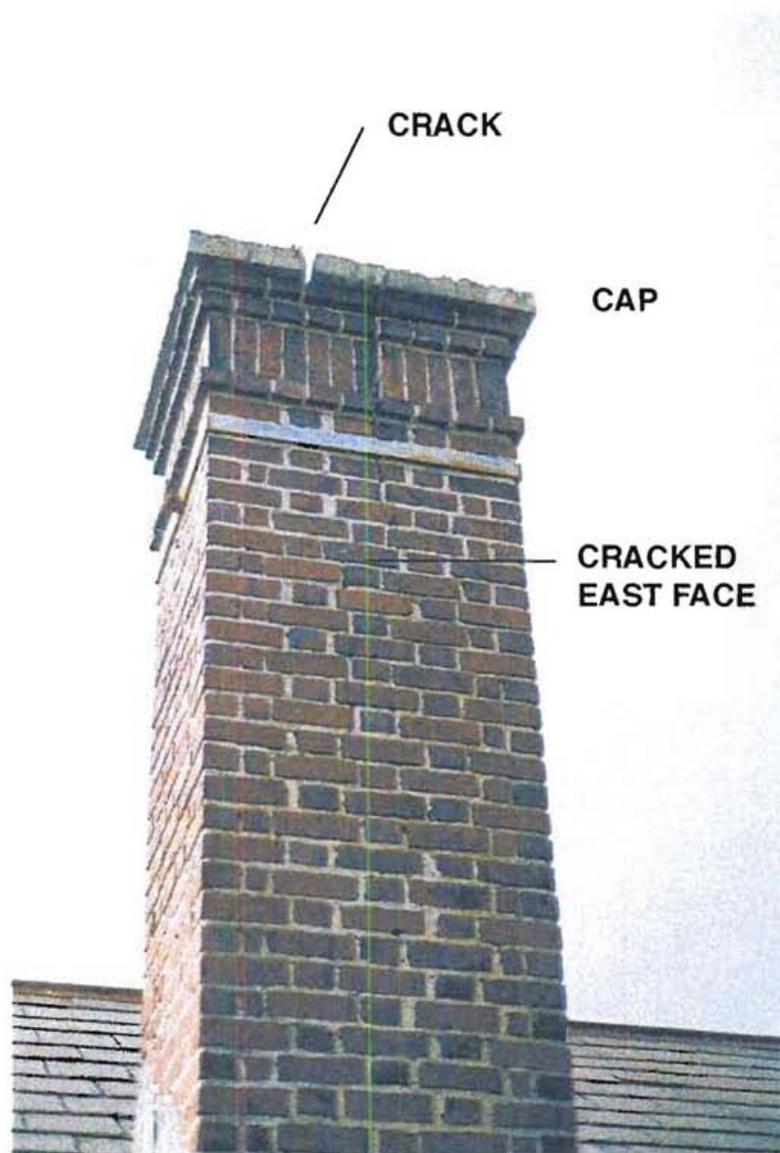
Photo 9

A brick masonry chimney is located just south of center on the east slope of the roof. Its top corbels out slightly and is covered by a stone or cast stone cap. The chimney is in poor condition, suffering from open mortar joints, a cracked cap, and significant cracks through the brick on its south and east sides (Photograph No. 10). A steel band has been installed six courses below the cap to help prevent the chimney from splitting apart. The best solution for addressing these problems is rebuilding the chimney.

13. Carefully dismantle the existing brick masonry chimney to a point 2 to 3 feet below the roof line, salvage and clean the brick, and rebuild the chimney to match the existing Flemish bond (approximately 50 courses). Assume the replacement of 75 cracked and damaged brick. Remove the existing chimney cap and install a new masonry cap to match the existing.
