4.0 ARCHITECTURAL INVENTORY AND EVALUATION

4.3 ARCHITECTURAL CONTEXT AND EVALUATION

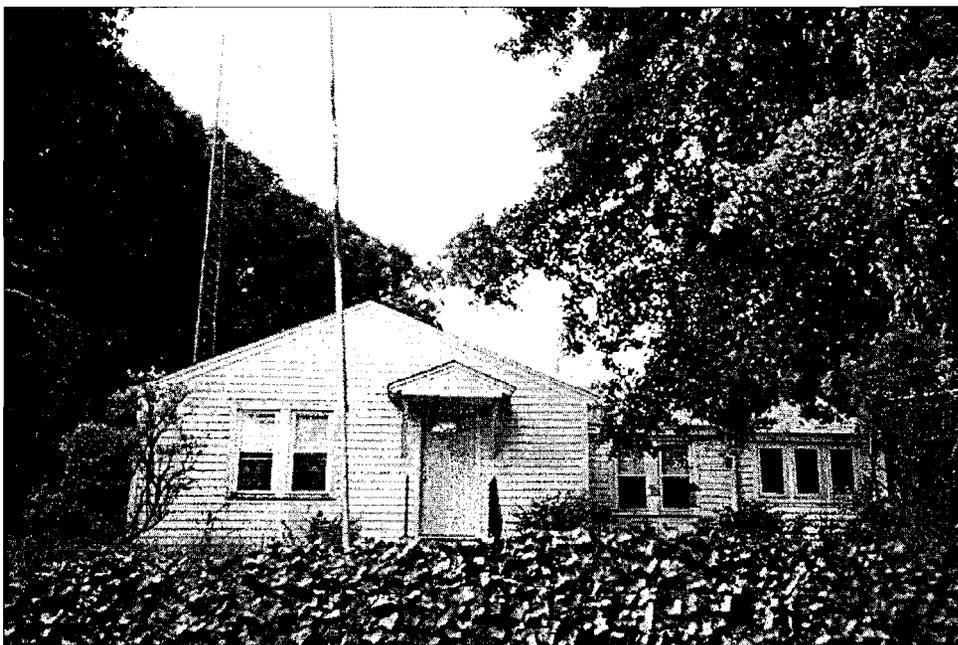
Figure 4-2. View of 14559 Sand Hill Road, Main Elevation (9/2002)

The main (north) elevation is four bays wide with the main block of the house consisting of two bays with a pair of 1/1 double-hung, vinyl sash replacement windows with modest wood sills and surrounds at the east bay. The main entrance, located at the second bay, has a modern metal and glass, single-leaf door with a semi-circular pane. Concrete stairs lead to the main entrance and the entrance is capped by a projecting, pedimented hood. The shaft of the T is recessed from the main block and includes a pair of 1/1 double-hung, vinyl sash windows with modest wood sills and surrounds at the third bay. The west end of the main elevation is pierced by a ribbon (3) of vinyl casement windows with vinyl sills and surrounds.

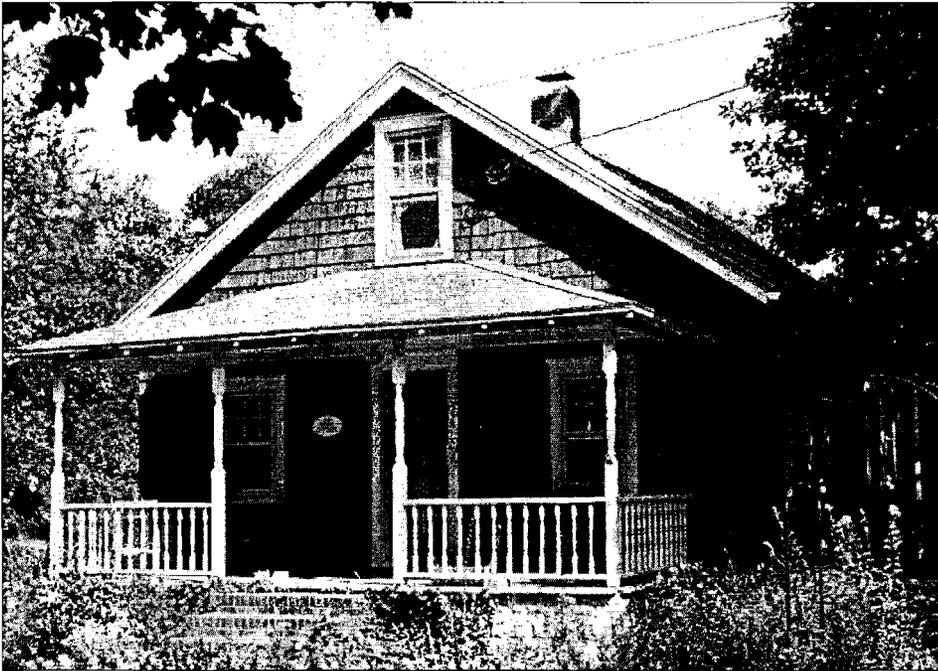
The main (south) elevation is three bays wide with the first story pierced by two 6/1 double-hung, wood sash windows flanking a 15-light, single-leaf, wood and glass door. The windows and main entrance have a decorative wood surround with a molded cap. The one story porch has a concrete floor with spindle balusters and turned porch supports. The Queen Anne style balusters and porch supports are not original to the building and were installed during the later two decades of the twentieth century. The half-hipped roof is clad in asphalt shingles and the rafters are exposed. A 6/1 double-hung, wood sash window pierces the gable end.

Figure 4-3. View of 14102 Sand Hill Road (Rose Cottage), Main Elevation (9/2002)

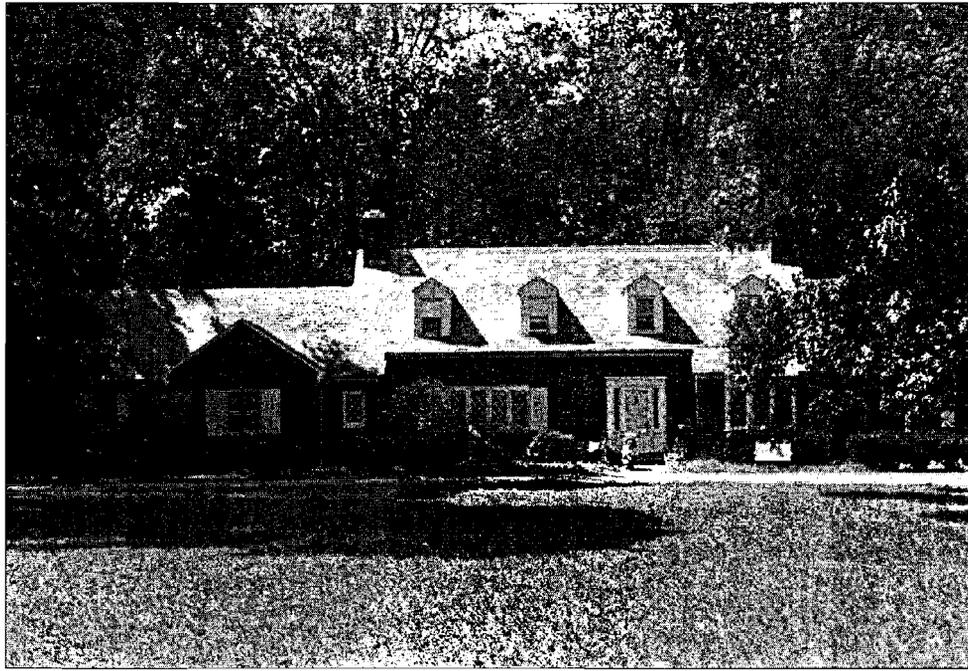
The east (main) elevation is pierced by a 6/6, double-hung, wood sash window with a pair of two-paneled, fixed wood shutters at the first bay and an 8/1 double-hung, wood sash window at the projecting gable (second bay) of the south wing. The main block of the house is pierced by a single, multi-diamond pane casement window at the third bay, a ribbon (4) of multi-diamond pane casement windows with a pair of two-paneled, fixed wood shutters at the fourth bay and a projecting ribbon (3) of multi-diamond pane casement windows at the sixth bay. The two bays of the garage wing have a 6/6 double-hung, wood sash windows with two-paneled, fixed wood shutters at each bay. The main entrance, located at the fifth bay, has a wood paneled door with multi-pane sidelights and a molded, wood surround with an entablature and pilasters. The second story of the main block is pierced by four gabled dormers with 6/6 double-hung, wood sash windows. The second story of the garage wing (north) has a single, flat roof dormer with a multi-diamond pane casement window.

Figure 4-5. View of Draper/Bonk House, Main (East) Elevation (9/2002)

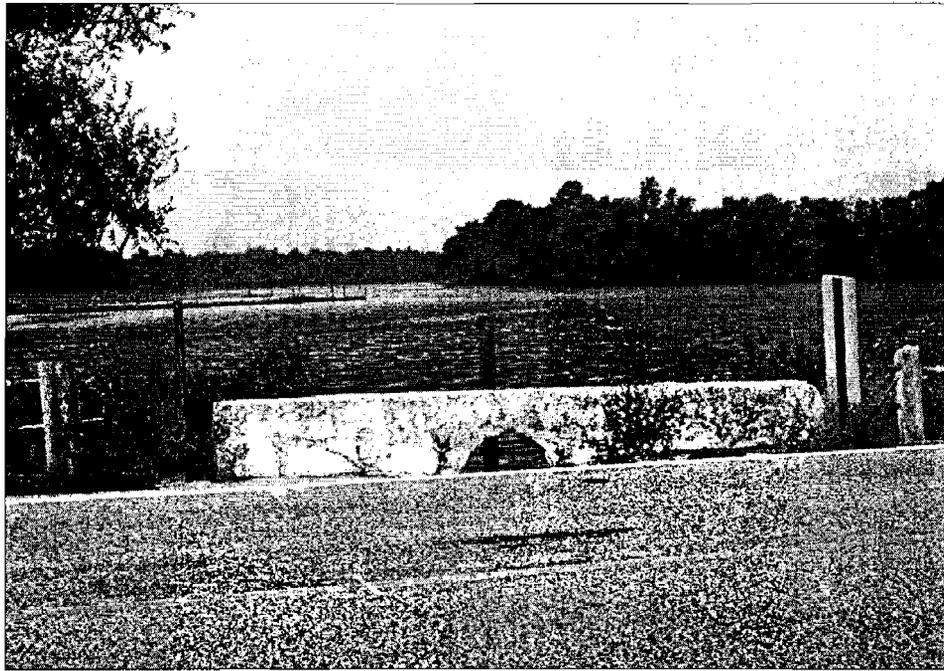
Figure 4-6. View of Bridge 3-918's Parapet Wall (West) at Reynolds Mill Pond (9/2002)

The Reynolds Mill Pond Bridge is in extreme disrepair with exposed rebar throughout and substantial settlement of the wingwalls. The concrete contains cracks and spalling (erosion) and DelDOT has previously repaired the concrete to attempt to control the problem.

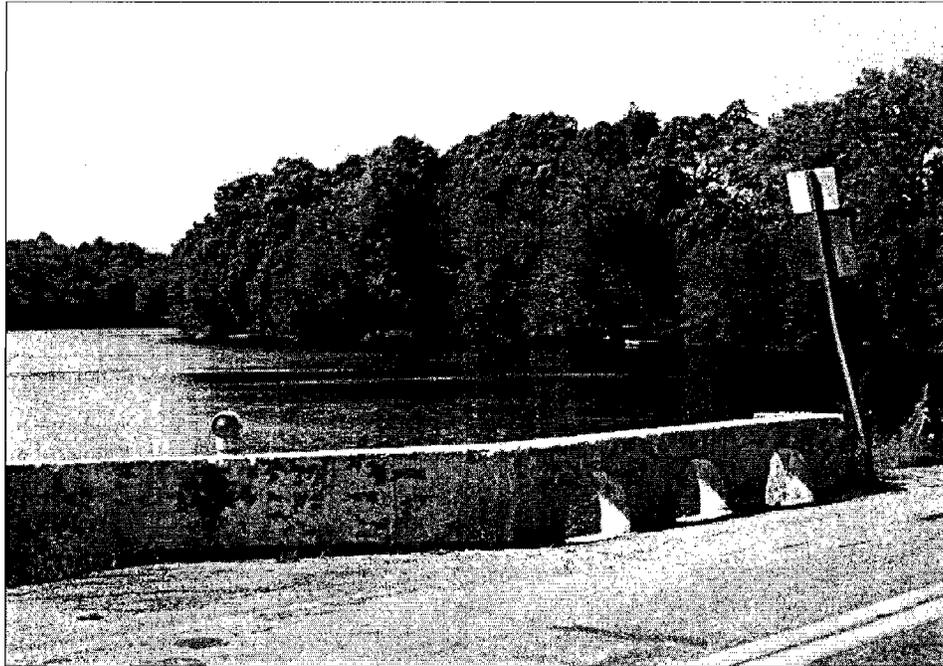
Bridge 3-806 has undergone a degree of deterioration to the parapet walls, wingwalls, and apron corner. The design of Bridge 3-806 has been attributed to the same designer of Bridge 3-808 and its associated penstock bridge off of Wagamon's Pond on Route 197 in Milton (demolished ca.1991). Bridge 3-806 and the penstock bridge were both multiple-cells, single span reinforced concrete box culverts with three arches in the parapet walls. The penstock bridge had a single parapet wall with functioning wood gates. Bridge 3-808 was a larger, multiple-cell, two-span, bridge and water flow control structure measuring 23' in length with six arches in each parapet wall. The multi-arch design in the otherwise modest parapet wall

Figure 4-7. View of Bridge 3-806’s Parapet Wall (South) at Diamond Pond (9/2002)
