IV. HISTORIC ARCHITECTURE

Chandler-Taylor House

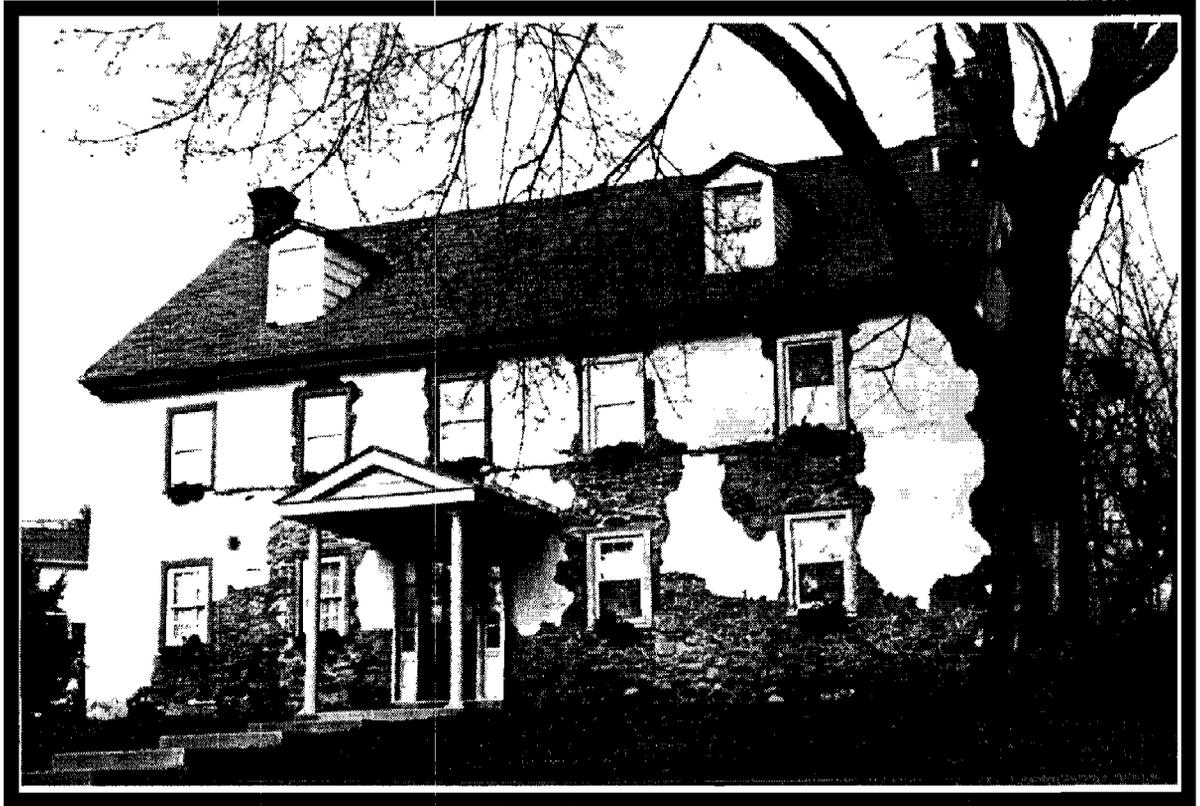
Plate 1 Chandler-Taylor House, South Side Elevation

The Chandler-Taylor House faces south to the original Newport and Gap Turnpike (Plate 1). It is a 2-½ story uncoursed rubble fieldstone dwelling covered with stucco. It is rectangular in shape with two brick interior end chimneys, the west one with a corbelled cap and the east with a castellated cap. The eastern half dates from around 1815 while the western half was added c. 1865-70, doubling the size of the house.

The south façade is five bays wide with 6/6 vinyl sash windows. The dormers are gabled and contain 1/1 double hung wood sash windows. The cornice, the only decorative touch on the house, is a large wood box cornice with a molding running below. It runs along the south and north facades only. A small front porch has been added to the center of the south (front) façade, replacing a wider porch that ran almost the entire length of the façade. The central doorway is also new and replaces two entrances located to the east and west of center on the south façade. These two doors entered into the original and added halves of the house separately. The new door contains nine lights over four recessed wood panels with 4-pane sidelights and no transom. Windows have replaced the two former doorways.

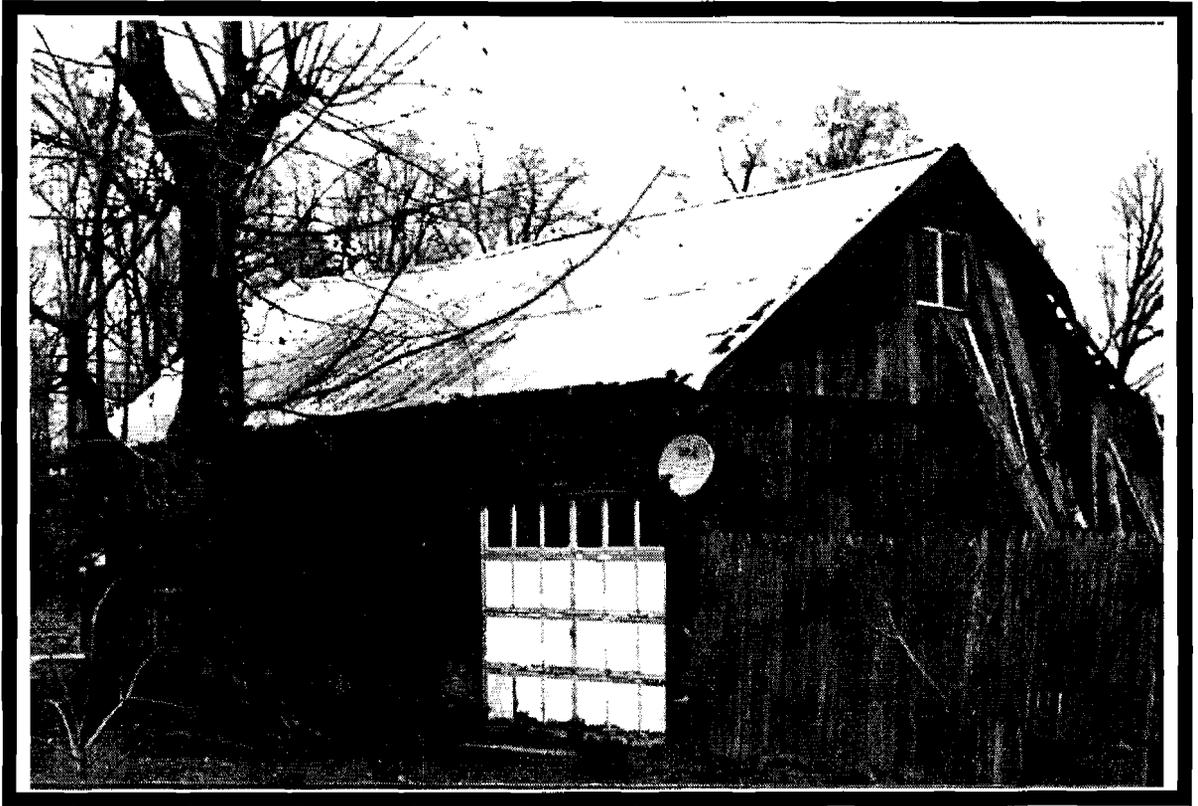
Plate 2 Carriage House Looking Southeast

The carriage house, dating from the last quarter of the nineteenth century, is located immediately to the north of the house (Plate 2). It faces southwest with two doors that were at one time accessible from Brackenville Road. The building is generally rectangular in shape with a gable roof and shed addition to the north. The main block is timber frame and rests on an elevated fieldstone foundation. It is sheathed with wide vertical boards and has an undecorated vergeboard beneath the east and west gables. It has a standing seam metal roof, moderate eave, and exposed rafter tails.

The south façade contains two large openings, one sliding wood door on the west and a newer metal panel garage door with 6 lights along the top on the east. There is an inserted panel of corrugated metal above the west door. The east gable contains one small window in the gable. It is a 2-pane vinyl slider. The lean-to at the north end is sided with horizontal boards on the east and west and is open to the north. It is roofed with patches of sheet metal and contains one opening in the east wall, which has been boarded up.
