CULTURAL RESOURCE SURVEY
SURVEY UPDATE FORM

CRS # S03567

1. HISTORIC NAME/FUNCTION: Beaver Dam Methodist Protestant Church/ Harbeson United Methodist Church

Resurveyed for the US 9 and SR 5 Intersection Improvements project, Delaware Department of Transportation.

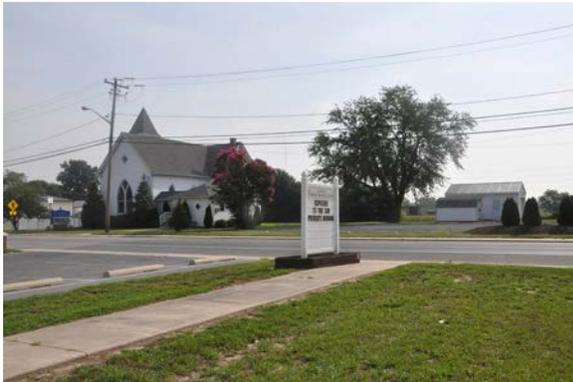
S03567: church (S03567) and outbuildings (modern and S03566.002), looking east-northeast.

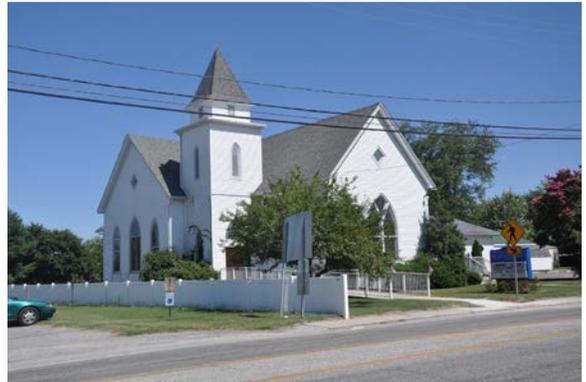
S03567: church (.001) façade and north side, looking southeast.

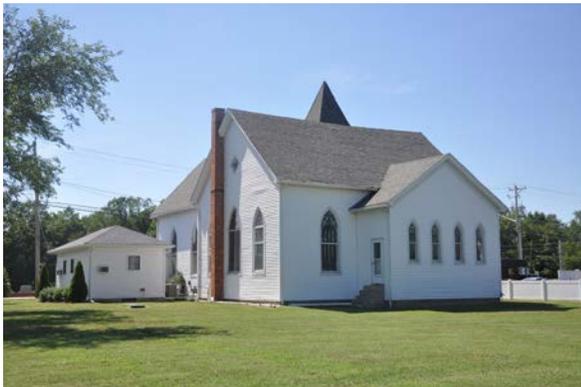
S03567: church (.001) rear and south side, looking northwest.

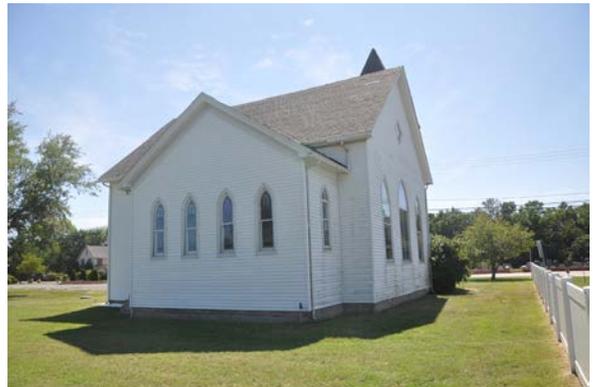
S03567: church (.001) rear and north side, looking west-southwest.

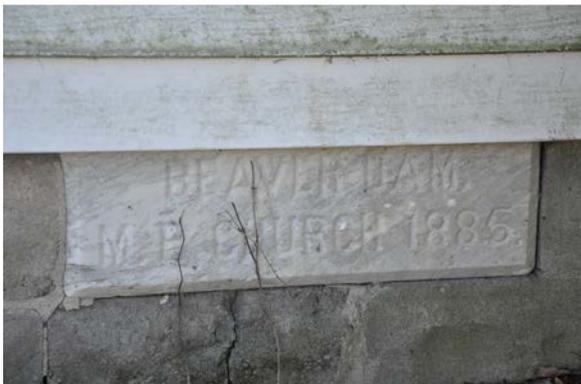
Stone near NE corner reads,

Beaver Dam
M.P. Church 1885

S03567: detail of 1885 datestone on north wall of church.

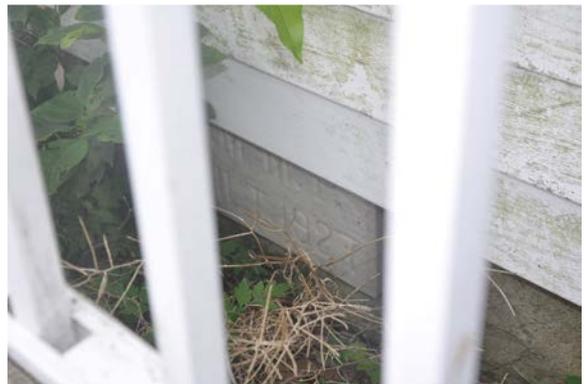
Stone near NW corner reads,

Beaver Dam M.P.
Church Rebuilt 1927

S03567: detail of 1927 datestone on north, front wall of church.
