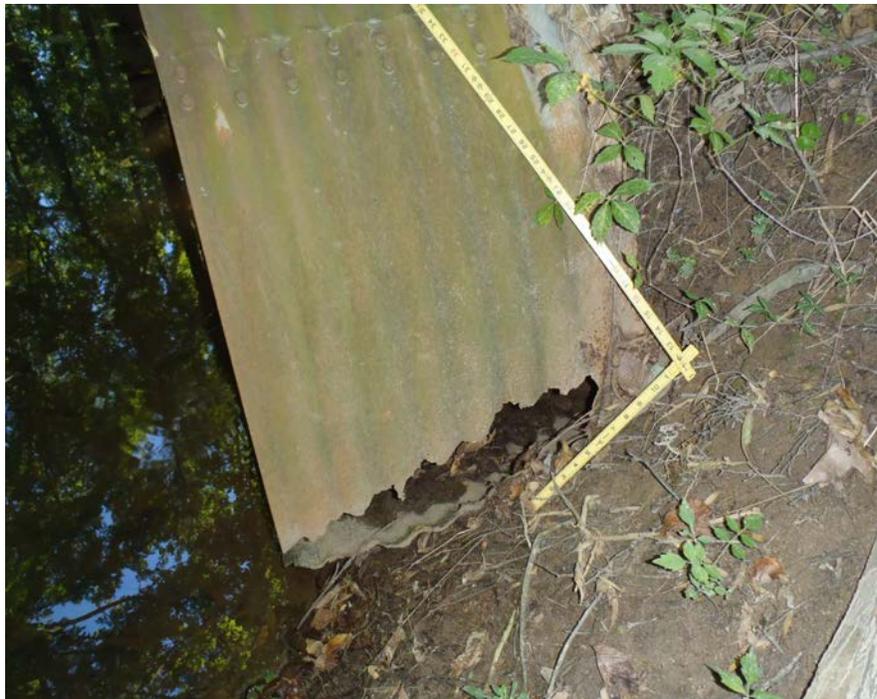
6. SPAN#1 EXISTING PERFORATION @
NORTH END

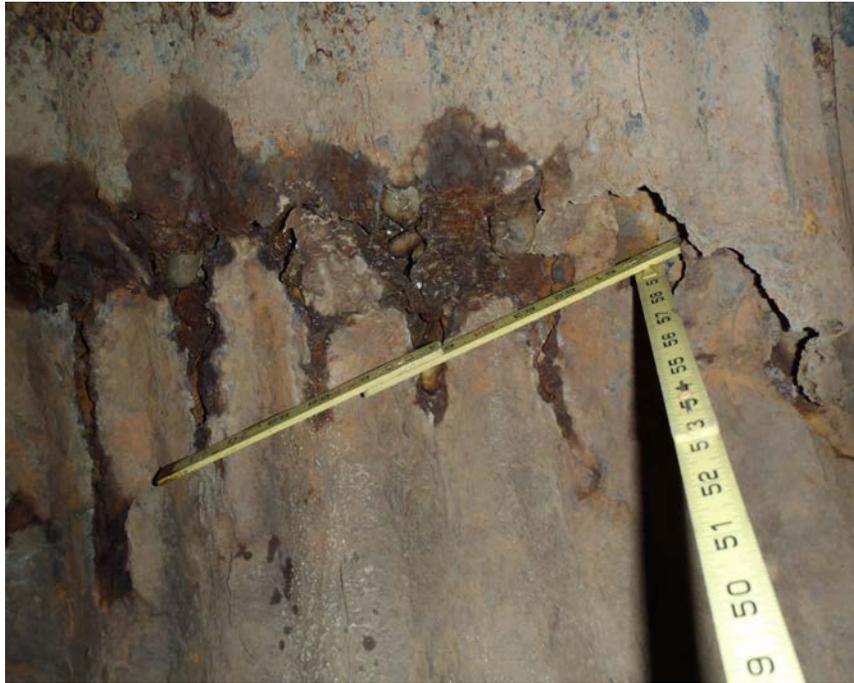
7. SPAN#1 PERFORATION AND KINKING W/
LOSS OF FILL @ SOUTH END

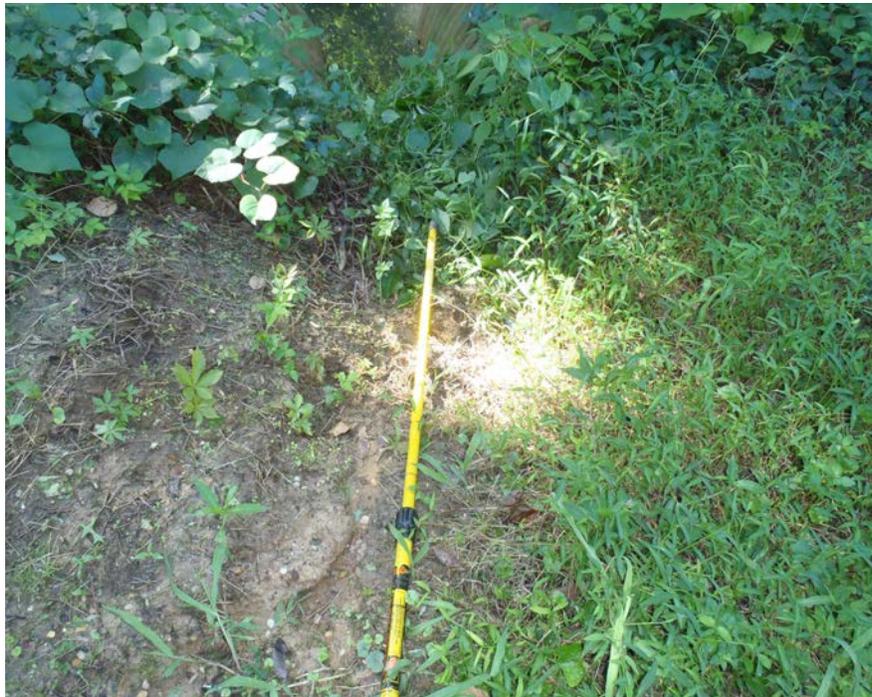
8. MINOR EROSION BETWEEN PIPES 1&2 AT
SOUTH END
