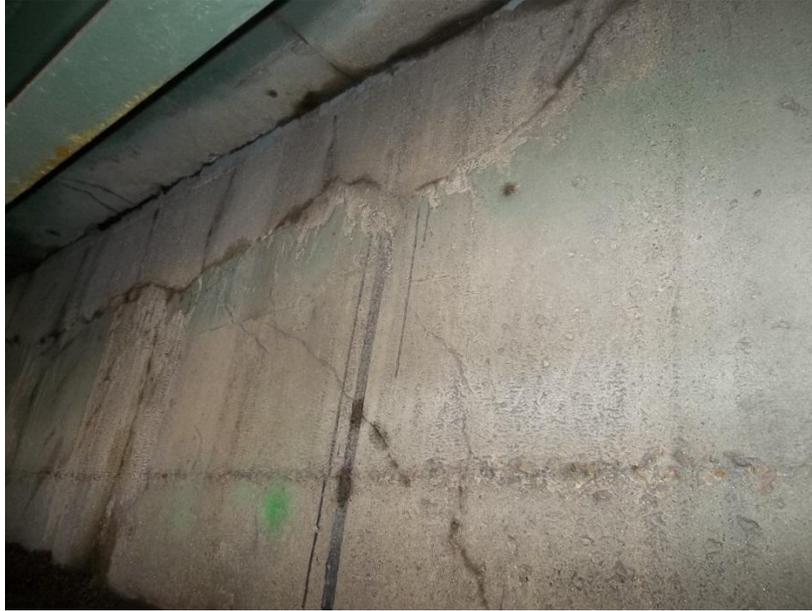
Abutment A backwall, looking southeast. Note hairline cracks and previous concrete repair patch.

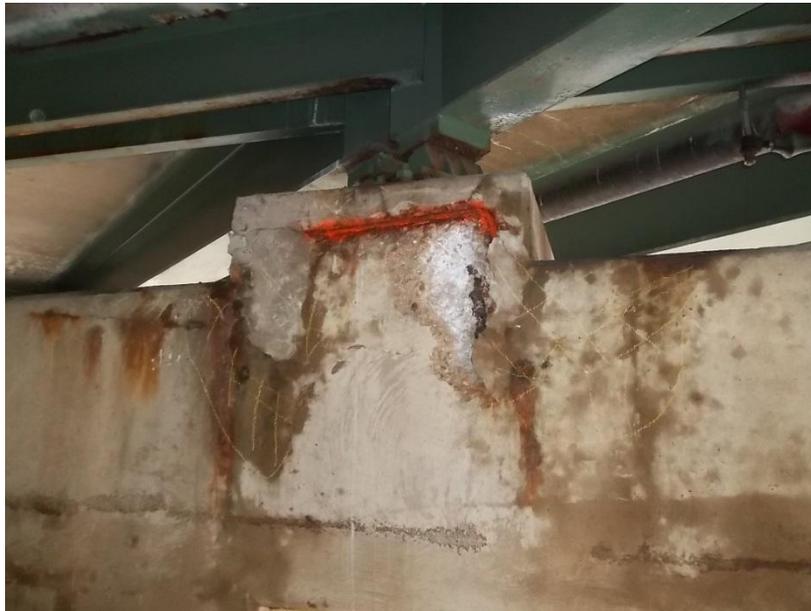
Pedestal 8, Pier 1, looking north. Note spalled and delaminated concrete with associated fine cracks and exposed reinforcement with moderate delaminations.

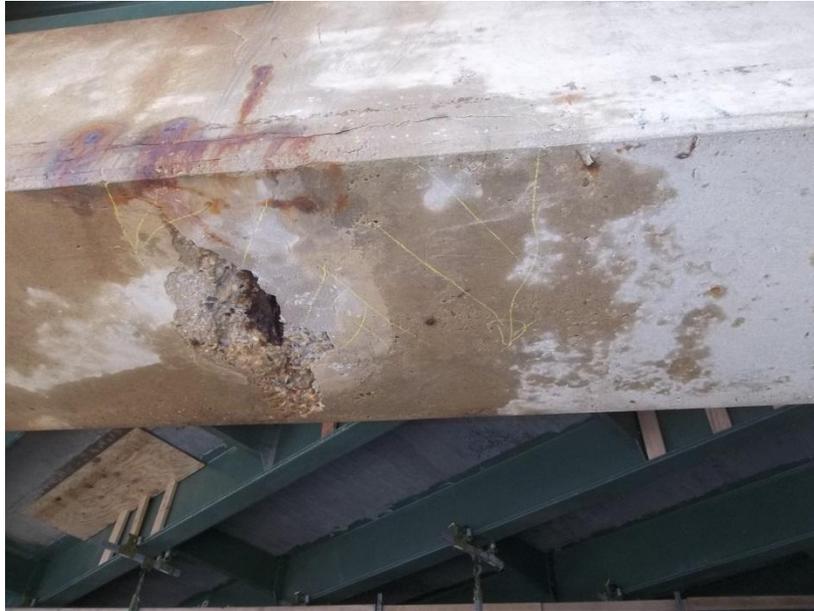
Pier 1 underside of cap between Columns 3 and 4, looking south. Note spalled and unsound concrete with exposed reinforcement with minor delaminations.

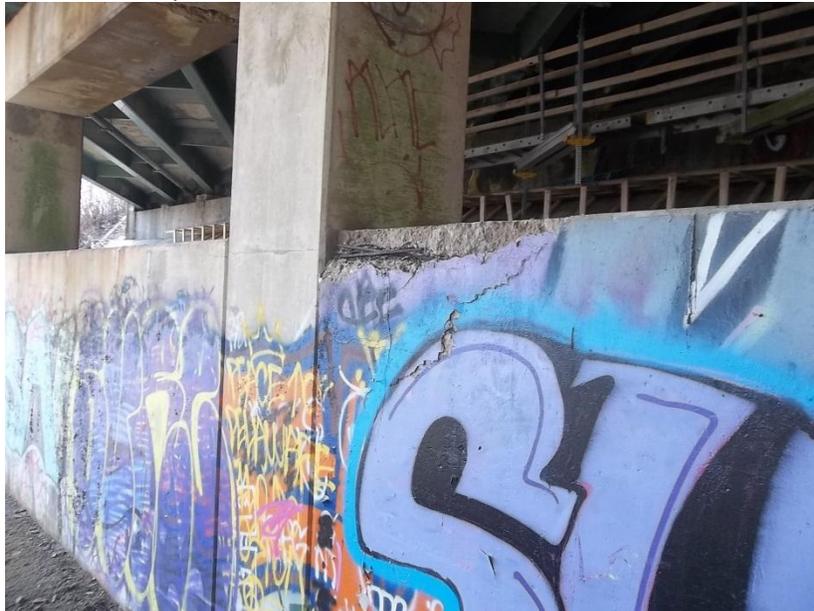
Pier 1, looking southeast. Note crashwall has spall with exposed rebar on north face adjacent to Column 3.

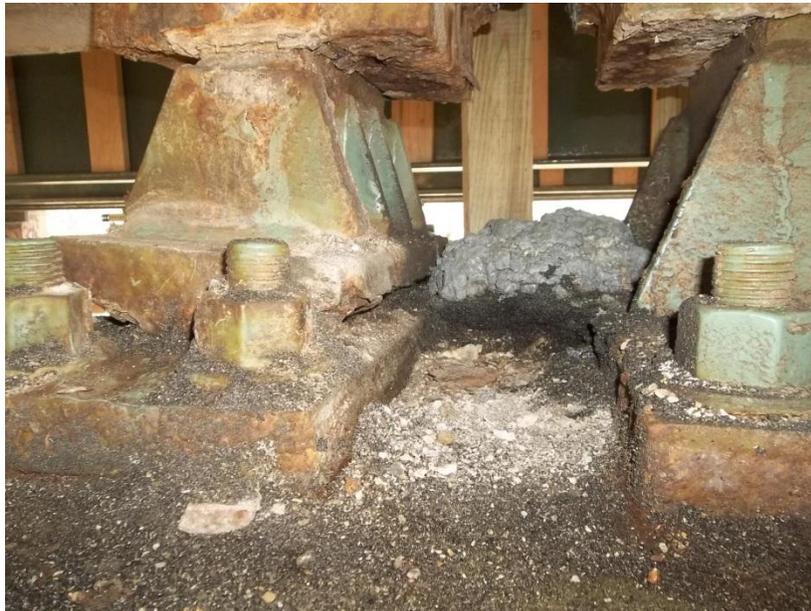
Expansion and Fixed Bearing 4 at Pier 1, looking south. Concrete debris is in contact with the expansion and fixed bearing.

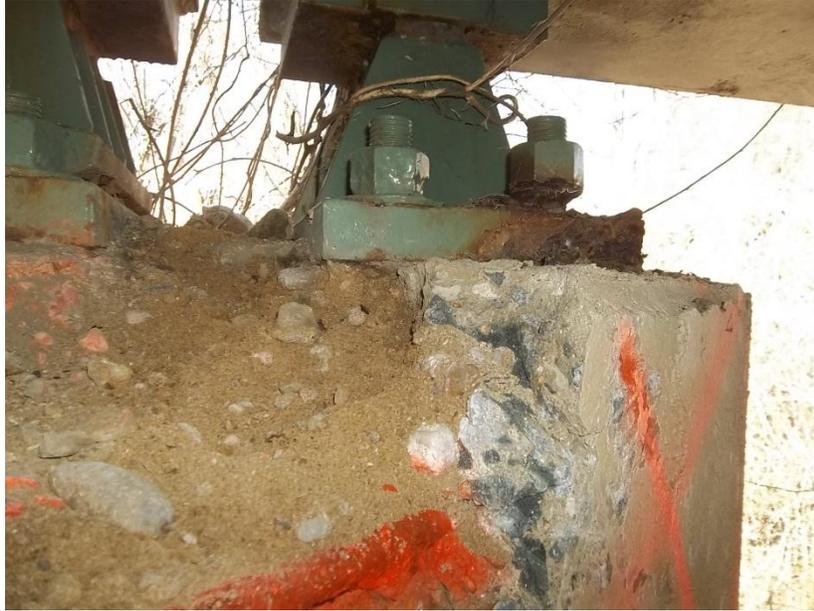
Fixed Bearing 1 at Pier 1, Span 2. Note the anchor bolt is not engaged and the washer is completely corroded.

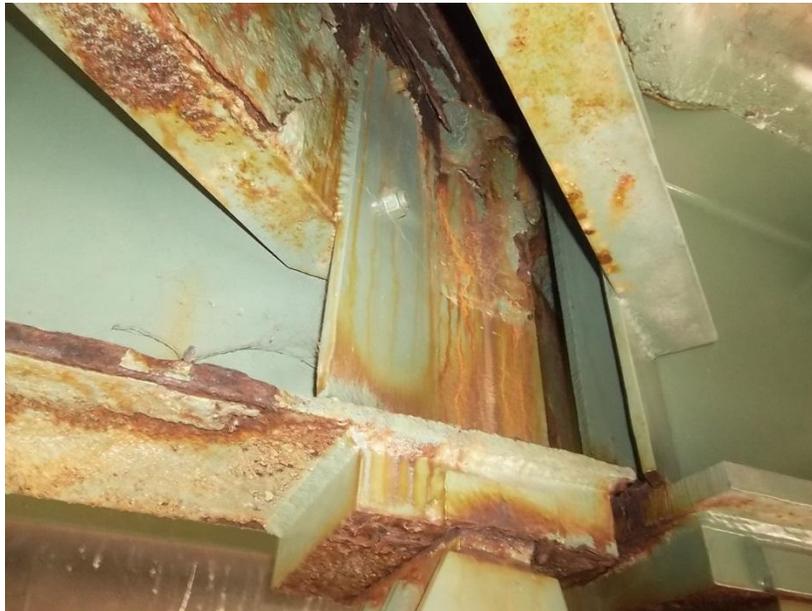
Beam 9 in Span 1 at Pier 1, looking west. Note paint failure, and moderate to severe rust near the bearing.

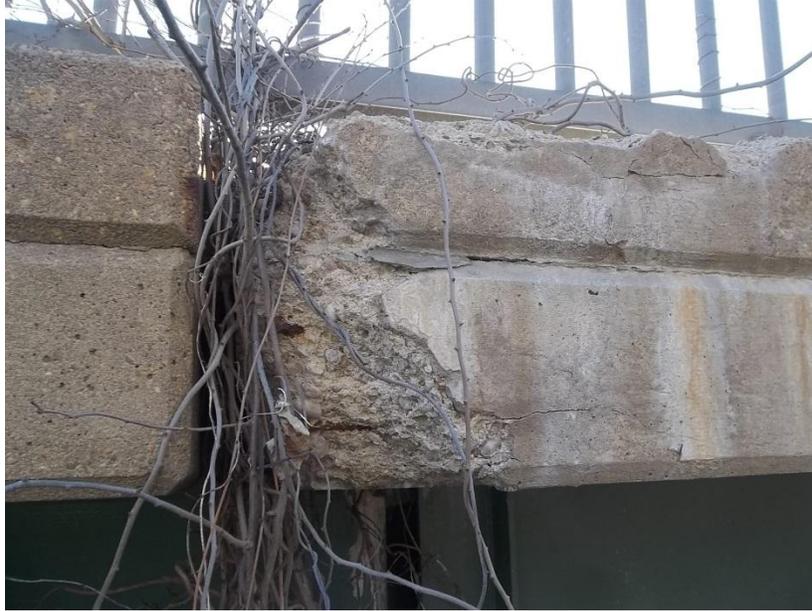
West fascia overhang in Span 1 at Pier 1, looking east. Note heavy vegetation in joint and spall with exposed reinforcement.

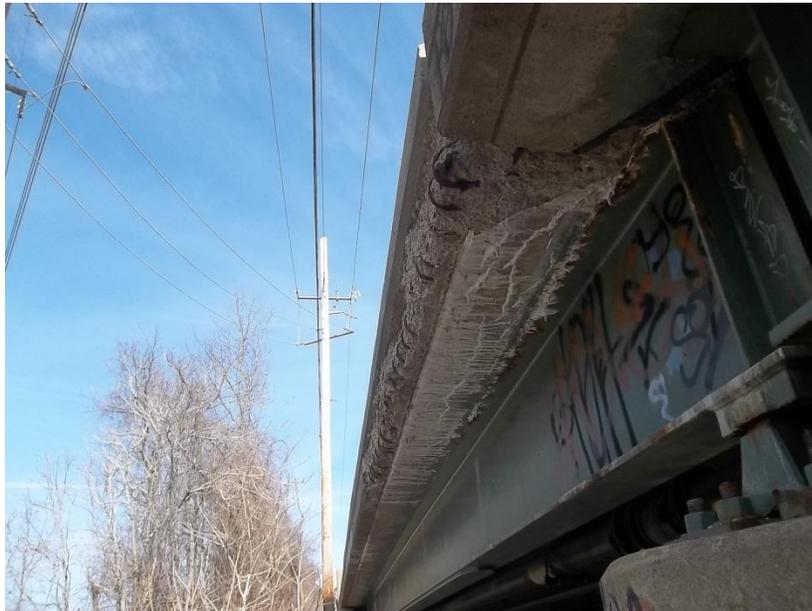
West fascia overhang in Span 3, looking north. Large corner spall with exposed reinforcement.

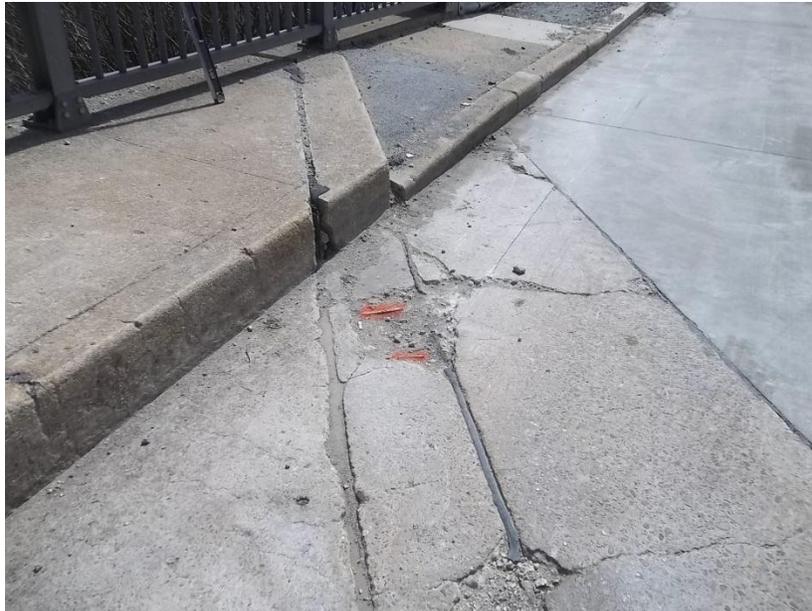
South approach header on east side, looking east. Note spall with exposed reinforcement.
