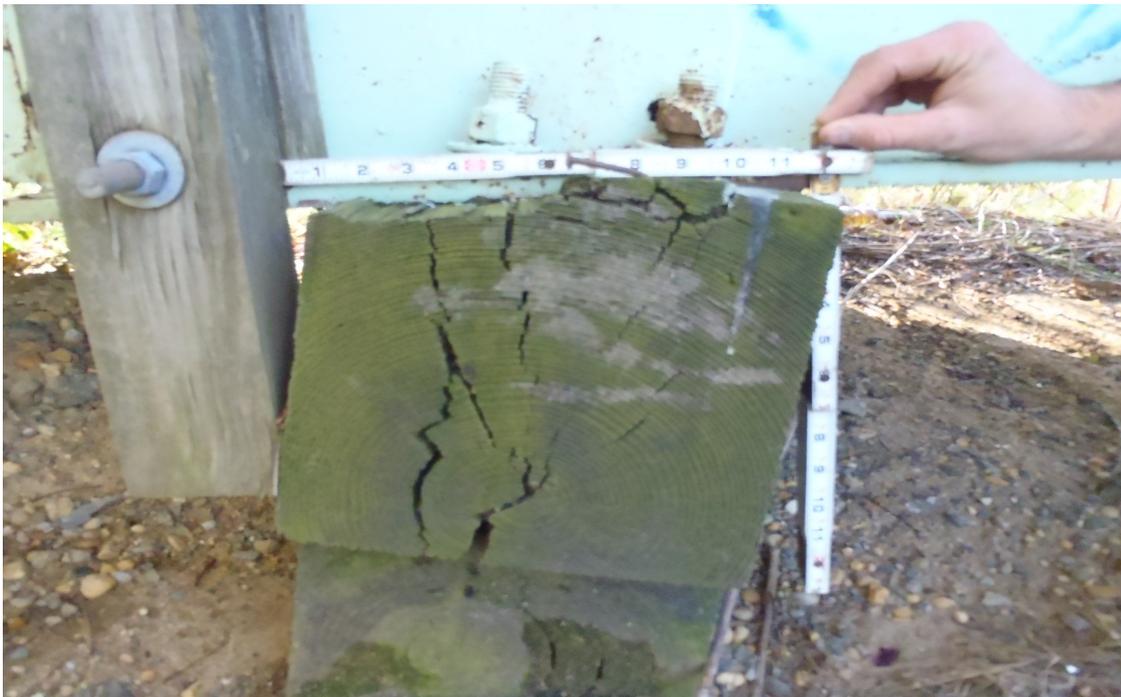
6. NORTH TIMBER ABUTMENT CRUSHED AND ROTATING WESTWARD

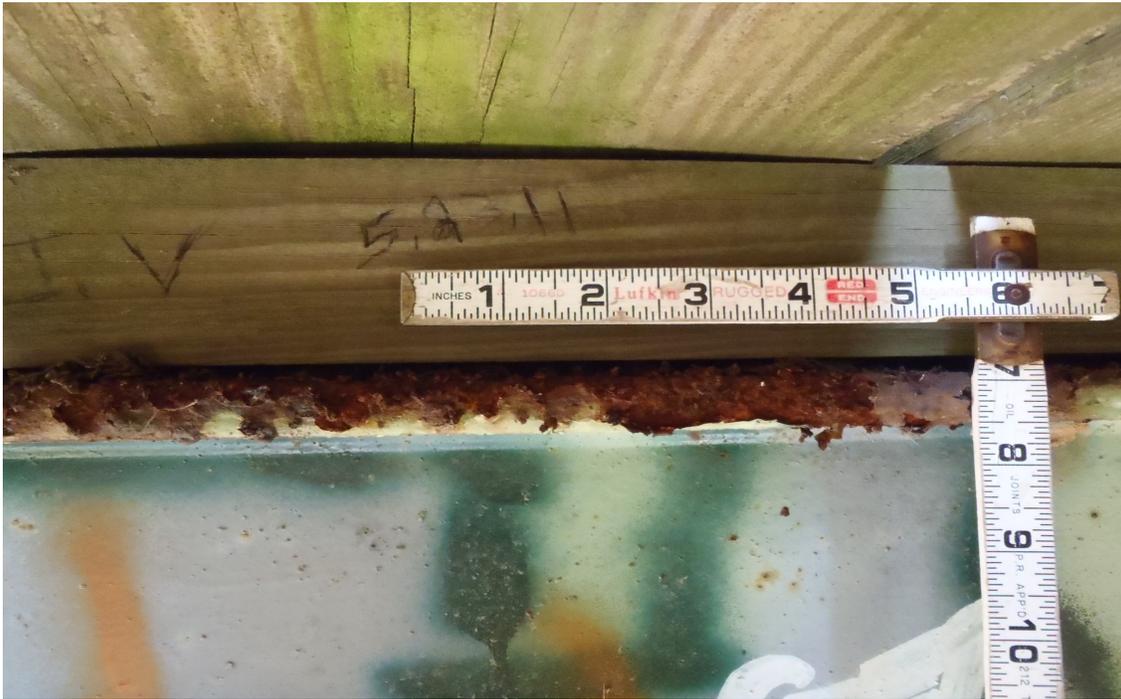
7. ACTIVE CORROSION TYP. TO GIRDERS IN SPAN #3

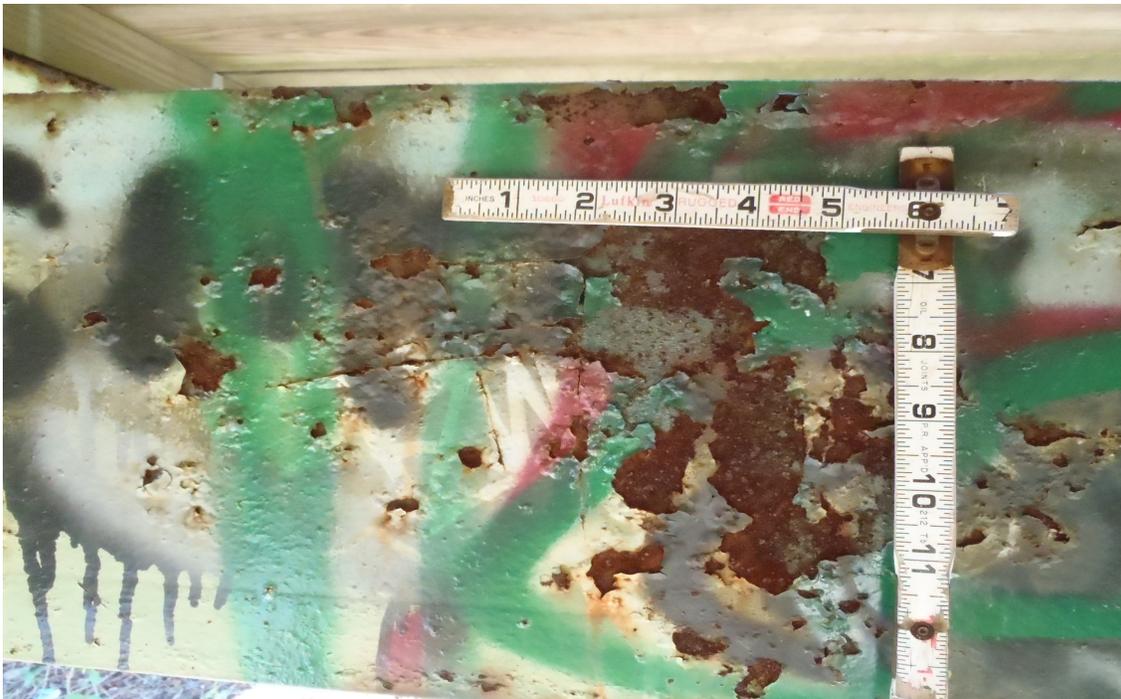
8. ACTIVE CORROSION TYP. TO DIAPHRAGMS IN SPAN #3

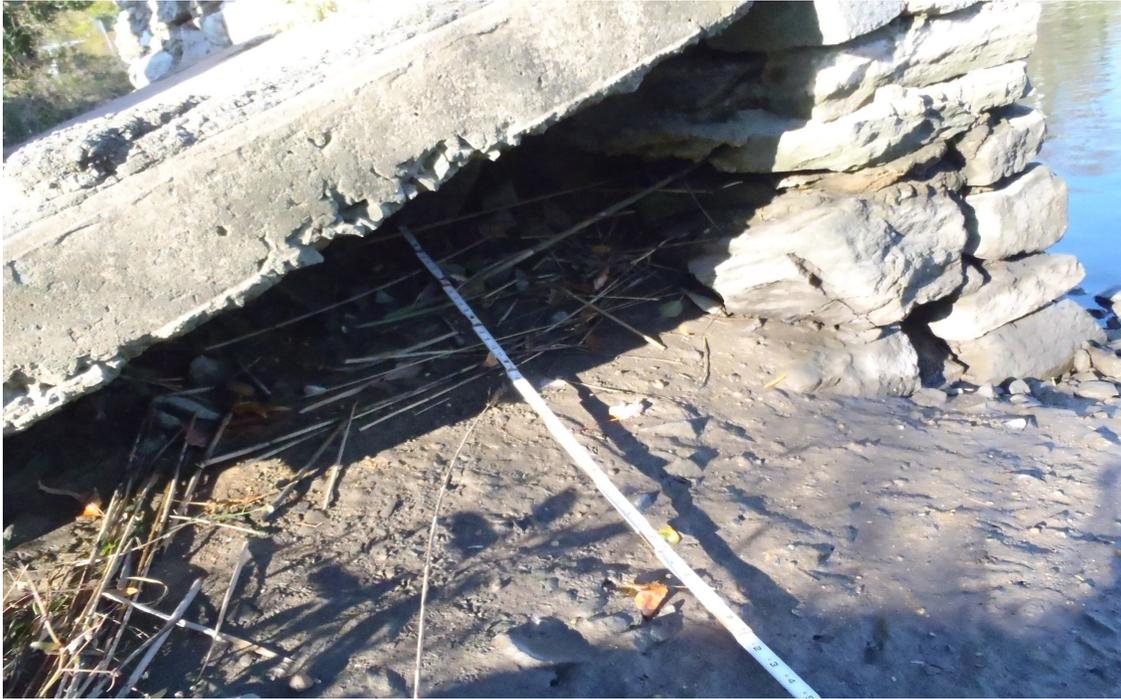
9. EROSION/UNDERMINING OF SUBSTRUCTURE AT PIER#2

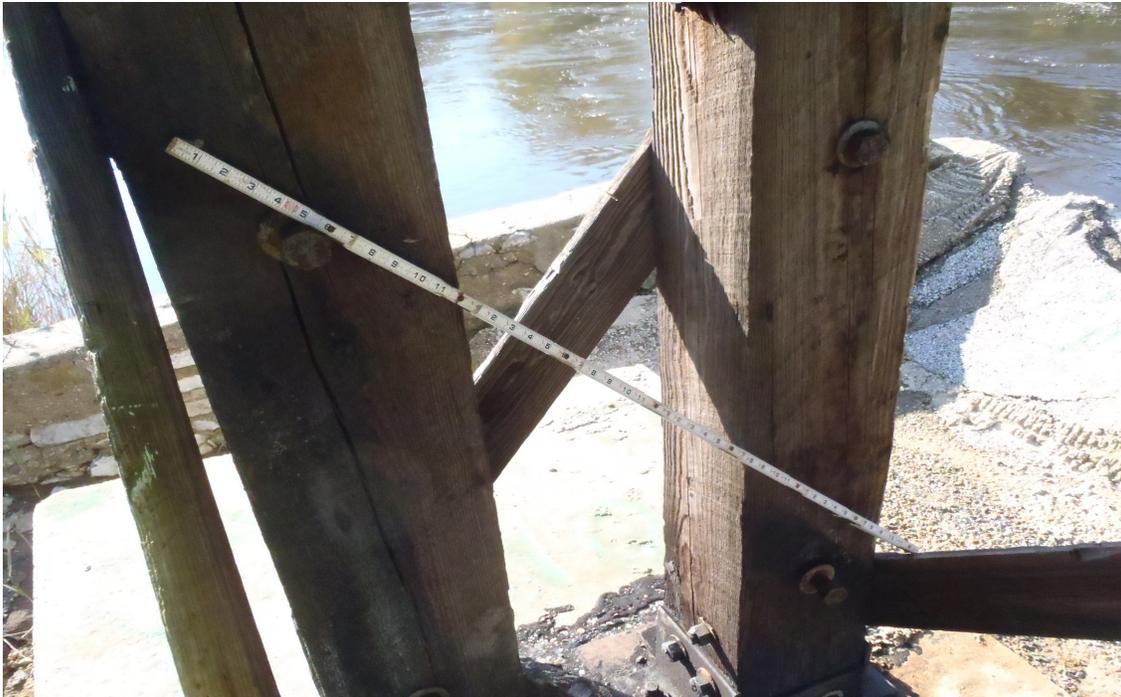
10. MISSING STRUT AT PIER #2

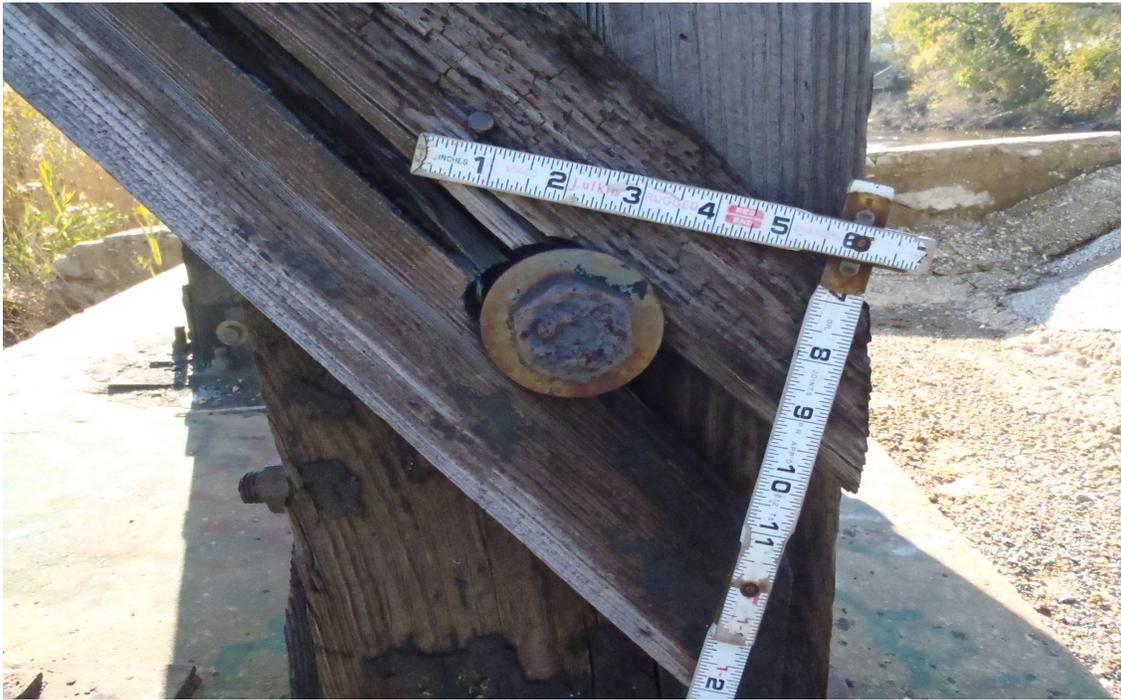
11. SPLIT STRUT AT PIER#2

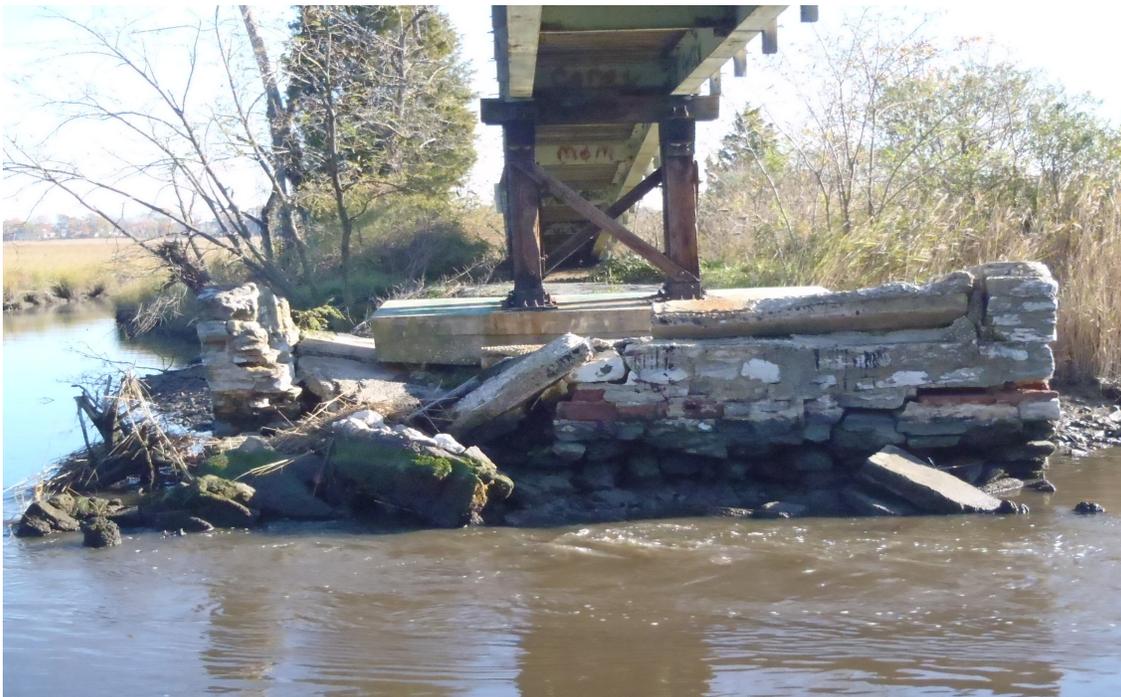
12. GENERAL SETTLEMENT AND DETERIORATION
OF SUB STRUCTURE SPAN #2

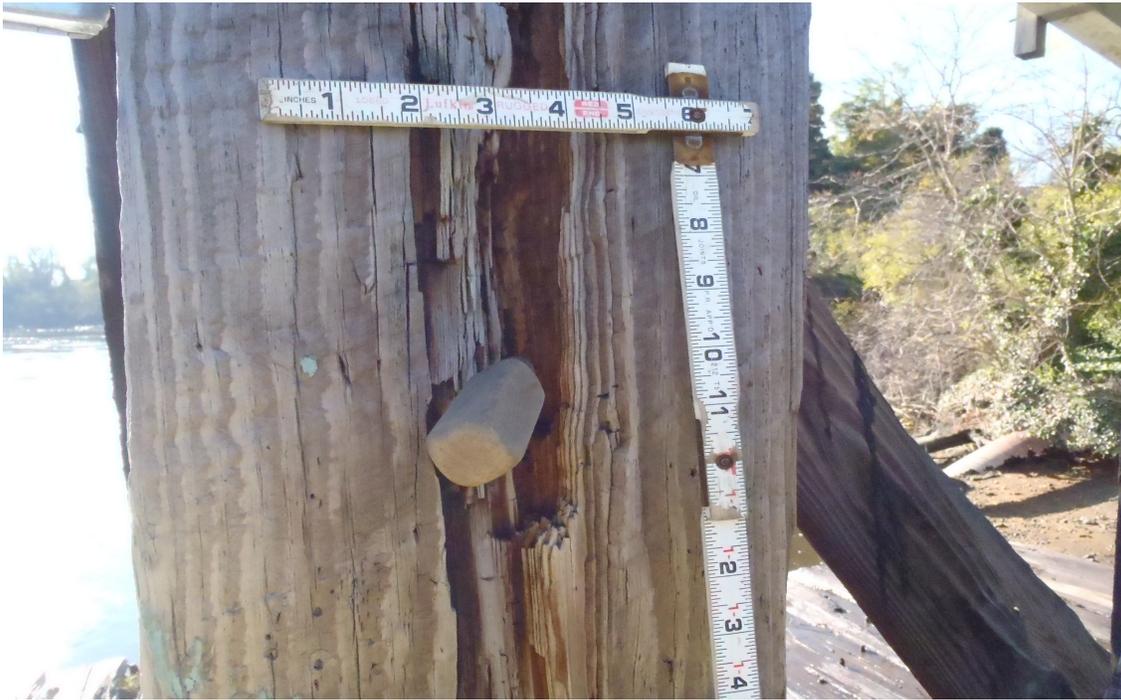
13. DECAY/ROT IN SOUTHEAST COLUMN OF PIER #2

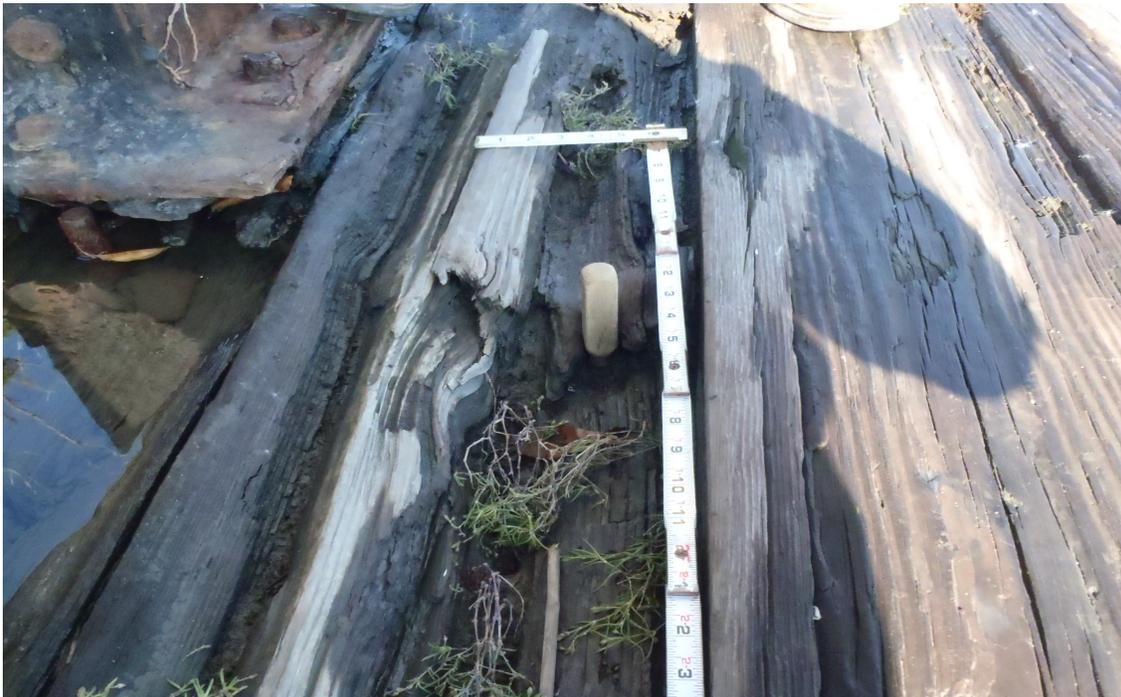
14. DECAY/ROT OF WOODEN STRUCTURE UNDER
PIER #1
