## Chapter 5

### HISTORIC ARCHITECTURAL RESOURCES

#### **A. APPROACH TO HISTORIC ARCHITECTURAL FIELD INVESTIGATION**

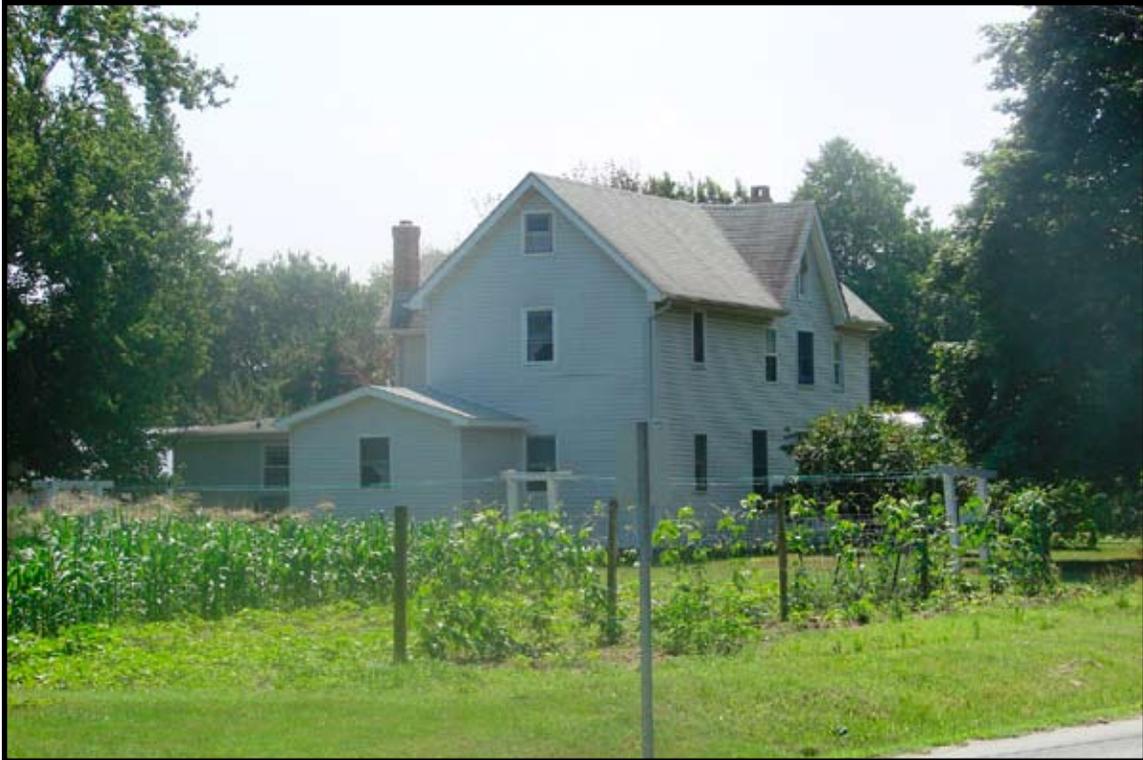
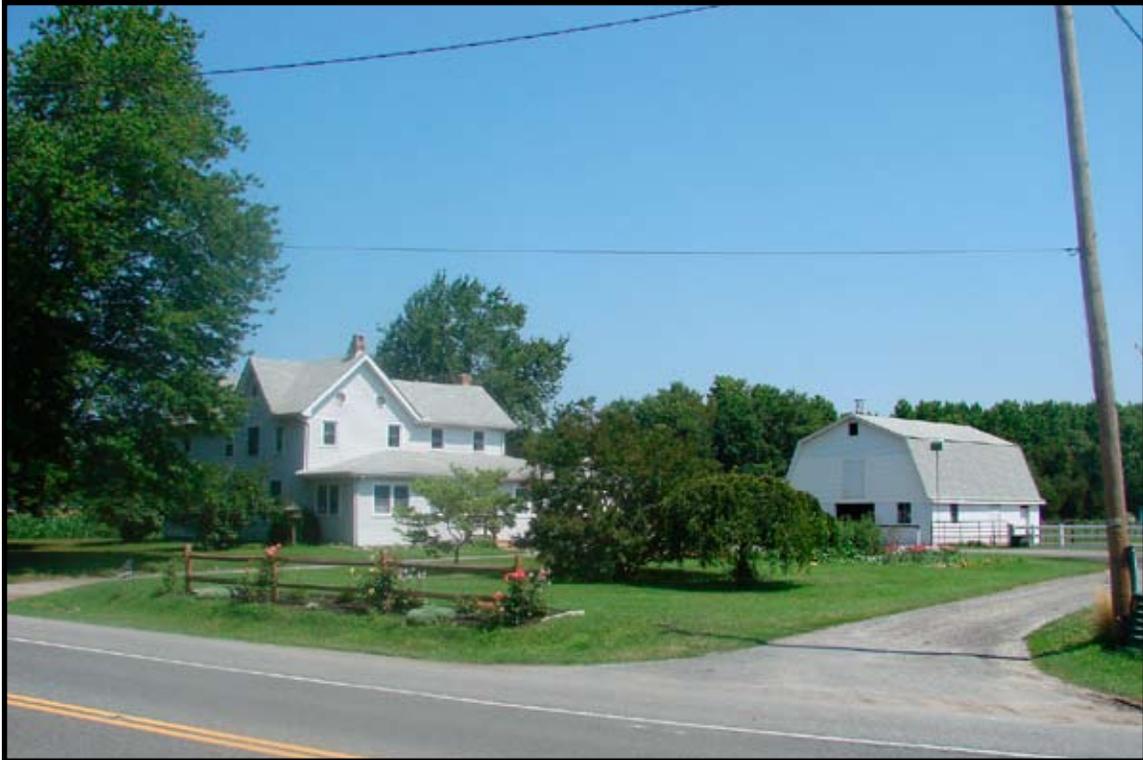
##### **3299 Hartly Road [CRS # K-6880] (Plates 5.1 and 5.2)**

Plate 5.1. View facing southeast from Hartly Road towards 3299 Hartly Road [CRS # K-6880].  
(Photographer: William Liebeknecht, July 2008) [HRI Neg. # 08021/D1:4081].

Plate 5.2. View facing northeast from Hartly Road towards 3299 Hartly Road showing main house and modern outbuildings [CRS # K-6880]. (Photographer: William Liebeknecht, July 2008) [HRI Neg. # 08021/D1:4086].

This two and a half story Carpenter Gothic house sits on the northeast side of Hartly Road (Delaware Route 44) approximately 650 feet northwest of its intersection with Forrest Avenue (Delaware Route 8) and Halltown Roads. The current property represents the heart of what was once a much larger farm that formerly spanned both sides of the roadway. The main block of the house, which sits on a parged masonry foundation, is covered by a cross gabled asphalt shingle roof. The original siding materials and most of the building’s exterior architectural detailing have been obscured or removed by the application of vinyl siding. A steeply pitched central gable with a large lancet window crowns the street elevation. The house appears to have formerly faced Hartley Road but has had its principal entrance relocated to the southeastern corner of the building. All existing window and door fixtures appear to be modern replacements with the most glaringly unsympathetic of these replacements being the installation of a pair of small octagonal windows in the upper level of the southern gable end wall of the original block of the building.

A two story frame addition has been added to the buildings northern gable end wall while a single story addition has been attached to its southern elevation. A two story wing that projects from the rear (eastern side) of the building may be an element of the original plan or a 19th-century addition. The core of this building appears consistent with a date of construction in the late 1840s or 1850s but subsequent alterations have dramatically altered its architectural character.

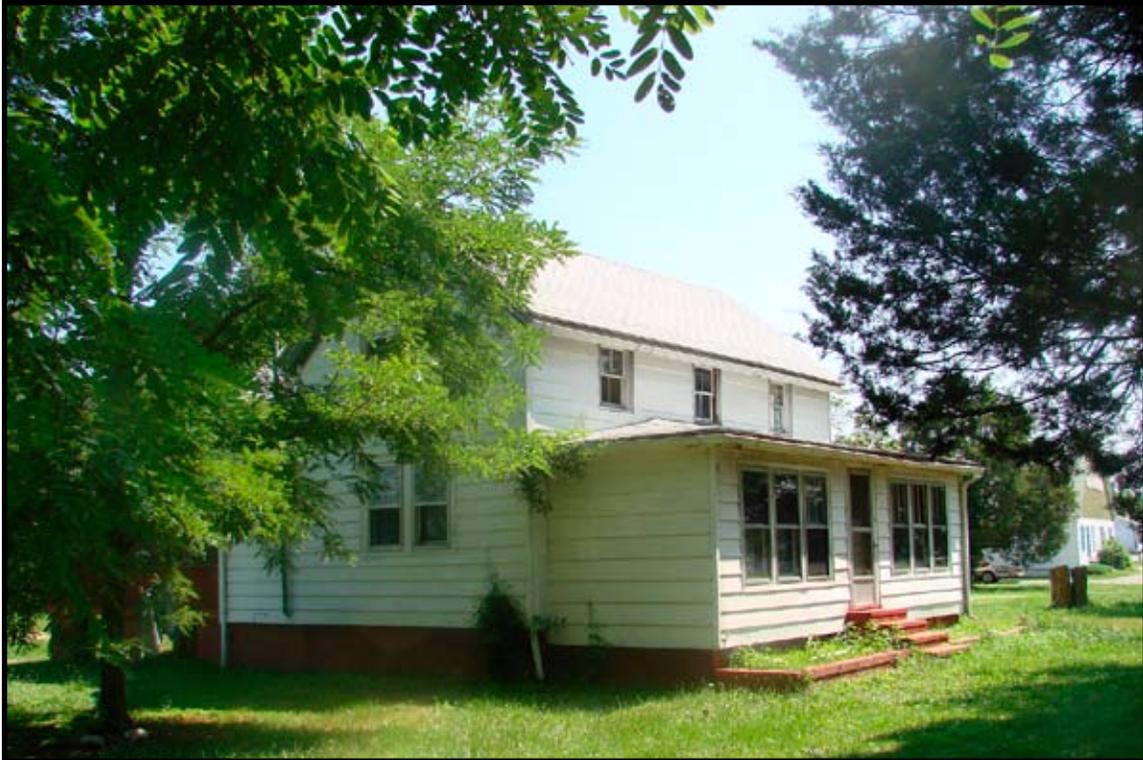
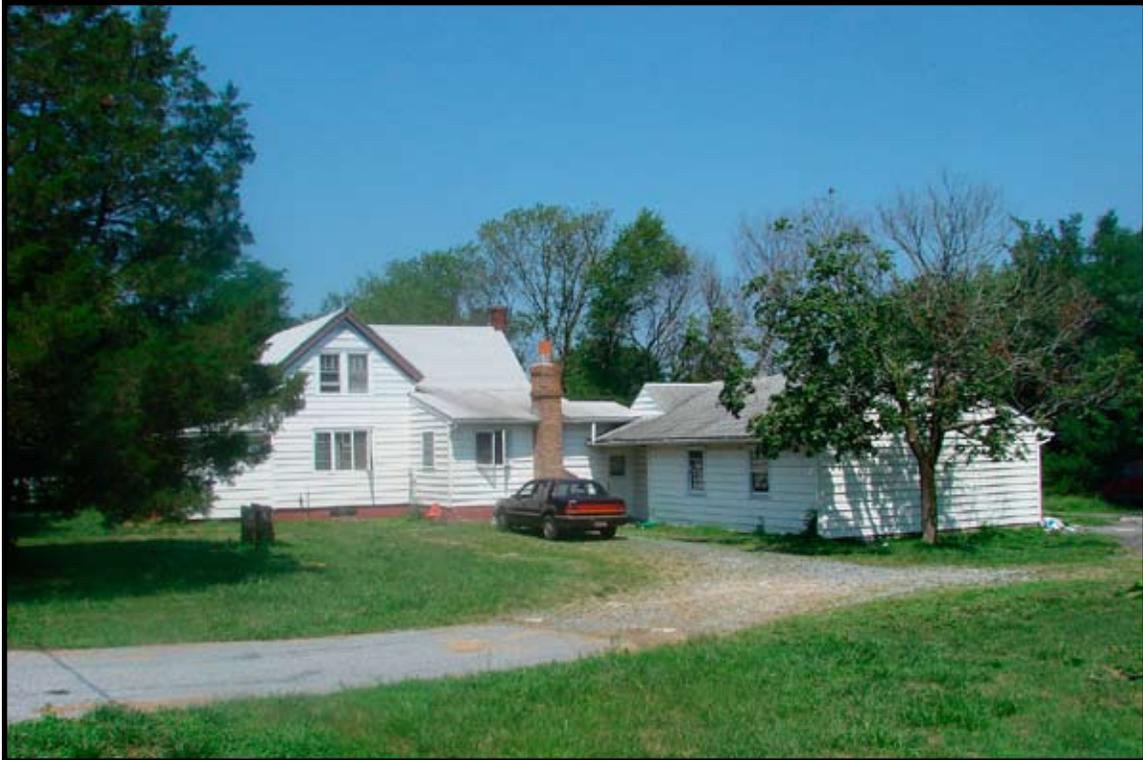
### **3399 Hartly Road [CRS # K-1092] (Plates 5.3 and 5.4)**

Plate 5.3. View facing northeast looking at 3399 Hartly Road [CRS # K-1092]. (Photographer: William Liebeknecht, July 2008) [HRI Neg. # 08021/D1:4092].

Plate 5.4. View facing northwest looking at 3399 Hartly Road [CRS # K-1092]. (Photographer: William Liebeknecht, July 2008) [HRI Neg. # 08021/D1:4095].

foundation, the vernacular residence is covered by an end gabled asphalt shingle roof and is sheathed in aluminum siding. A telescoping row of additions has been attached to northeast corner of house connecting the structure to a two bay frame garage. The building is fronted by an enclosed porch and a second porch structure wraps around the northwest corner of the house.

naular architecture. Many examples of similar houses possessing more original fabric can be observed along the rural roadways of Kent County, Delaware. The building’s architectural integrity has been diminished through the installation of replacement window and door fixtures, the application of aluminum siding to its exterior, the enclosing of its front porch and the construction of several small additions which have altered its original form.

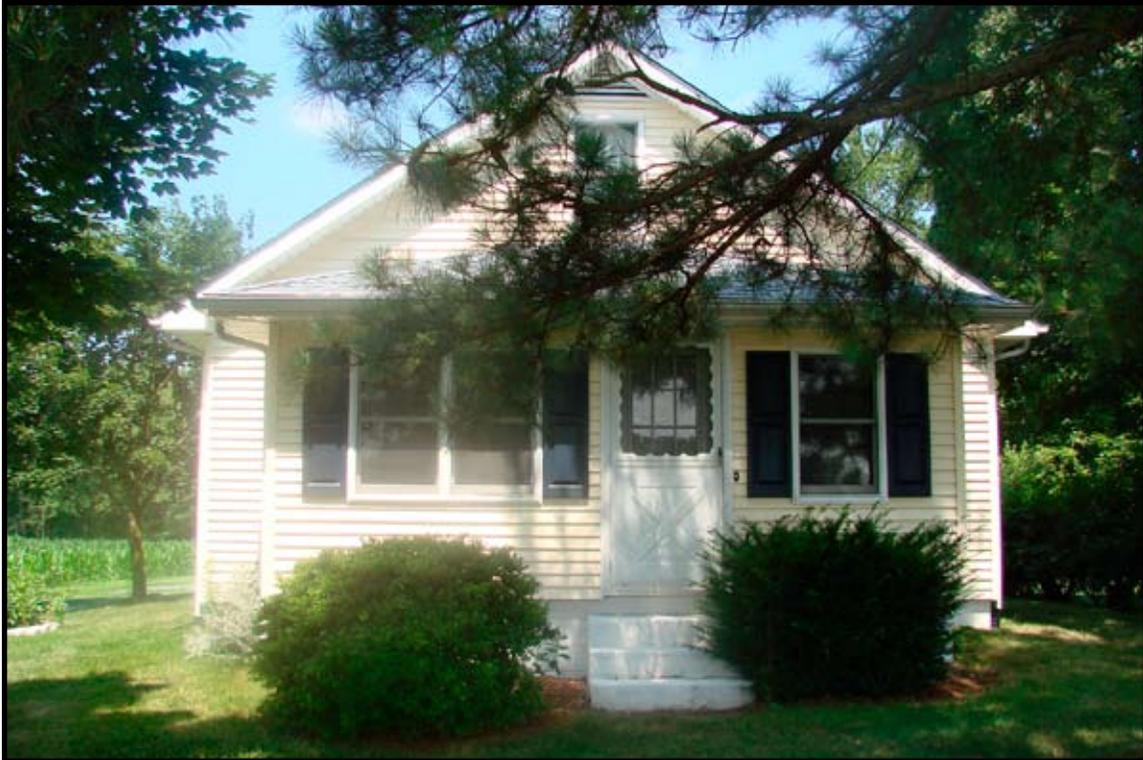
These two diminutive mid-20th-century wood frame, front gabled, clapboard cottages have been considerably altered through the replacement of original window and door fixtures. Formerly open front, porches have been enclosed. The building’s original clapboard walls have been covered in modern siding materials and several small additions have been added to the rear of both buildings. From a historic architectural perspective they are typical, yet poorly preserved examples of a type of modest housing stock common within the surrounding landscape of central Delaware.

Plate 5.5. View facing north from Halltown Road looking at 6401 Halltown Road [CRS # K-1111].  
(Photographer: William Liebeknecht, July 2008) [HRI Neg. # 08021/D1:4144].

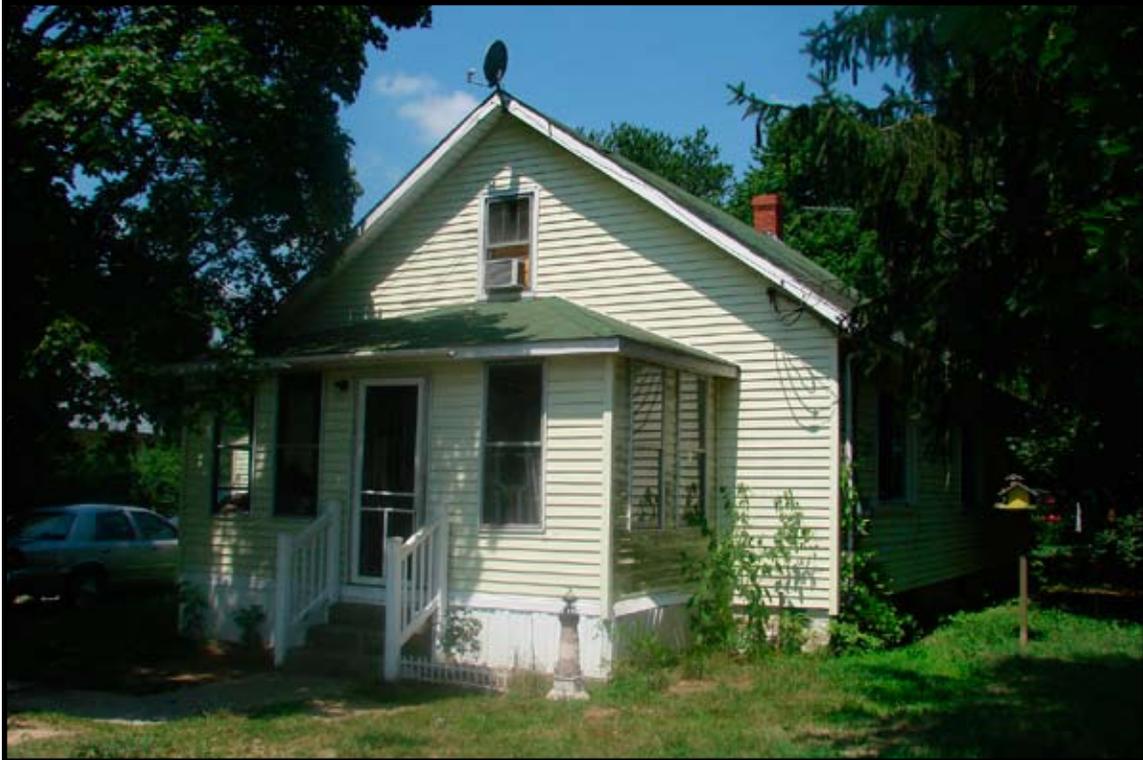
Plate 5.6. View facing northwest from Halltown Road looking at 6417 Halltown Road [CRS # K-6920]. (Photographer: William Liebeknecht, July 2008) [HRI Neg. # 08021/D1:4136].

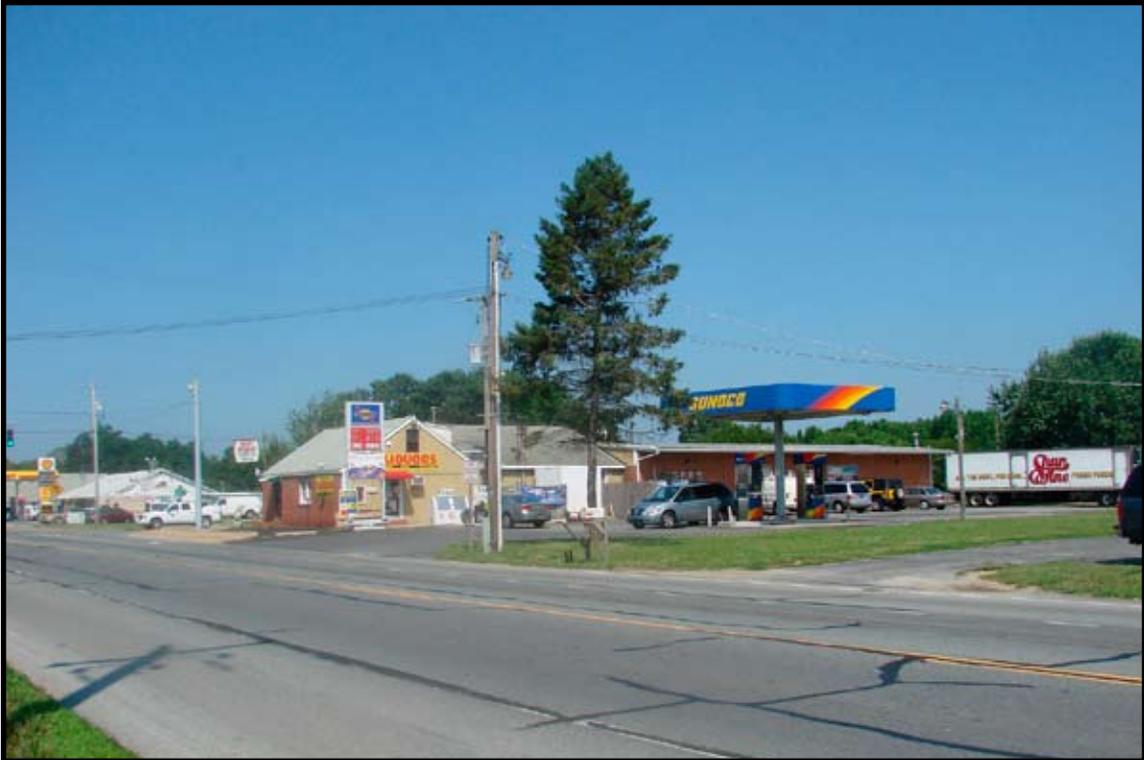
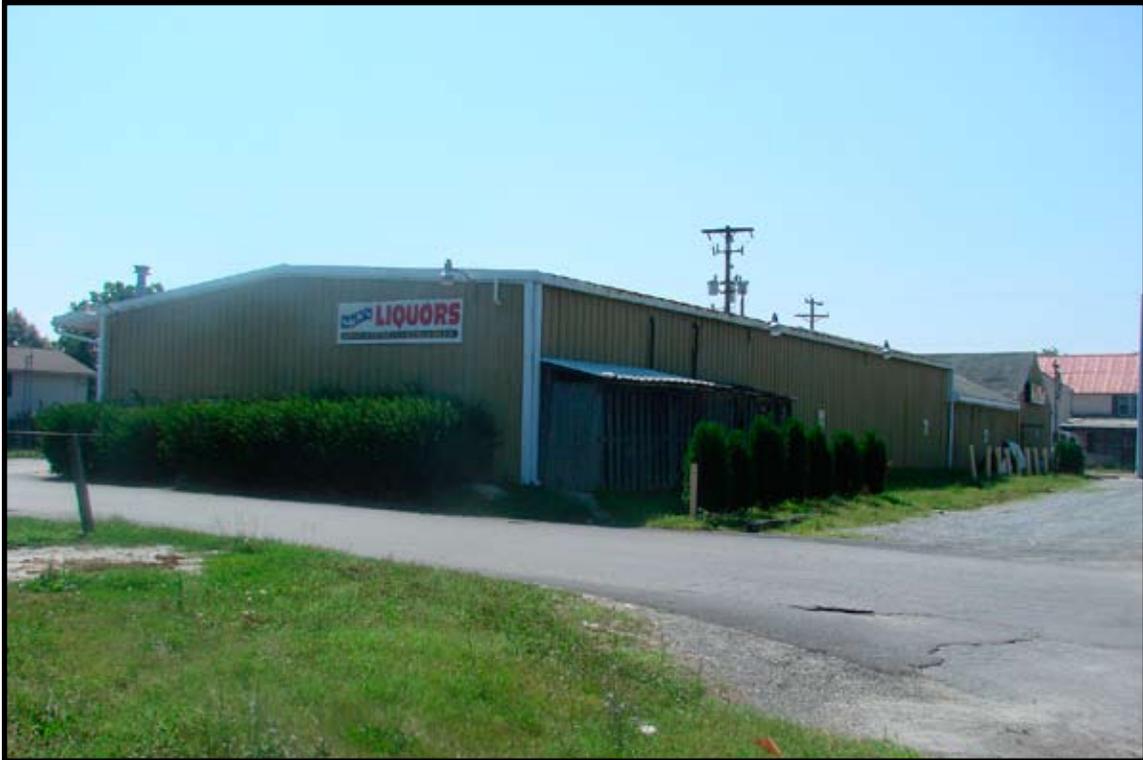
**5782 Forrest Ave [CRS # K-7613] (Plates 5.7 and 5.8)**

The southern portion of the commercial building at 5782 Forrest Avenue was built sometime between 1937 and 1953, when the land on which the building stands was part of a 35 acre farm. An aerial photograph from 1937 shows an undeveloped lot at this location, but the Delaware State Highway Department's *Plan for Construction of Contract No. 1219* (1953) depicts a one and a half story frame house and luncheonette in the building's present location (Delaware DataMil). The earliest part of the existing building appears to be a one and a half story end gabled frame building located on the northern edge of Forrest Avenue at its intersection with Pearson's Corner Road. The house and luncheonette was converted to a store and gas station by 1959 (Kent County Deed Z21/305). During the 1970s the first in a series of telescoping additions was attached to the northern end of the building. The street façade of the earliest block of the building and the eastern elevation of the northernmost addition have been "brick faced". The remainder of the building is sheathed in corrugated metal siding. According to the current owner, part of the building continued to be occupied by a diner into the 1990s. It is now occupied by a liquor store.

Plate 5.7. View facing northeast from Forrest Avenue looking towards commercial building at 5782 Forrest Avenue [CRS # K-7613]. (Photographer: William Liebeknecht, July 2008) [HRI Neg. # 08021/D1:4028].

Plate 5.8. View facing southeast from Pearson's Corner Road looking towards commercial building at 5782 Forrest Avenue [CRS # K-7613]. (Photographer: William Liebeknecht, July 2008) [HRI Neg. # 08021/D1:4035].

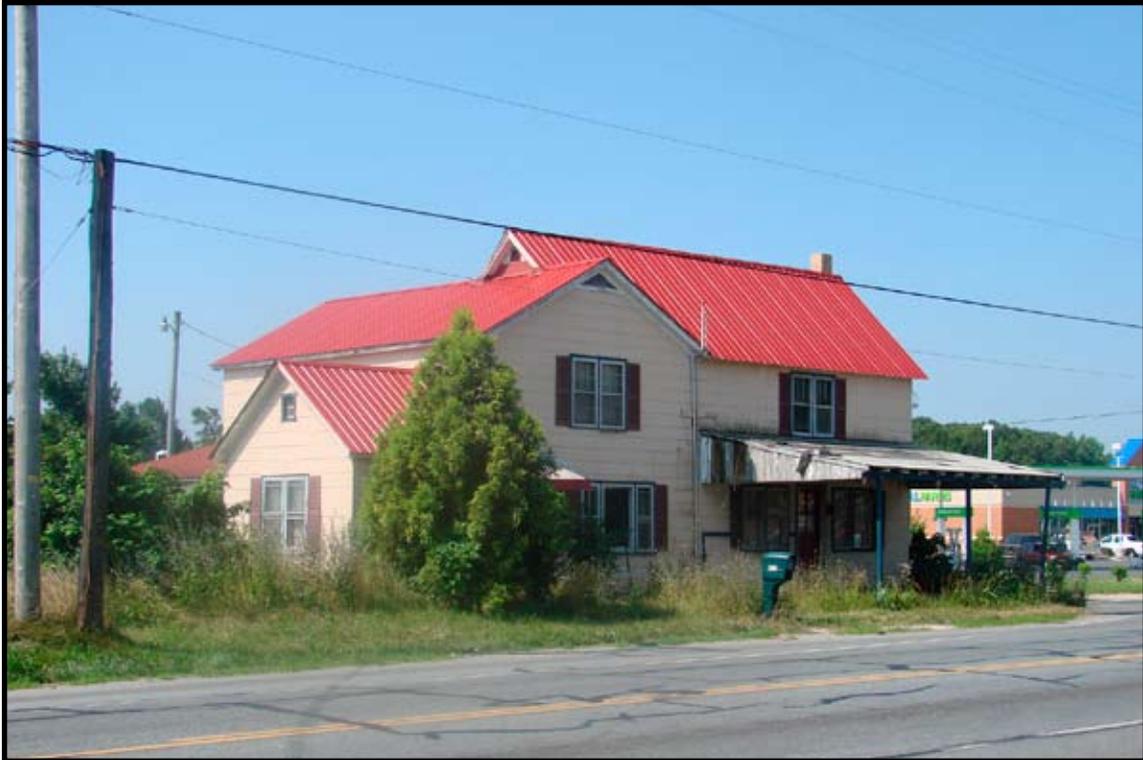
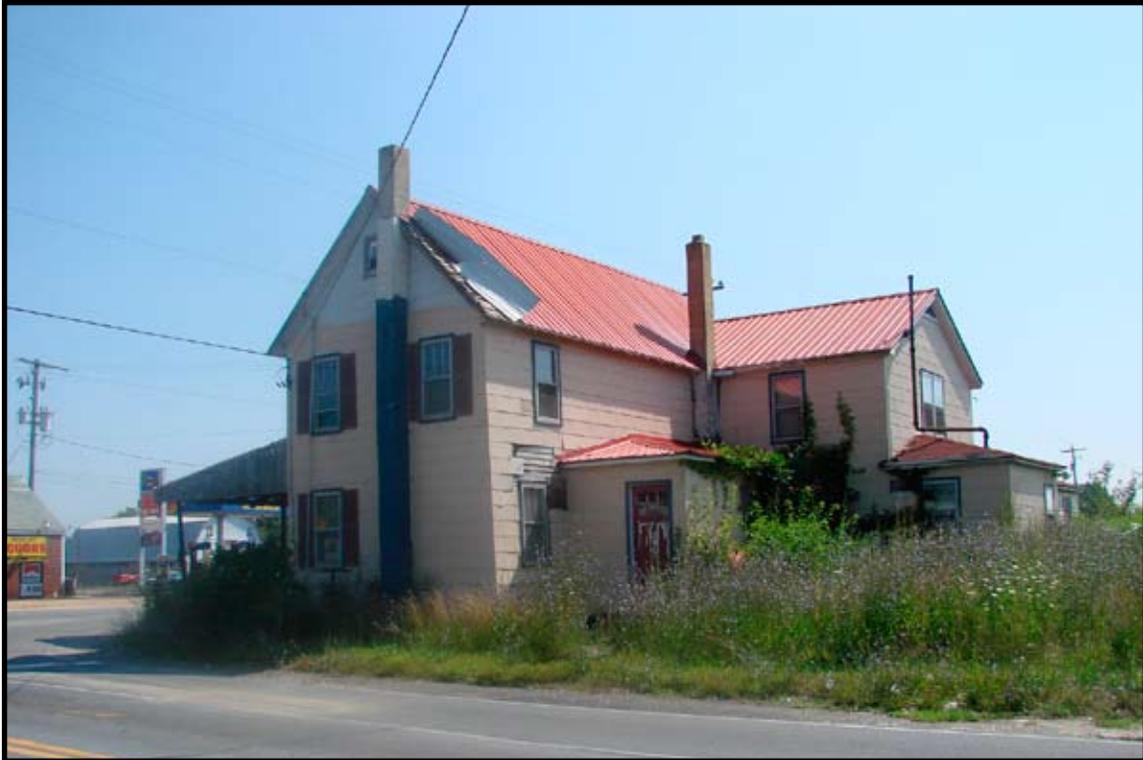
Plate 5.9. View facing southwest from Forrest Avenue looking at the southeast corner of the intersection of Pearson's Corner Road and Forrest Avenue showing 5779 Forrest Avenue[CRS # K-6920]. (Photographer: William Liebeknecht, July 2008) [HRI Neg. # 08021/D1:4000].

Plate 5.10. View facing northeast from Pearson's Corner Road showing 5779 Forrest Avenue [CRS # K-6920]. (Photographer: William Liebeknecht, July 2008) [HRI Neg. # 08021/D1:4004].

The house that currently stands at 5779 Forrest Avenue is a two story, frame building that stands on a concrete block foundation. The original exterior skin of the core of the house was wood clapboard but this has subsequently been covered with asbestos shingling. Similarly, the side gable roof of the main block of the home was first covered with wood shingles. These can still be seen on the southern face of the roof where wind has torn away the standing seam metal roofing that now covered both the main roof and the roofs over the building's multiple additions. The first story of the street façade is shielded by a projecting shed roof supported by three metal pipe columns. This roof is deep enough to have accommodated automobiles beneath it and likely served to protect the store customers and the gasoline pumps that once fronted the building from inclement weather.

A two story, modern front gabled addition has been attached to the buildings eastern wall. The gable roof of the main block of the building was extended at this time partially over the top with the roof of the addition in order to better facilitate the transition between the two structures. A single story end gabled addition and an even lower enclosed porch have also been attached

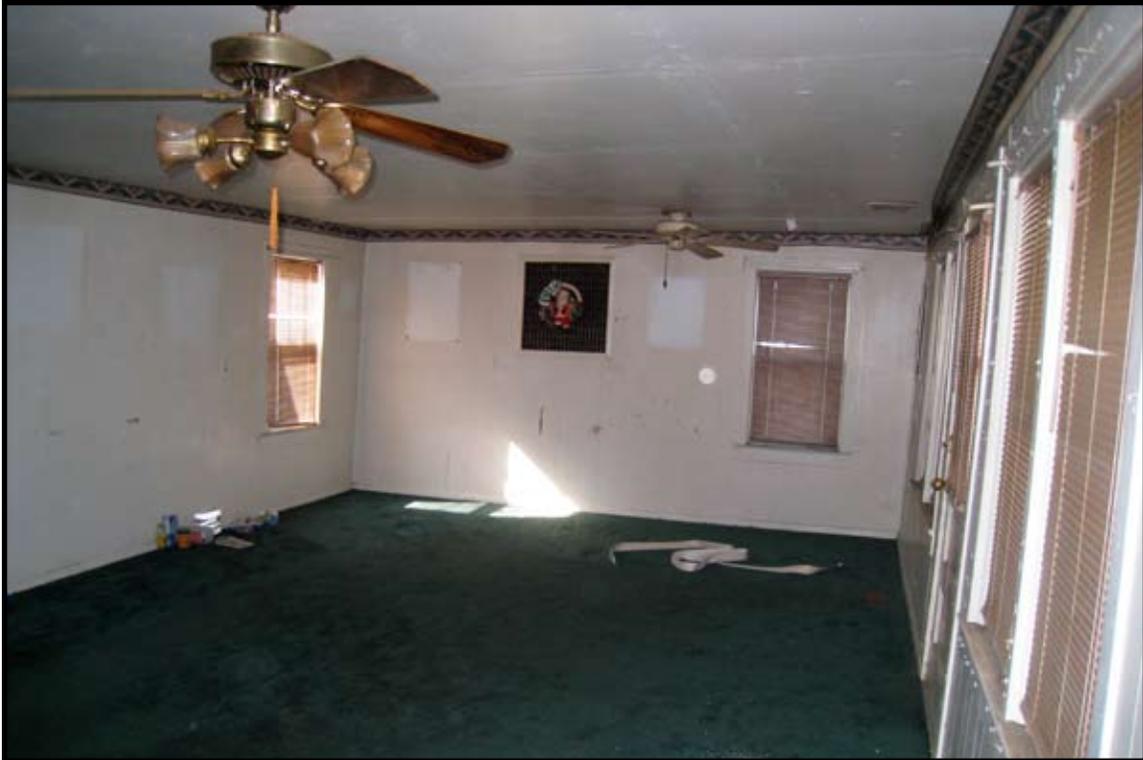
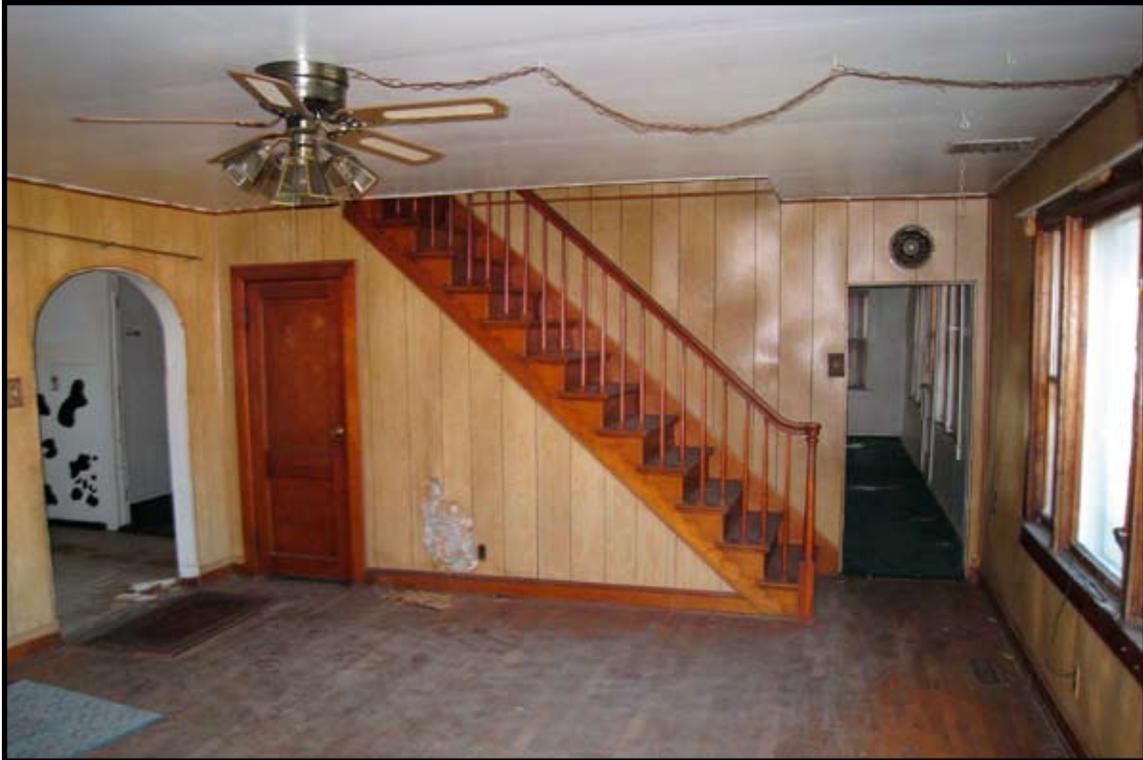
Plate 5.11. View of first floor interior of 5779 Forrest Avenue [CRS # K-6920], showing west room, main block of house, looking west. (Photographer: Damon Tvaryanas, October 2008) [HRI Neg. # 08021/D2:0232].

Plate 5.12. View of first floor interior of 5779 Forrest Avenue [CRS # K-6920], showing east room, main block of house, looking west. (Photographer: Damon Tvaryanas, October 2008) [HRI Neg. # 08021/D2:0222].

Examination of the interior of the building found that no basement existed beneath the structure. The second floor of the building was accessed from a staircase leading upwards from the front door. Examination of the building's framing and roof rafters visible in the attic of the main building and the addition shows the building to be constructed with modern balloon frame. No evidence of structural members apparently dating any earlier than the 20th-century were observed. All visible members, wood planking and the wood shingles that cover the roof were observed to be secured / fastened/joined with wire nails. No evidence of any hardware or architectural detailing indicative of a date prior to the 20th-century was observed.

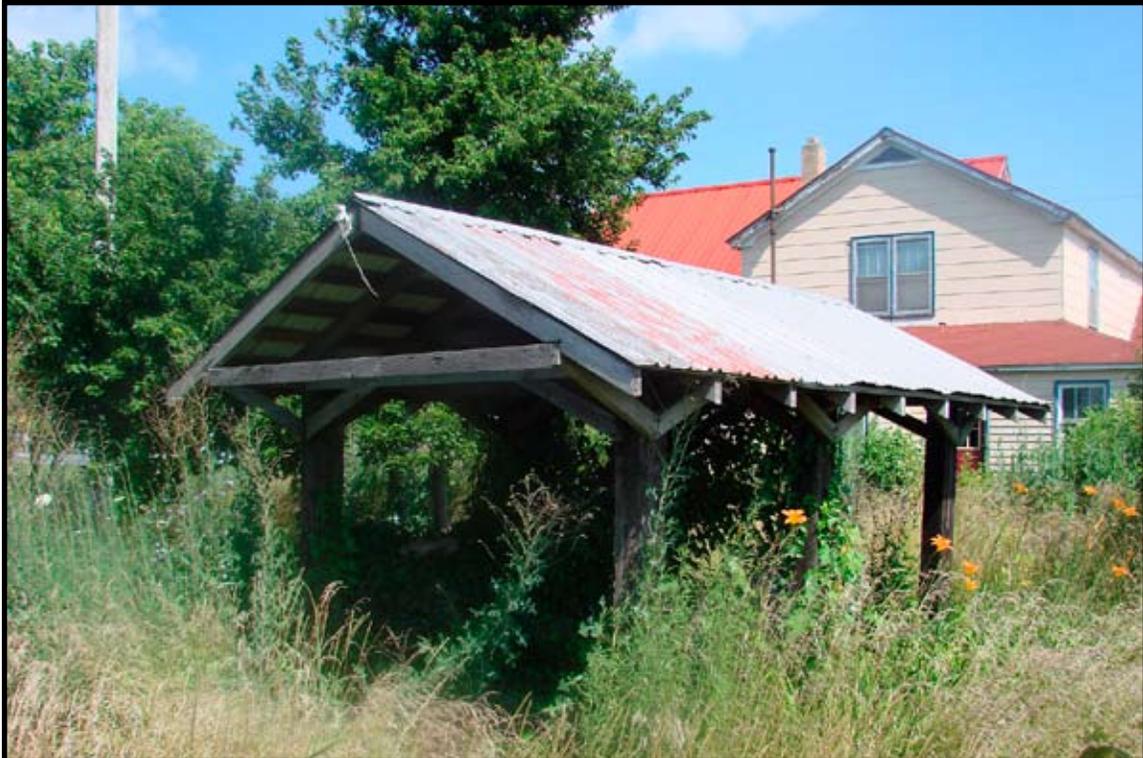
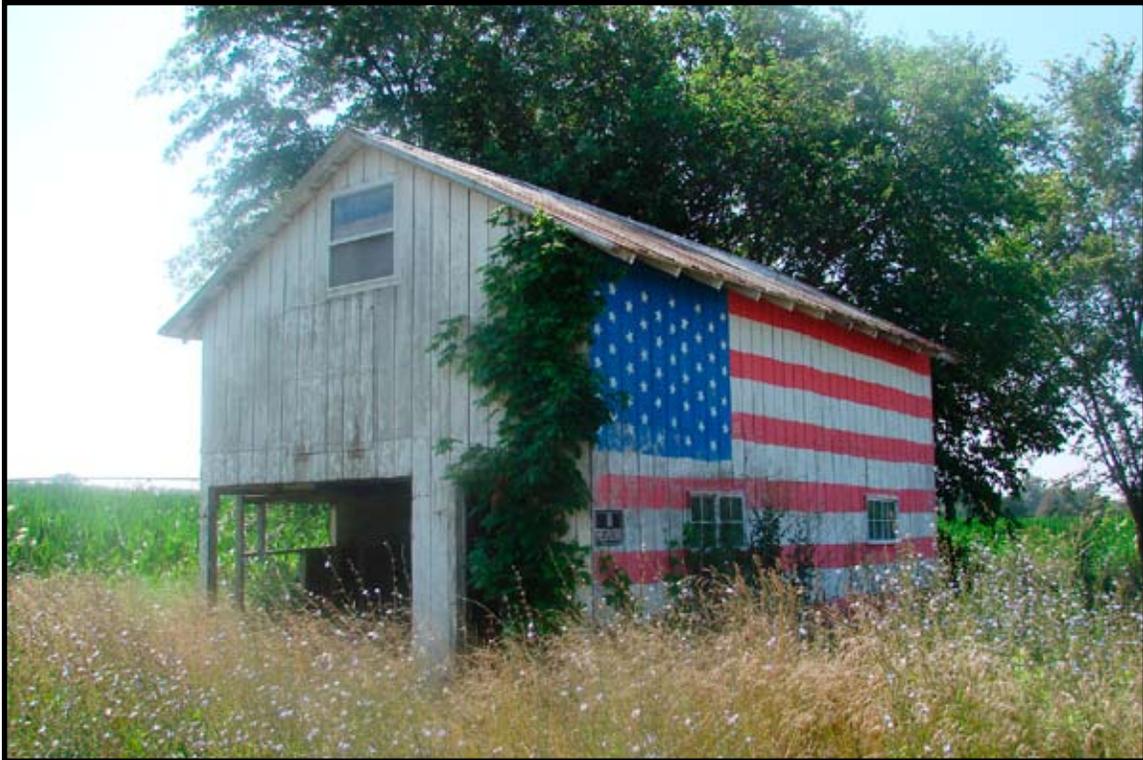
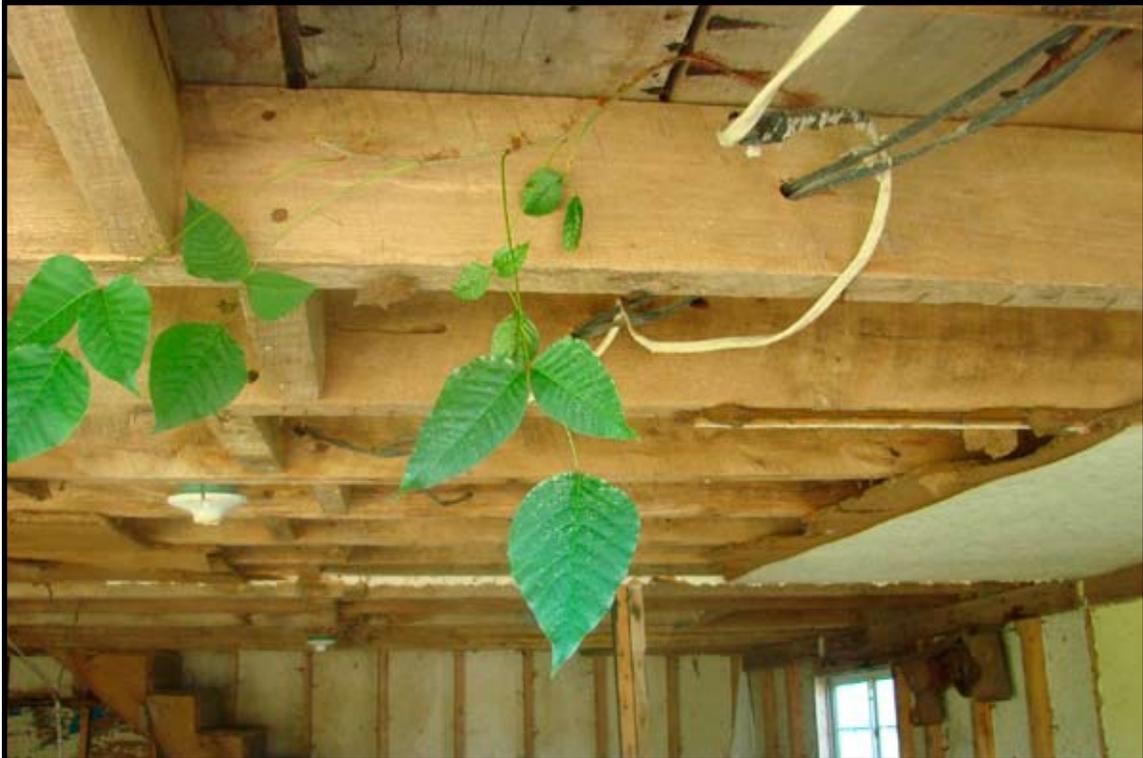
Plate 5.13. View facing northwest showing secondary structure to the rear of 5779 Forrest Avenue [CRS # K-6290]. (Photographer: William Liebeknecht, July 2008) [HRI Neg. # 08021/D1:4007].

Plate 5.14. View facing southeast from Pearson's Corner Road showing barn/carriage house at 5779 Forrest Avenue [CRS # K-6290]. (Photographer: William Liebeknecht, July 2008) [HRI Neg. # 08021/D1:4009].

Plate 5.15. View facing south the interior and second floor joists and framing of the barn/carrriage house at 5779 Forrest Avenue [CRS # K-6290]. (Photographer: William Liebeknecht, July 2008) [HRI Neg. # 08021/D1:4010].

Two structures were observed to the rear (south) of the primary residence. The first was a single story open shed/roofed covering. This consisted of a standing seam metal roof with open rafters supported by six timber post. The second structure was a two story light timber framed carriage house or barn. Relatively large members and wide planking was observed to form the second story floor within the building but the exterior walls were observed to have been constructed of two by four framing sheathed with modern faux wood panel siding.

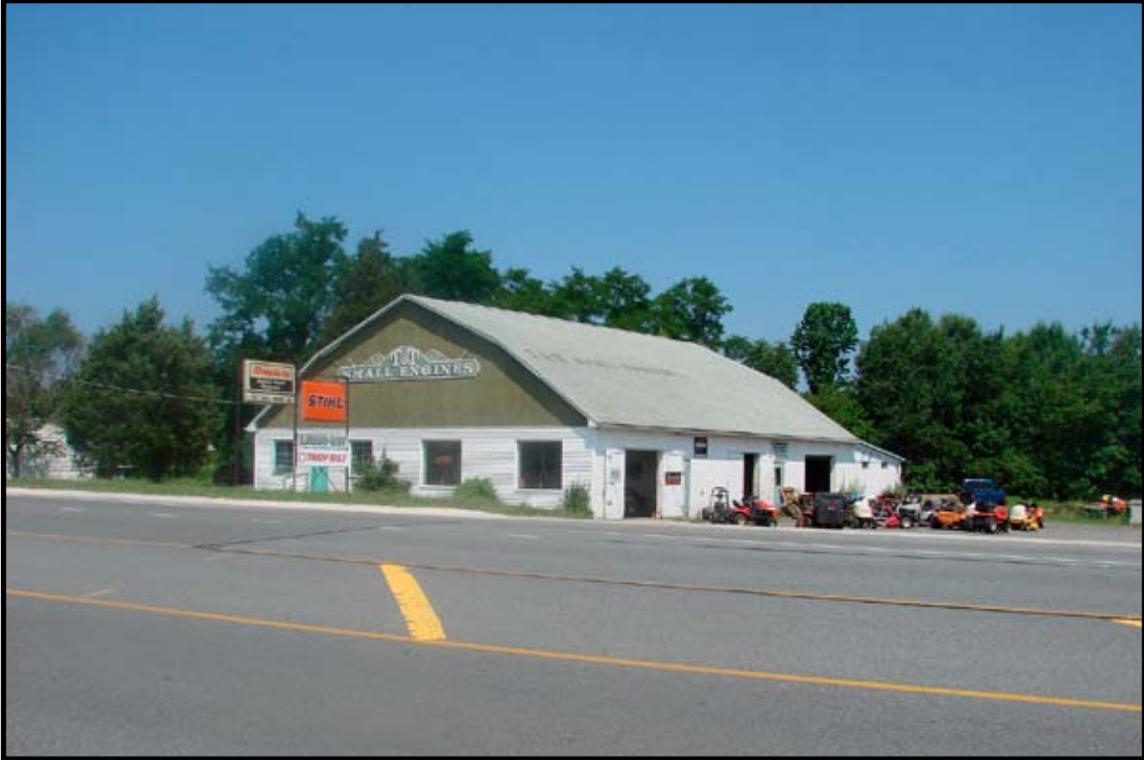
#### **6503 Halltown Road [CRS # K-7611] (Plate 5.16)**

Plate 5.16. View facing northwest from Halltown Road showing 6503 Halltown Road [T&T Small Engines]. (Photographer: William Liebeknecht, July 2008) [HRI Neg. # 08021/D1:4110].

According to the present owner the office portion of the existing shop building was formerly utilized as "Betty's Diner" and stood at a location on South Governors Avenue in Dover, Delaware. Since the date of the move, the original building has been significantly expanded in order to create the existing engine repair shop. The frame building is covered with asbestos shingling and sits on a concrete block foundation. Currently a large asphalt shingle gambrel roof covers both the new repair shop with its three large bay doors and the earlier diner/office building. A concrete block addition covered by an asphalt shingle shed roof projects from the building's northern wall. Although one can barely discern some visual clues that hint at the form of the original diner building, little overall architectural integrity survives from the era prior to the building's conversion into a repair shop.

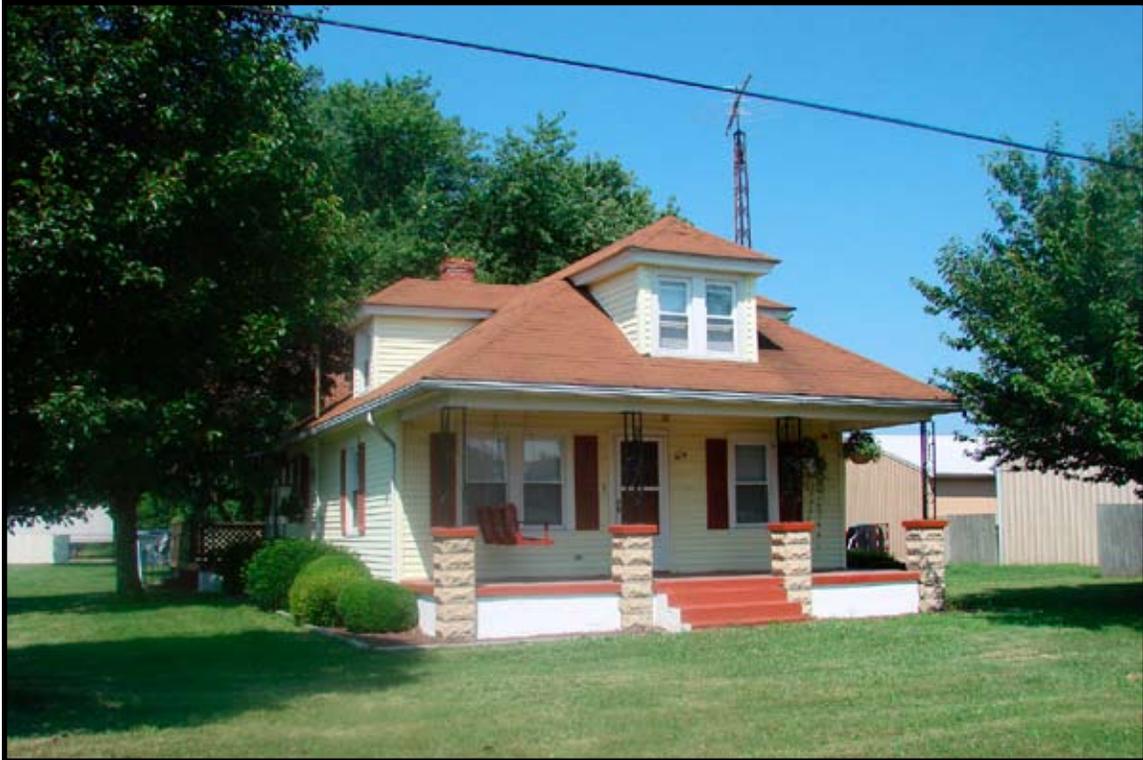
**2333 Pearson's Corner Road [CRS # K-7614] (Plate 5.17)**

Visual inspection of the property revealed that the house currently standing on this site is a one and a half story Craftsman style bungalow consistent in design with a date of construction in the second or third decades of the 20th century. It is a three-bay, one-and-a-half story house with a hipped roof pierced by hipped dormers. The roof extends forward to shelter a full-width concrete porch supported on concrete block piers and ornamental iron supports. The materials used to construct the porch suggest that it was built after the house was moved here. Windows are modern one over one units. Siding is modern.

Plate 5.17. View facing northwest from Pearson's Corner Road showing 2333 Pearson's Corner Road [CRS # K-7614]. (Photographer: William Liebeknecht, July 2008) [HRI Neg. # 08021/D1:4038].

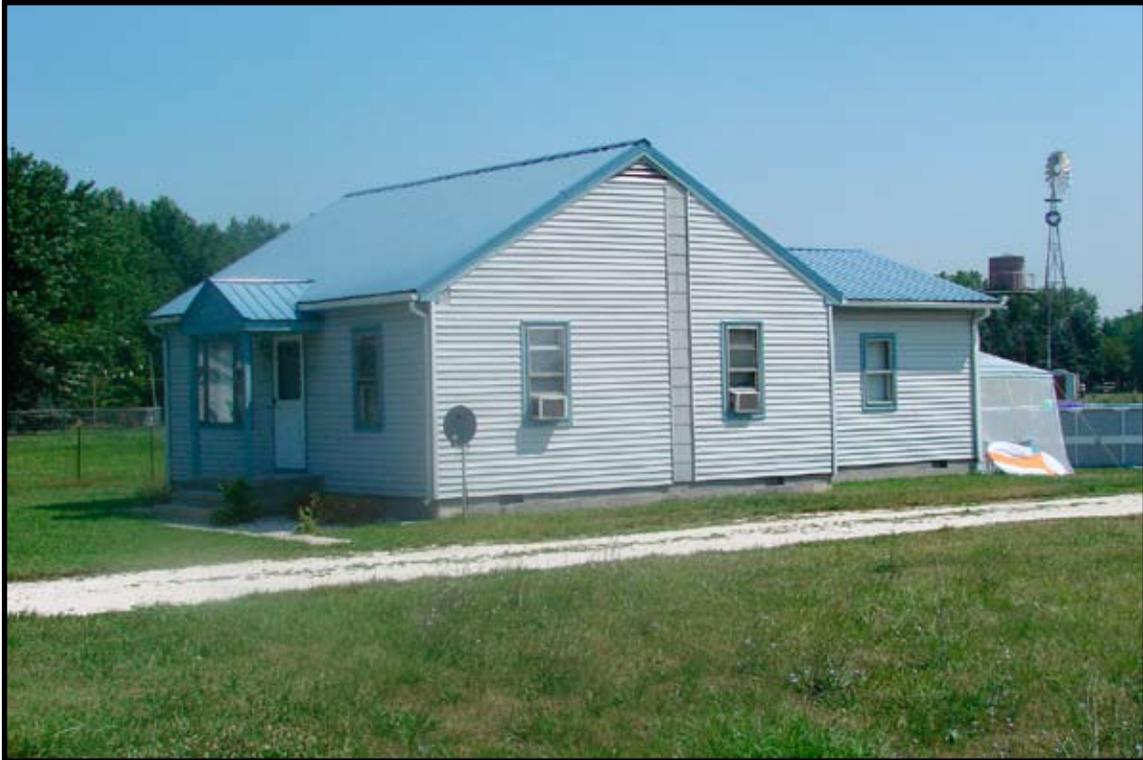
**2400 Pearson's Corner Road [CRS # K-7617] (Plate 5.18)**

Plate 5.18. View facing northeast from Pearson's Corner Road showing 2400 Pearson's Corner Road [CRS # K-7617]. (Photographer: William Liebeknecht, July 2008) [HRI Neg. # 08021/D1:4058].

DelDOT has verified with the current owner that the house probably dates from the mid- to late 1950s and that it was moved to this site extensively renovated early in the 21st century, including construction of an addition, to the extent that no significant evidence was observed during field survey activities that would point to this building being of greater than fifty years in age. Both the main rectangular block of the house and the short perpendicular wing that extends eastward sit on a modern concrete block foundation. All exterior detailing including the modern door and window fixtures, the vinyl siding that sheaths the building, the projecting gable above the main entry and its supports all appear consistent with a date of construction in the 21st century. The only possible inconsistency is the standing seam metal roof that covers the building. This is clearly a modern roof but the choice of materials is somewhat unusual for a modern building unless it was chosen to replace an earlier roof of the same construction.

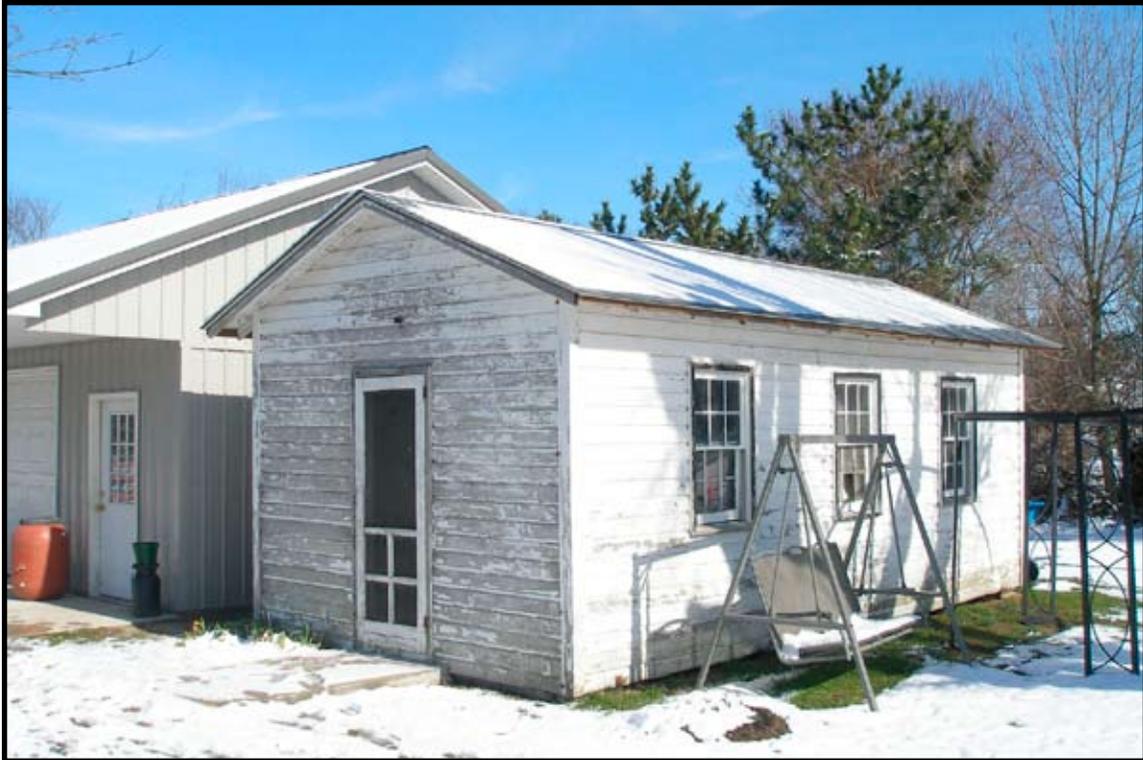
**3327 Hartly Road [CRS # K-7618] (Plate 5.19)**

The building is situated to the rear of a frame, single-story residence believed to date to the mid-1960s and to the immediate fore of a large modern shed. The single story, frame outbuilding, appears to sit on blocks or piers with no foundation visible. It is entered by single door on its north western elevation. Three six over six double hung windows are evenly spaced across its south western wall. Another boarded

Although a date of construction in the late 1950s, as the deed and aerial photography evidence would seem to suggest, is not completely out of the question, visual inspection seems to point to an earlier date for the construction of this building, possibly in the second or third decades of the 20th century. This was confirmed by a conversation with Daniel Beachey, the present owner, who reported that it had been moved from Donald Isaac’s farm in Middletown in the 1970s.

Plate 5.19. View small out building at 3327 Hartly Road looking southeast [CRS # K-7618].  
(Source: Delaware Department of Transportation).

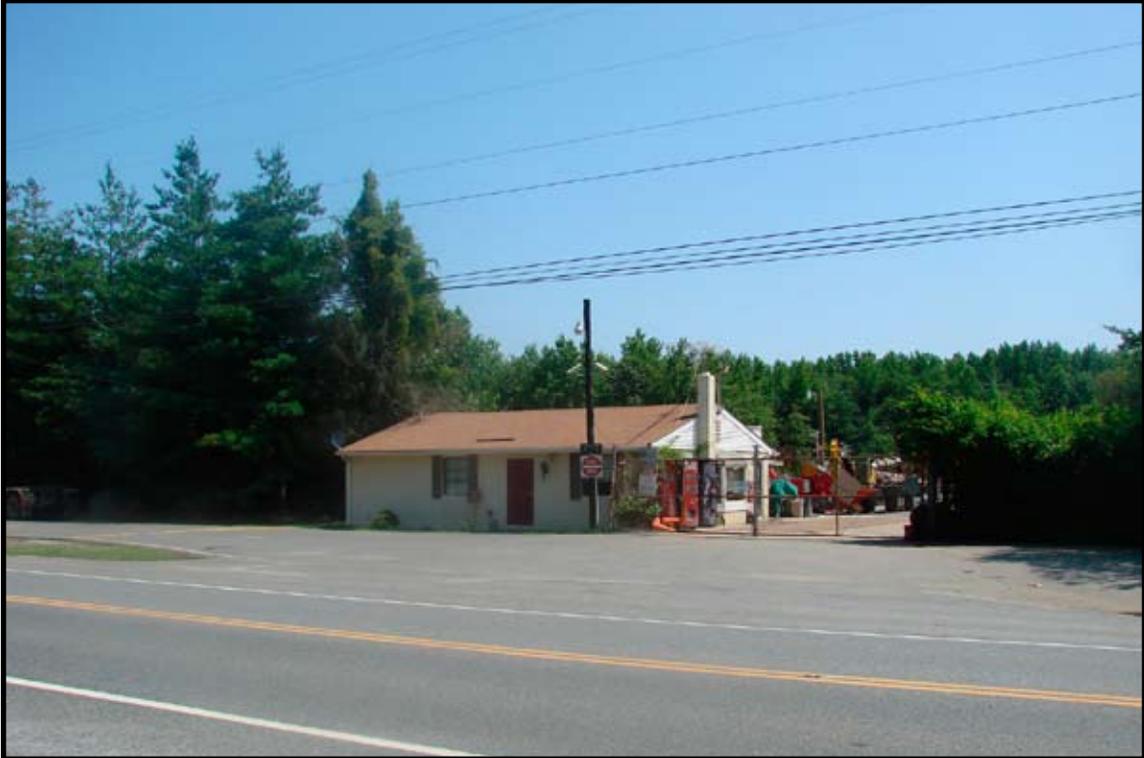
**3221 Hartly Road [CRS # K-7619] (Plate 5.20)**

The present owner of the property was interviewed by Delaware Department of Transportation employees concerning the age of this building. He stated that he had purchased the property around 1960 and that the office was on the property at the time of purchased. Information developed during historic research activities would seem to contradict this account. Title research indicates that the property last changed hands in 1977 when Ralph and JoAnn Peck sold 7 acres of their 54 acre farm to William and Mary Cannon (Kent County Deed N31/63). Aerial photography shows that the property was still in cultivation as farm land in 1961. A slightly later aerial photograph, taken in 1968, appears to show the existing building under construction (Delaware DataMil). According to the owner, a recent fire destroyed the interior and original roof.

Plate 5.20. View facing northeast from Hartly Road towards 3221 Hartly Road [CRS # K-7619].  
(Photographer: William Liebeknecht, July 2008) [HRI Neg. # 08021/D1:4080].

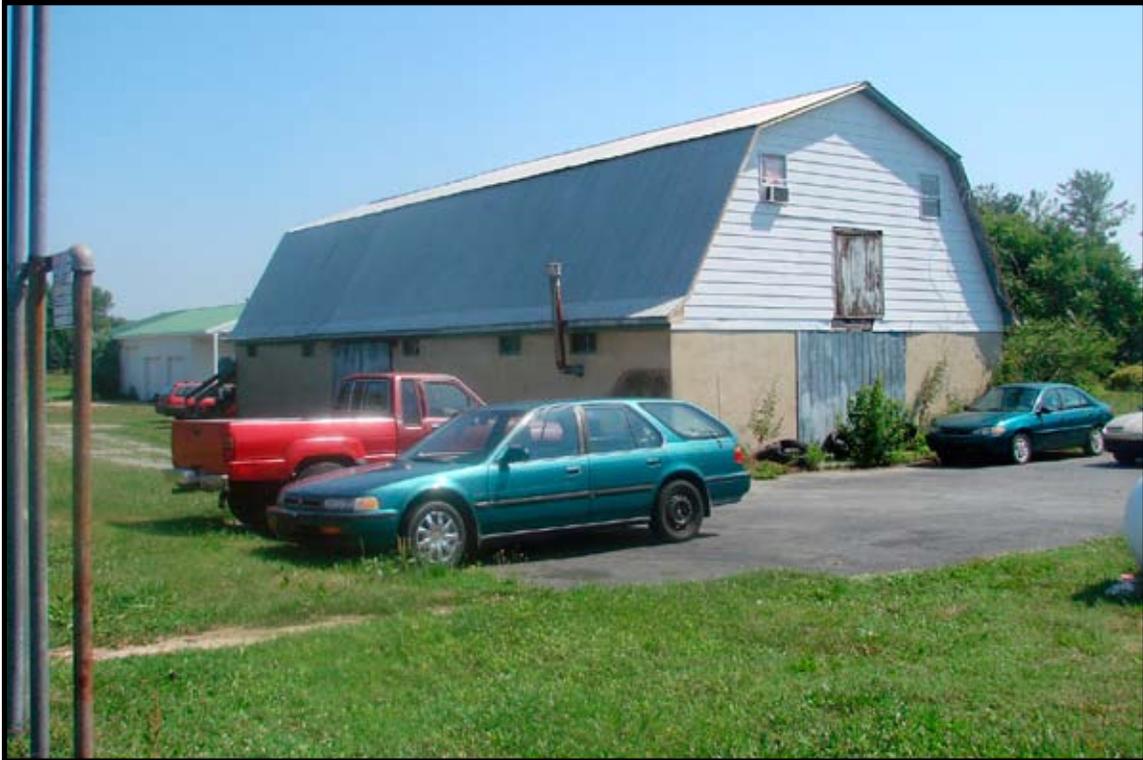
**5752 Forrest Avenue [CRS # K-7615] (Plate 5.24)**

The building is a single story barn with loft under a large standing seam gambrel roof. The first story of the building is constructed of parged concrete block. The upper portions of the walls on the northern and southern elevations are of frame construction. The upper level of the northern wall is sheathed in vertical plank siding. The upper portion of the southern wall is covered with vinyl siding.

The first floor of the building is lit by small, two pane casement windows shaded by the eaves of the gambrel roof. Sliding vertical plank doors cover the large bay openings on the southern, northern and western elevations. The loft level appears to have been converted into residential space. On the northern elevation an exterior wooden staircase has been installed. This structure leads upwards to shallow deck fronting a modern sliding glass door.

Plate 5.24. View facing northeast showing Dairy Barn at 5752 Forrest Avenue [CRS # K-7615].  
(Photographer: William Liebeknecht, July 2008) [HRI Neg. # 08021/D1:4032].
