CULTURAL RESOURCE SURVEY
PROPERTY IDENTIFICATION FORM

CRS # N08808
SPO Map 08-09-34
Hundred White Clay Creek
Quad Newark East
Other Parcel 0903000069

1. HISTORIC NAME/FUNCTION: Dwelling, 116 Stanton Christiana Road
2. ADDRESS/LOCATION: 116 Stanton Christiana Road, New Castle, Delaware 19702
3. TOWN/NEAREST TOWN: Christiana vicinity?
4. MAIN TYPE OF RESOURCE: building structure site object
 landscape district
5. MAIN FUNCTION OF PROPERTY: Single Dwelling
6. PROJECT TITLE/ REASON FOR SURVEY (if applicable): SR1 Lane Widening

CULTURAL RESOURCE SURVEY
MAIN BUILDING FORM

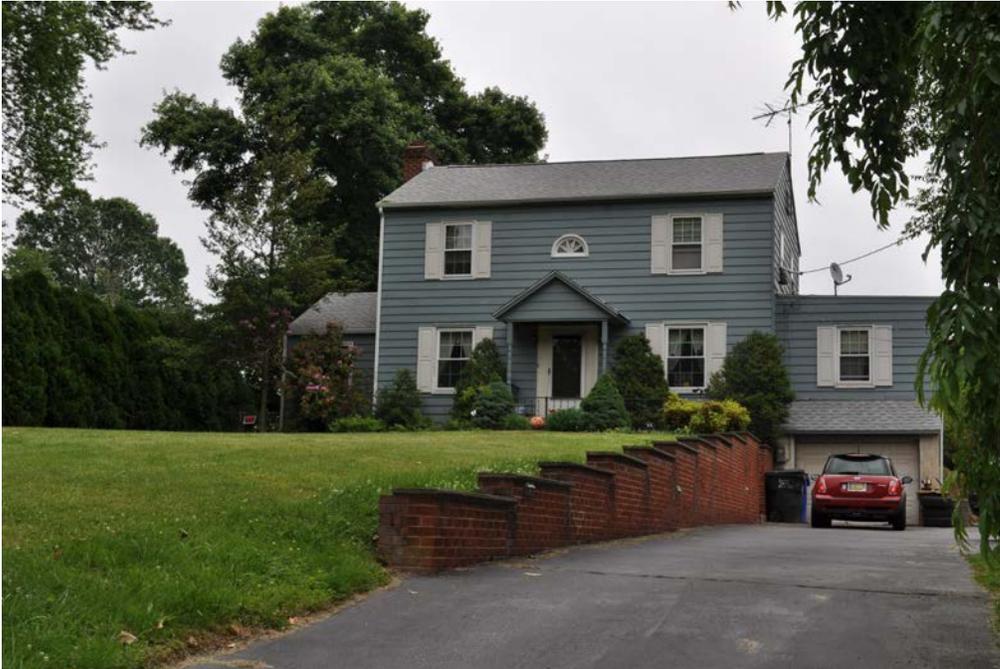
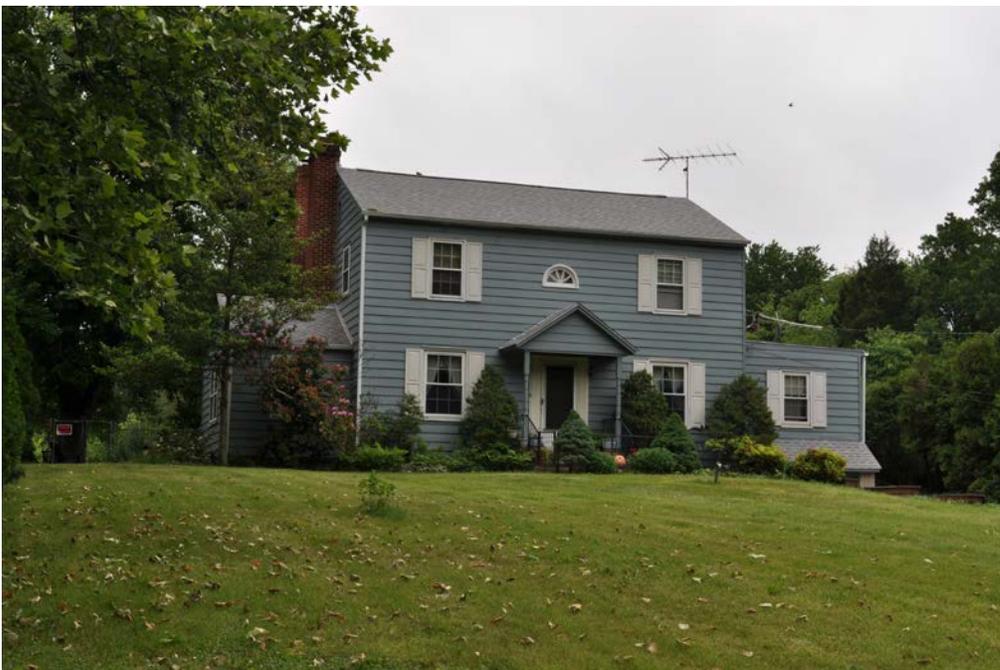
Description Main (west) elevation looking east; West and north elevations, looking southeast
