CULTURAL RESOURCE SURVEY
PROPERTY IDENTIFICATION FORM

CRS # N08826
SPO Map 08-09-31
Hundred Red Lion
Quad St. Georges
Other Parcel:1201300005

- HISTORIC NAME/FUNCTION: Stapleford Property
- ADDRESS/LOCATION: 4307 Wrangle Hill Road , New Castle, Delaware 19702
- TOWN/NEAREST TOWN: St Georges vicinity?
- MAIN TYPE OF RESOURCE: building structure site object
landscape district
- MAIN FUNCTION OF PROPERTY: Commercial
- PROJECT TITLE/ REASON FOR SURVEY (if applicable):
SR 1 Road Widening

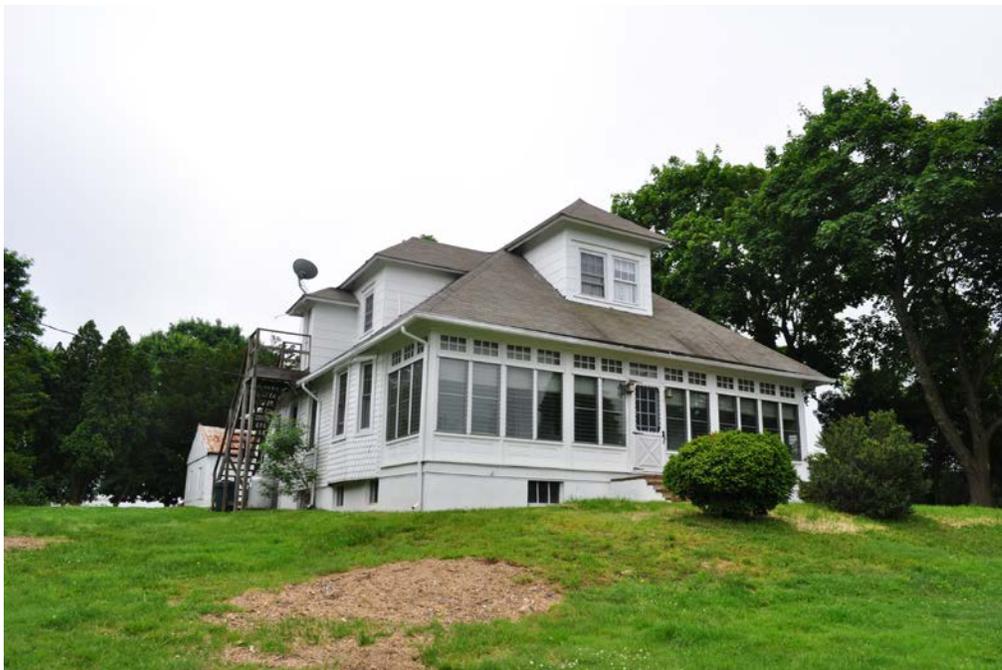
- 1) Bays 5
- 2) Windows 6
 fenestration irregular, three window bays on basement level, triple windows on enclosed porches on N end of elevation, bay window S of porch, 3 single bays to S; dormer window on 1.5 story; 3 windows on basement level
 type louvered wood sash on enclosed porch, 6/1 double-hung vinyl sash
 trim 6-light wood sash transom, wood paneling below on N enclosed porch
 shutters N/A
- 3) Door(s) 1
 location 1.5-story dormer, projecting bay w/ hipped roof S of dormer window
 type single-leaf flush wood
 trim N/A
- 4) Porch(es) wood stair leading to 1.5-story door

Description Northeast corner of dwelling (.001) looking southwest; Southwest corner of dwelling (.001) looking northeast

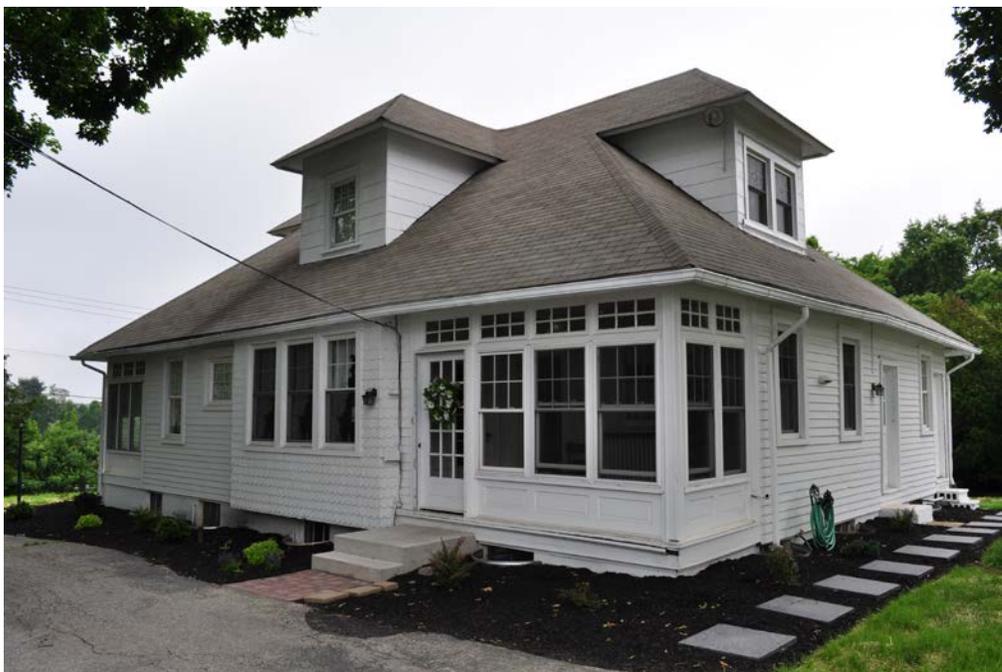
- 1) Bays 6
- 2) Windows 9
 fenestration irregular, three window bays on basement level, triple windows on enclosed porches on N & S ends of elevation, triple windows on projecting bay, and single windows south of enclosed front porch
 type louvered wood sash on N porch, 6/1 double-hung vinyl sash, 16-light vinyl sash
 trim 6-light wood sash transom, wood paneling below on N & S enclosed porches
 shutters N/A
- 3) Door(s) 1
 location enclosed porch on S end, N bay
 type single-leaf wood with 15 glazed lights
 trim 6-light wood sash transom
- 4) Porch(es) enclosed porch under main roof on N & S ends of elevation

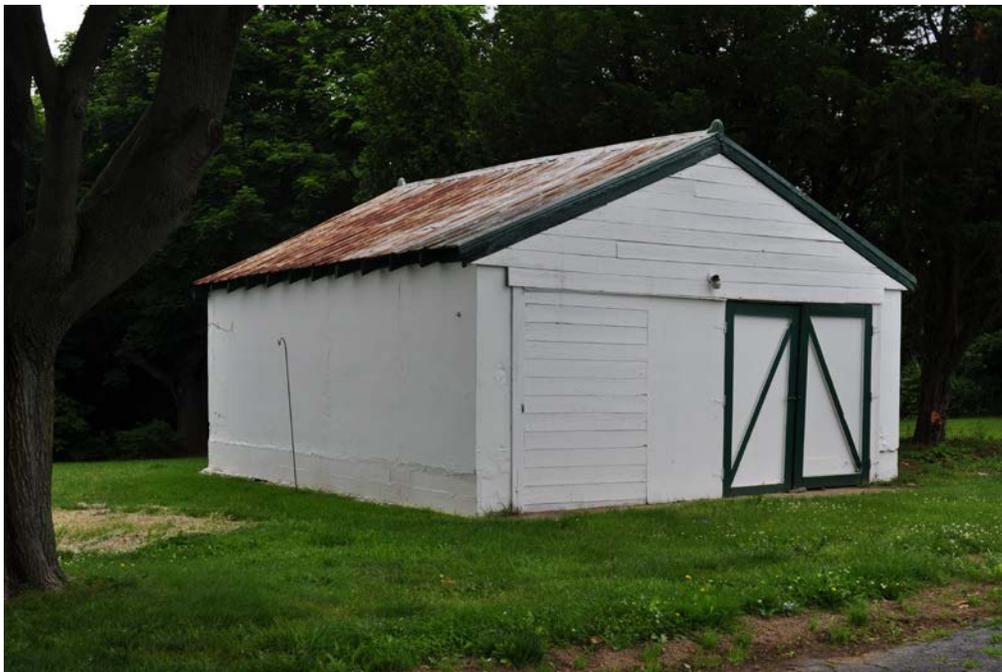
3) door(s): 1, double-leaf shed doors on S side of what appears to have been a larger opening that has been enclosed

Description Northwest corner of shed (.003) looking southeast; Southeast corner of garage (.004) looking northwest.

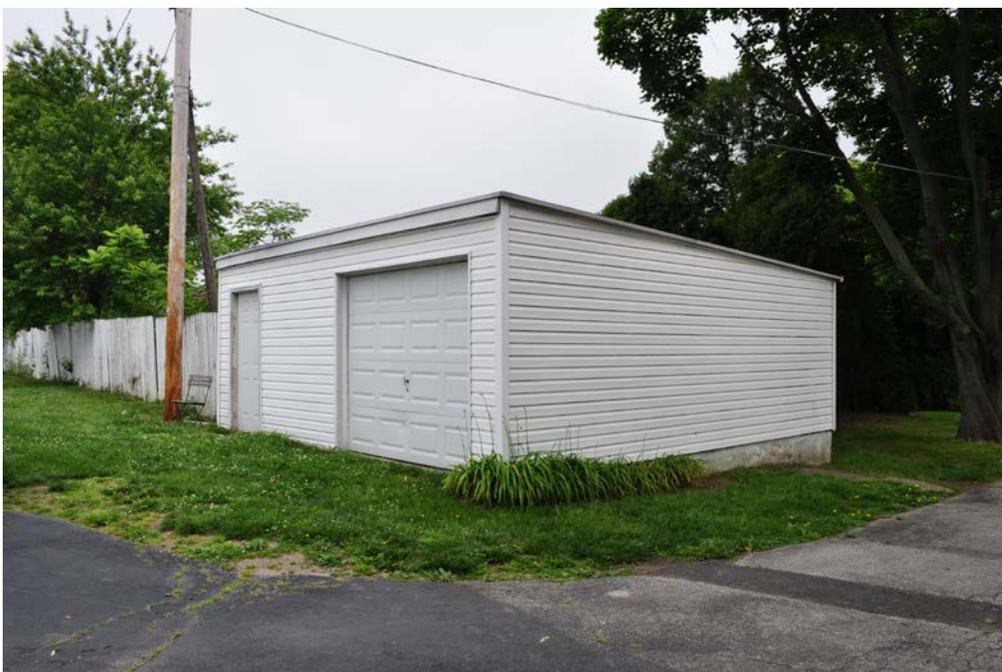
3) door(s): 2, metal garage door in E bay and single-leaf metal door in W bay

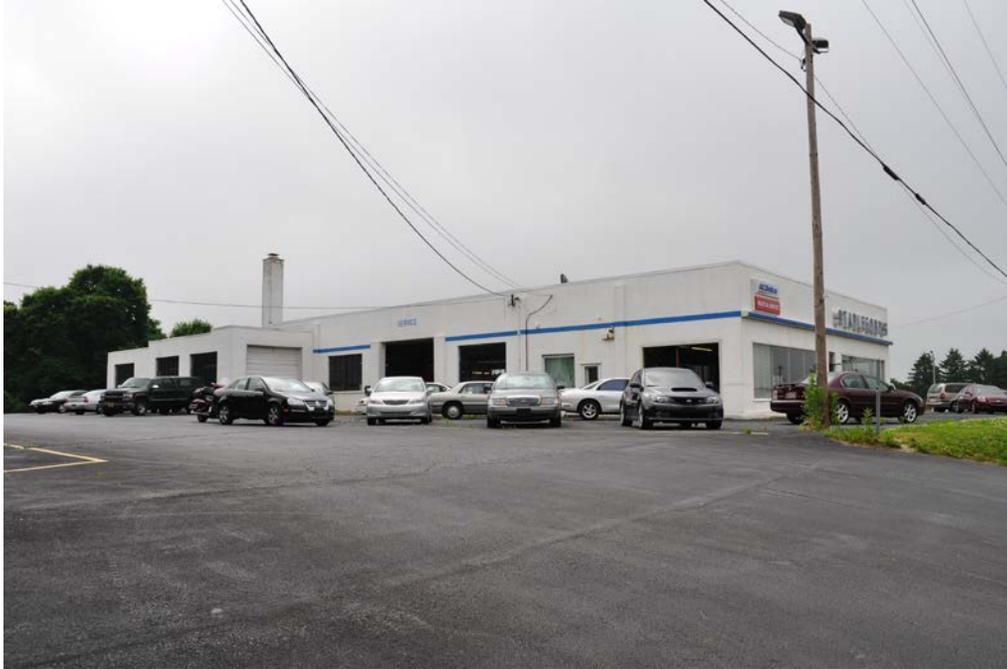
- a. Facade: Direction: West
 - 1) Bays 4 (3 on main block, 1 on east addition)
 - 2) Windows 2
 - fenestration regular
 - type picture window, 3-light fixed metal sash to south, 4-light to the north
 - trim N/A
 - shutters N/A

Description Northwest corner of commercial building (.002) looking southeast; Northeast corner of commercial building (.002) looking southwest

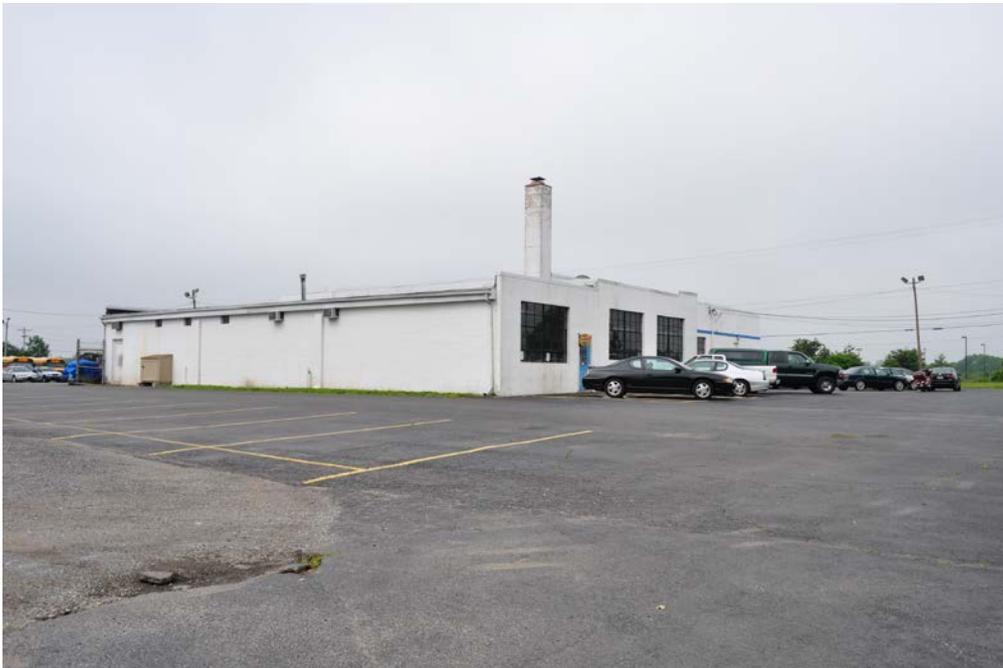
- 1) Bays 10
- 2) Windows 7
 fenestration irregular
 type large metal sash picture windows on W 2 window bays, multi-light metal sash on main block and east addition
 trim N/A
 shutters N/A
- 3) Door(s) 3
 location 3rd bay from W on main block, near center of main block, 2nd bay from E on E addition
 type single-leaf wood paneled door w/ 6-light upper half on addition, single-leaf glazed metal on 3rd bay from W on main block, vehicle door near center of main block
 trim N/A
- 4) Porch(es) N/A

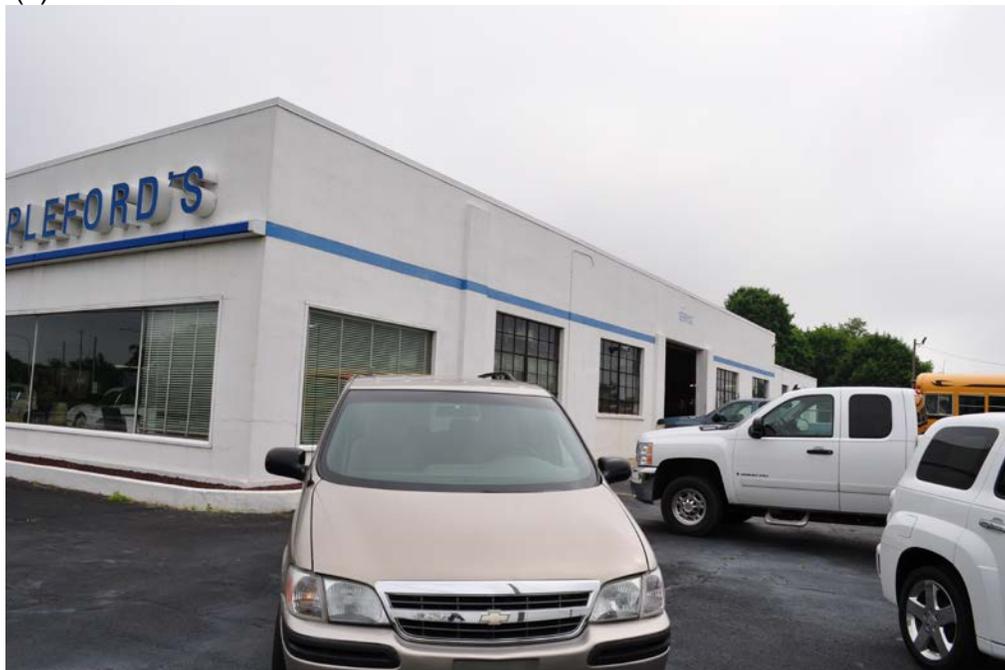
- 1) Bays 7
- 2) Windows 6
 fenestration irregular
 type 4-light metal sash picture window on W bay, multi-light metal sash windows on 4 east bays, 8-light metal sash window on E addition
 trim N/A
 shutters N/A
- 3) Door(s) 2
 location off-center, main block, east bay on addition
 type vehicle door on main block and addition
 trim N/A
- 4) Porch(es) N/A

Description South elevation of commercial building (.002) looking northeast;
