CULTURAL RESOURCE SURVEY
SURVEY UPDATE FORM

CRS # N14168

1. HISTORIC NAME/FUNCTION: Dwelling, 128 Stanton Christiana Road

2. ADDRESS/LOCATION: 128 Stanton Christiana Road, Newark DE 19702

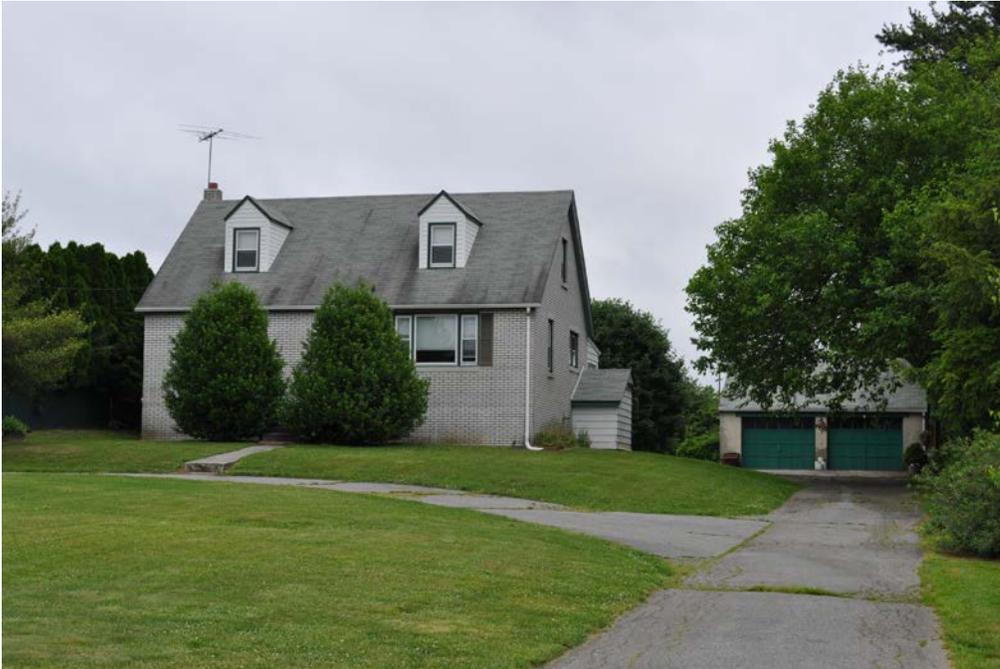
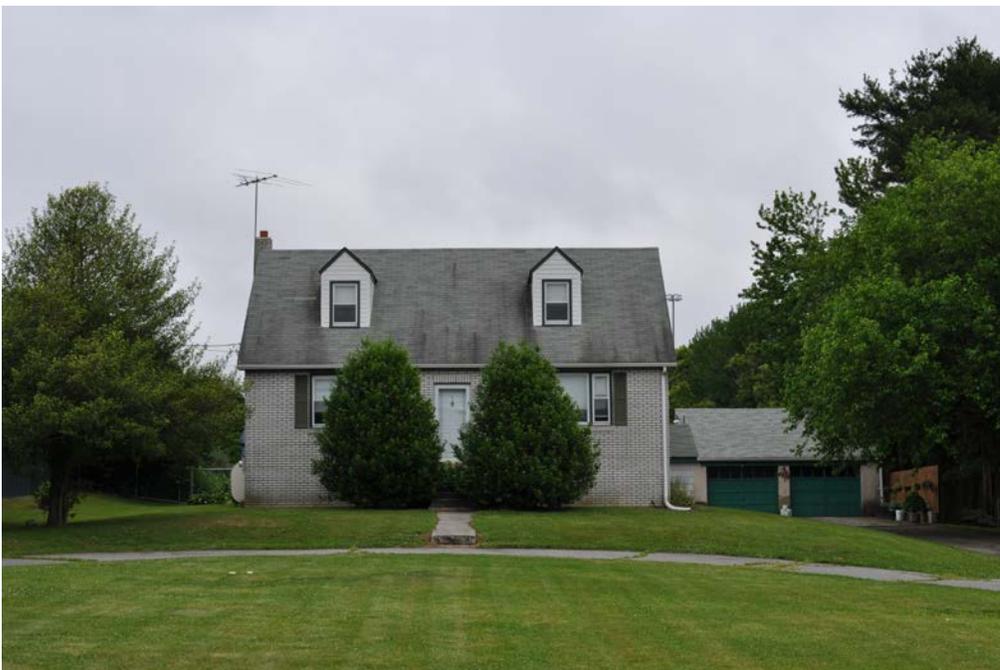
Description Main (west) and south elevations of house (.001) and west elevation of garage (.002), looking northeast; Main (west) elevations of house (.001) and garage (.002) looking east

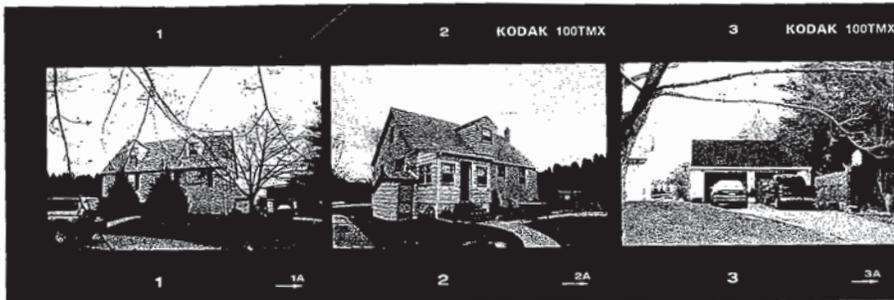
Description View of front, W side of dwelling; View of rear, E and S side of dwelling; View of front, W side of garage
