CHAPTER 4

THE LOG BUILDING

B. DESCRIPTION OF THE BUILDING, ITS DATE AND ITS EVOLUTION

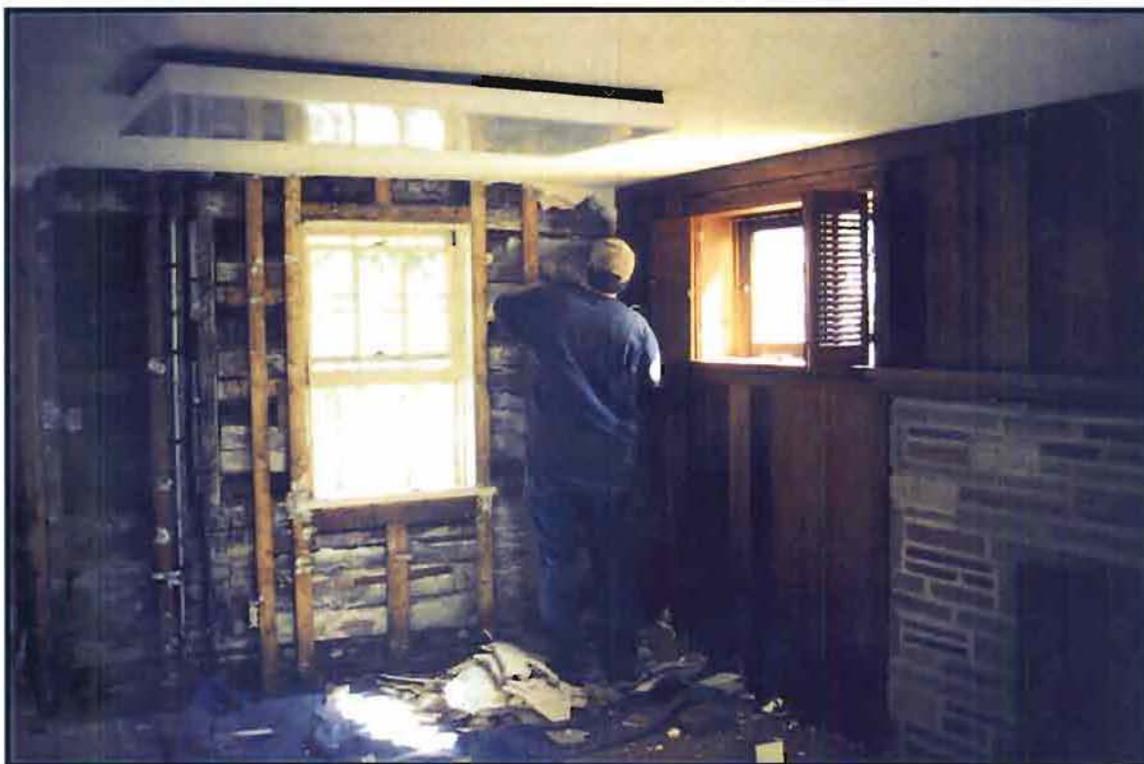
Plate 4.1. Archaeologist Bill Bulger removing wall fabric to expose the log structure (Photographer: Dawn Turner, December 1999)[HRI Neg.# 98039/19:1]

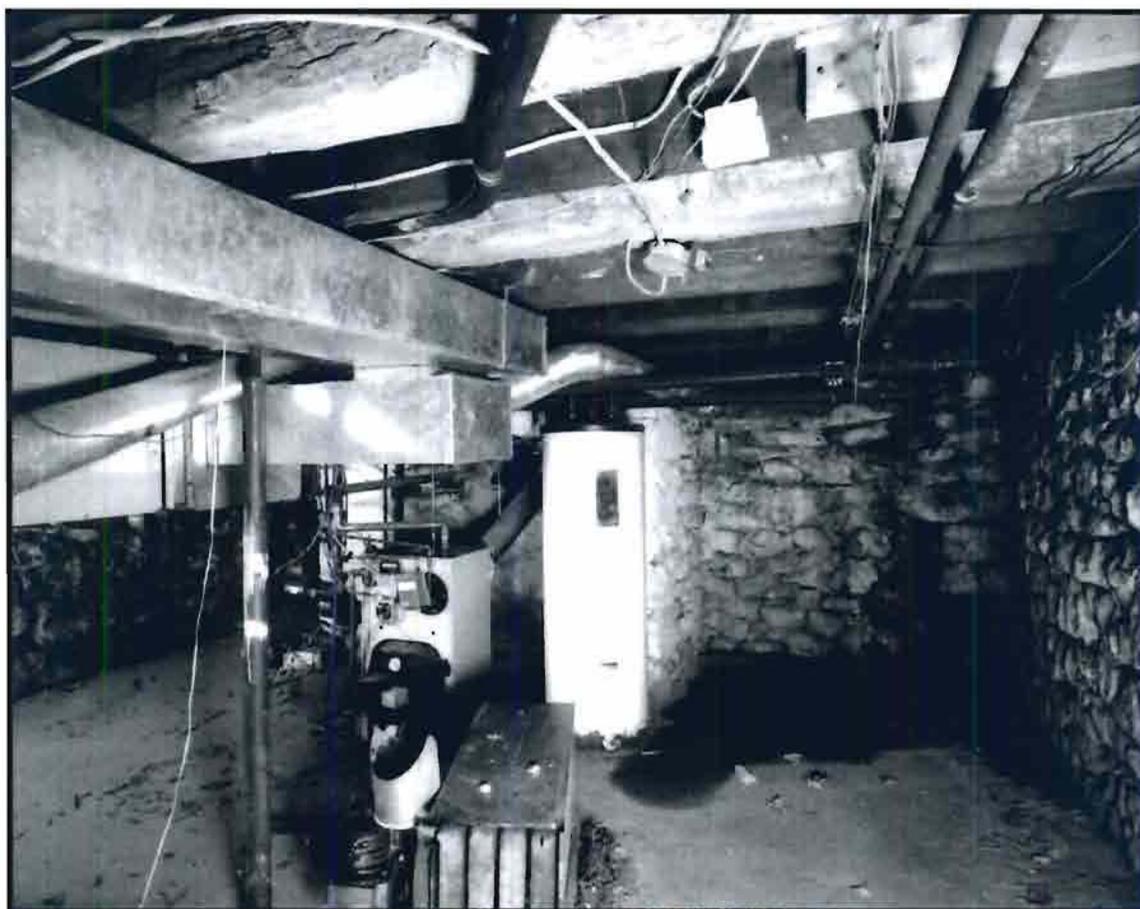
Room B-1 represents the cellar of the earliest portion of the house (Plate 4.4). The space measures approximately 23' x 18' and contained the building's modern furnace and fuel oil tanks. A large arched stone support for the original chimney stack and hearth survived along the southern wall (Plate 4.5).

Plate 4.4. View of Room B-1, looking southeast with original chimney supports at center of view (Photographer: Dawn Turner, December 1999)[HRI Neg.# 99037/35:11].

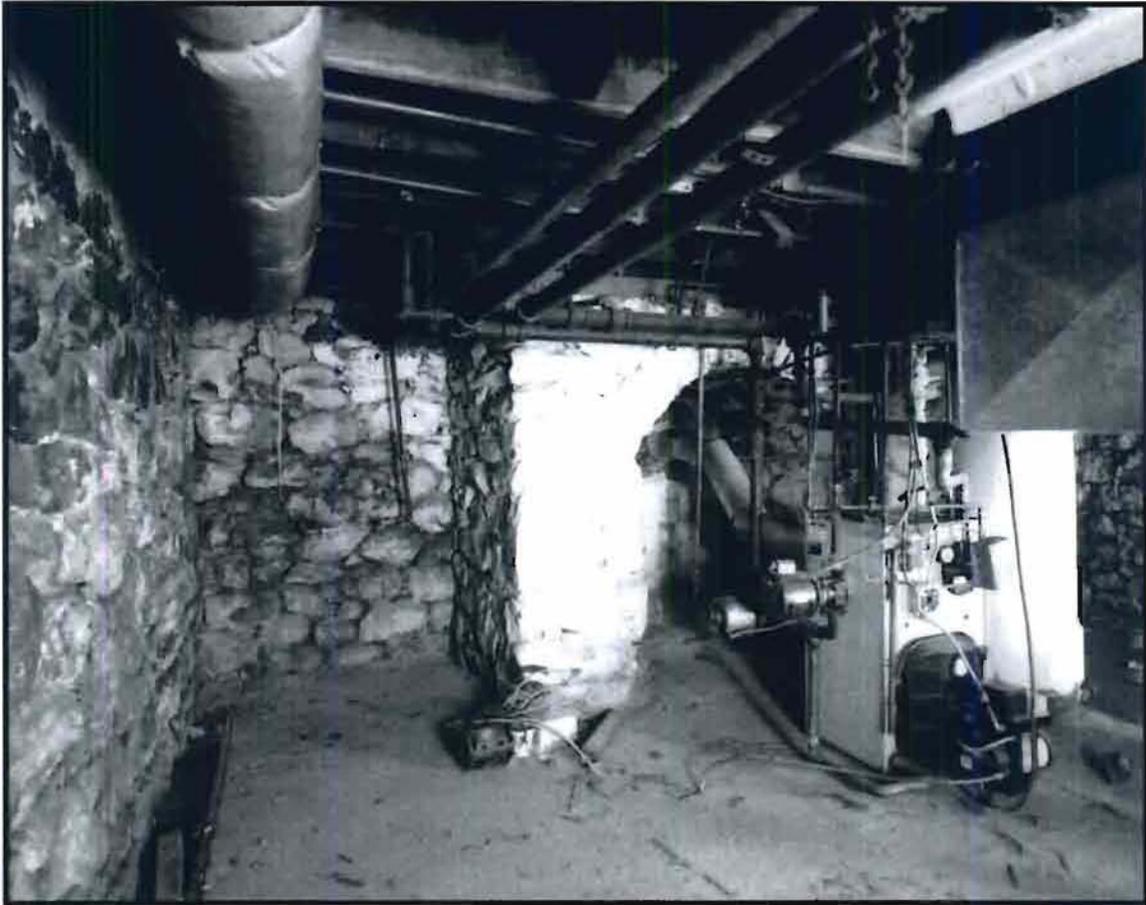
Plate 4.5. View showing the stone rubble foundation, and the large arched stone fire-place support located at the center of the basement's south wall. The building has since been removed from its original foundation to a new location (Photographer: Dawn Turner, December 1999)[HRI Neg.# 99037/36:7].

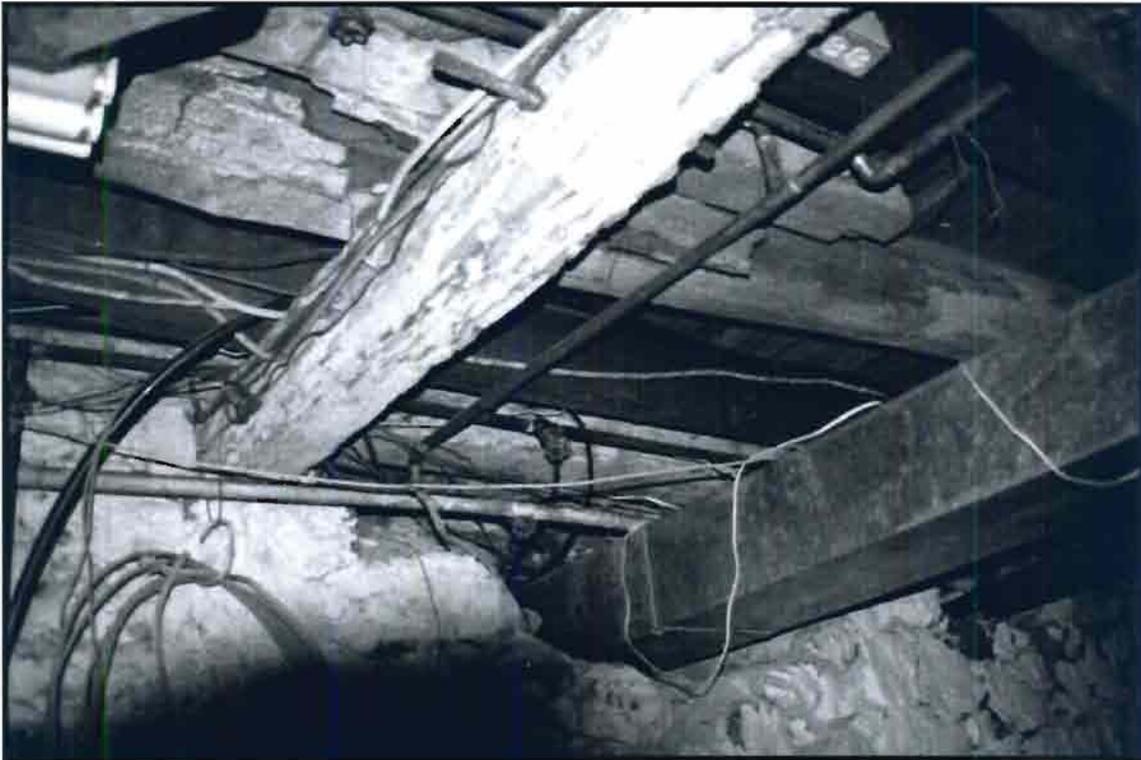
Plate 4.6. View of first floor framing, Room B-1 looking northeast. Summer beam is visible at top center. Opening made in northern foundation wall to accommodate late ductwork appears at right (Photographer: Dawn Turner, December 1999)[HRI Neg.# 98039/1:18].

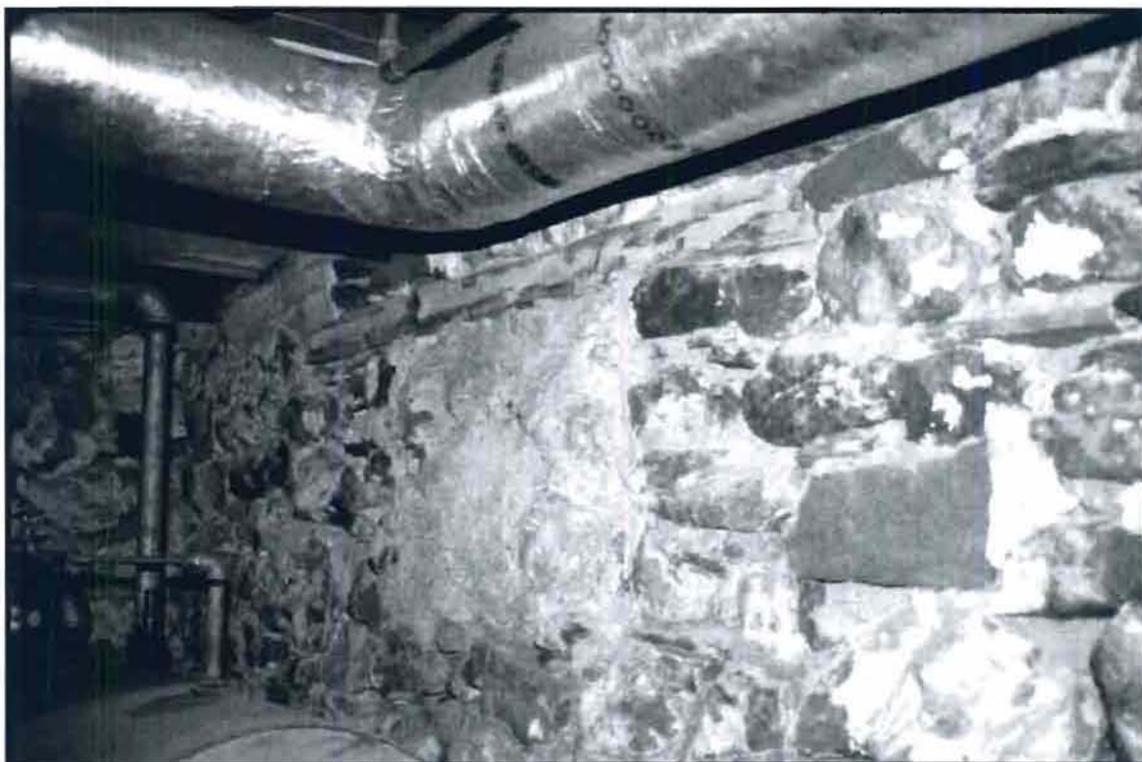
Although currently a window-less space, two window openings (Windows B1b and B1c) that formerly provided light to room were observed near the top of the east wall. The southernmost of these, Window B1b appears in a historic photograph of Tweed's Tavern to the left of the concrete block porch deck in Plate 3.6. The photograph shows the opening prior to infilling with stone. These openings were centered on each side of original first floor door openings and topped by a wooden lintel. No evidence of the sash type was identified either through first hand inspection or from detailed examination of historic photographs. Window B1c, filled in and topped by a wood lintel appears in Plate 4.7. Windows B1b and B1c would likely have consisted of a simple casement fixture or, alternatively since these were basement windows, they may have barred with wood or iron and lacked a sash entirely.

Plate 4.7. View of cellar wall in Room B-1 looking east-northeast. Filled in opening of Window B1c and wooden window lintel visible at center of image (Photographer: Dawn Turner, December 1999)[HRI Neg.# 98039/1:25].

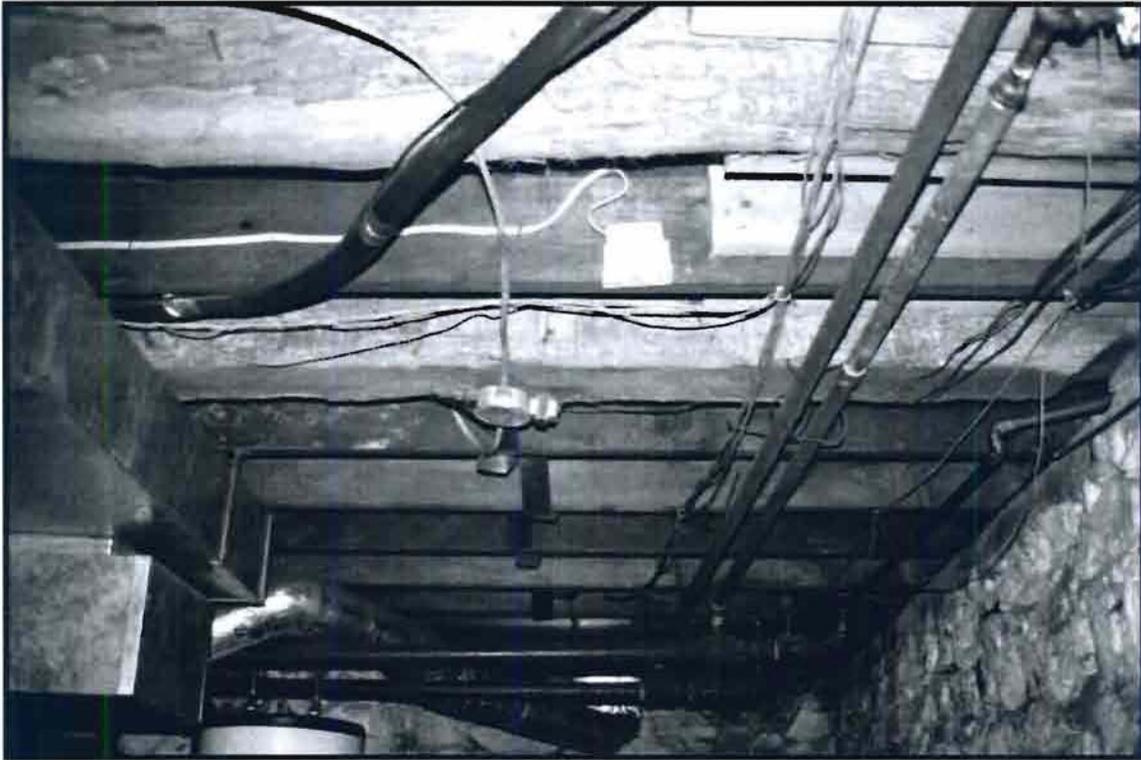
Joist framing for the first floor was exposed (Plate 4.9). A 20 foot long summer beam (6" x 6.5") rested atop the southwestern jamb of the fireplace support and extended the full length across the room resting atop the northern wall just west of center. Original joists had been removed from the southern half of the room and replaced by modern members carrying a plywood subfloor. Joists above the northern half of the room consisted of five irregularly-spaced fully round logs. These log joists rested atop the eastern and the western walls and are carried by the summer beam. The northernmost log joist has been cut off approximately 4 feet short of the western wall. This beam may have been left shorter than the others in order to accommodate the well hole of a winder staircase providing interior access to the basement.

Plate 4.9. View of first floor replacement joists in Room B-1 looking south
(Photographer: Dawn Turner, December 1999)[HRI Neg.# 98039/1:24].

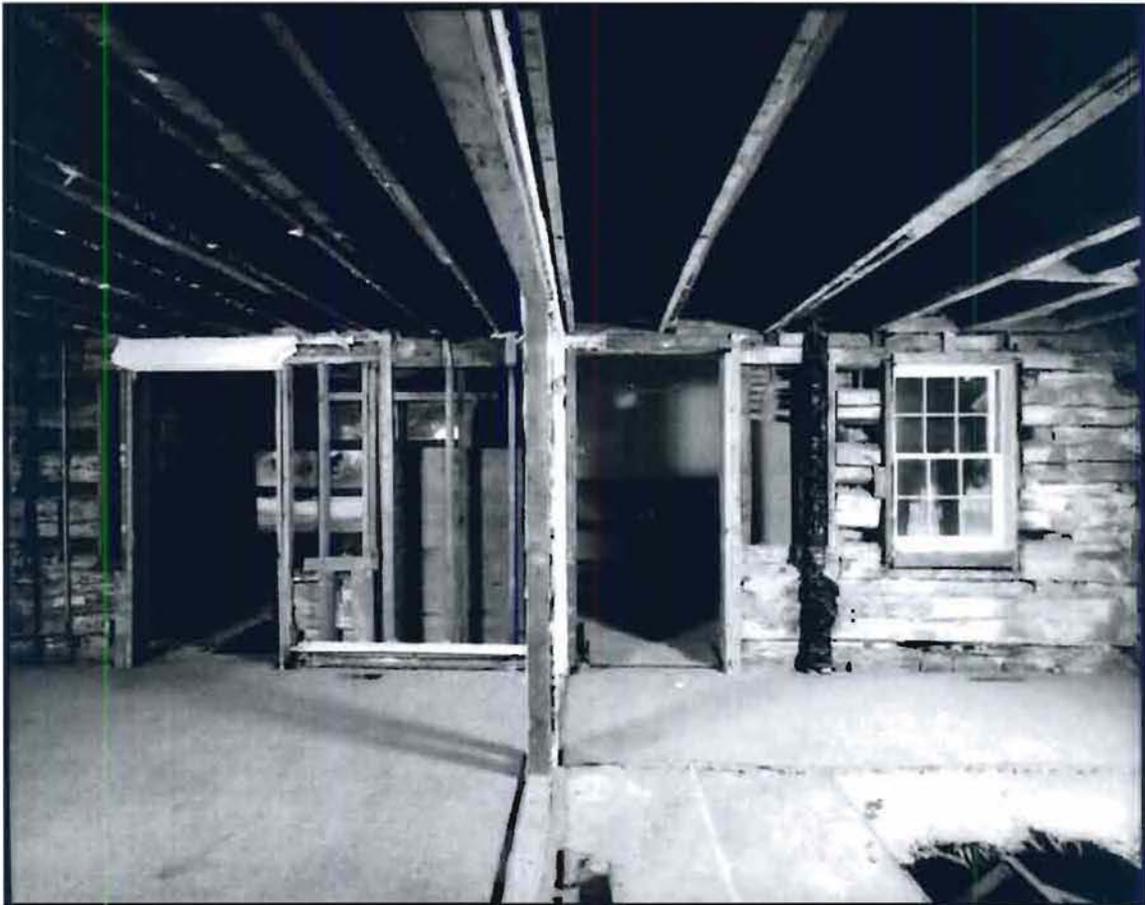
Plate 4.10. Interior view of east wall, Rooms 101 and 102. Room 102 at left. Twentieth century interior room partition at center of view (Photographer: Dawn Turner, December 1999)[HRI Neg.# 99037/31:1].
