ENCLOSURE 8
Integrity Factors Of Antonini Mushroom Building and
Dwelling (N-14127)

N-14127 Antonini Mushroom Building and Dwelling

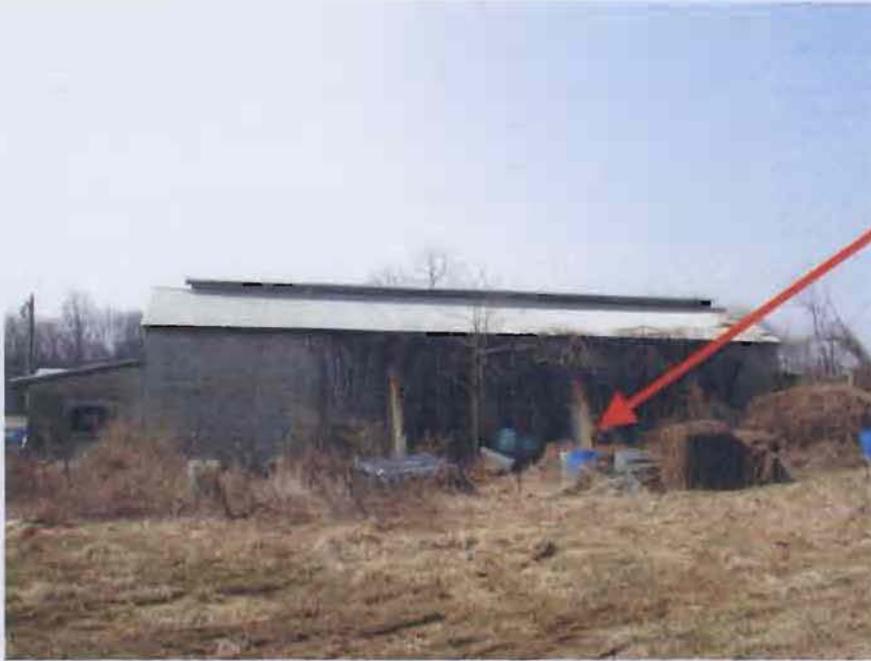
The east side of building is characterized with three step-up concrete block walls to help support the outside wall of the dirt room. Support wall bracing seen at other facilities is typically reinforced concrete and spaced equally throughout the entire side wall. Portions of this step wall are believed to be removed and not replaced when a portion of the building was reconstructed.

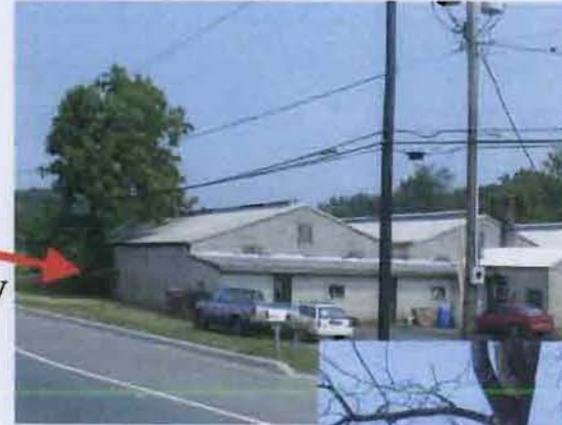
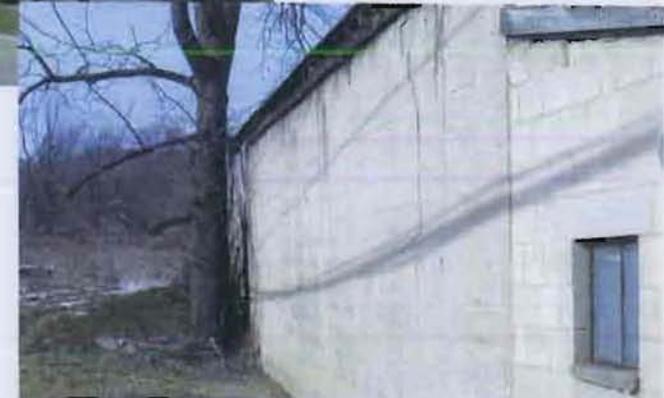
As seen on the the west side of building from SR 7/Limestone Road, most mushroom houses are purposely built into a hillside or constructed with an upper slope graded into the rear of the building. However, grounds are typically clear of all impediments and are characterized with concrete padding and pavement that is sloped for ideal drainage, access circulation, and site operations. The large tree in slope of bank is not ideal. Also, sloping and access site conditions are neglected and are no longer functional.

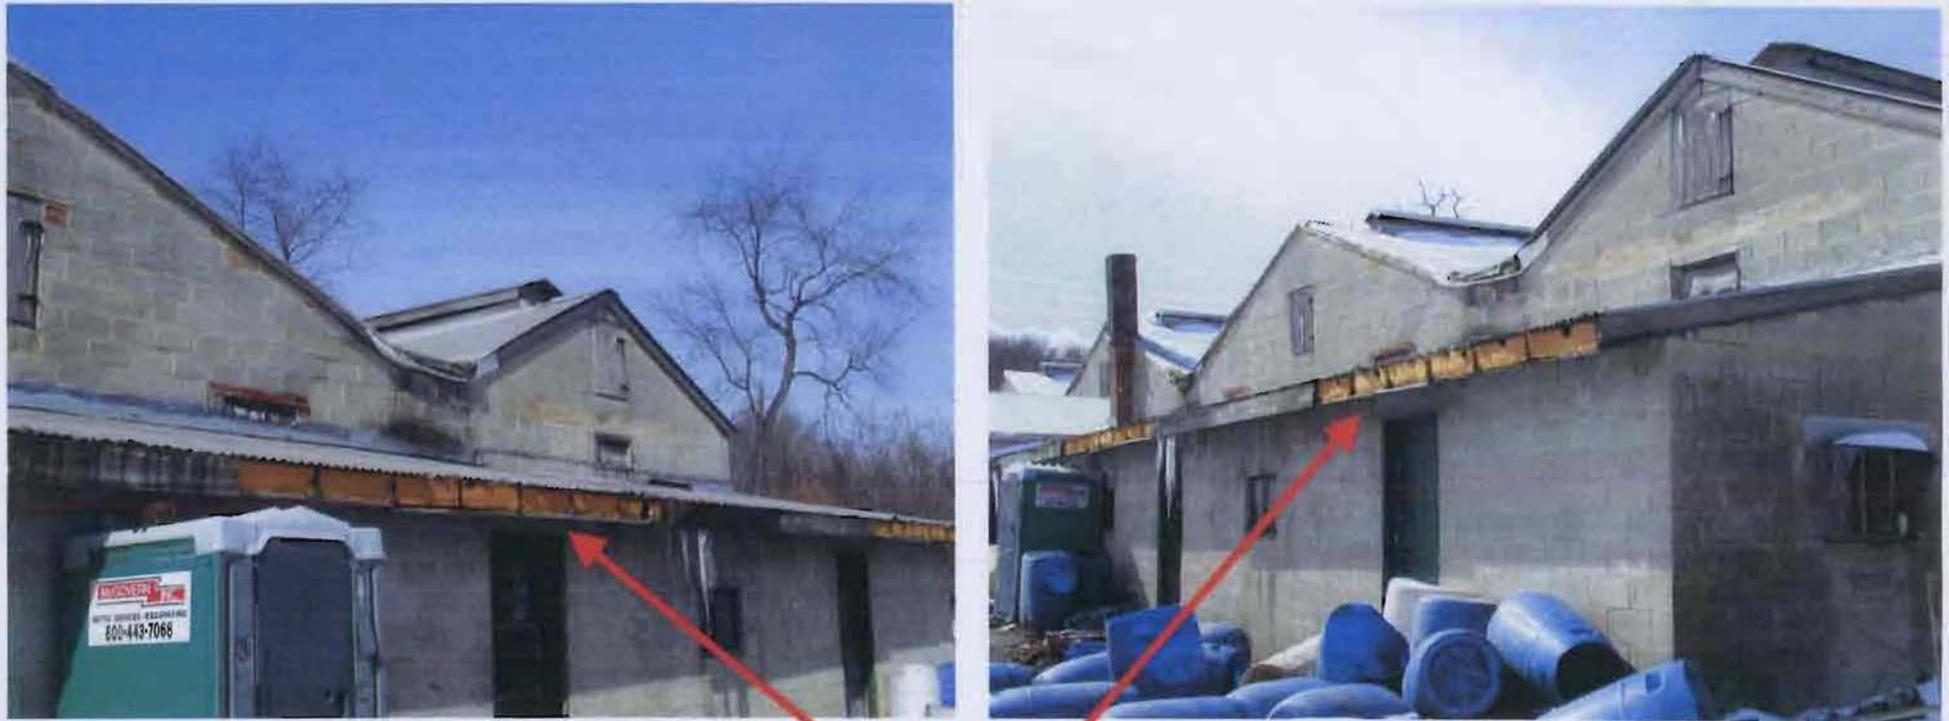
Missing fascia and damaged wood trim are evident throughout the building's construction. This is just a sample of missing, deteriorated, or compromised building materials.

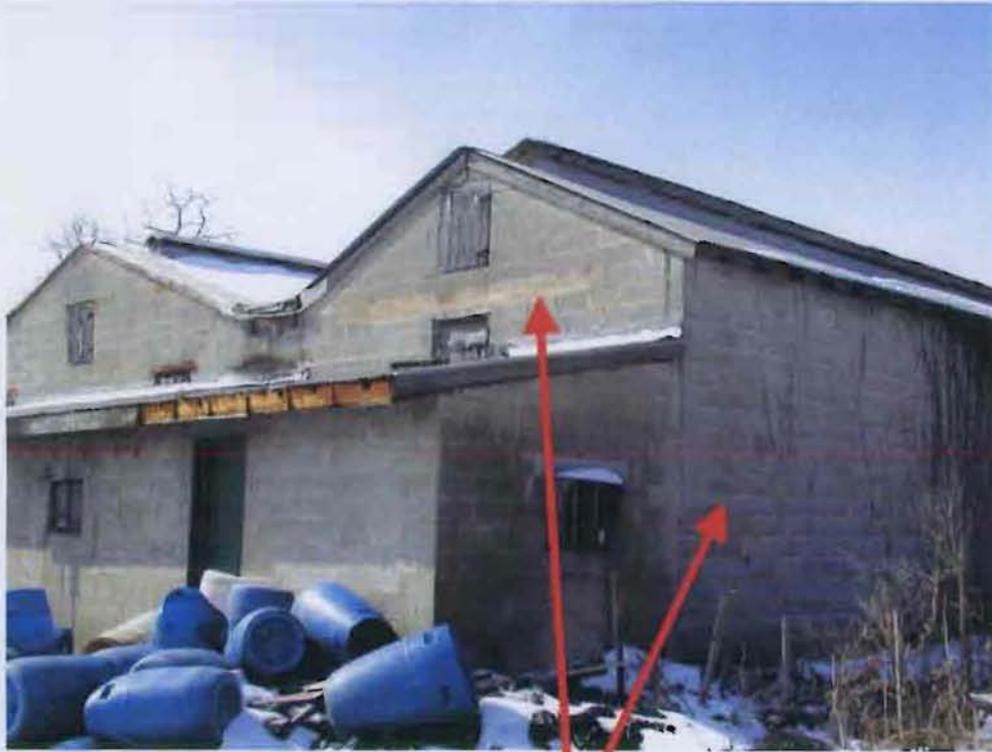
Dirt Room replacement blocks

In multiple areas, concrete block walls have been replaced by reconstruction.

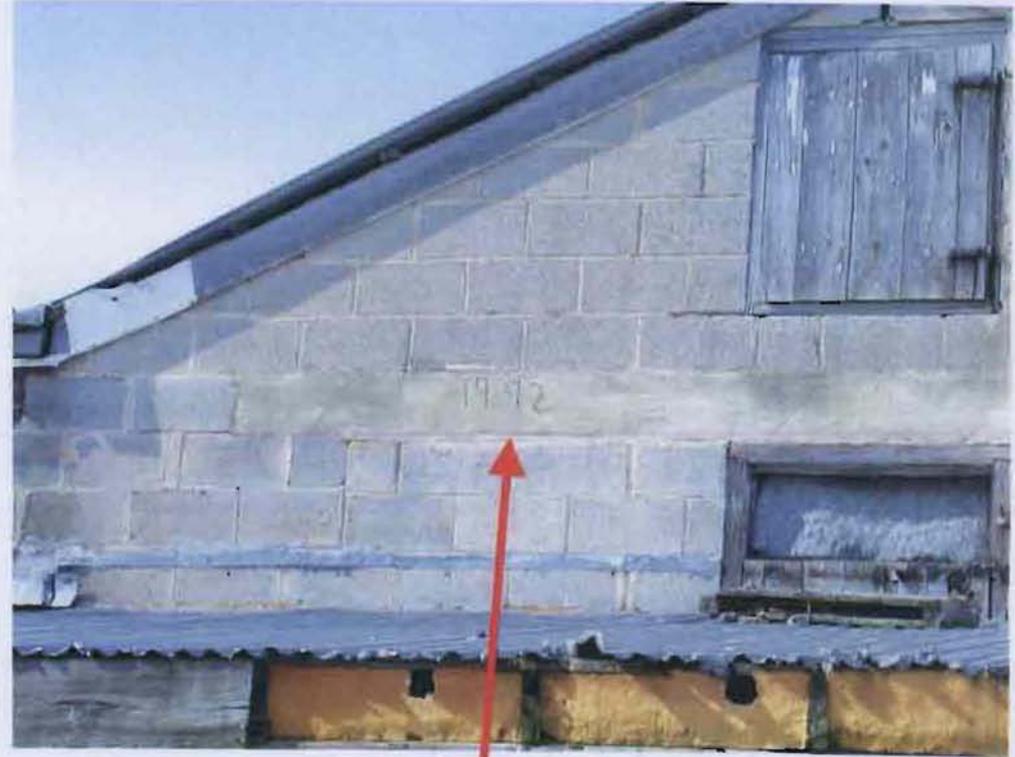
1992 Inscribed repairs

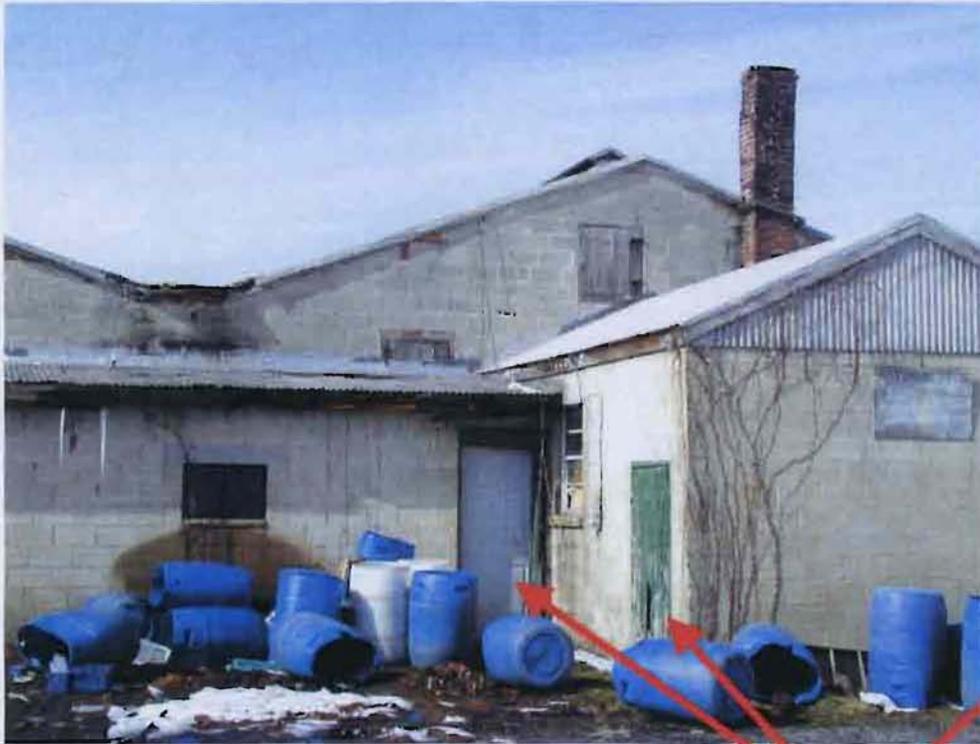
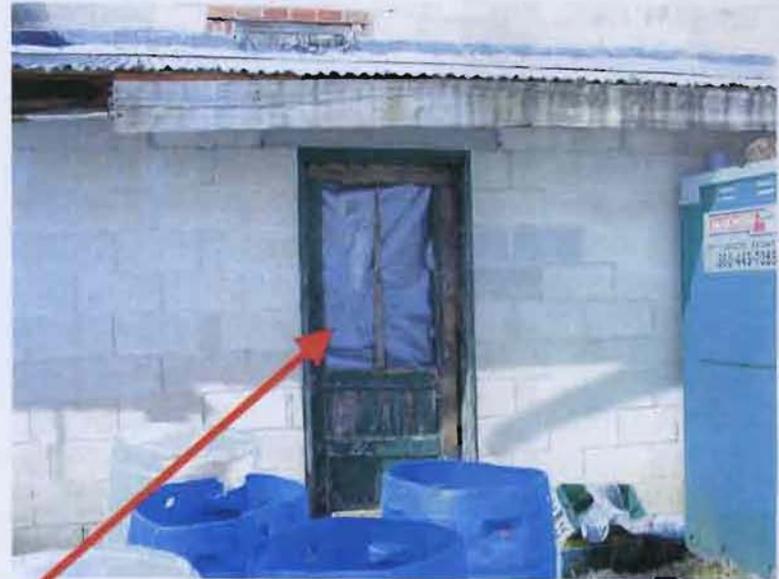
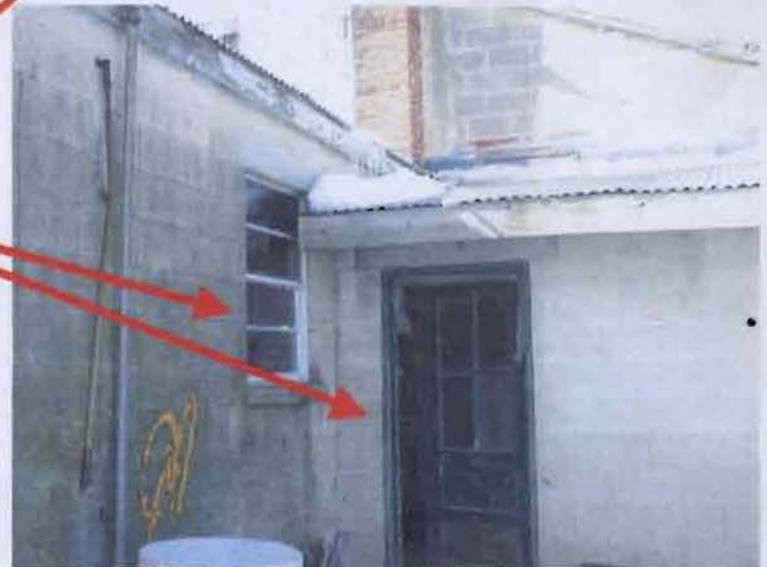
Missing, new, or damaged wood doors are evident in the packing room. All doors are missing the majority of their hardware. Also, they are not of the latch type that are commonly used in most mushroom buildings. A typical packing room is constructed as a lean-to addition (not original in older buildings) towards the front of the doubles. A separate central office (sometimes with a dwelling above) is also evident. The central office might have a chimney with windows that are fixed 2 over 2 hung metal. This is representative here and in the packing room, but several in windows are covered, missing, or broken.

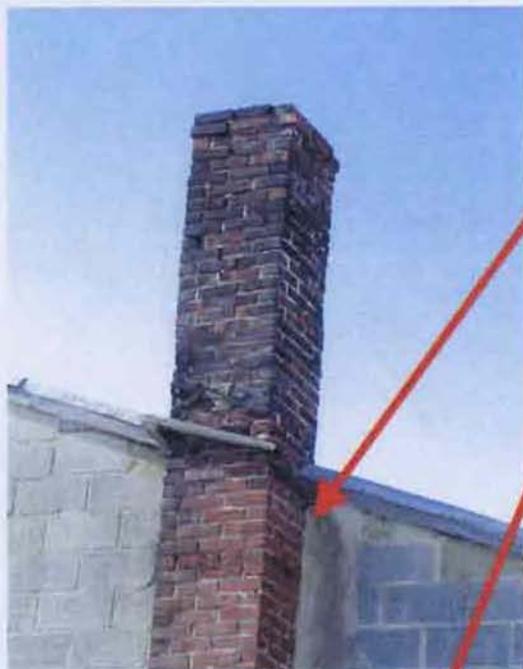
Damage/deterioration.

Chimney and gable end wall alterations and concrete block repair.

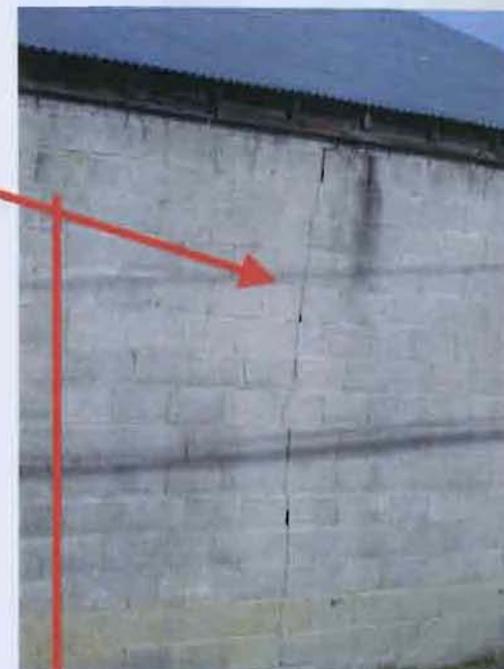
Gable end is sheathed with corrugated metal. Wood siding, clapboard pane, or seamless metal strips were noted as more typical throughout the region. Although not seen here, the gable ends of the dirt room are a solid concrete block.

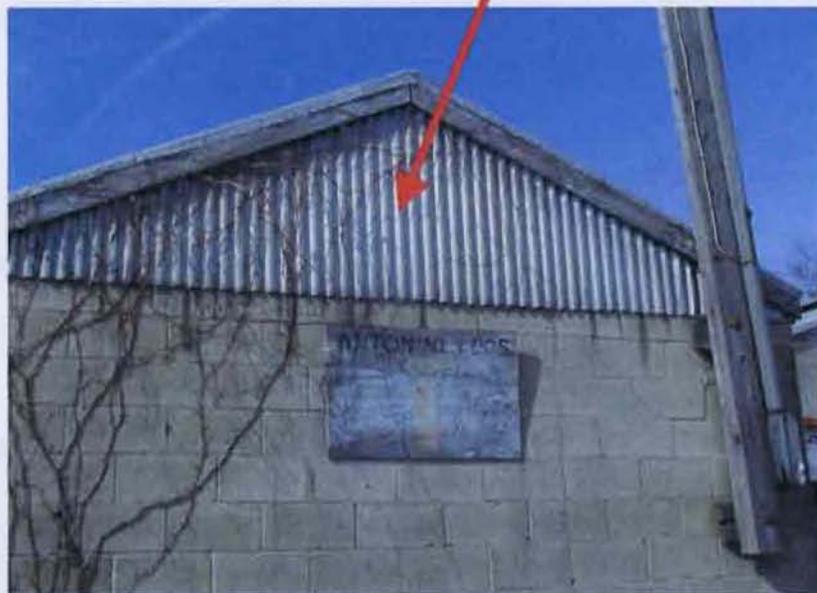
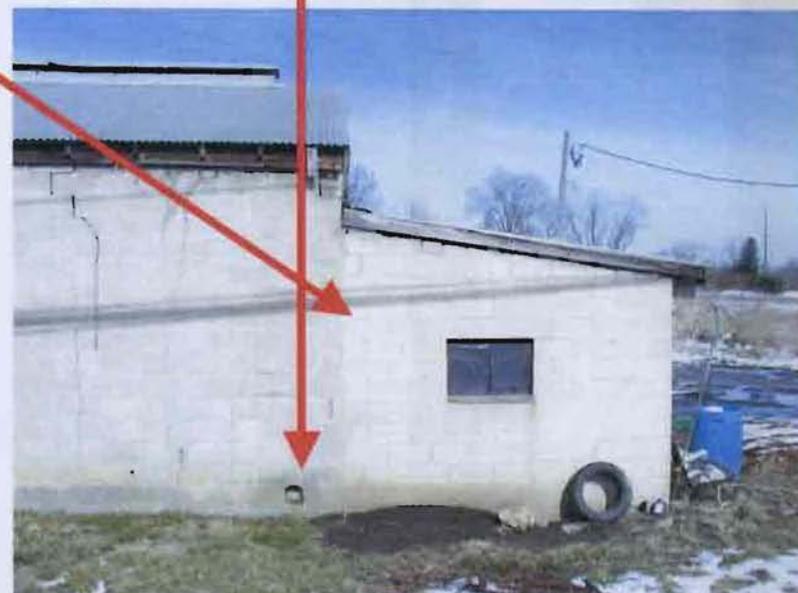
Packing Room addition. Packing rooms were typically added at later stages with the innovation of air temperature control systems.

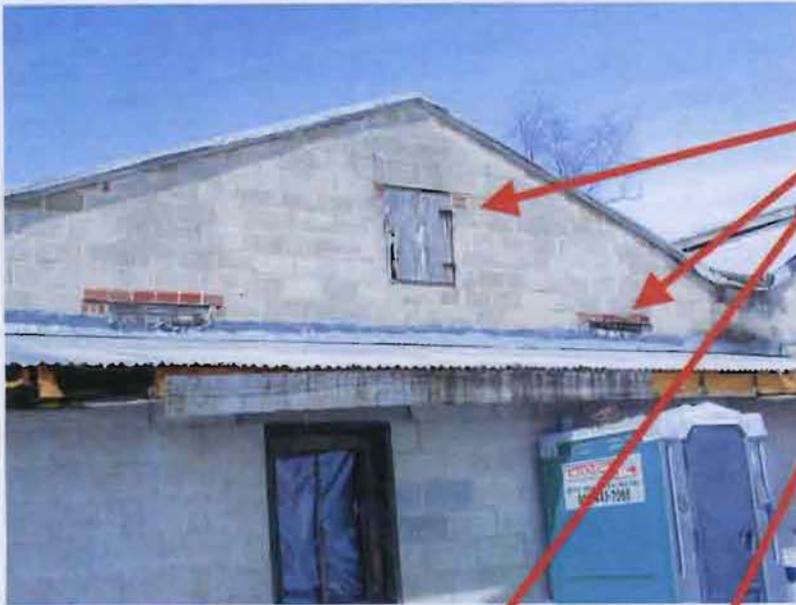
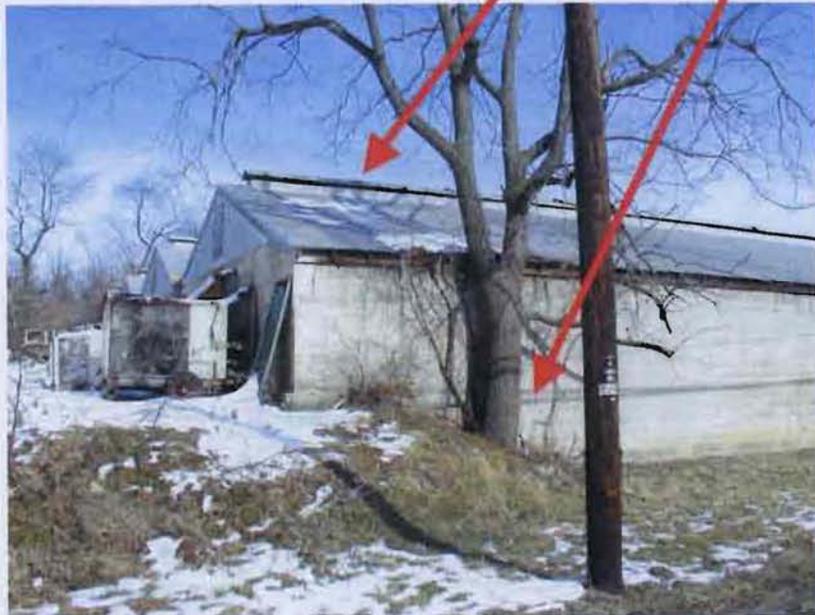
Wood hatch loft doors and ridge vents are still evident for early ventilation, access function, and temporary light. Most buildings have removed, blocked, and/or filled in their early and exterior loft and access doors, and enclosed ridge vents due to innovation of air temperature control systems and sanitation.

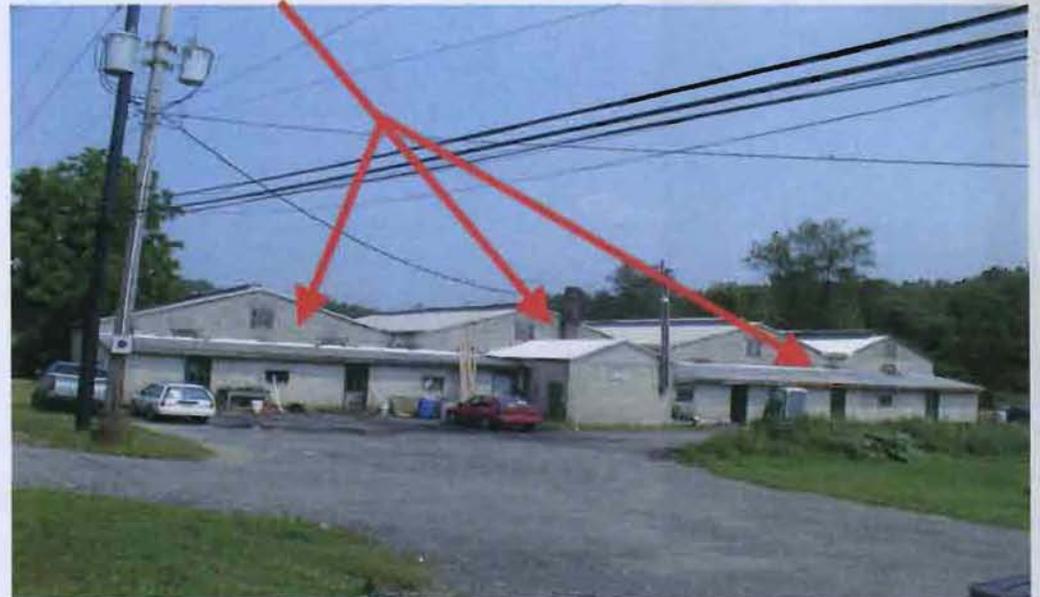
Packing room with a central office were commonly added during the mid 20th century. Other facility support buildings, such as compost storage, garages, some form of tenant/working or owner housing, and work areas with paved and concrete pad surfaces should be present. Overall conditions are deteriorated and non-functional.

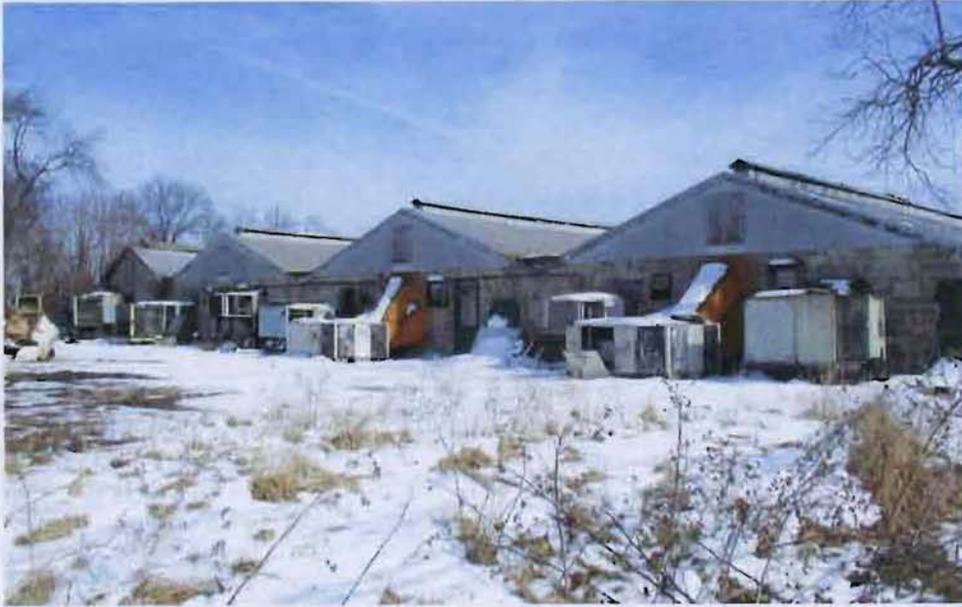
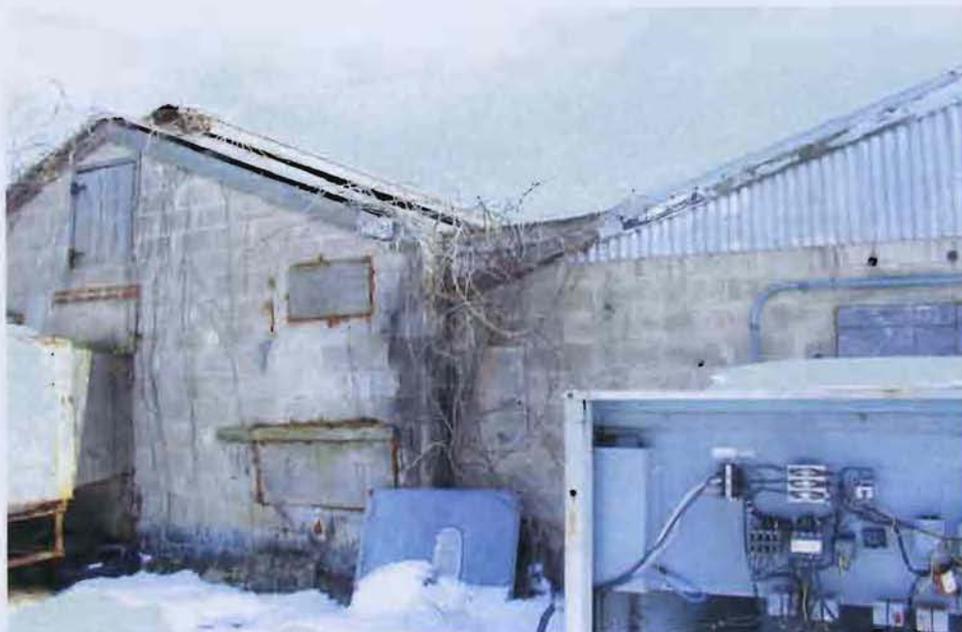
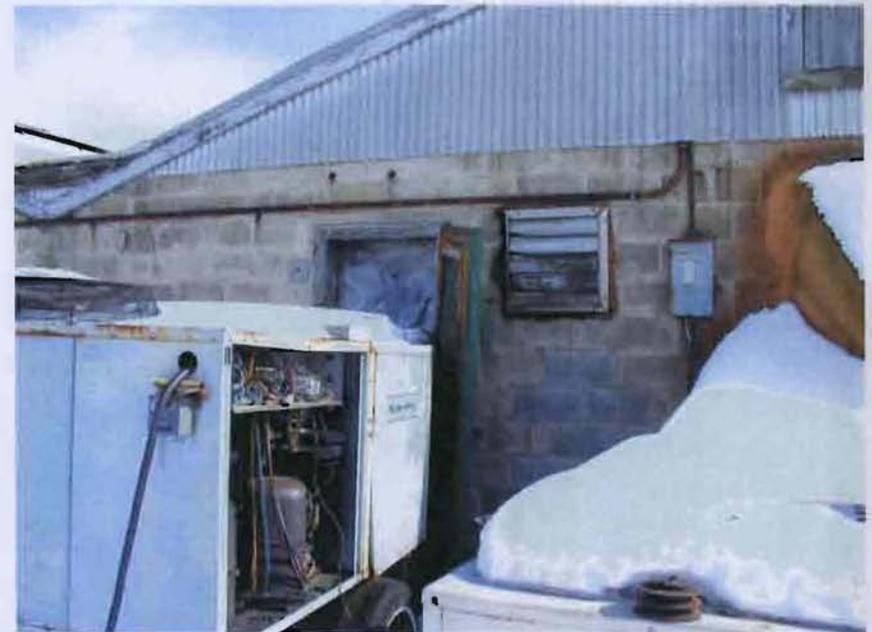
Within the rear or back of most mushroom buildings, there are two main access doors to each double that are hinged with special hardware latches. Also evident are louvered vents and an upper gable vent which is now typically filled or blocked in. A central HVAC (air control) system is commonly positioned between the two bay doors to each double. Throughout the rear of this building, there are missing, damaged latch doors, retrofitted wall break-in's, missing air control units, covered, damaged, or missing vents. HVAC (air control) units are temporary at best and non-functional.

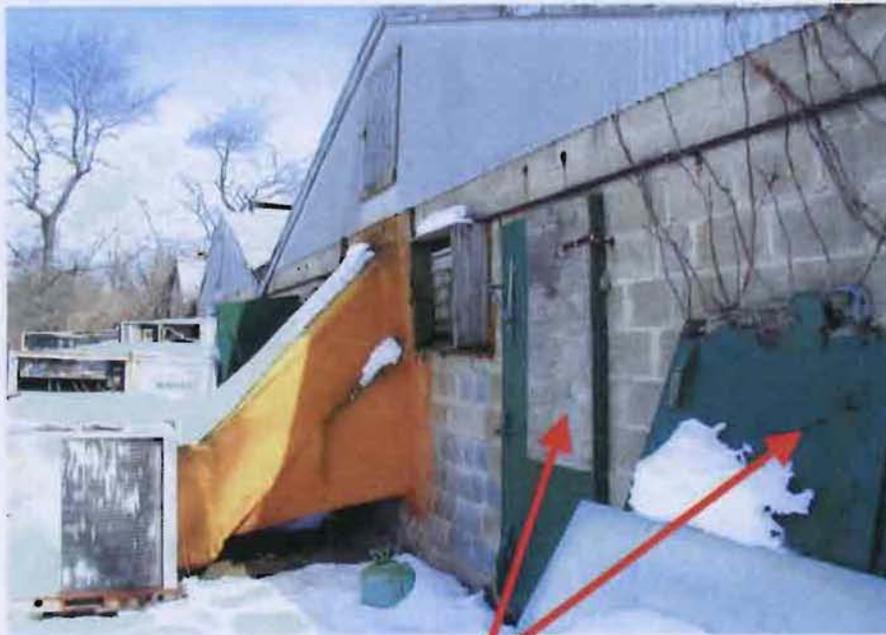
Hinged gable wood door – original and not filled in

Doors damaged and removed; hardware missing or non-functional.

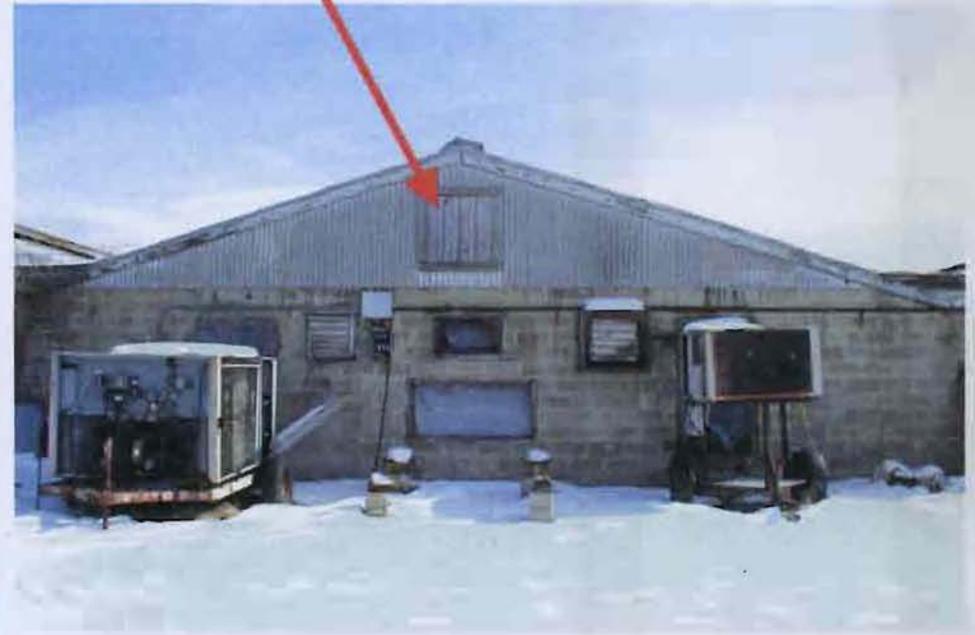
Door units have been removed for two smaller units; no central unit. This is not typical and only demonstrates a lack of full operations and missing functions of the building.

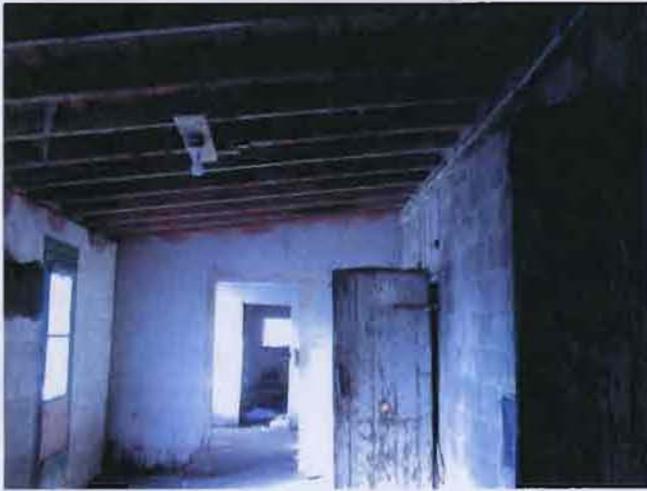
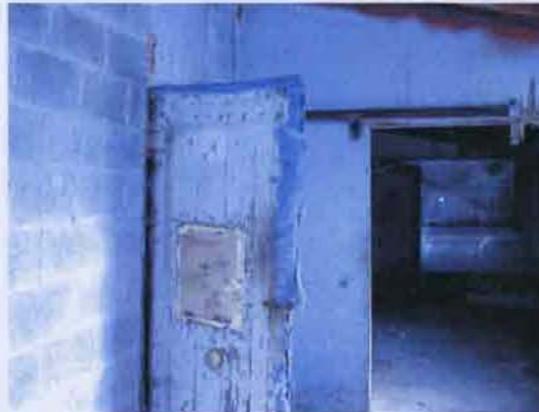
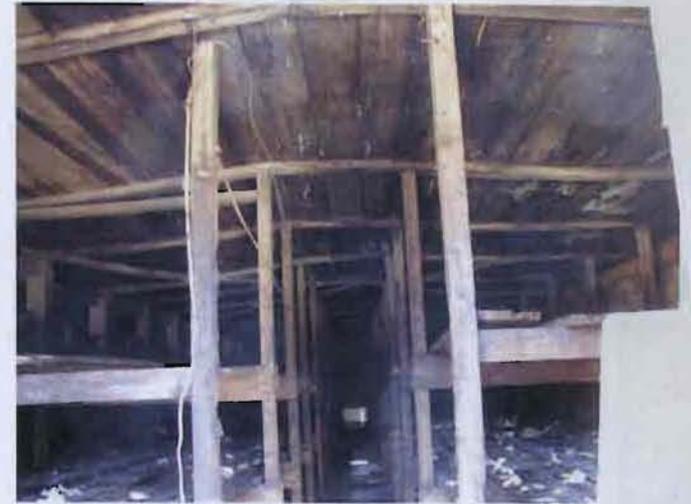
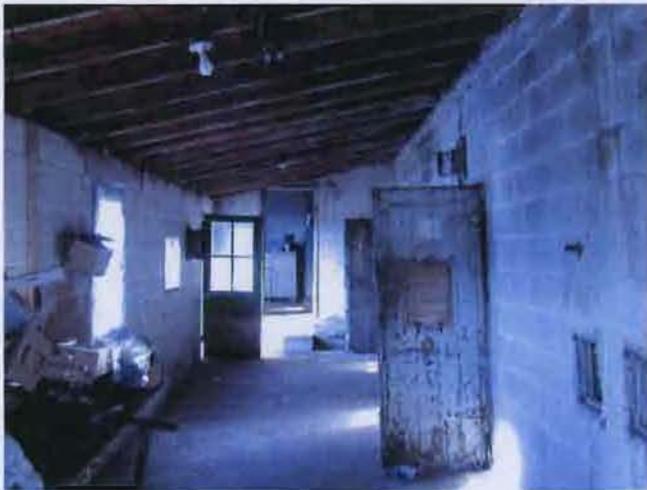
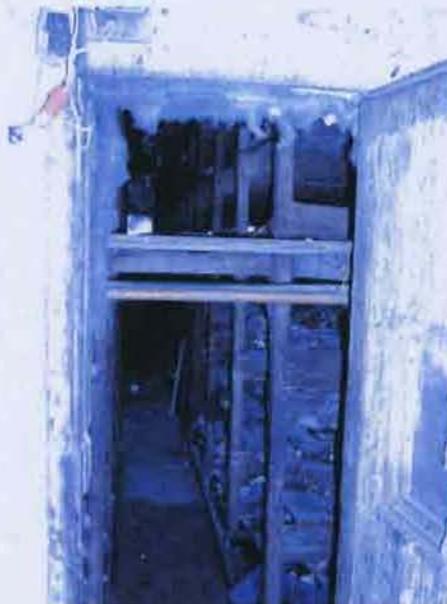
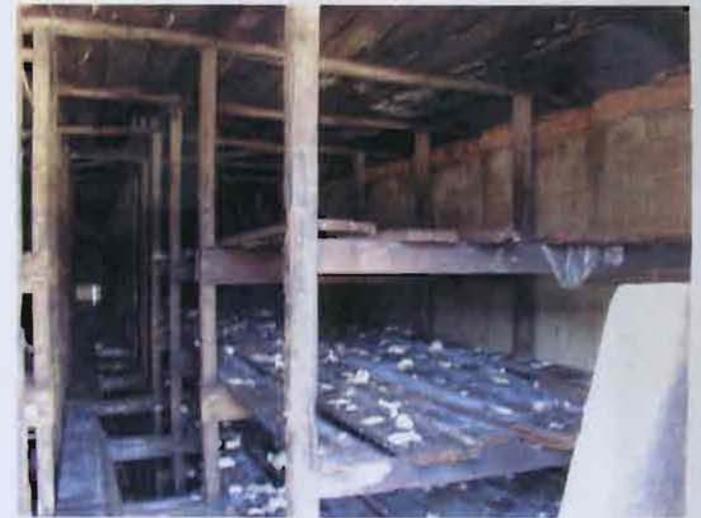
Interior photos in packing room and growing bed shelves. No original bed crates present.

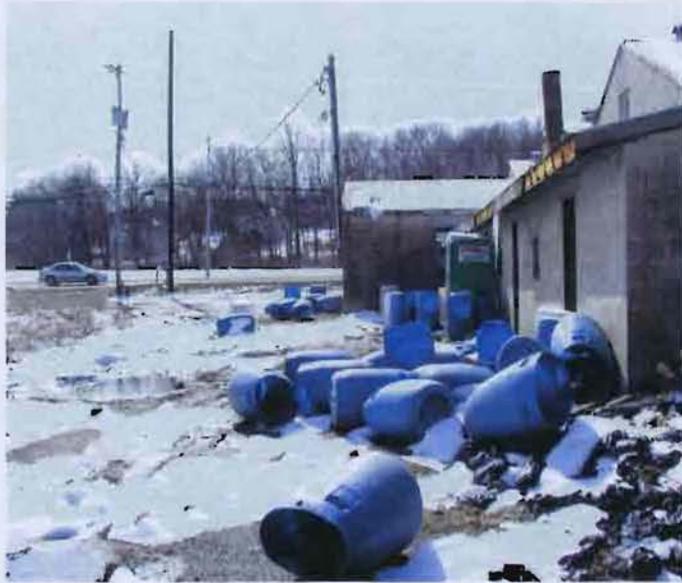
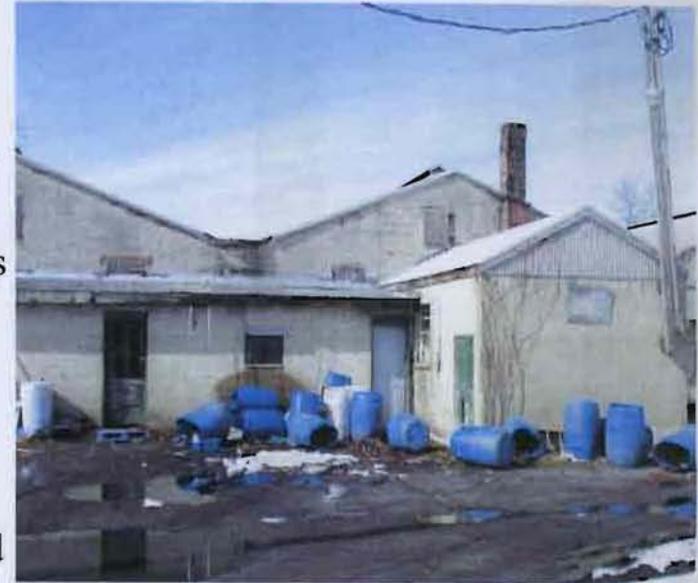
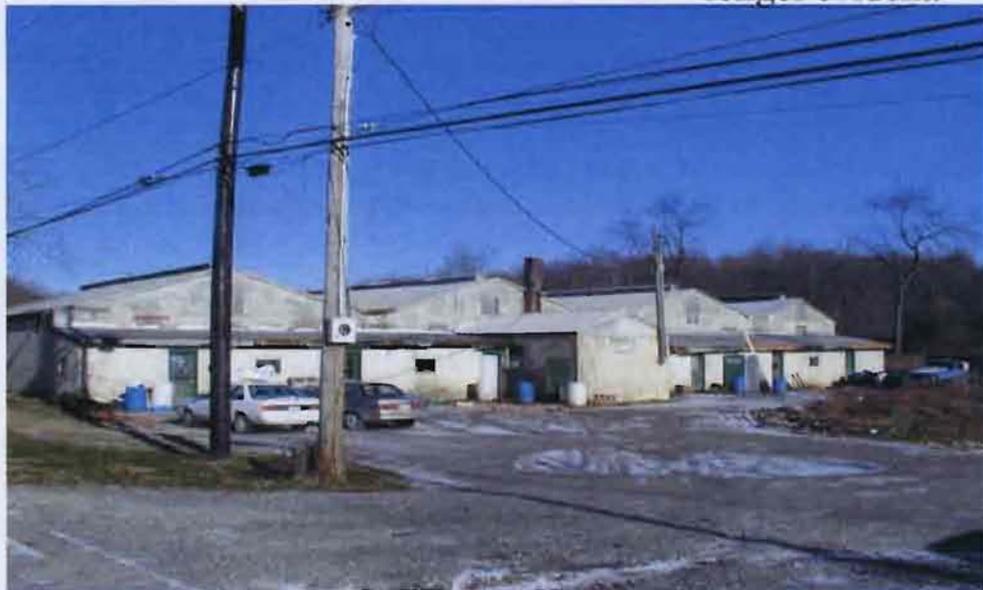
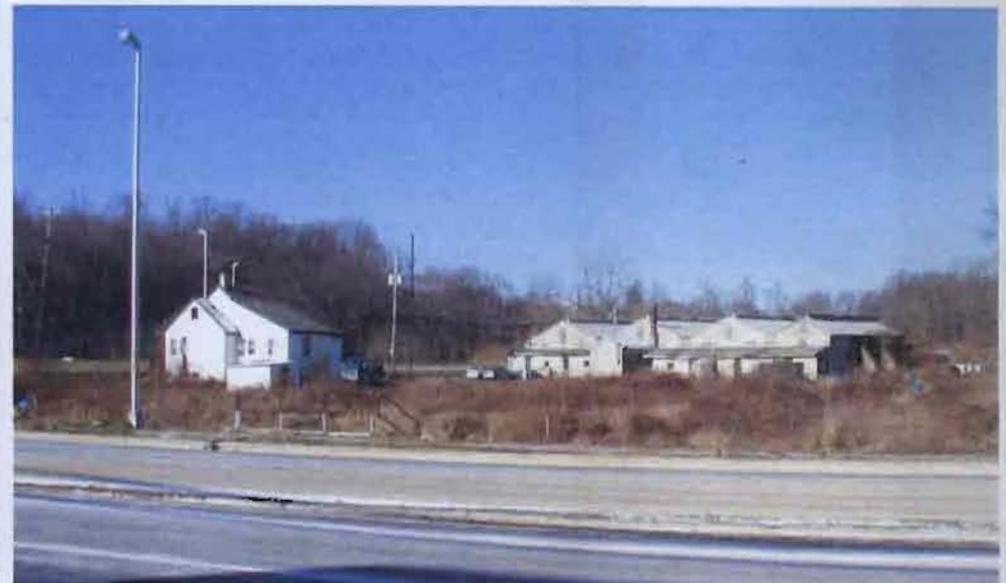
Property exhibits a loss of setting, feeling, and association as operations cease to exist. When recently operating, the property displayed poor quality of operations, contrary to best practices and recommended guidelines in the mushroom growing culture. Also, according to historical and current accounts, growers of the industry, plant management, or property owners are most likely to be of Italian-American descent – past and actively. This ethnic affiliation is no longer evident.

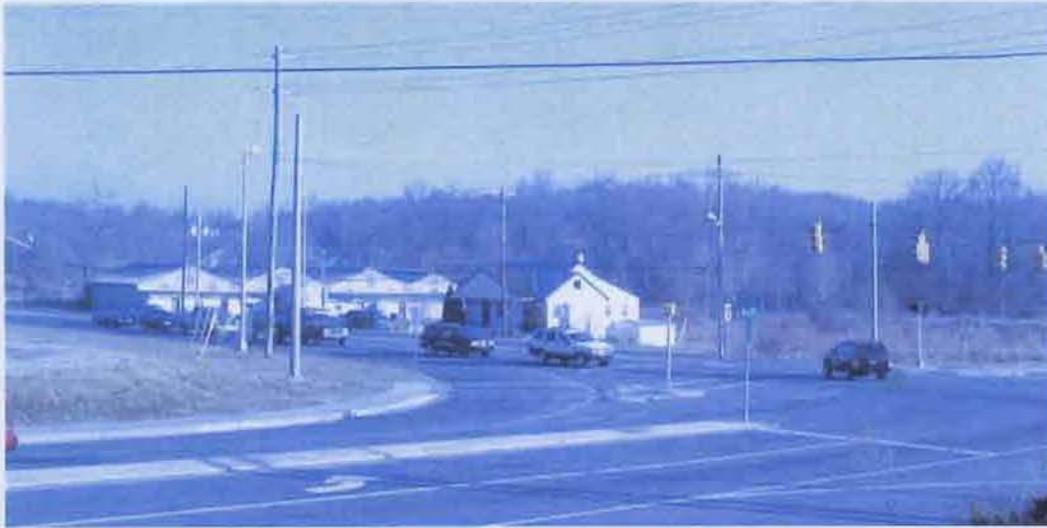
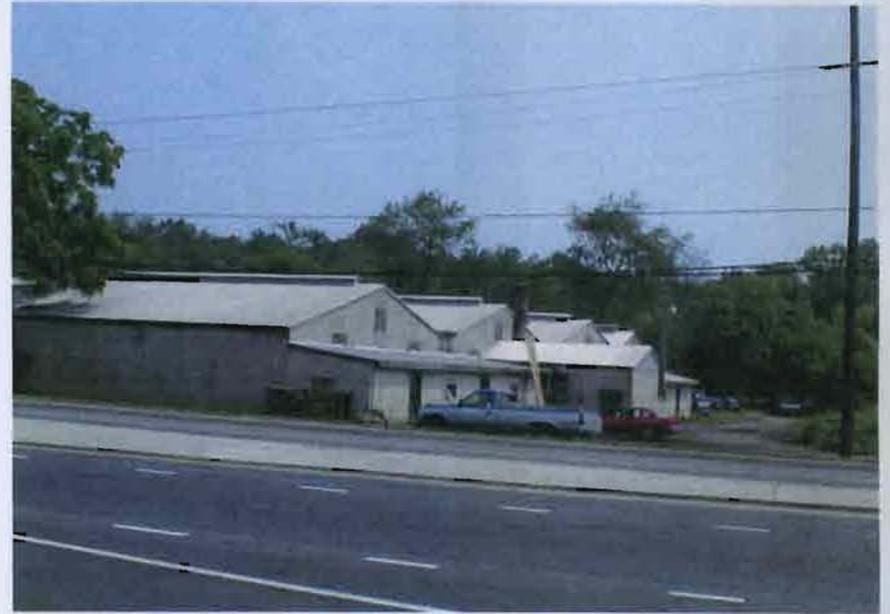
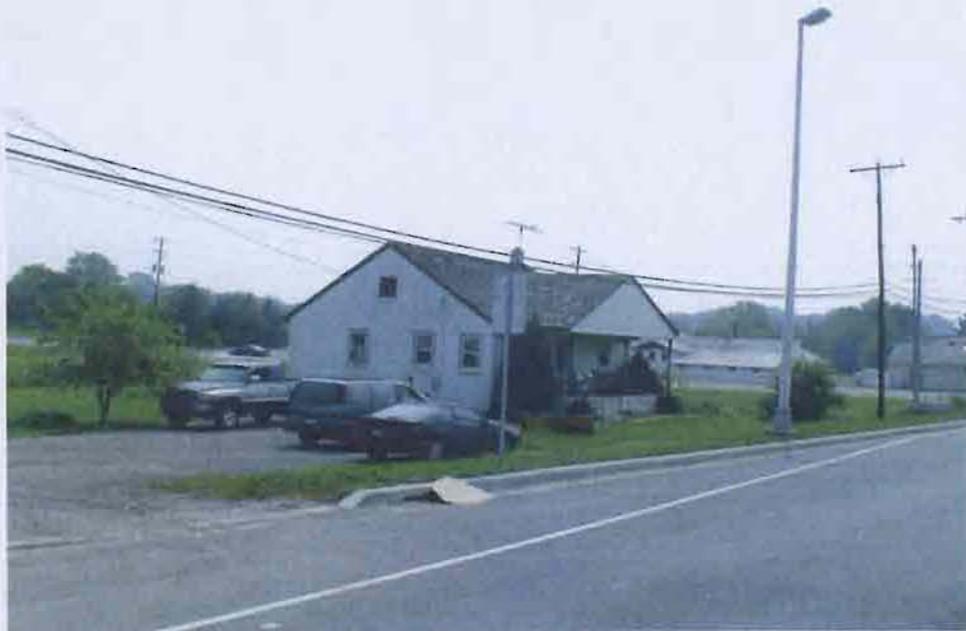
Integrity of setting, feeling, and site design elements appear compromised. The property has been subject to past roadway improvements encroaching upon the buildings and property's grounds, which has resulted in proximity and livability issues. Greater setbacks and improved grounds were noted in the region that allow adequate trucking and access operation into the property and around the building(s). Finer examples exist in state and in the region.
