S-03182. Jonathan Macklin House, U.S. 113
(PIN: 135-3.00-27.00)
(Detail Map #4)

**S-03187. Clarence Burton House, McColley's Chapel Road
(PIN: 135-5.00-24.00)
(Detail Map #5)**

**S-03221. Dwelling, 18912 Redden Road
(PIN: 135-6.00-10.04)
(Detail Map #5)**

S-03235. Dwelling, DuPont Highway
(PIN: 135-6.00-10.01)
(Detail Map #6)

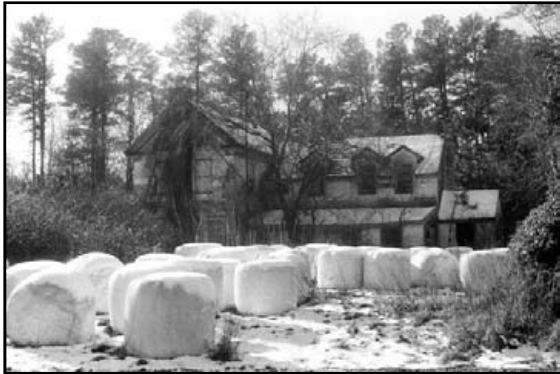
This two-story, wood-framed, c. 1860s I-house has a gabled two-story rear ell. Its south façade wall features a shed-roofed, full-width porch with a concrete-block foundation and wood decking. The porch shelters a six-light, four-panel door, placed at the west end of the wall, and two six-over-six, double-hung sash windows. Three six-over-six, double-hung sash windows are placed in the second story. The east gable end of the main block has two six-over-six, double-hung first-story windows. Second-story windows are boarded over but may also be six-over-six, double-hung sashes. Paired three-light attic windows are placed to either side of the center line of the wall. A brick chimney adjoins the wall. The opposite gable end has a single, double-hung, second-story window and paired three-light attic windows.

main building (.001) facade, view to SW

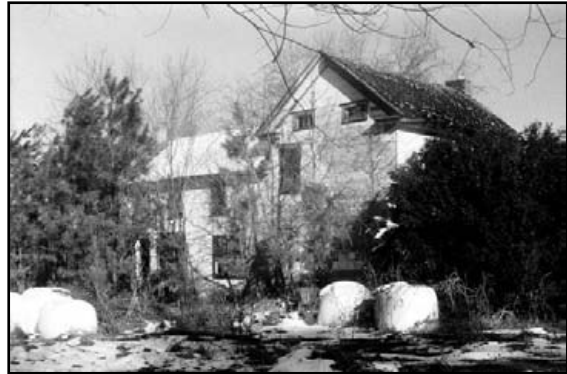
The one-and-one-half story, gabled roof, rear ell has been enlarged with a single-story shed roofed addition running the length of its east wall. This addition is fenestrated with double-hung sash windows. Three wall dormers rise from the east roof slope of the main ell wall. The west wall of the ell has a door opening at the north end of the wall and regularly placed single and paired window openings. A single-story, gabled vestibule projects from the rear wall of the ell. A concrete-block chimney adjoins the gable end of the main block of the ell. The house sits on a brick and concrete-block foundation and is sheathed in cement-asbestos shingles. Its eaves are marked by a boxed cornice with returns, and its roof is sheathed in wood shingles. The house is abandoned and deteriorating. A portion of the roof sheathing of the ell is gone.

Years of abandonment have taken their toll on the property. As noted, the barn, standing at the time of the LeeDecker et al. survey, has collapsed, and the exposed roof framing on a portion of the ell of the house may presage a similar fate for the house. Due to this deterioration, the house is no longer able to convey its architectural significance, and, as a result, JMA recommends that the property no longer be considered eligible for the National Register under Criterion C.

main building (.001) rear, view to NE

Deconstruction and demolition may reveal the property contains information important to the understanding of vernacular architecture traditions. If the building is to be demolished as part of the project, it should first be evaluated by a qualified architectural historian; selective demolition should be used to fully determine whether the property is eligible under Criterion D and has important information to yield. If it is determined that the building was constructed using standard building technology of the time, including balloon or platform framing, this property would not be eligible for listing under Criterion D and the demolition could proceed. Should the property be recommended significant by the qualified architectural historian, it should be fully documented prior to demolition.

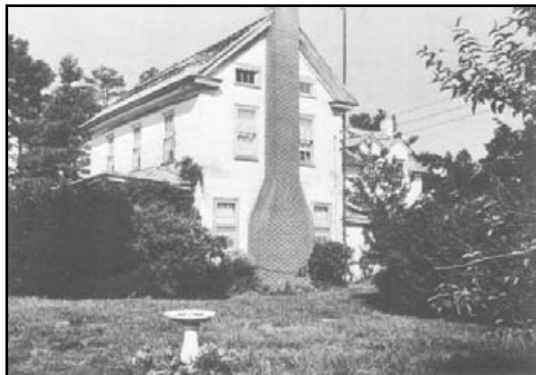
Macklin house in 1992
(LeeDecker et al. 1992:94)

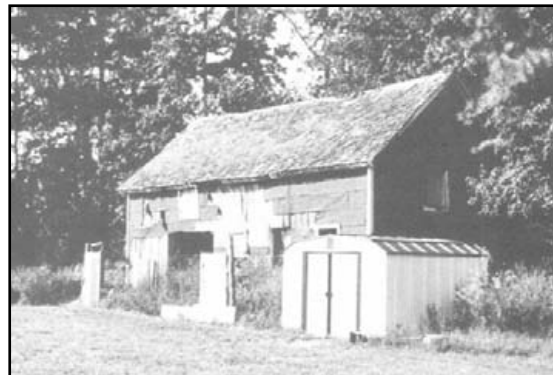
The collapsed barn currently consists of framing timbers and portions of vertical board walls. Due to its deterioration, it was not intensively surveyed.

Macklin barn in 1992
(LeeDecker et al. 1992:95)

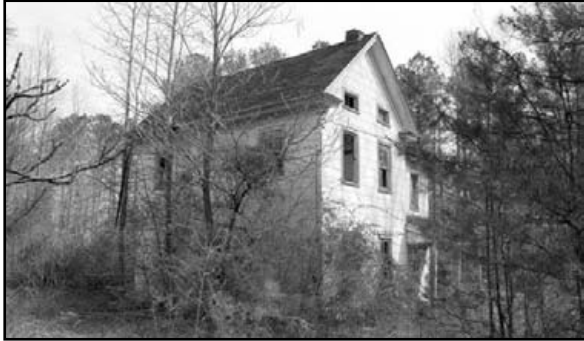
The east gable front wall contains a central one-light, four-panel wood-and-glass door. The shadow of the former entry stoop (present at the time of the reconnaissance survey) is visible. Fenestration of the façade consists of two, two-over-two, wood-framed windows in the first and second floors, and a single, two-over-two, double-hung wood-framed window in the attic. Most of the windows have broken sashes. The south wall is fenestrated with two-over-two, double-hung, wood-framed windows, also with broken sashes. An original, one-light, four-panel, wood door is placed in the east wall of the eaves-front block and is sheltered by the south porch. This porch has replacement square posts, a beadboard ceiling, and a concrete floor. It has partially collapsed. Another one-light, four-panel, wood door is placed at the north end of the east wall of the eaves-front block. The north wall is also fenestrated with original two-over-two, double-hung wood sash windows, as is the rear wall. A door opening with a missing door and a flat concrete stoop is placed in the rear wall. Brick chimneys rise slightly above the roof ridge of the south end of the south roof and the center of the east roof ridge. The roof is sheathed in asphalt shingles.

main building (.001) façade and south side,
view to ENE

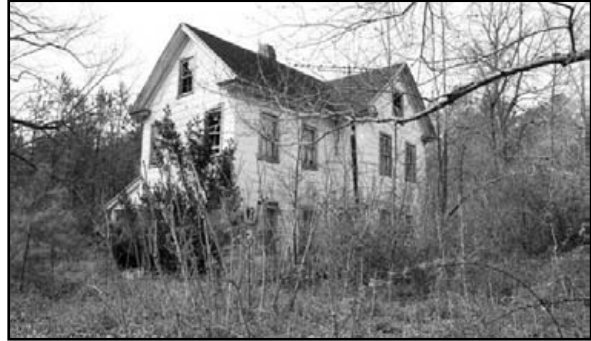
The house, as mentioned, is an example of a T-plan dwelling, a late nineteenth- and early twentieth-century vernacular plan type. Less common than the I-house, it is, nonetheless, one of the characteristic vernacular house types of central Delaware. The house has been abandoned for a number of years, and, as a result, is in poor condition. Alterations have included covering of the original siding with cement-asbestos siding, and rebuilding of portions of the south porch. Due to both alterations and deterioration, the house does not possess the integrity required to be a representative example of a T-plan house. Therefore, it is recommended not eligible for the National Register under Criterion C.

main building (.001) rear and north side,
view to SW

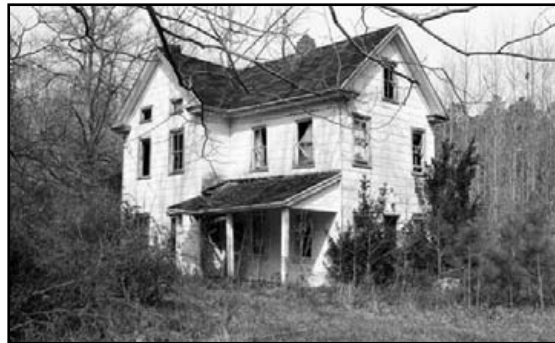
main building (.001) rear and south side,
view to WNW

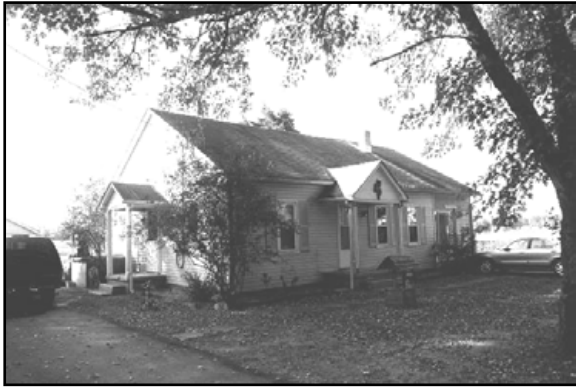
This c. 1945 one-story, wood-framed, house has a four-bay façade. A gabled portico shelters the centrally located front entrance. Fenestration of the façade wall consists of single, one-over-one, double-hung vinyl sash windows. The northeast side features a centralized secondary entrance sheltered by a gabled portico flanked by one-over-one, double-hung vinyl sash windows. Fenestration of the rear, southeast side is irregular and includes three one-over-one, double-hung vinyl sash windows. A one-story, single-room, gabled ell stands attached to the southwest side. Sliding glass doors are featured on the front, northwest façade. The house sits on a concrete-block foundation and is sheathed in vinyl siding. A concrete-block chimney rises from the center, interior of the house.

To meet National Register eligibility requirements, well-preserved dwellings of this architectural type typically must be architect-designed or magazine-type examples. This example exhibits no outstanding history, significance, and/or integrity. The doors and windows have been replaced, an addition has been attached to one end, and the exterior has been re-covered in modern siding. These changes have compromised the house's integrity of design, materials, workmanship, and feeling. For these reasons, this dwelling is not recommended eligible for inclusion in the National Register under Criterion C.

main building (.001) façade and east side, view to SW

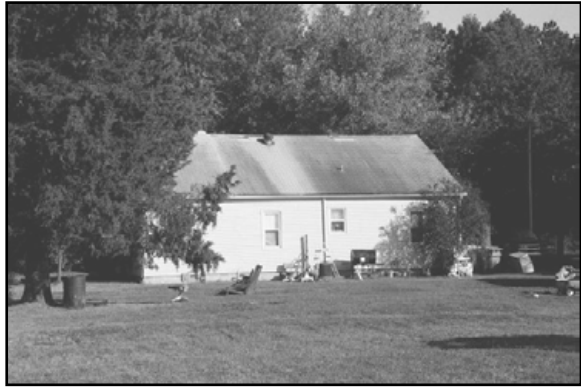
main building (.001) rear, view to NE

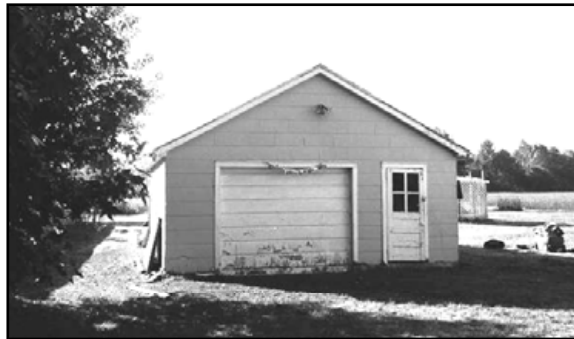
Southeast of the dwelling stands a c. 1945 garage (.002). This one-story wood-framed building is clad in asbestos and is covered by a gabled roof sheathed in composition. Two side-by-side entrances pierce the façade, a garage door and a wood-and-glass entrance. The building's sides feature single-pane fixed windows. A rear entrance is featured in the rear, southeast side.

garage (.002), view to SW

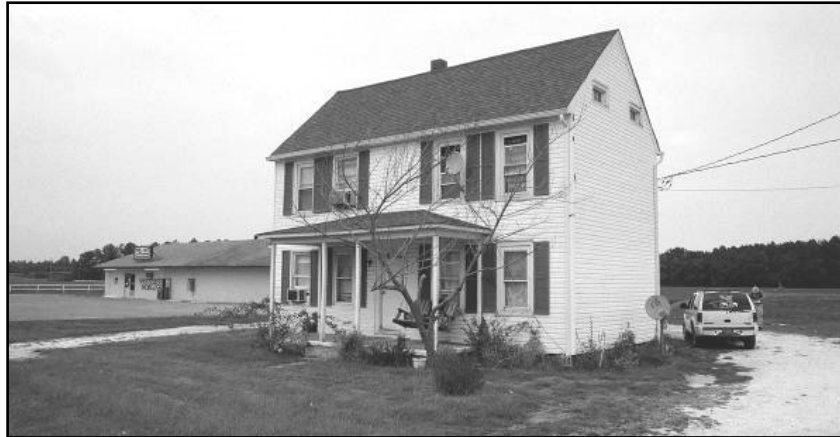
This rectangular-shaped, wood-framed house stands two-and-one-half-stories in height with a one-story, shed-roofed addition attached to the rear, northeast side and a one-story, gabled addition attached to the north corner. The front, southwest façade measures five bays in width. A hipped-roof porch shelters the centralized main entrance. Fenestration of all walls consists of single, one-over-one, double-hung, vinyl sash windows. Fixed, single-pane windows are centered within the gable-ends. The one-room, shed-roofed addition on the rear features a modern entrance on its southeast wall and single, one-over-one, double-hung, vinyl sash windows. The corner addition also features one-over-one, double-hung, vinyl sash windows and is pierced by a modern garage door on its southwest wall. The entire house sits on a concrete-block foundation and is clad in vinyl siding. The side-gabled roof is sheathed in asphalt shingles. A concrete-block chimney rises from the exterior of the northeast side of the main block.

Elements contributing to the significance and integrity of a hall-and-parlor house would include original chimneys, exterior fabric, fenestration configuration, roof profile and structure, porches, and elaborate interior woodwork. This house has undergone the following alterations: the replacement of the front porch, insertion and replacement of all windows and doors, fenestration pattern changes, the application of modern siding to the exterior, and the construction and attachment of two additions. These changes have compromised the dwelling's integrity of location, design, materials, workmanship, and feeling. Since the dwelling's original location is unknown, its integrity of setting may or may not have been affected or compromised. As a

main building (.001) façade and southeast side, view to N

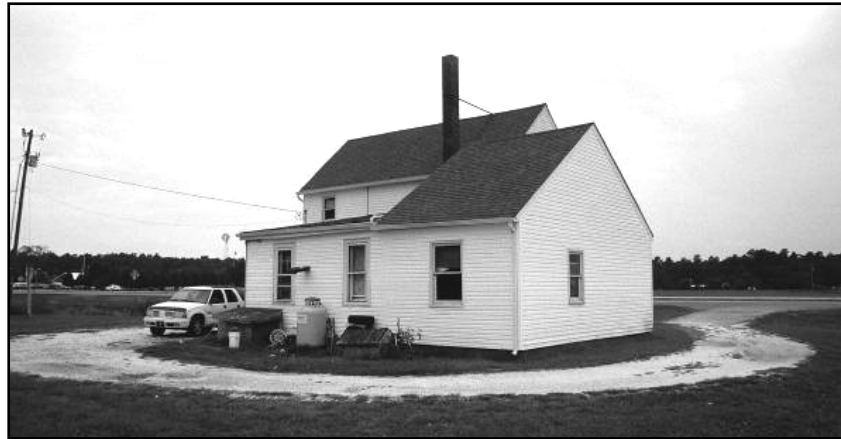
This dwelling is not in its original location. While its newer, concrete-block foundation suggests that it may have been moved, historical aerials provide confirmation. The building does not appear on the 1937 aerial, but it can be clearly seen on the 1954 aerial. Although the dwelling may have once served as a farmhouse, its original context is unknown, and the historic context with which it is now most closely associated is the subdivision of farmland along a major transportation corridor, in this case the DuPont Highway. Individual examples of farmland subdivision rarely possess historic significance, and this property is therefore recommended not eligible under Criterion A.

main building (.001) rear and northwest side, view to S
