**S-08568. Dwelling, DuPont Highway**  
**(PIN: 230-19.00-62.00)**  
**(Detail Map #7)**

**S-08569. Dwelling, DuPont Highway**  
**(PIN: 230-19.00-74.00)**  
**(Detail Map #7)**

**S-08570. Maringola House and Produce Stand, DuPont Boulevard  
(PIN: 230-19.00-81.00 & 230-19.00-78.00)  
(Detail Map #7)**

**S-08571. Clyde Clark House, DuPont Highway  
(PIN: 230-19.00-24.00)  
(Detail Map #7)**

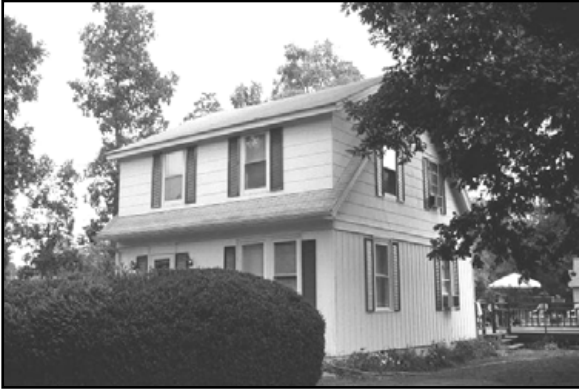
main building (.001), façade and south side, view to NE

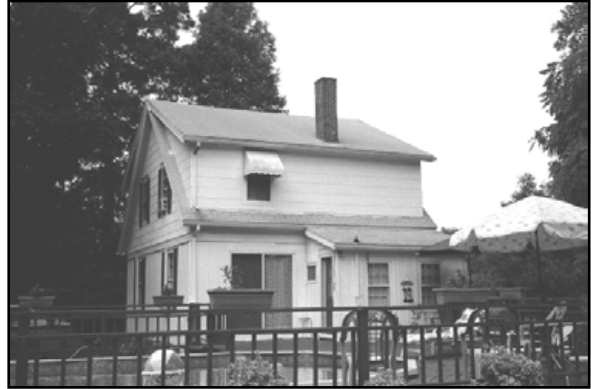
main building (.001), rear and south side, view to NW

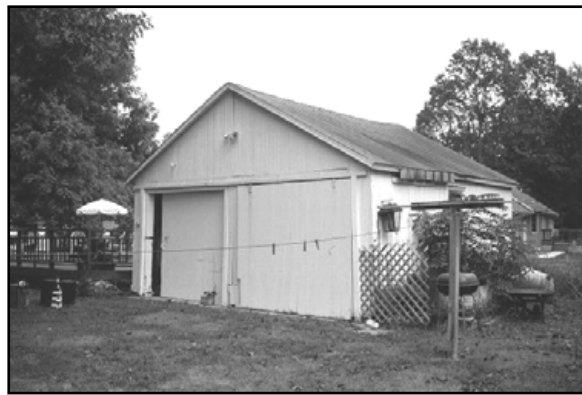
garage (.002), view to NE

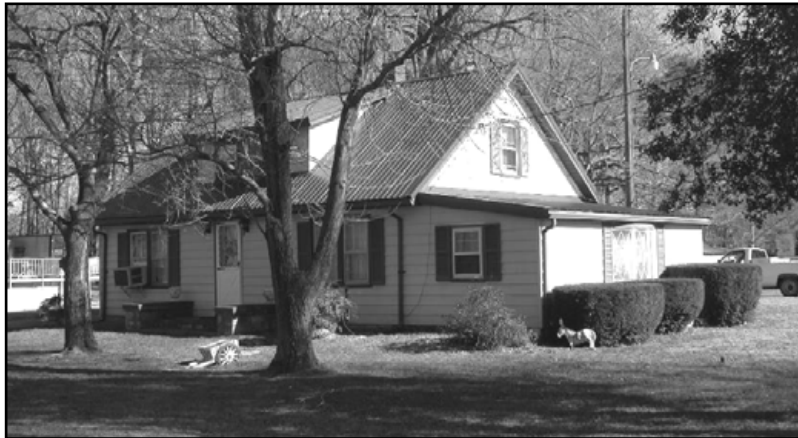
main building (.001), façade and south side, view to NE

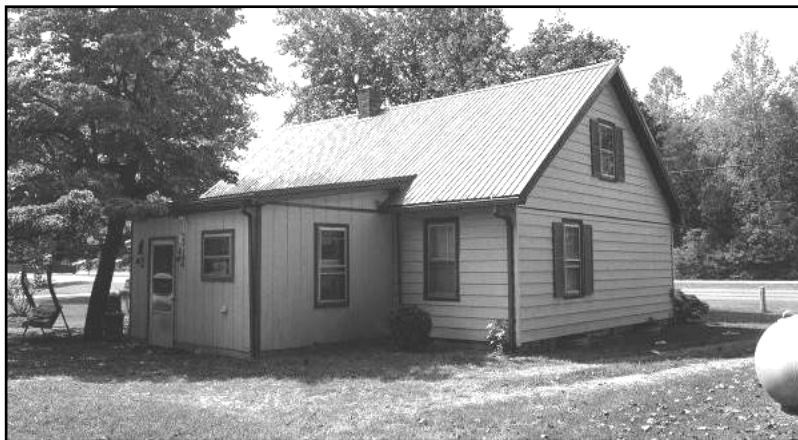
main building (.001), rear and north side, view to SW

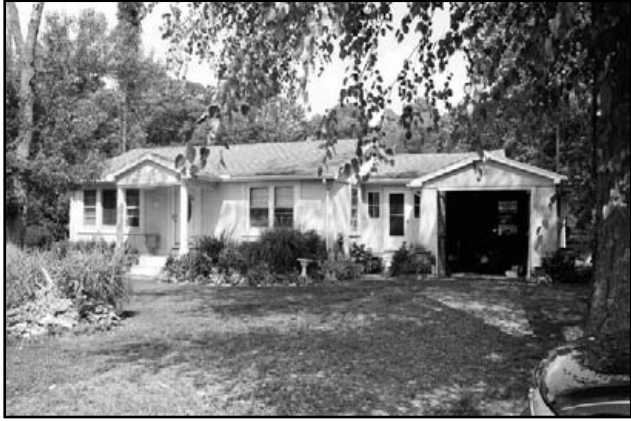
main building (.001) facade, view to E

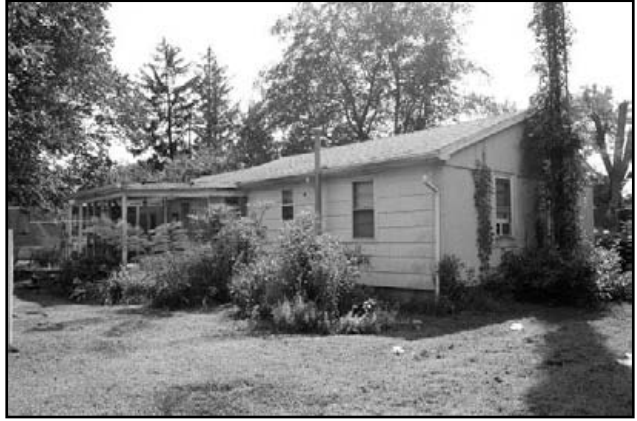
main building (.001) facade, view to SW

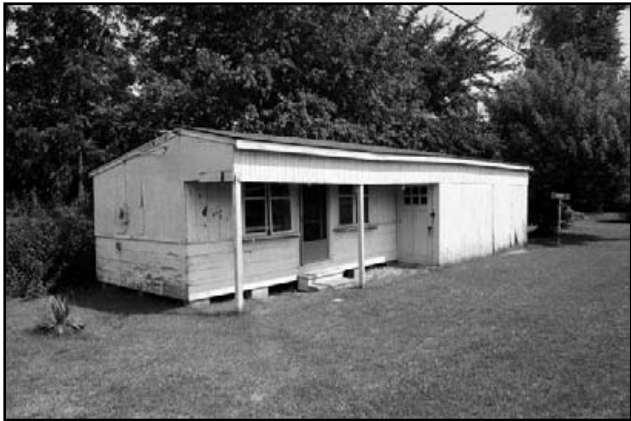
farm stand (.002), view to SE

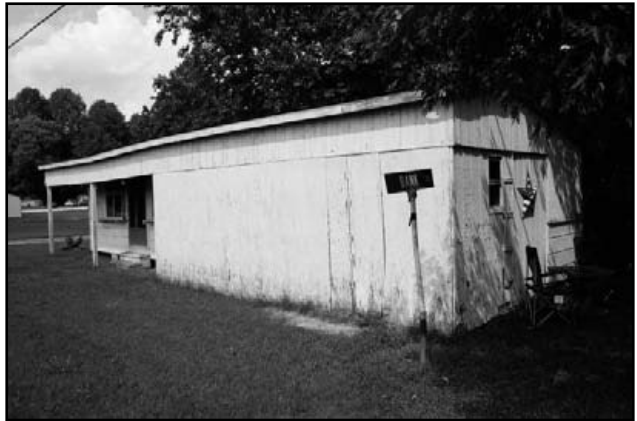
farm stand (.002), view to NE

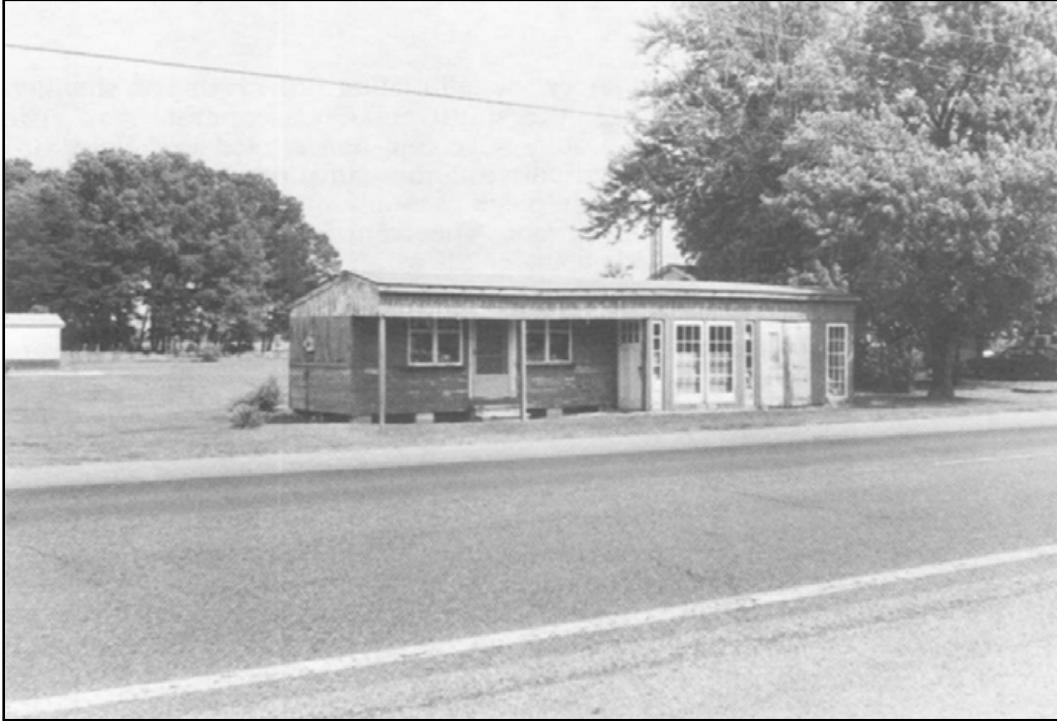
**Evaluation:** The produce stand was individually surveyed in the early 1990s by Louis Berger & Associates (LeeDecker et al. 1992). At that time, the south end of the façade of the building was enclosed with a combination of salvaged sidelights and French and wood-panel doors. In that survey, the stand was recommended as eligible for the National Register under Criterion C “as a good example of one of the earliest types of commercial enterprise fostered by the automobile, as local farmers set up small stands along roads to sell produce and home-made goods to passing motorists.” In a follow-up study, the authors changed their recommendation to not eligible based on it appearing “to have been built with salvaged materials,” and “probably less than 50 years [of age]” (Louis Berger & Associates 1992b). In a *Documentation of Adverse Effect and Memorandum of Agreement* written that same year (Louis Berger & Associates 1992a), the building was once again considered eligible “as an example of auto-oriented commercial roadside architecture,” and its construction date was estimated to have been before 1941. Since Berger’s original evaluation, the salvaged elements appear to have been removed from the produce stand, and it has been re-sheathed in wood paneling, which is probably closer to its historic appearance.

Maringola farm stand (then known as the Ronald Smith farm stand) in 1992 (from LeeDecker et al. 1992:130)

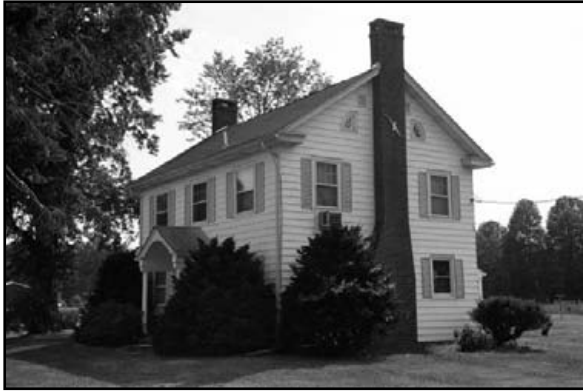
well-kept, this house is a typical, not exceptional example of its architectural type, with few distinguishing details. The integrity has been compromised by the addition of fluted aluminum replacement columns on the front porch and modern aluminum siding. Lacking both architectural significance and integrity, the property is recommended not eligible under Criterion C.

main building (.001), façade and north side view to SW

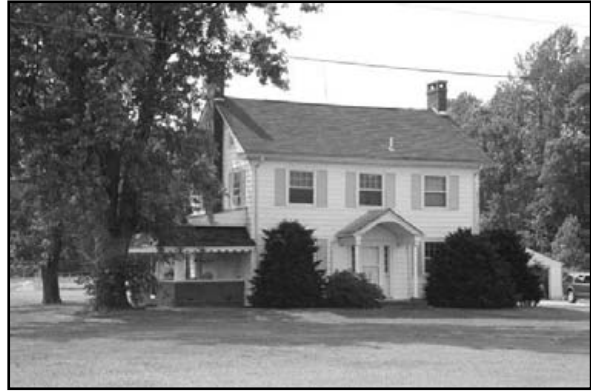
main building (.001), façade, view to W

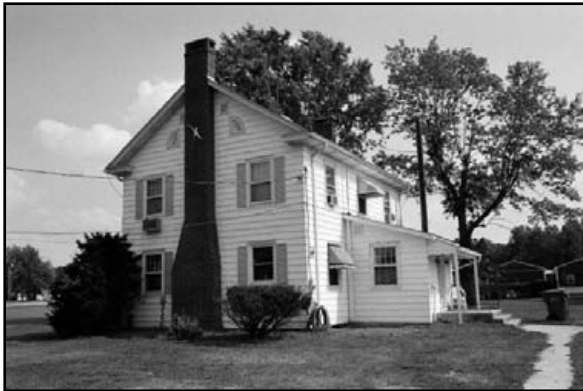
main building (.001), rear and north side, view to SE

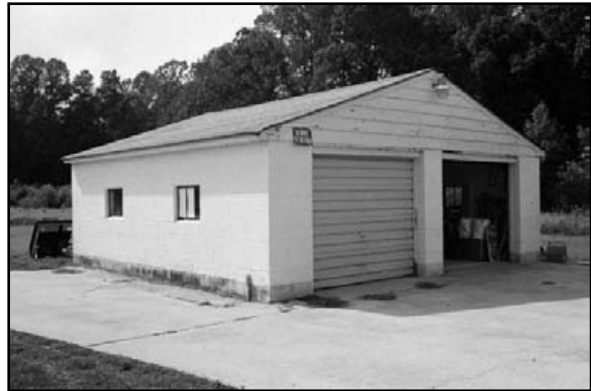
garage (.002), view to NE
