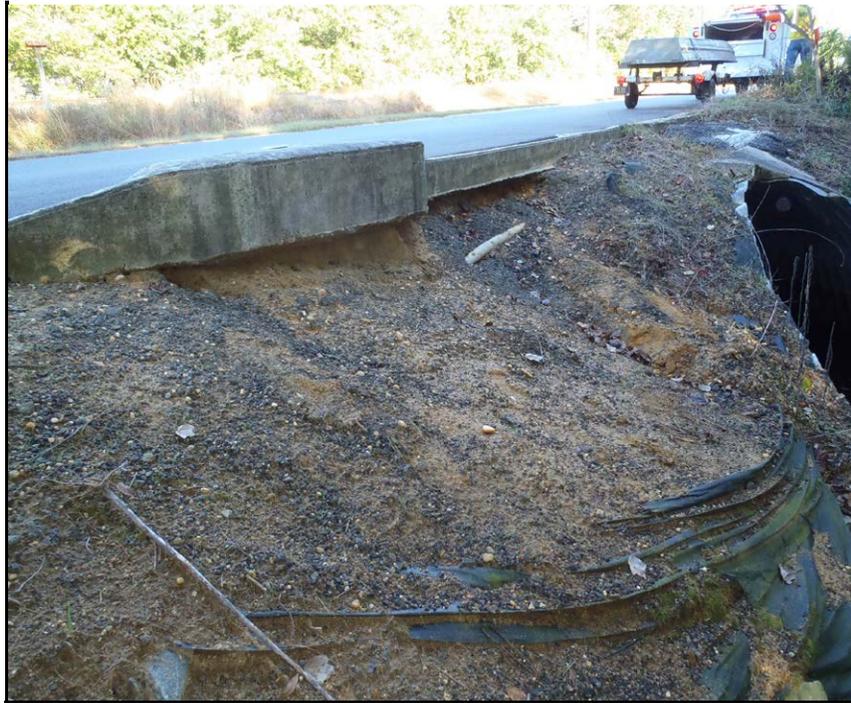
7. BANK EROSION BEHIND SOUTHEAST CURB LINE

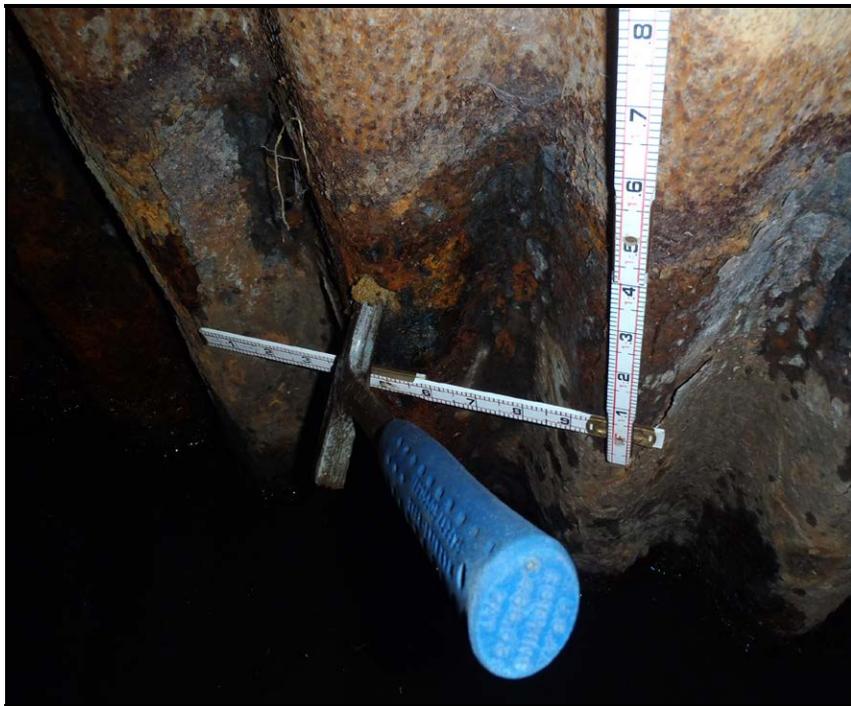
8. ADVANCED CORROSION ALONG WATERLINE TYPICAL, EASILY PERFORATED w/ PICK HAMMER
