LAST REVISED: 06/03/2014
 PA:60213789 - DELDOT AGR 1558 BRIDGE DESIGN SERVICES\TASK 0008 - REHAB BR 1-393 ODESSA\900 WORK\910 CAD\20-SHEETS\STRUCTURE\SD001.DGN

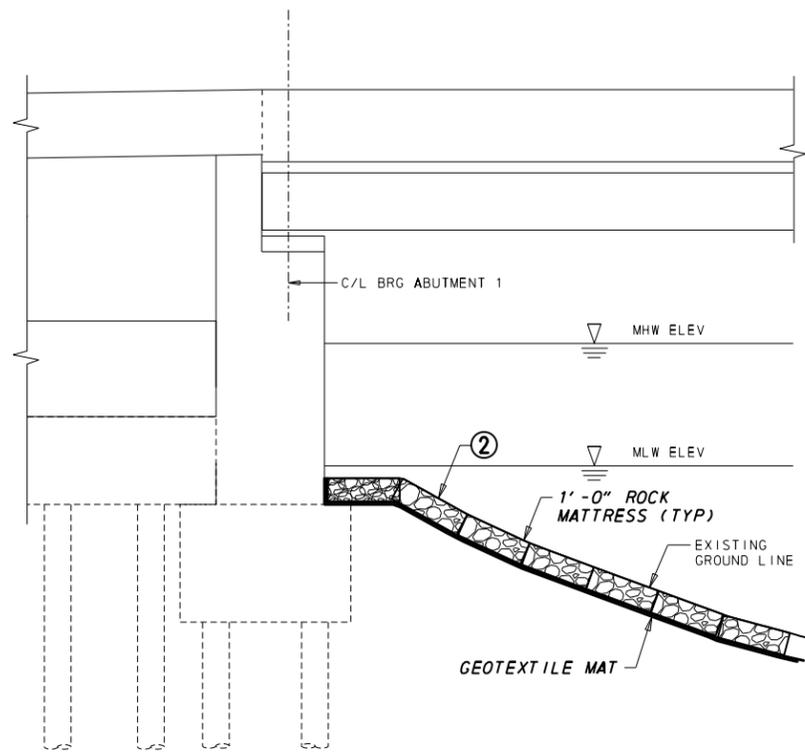
SECTION AT ABUTMENT 1

* BASED ON 2013 UNDERWATER INSPECTION REPORT. TO BE VERIFIED IN FIELD.

REPAIR ① NOTES

- OVERLAP JOINTS OF THE PRECEEDING GROUT BAG LAYER.
- DO NOT OVERFILL THE BAGS OR ALLOW GROUT TO BE POURED BETWEEN THE SEAMS OF TWO BAGS.
