Appendix II Results Of Architectural Survey

Historic Architectural Investigation Phase 1 Study Area

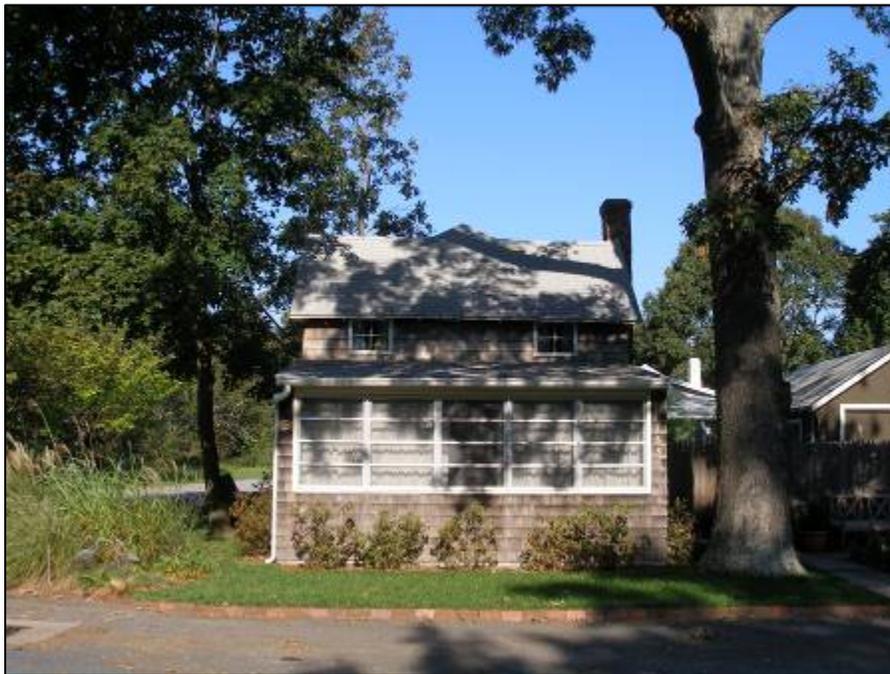
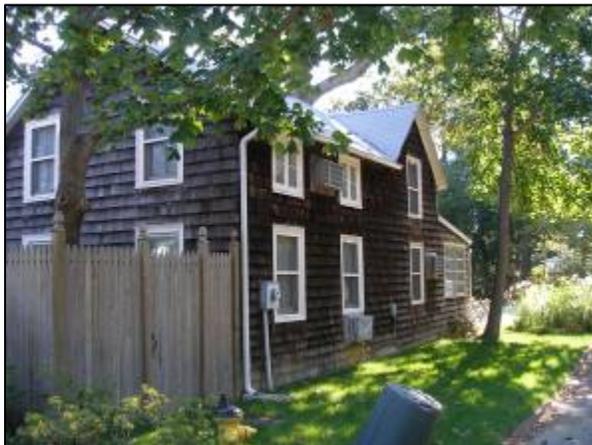
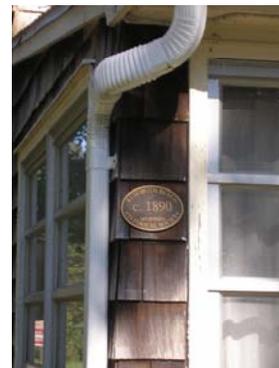
Example #1: 165 Henlopen Street

Description: The house located at 165 Henlopen Street (Tax parcel 3-34-13.20-115) is a circa 1890 two-story wood framed I-house (in vernacular form) with a cross-gabled roof and an adjoining rear wing of similar form and materials. The façade is two bays wide with a sheltered roof enclosed porch that extends the length of the front façade. The main block windows are mostly 2/2 wood frame, the enclosed porch have a bank of double hung windows across its front. The exterior walls are covered with wood shingles; and the roof is covered with asphalt shingles. A simple brick chimney rises from the exterior of the south wall of the main block.

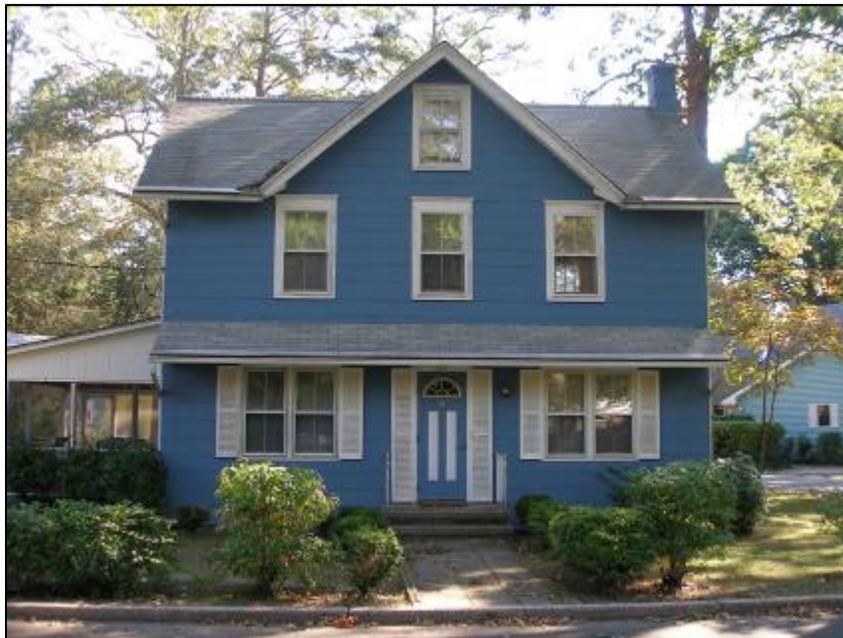
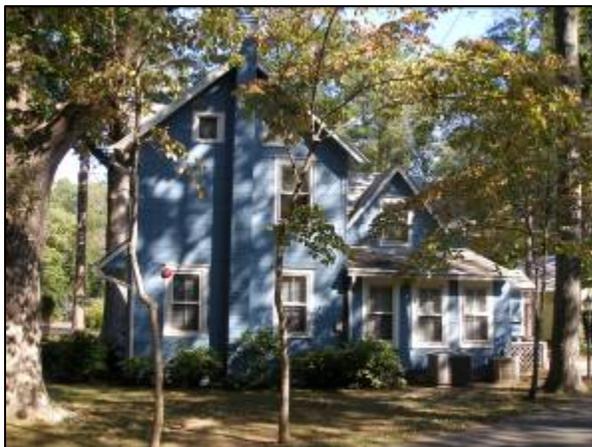
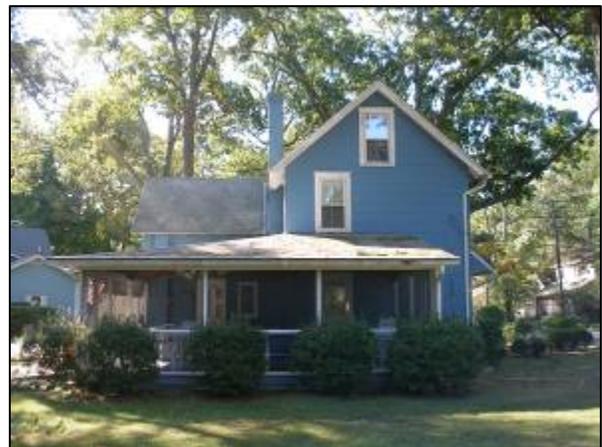
Example #2: 111 4th Street

Description: The house located at 111 4th Street (Tax parcel 3-34-14.13-159.01) is a mid to late 19th century 2-1/2 story wood framed I-house with some Gothic Victorian form. Constructed as a T-plan, it has a modern adjoining rear wing of similar form and material. The façade is three bays, the entry door is located in the center of the first story façade and flanked by paired two-over-two windows the door is sheltered by a shed roof porch that extends the length of the façade. Windows in the house are 2/2 wood-framed to include the windows located in the gables, wood shutters flank the first story façade door and windows. The exterior walls are covered with aluminum sidings; the roof is covered in asphalt singles. A simple brick chimney rises from the exterior of the south wall of the main block a shed roofed screened porch is attached to the rear wing.

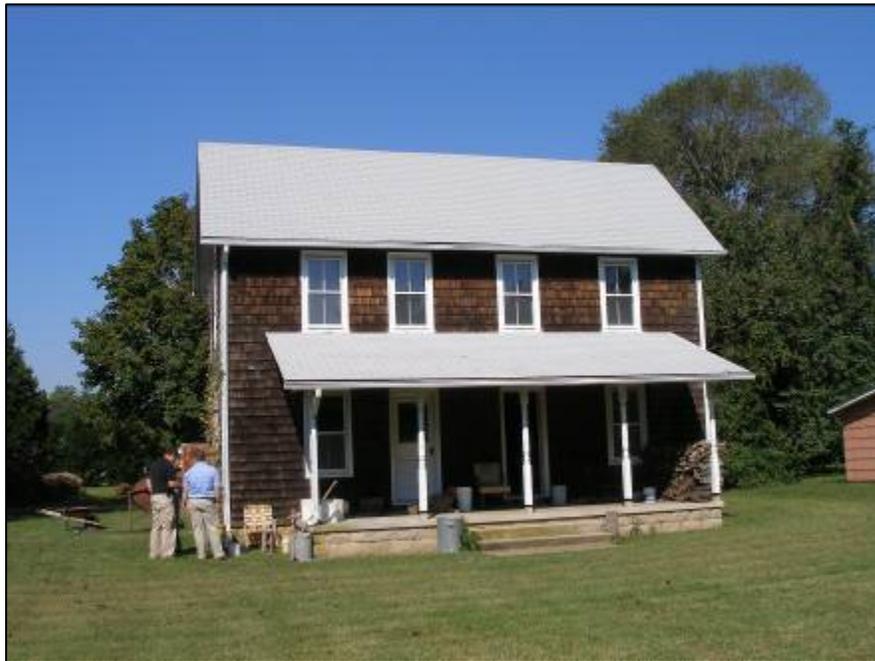
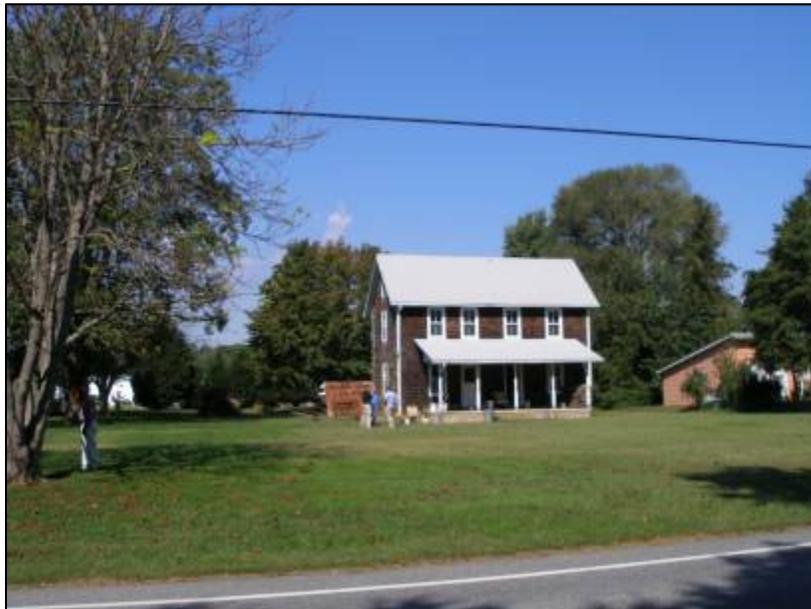
Example #3: 20386 Country Club Road

Description: The house located at 20386 Country Club Road (Tax parcel 3-34-19.00-8.01) is an early to mid 19th century 2 ½ story wood frame I-house with an adjoining rear wing (modern) of similar form and materials. The four bays façade has two-entry door flanked by a single 2/2 wood frame window. A shed roof porch held up by five turned spindle support posts shelters the doors. All the windows that can be viewed from the public space are 2/2 wood framed. The exterior is covered with wood shingles; the roof is covered with asphalt shingles. According to the owner (who was interviewed) the dwelling is the original farmhouse located across the street. Although the dwelling was moved and has been altered to accommodate the move, it exemplifies feeling and association as a former agricultural property type. Much of the design, materials/fabric, and craftsmanship are evident.

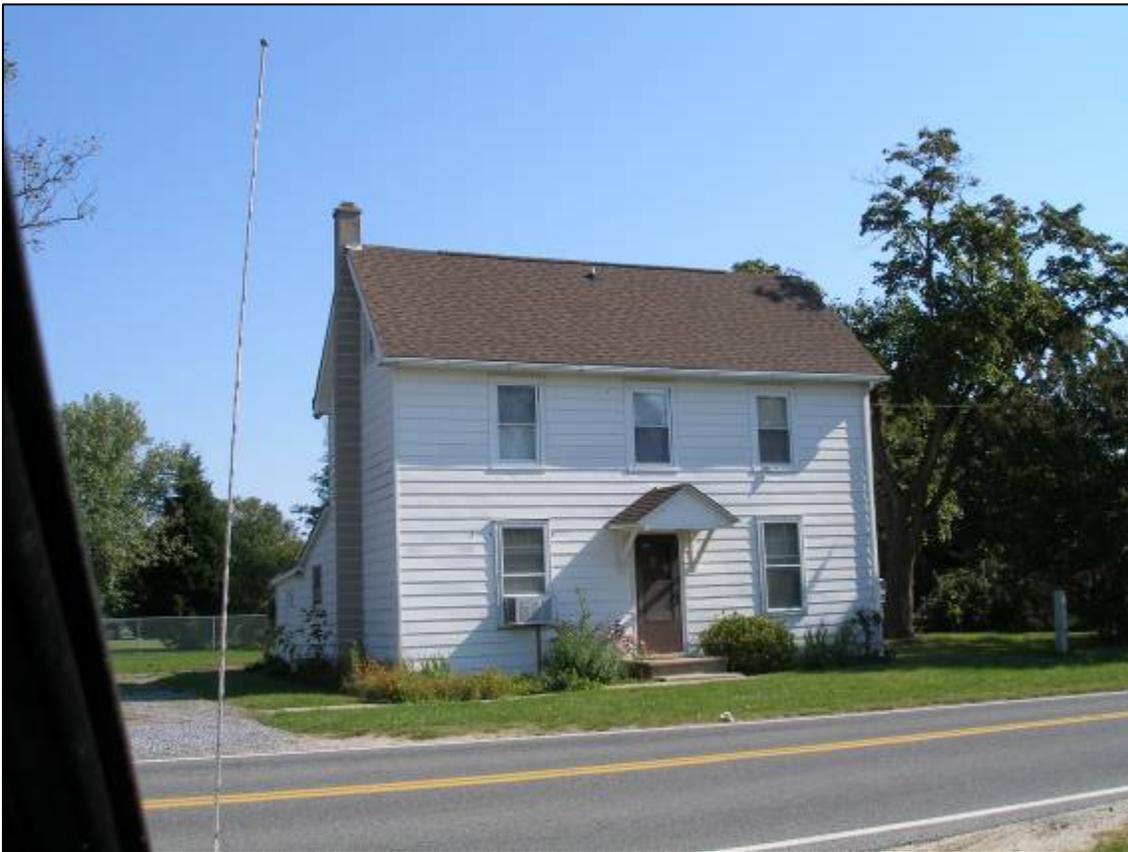
Example #4: 18663 Munchy Branch Road

Description: The house located at 18663 Munchy Branch Road (Tax parcel 3-34-13.00-104) is a mid to late 19th century 2-½ stories wood frame I-house with an adjoining rear shed wings (modern) of similar form and material. The three bays façade main entry door is centered in the façade; sheltered by a gabled hood roof and flanked by 6/6 wood framed windows. The second story façade consist of three 1/1 methodically placed windows. The exterior is covered with vinyl sidings and the roof is covered with asphalt shingles. A simple brick exterior chimney rises from the north end gable roof.

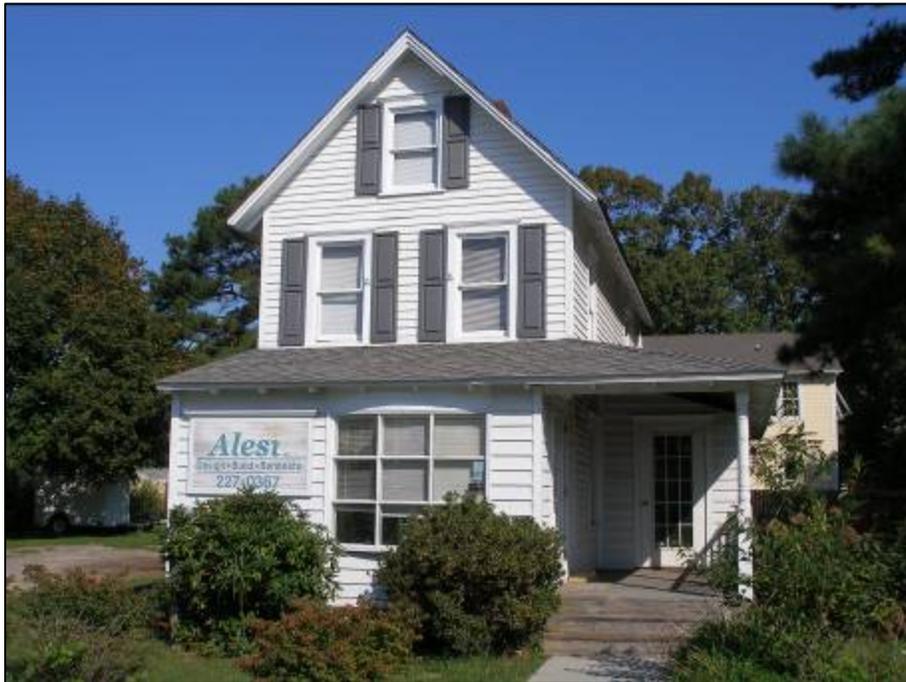
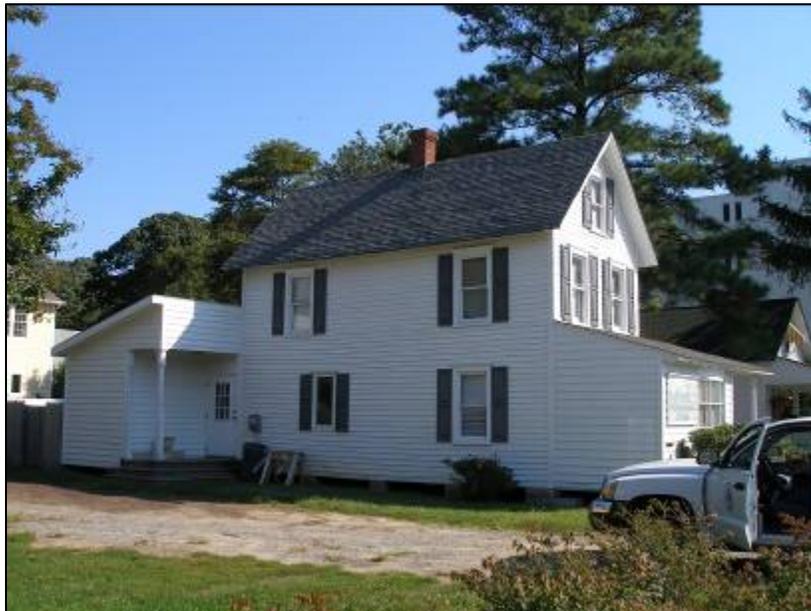
Example #5: 415 Rehoboth Avenue

Description: The house located at 415 Rehoboth Avenue is a late 19th century 2-1/2 story wood framed vernacular front gable dwelling with an adjoining shed roofed rear wing (modern) of similar form and materials. The front gabled roofed two bays façade has a partially enclosed shed roofed porch with a bay window (modern); the entry is located at the east end of the porch. A modern shed-roofed addition is attached to the rear of the house. All windows in the house other than the bay window are 1/1 wood framed flanked by shutters. The exterior walls are covered with vinyl sidings; the roof is covered with asphalt shingles; a simple interior brick chimney rises from the center of the roof peak. The dwelling has been extensively renovated and added onto, but is still reflective of the west Rehoboth Beach pre-resort dwellings of the area.

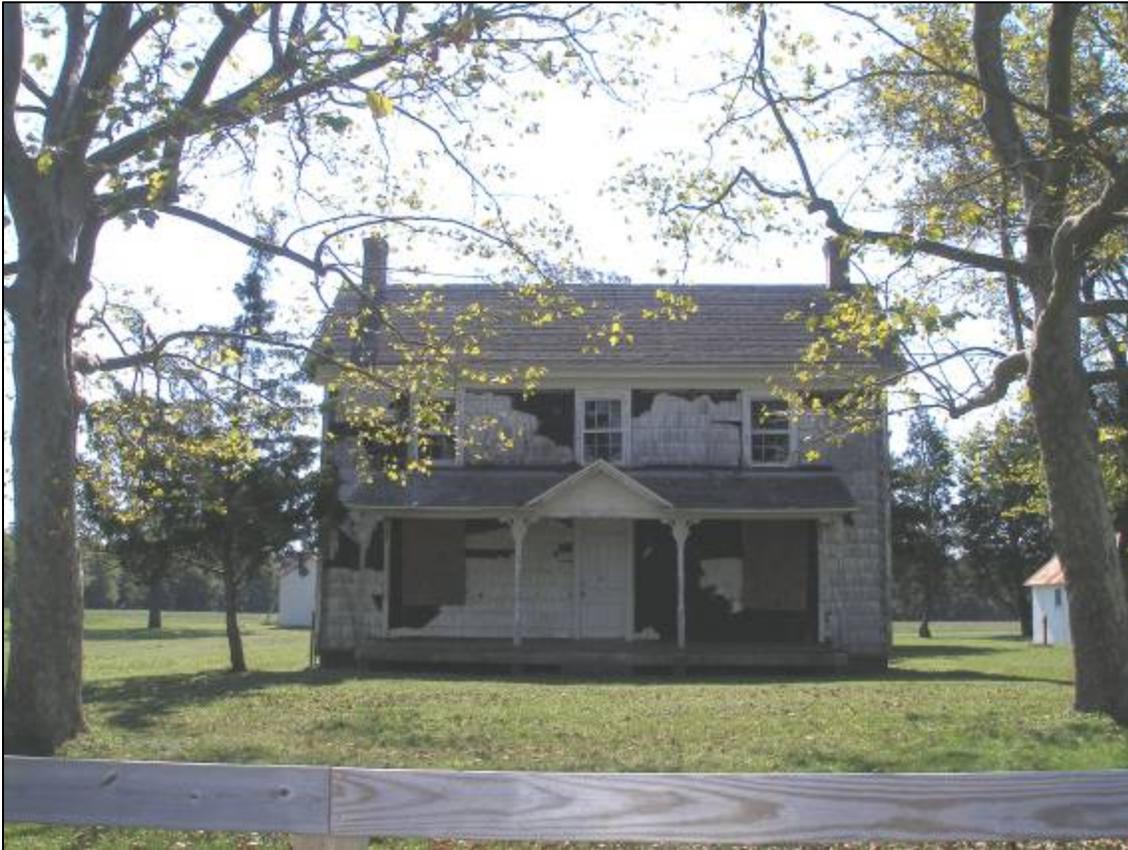
Example #6: DNREC State Parks, Dwelling off Wolfeneck Road

Description: The house located on Wolfeneck Road (Tax parcel 3-34-7.00-15.02) is an early to mid 19th century 2 and ½ story wood framed I-house. The entry door is located in the center of the first story three bays façade and is flanked by two covered windows and sheltered by a shed-roofed porch with a center gabled peak. Windows that can be viewed from the public space are 6/6 wood framed. The exterior walls are covered with wood shingles; several shingles are missing due to deterioration. The roof is covered with asphalt shingles, and simple brick interior chimneys rises from the east and west end of the side gabled roof. The dwelling and some outbuildings towards the rear of the property are part of the State Parks System for Cape Henlopen. The property's setting and design is in good condition representing a former agricultural property type.

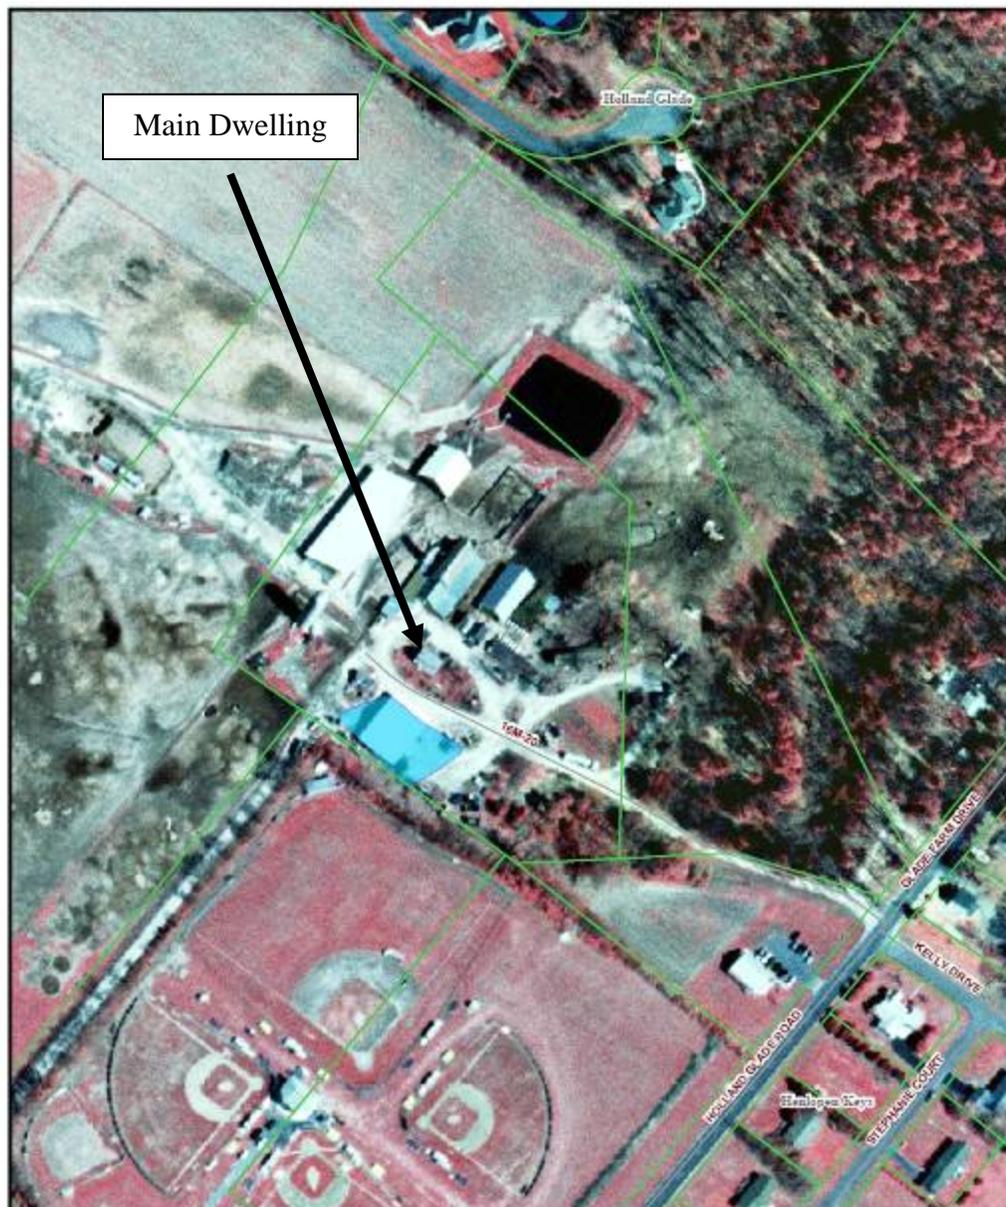
Example #7: Rustic Acres Dairy Farm

Description: The house located on the Rustic Acres Dairy Farm adjacent to Holland Glade Road (Tax parcel 3-34-13.00-326.00) is a late 19th century two and ½ story, five bay, wood frame I-house with a screen-enclosed porch attached to the rear of the house. The owner stated that there was a 17th century log farmhouse located on the back farm (in active fields), but that dwelling has been completely removed. The farm is an active dairy farming operation with an amalgamation of old and new outbuildings. Agricultural fields do exist on other tax parcels that help support the overall agricultural operations. DeIDOT personnel were not allowed to take on-site pictures by request of the property owner.
