**S-11905. Dwelling, north side of Fleatown Road
(PIN: 230-19.00-99.00)
(Detail Map #1)**

**S-11906. Dwelling, 18126 Fleatown Road.
(PIN: 230-19.00-103.02)
(Detail Map #1)**

**S-11907. Agricultural Complex, Shoemaker Lane, north side of Redden Road.
(PIN: 135-6.00-27.00)
(Detail Map #5)**

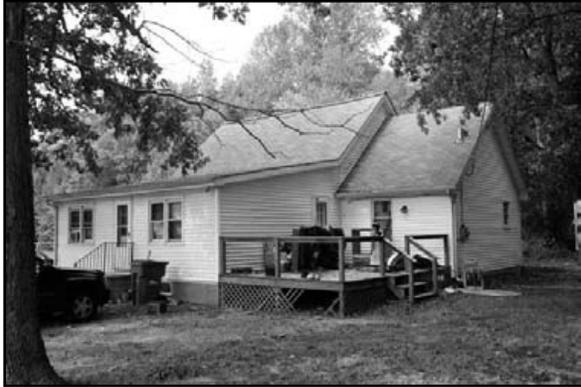
As described and visually evident, this house has undergone substantial alterations. Additions have been added to its façade, southeast corner, and eastern sidewall. The fenestration pattern on each elevation has been altered, in addition to all bays having been replaced with non-sensitive and/or period replacements. Lastly, vinyl siding has been applied to the entire exterior. Altogether these changes have greatly diminished the dwelling's integrity. Therefore, it is recommended not eligible under Criterion C.

main building (.001) façade and east side,
view to NW

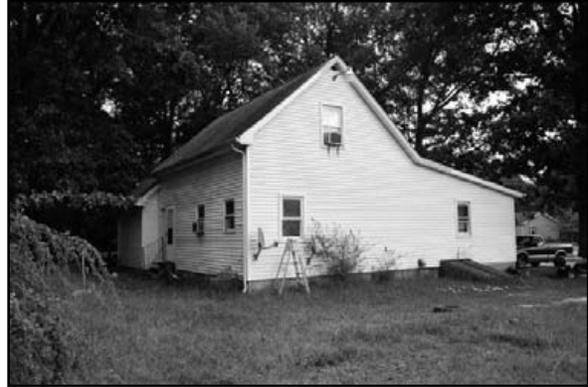
main building (.001) rear and west side,
view to SE

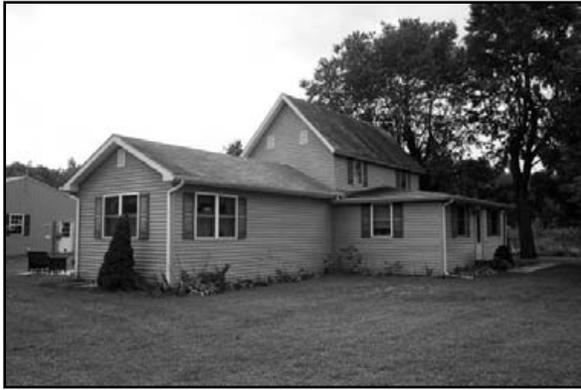
As evident, the house has undergone substantial alterations including the removal of the original front entrance, the addition of a full-width addition both to the façade and rear, the addition of a gabled ell from the eastern sidewall, the replacement of all the windows and doors, and the application of vinyl-siding to the entire exterior. Altogether these changes have greatly diminished the dwelling's integrity of design, materials, workmanship, and feeling. Therefore, it is recommended not eligible under Criterion C.

main building (.001) façade and east side,
view to SW

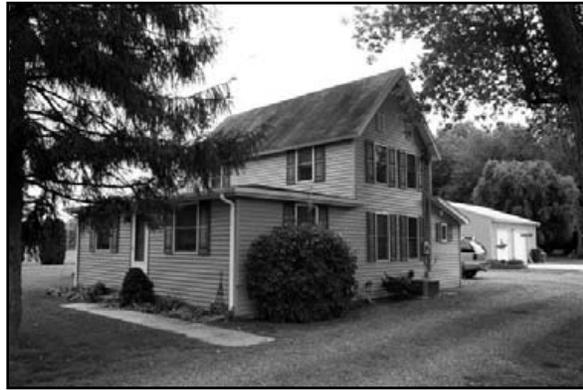
main building (.001) façade and west side,
view to SE

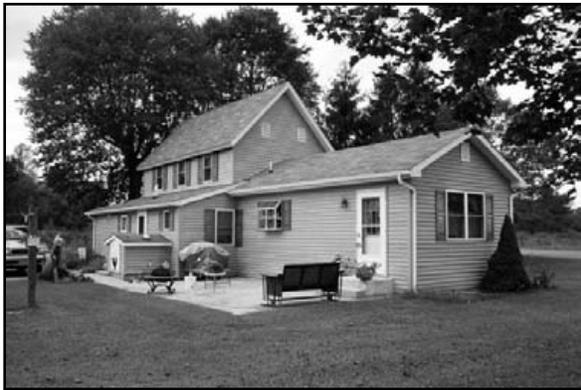
main building (.001) rear and east side,
view to NW

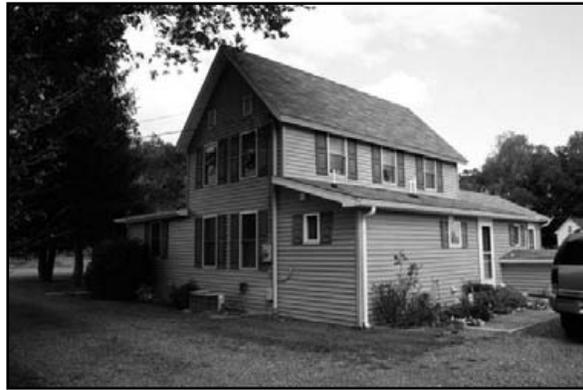
main building (.001) rear and west side,
view to NE

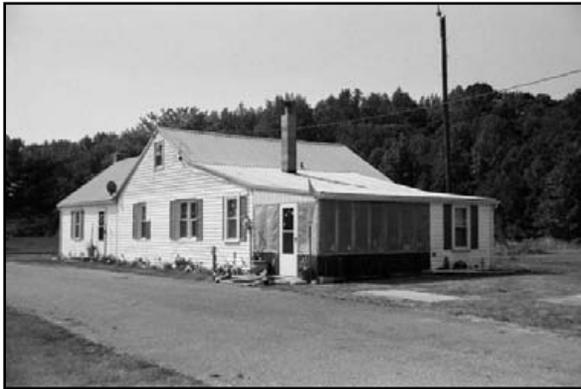
As noted, the vernacular bungalow has undergone substantial alterations. Most significant is the attachment of additions, which has resulted in the reorientation of the entrance façade. Additionally, fenestration openings have been altered and replaced, and the exterior has been covered in new siding. These changes have greatly compromised most aspects of its integrity. As a result of their severe deterioration, the outbuildings also lack integrity. For these reasons, this property is recommended not eligible under Criterion C.

main building (.001) façade and north side, view to SW

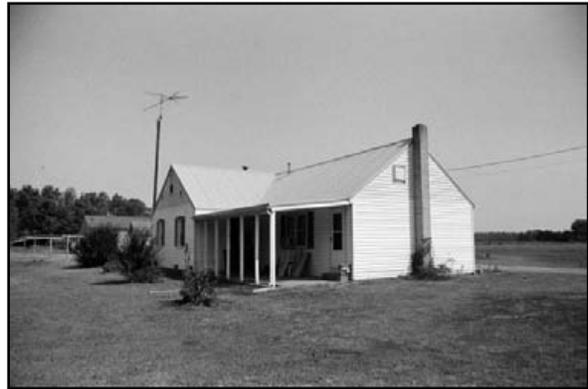
main building (.001) rear and south side, view to NE

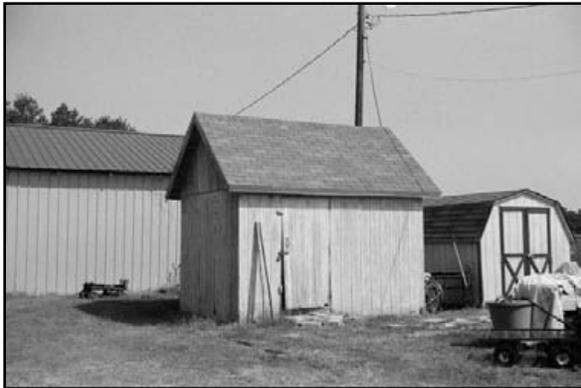
shed (.002), view to NE

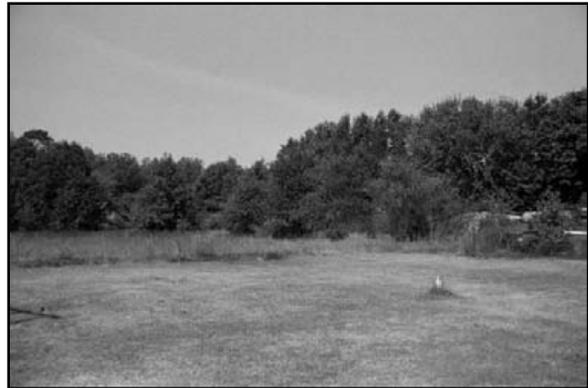
inaccessible and partially collapsed outbuildings (.003, .004), view to NW

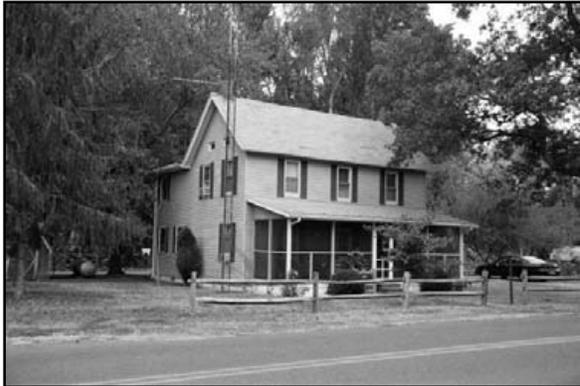
As evident and noted above, the house has undergone substantial alterations including the replacement of the front porch; the addition of a full-width, two-story addition across the rear; the addition of a modern deck along the east-northeast corner; the replacement of all the windows and doors; and the application of vinyl siding to the entire exterior. Altogether these changes have greatly diminished the dwelling's integrity of design, materials, workmanship, and feeling. Further, the large addition to the rear has visually obscured the dwelling's historic massing. Better-preserved examples of this architectural type exist elsewhere within the U.S. 113 study area between Milford and Selbyville, in particular the Benham House (S-02901; pictured below). For these reasons, this property is recommended not eligible under Criterion C.

main building (.001) façade and west side, view to NE

Deconstruction and/or demolition of the dwelling on this property may reveal that it contains information important to the understanding of vernacular architecture traditions. If the building is to be demolished as part of this project, it should first be more thoroughly investigated by a qualified architectural historian, conservator and/or specialist; selective demolition should be used to fully determine whether the property is eligible under Criterion D and has important information to yield. If it is determined that the building was constructed using standard building technology of the time, including balloon or platform framing, this property would not be eligible for listing under Criterion D and the demolition could proceed. Should the property be recommended significant by the qualified architectural historian, conservator and/or specialist, it should be fully documented prior to demolition.

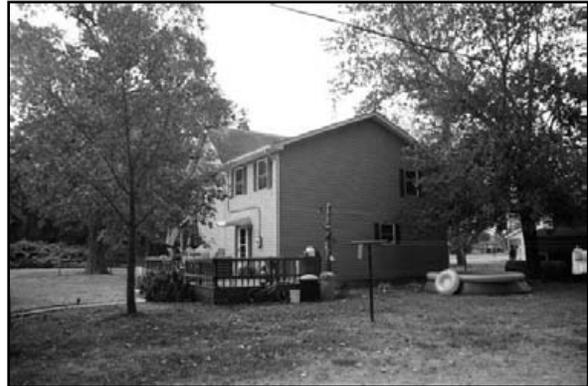
main building (.001) rear and east side, view to SW

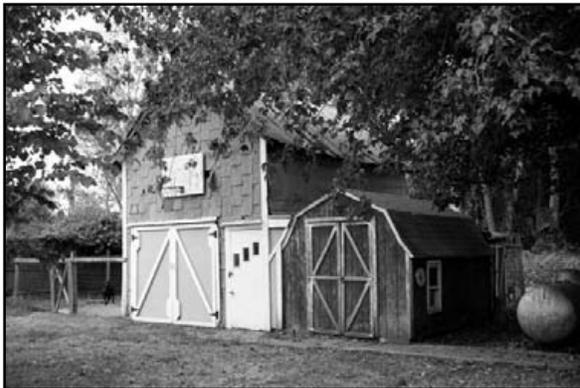
garage/barn (.002), view to NW

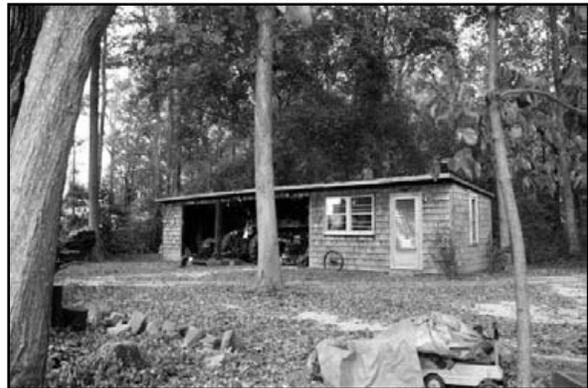
workshop/equipment shed (.003), view to N

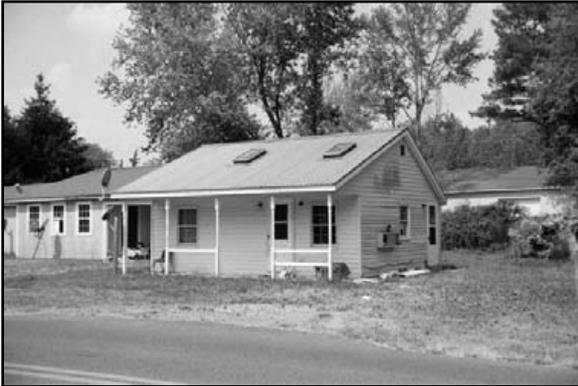
Eligibility under Criterion C for architecture requires that the historic function of a country store be readily discernable and that much of its historic character remain intact. Significance is increased if the store remains associated with an older residence. The historic-period residence on this property is no longer extant, and the building itself has undergone substantial alterations. The full-width, inset entry has been remodeled with new, decorative porch supports and railing, the fenestration pattern on each of the walls has been altered, all the windows and doors have been replaced, modern elements (skylights) have been added to the rooftop, modern siding has been added to the exterior, and an addition has been attached to the rear. Altogether these changes have greatly diminished the building's integrity, and its ability to convey its architectural significance.

main building (.001) façade and east side,
view to NW

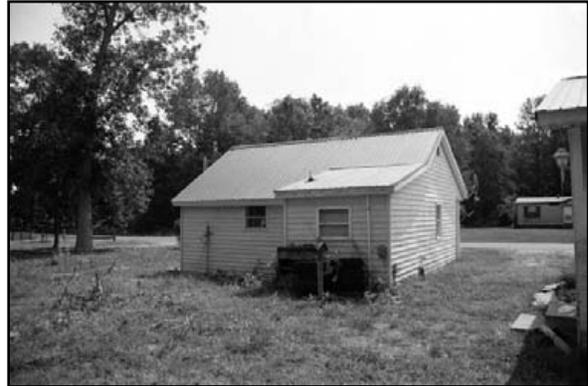
main building (.001) rear and west side,
view to SE
