**S-08572. McLaren House, 10769 DuPont Highway  
(PIN: 230-19.00-85.00)  
(Detail Map #1)**

**S-08574. Coleman Farmstead, Route 16**  
**(PIN: 230-26.00-15.00 and 230-26.00-18.00)**  
**(Detail Map #2)**

**S-08575. Cornelius Sutton House, DuPont Highway  
(PIN: 230-26.00-23.00)  
(Detail Map #1)**

**S-08576. Preston Evans House, 12241 U.S. 113**  
**(PIN: 230-26.00-32.00)**  
**(Detail Map #1)**

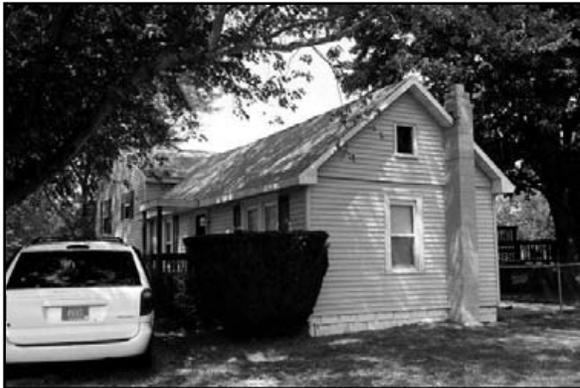
main building (.001) façade and north side, view to SE

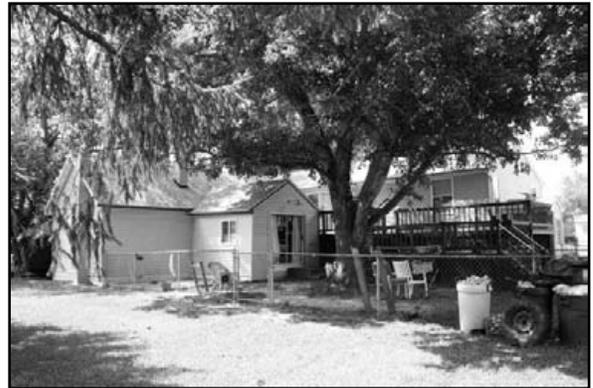
main building (.001) façade and south side, view to NE

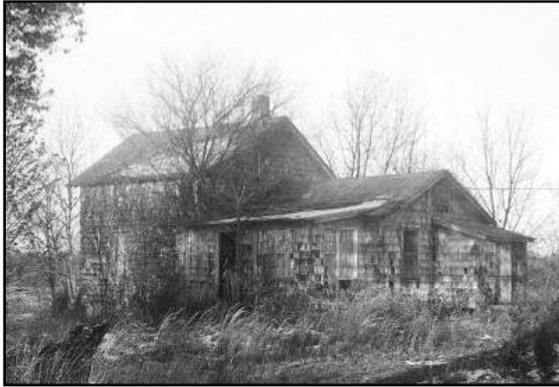
Since the time of the LeeDecker et al. survey, the property has been abandoned. The house clearly shows the effects of this abandonment with portions of the roof and wall shingles missing. The barn, on an adjacent tax parcel, has also suffered. The most notable evidence of deterioration is the lack of roof ventilators seen in a photo accompanying the 1992 report (see below), as well as the replacement of the original sliding barn doors. Deterioration has lessened the integrity of both buildings.

main building (.001) façade and south side, view to NE

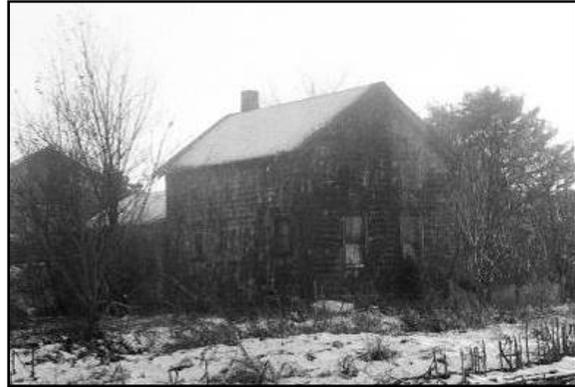
main building (.001) rear and north side, view to SW

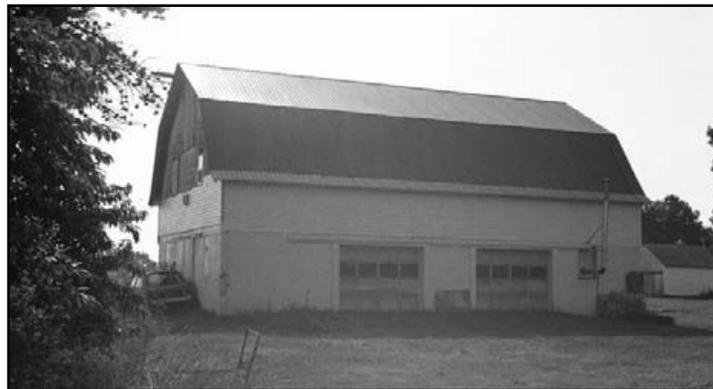
As noted, the house has suffered significant deterioration in recent years. The barn has also been altered by replacement of the ground-level openings with garage doors and the removal of roof ventilators, among other changes. Due to alterations and deterioration, both buildings lack the integrity to be able to convey their historic character, and are thus recommended not eligible under Criterion C.

barn (.002), view to SE

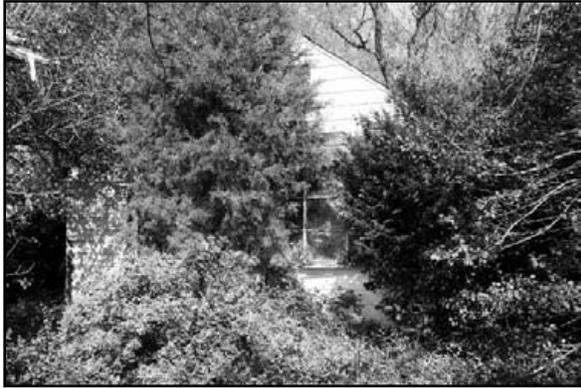
Alterations to the original house include newer siding, windows, and shutters, but the house has undergone severe deterioration. Its roof and ceiling are collapsing. The north side has a shed-roofed addition that is almost entirely collapsed. A front door has been added on the west side of the addition.

main building (.001) façade, view to E

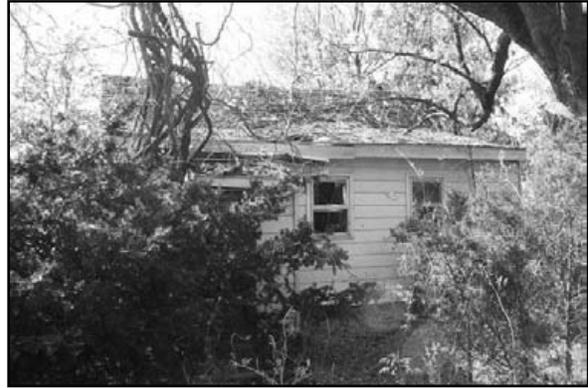
main building (.001) rear, view to W

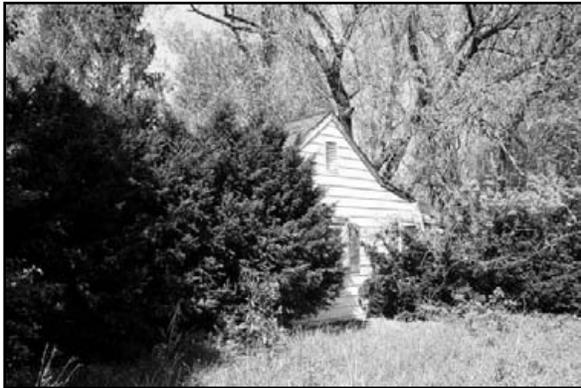
main building (.001) south side, view to NE

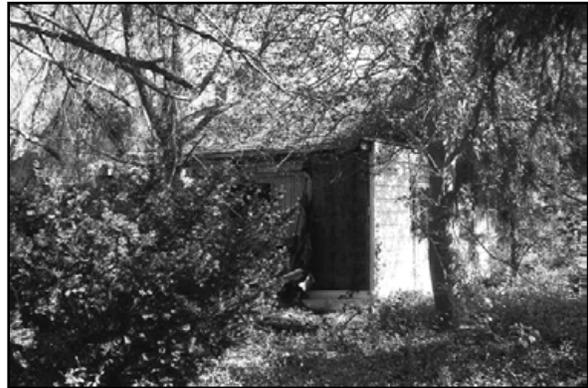
main building (.001) façade and north side, view to SE

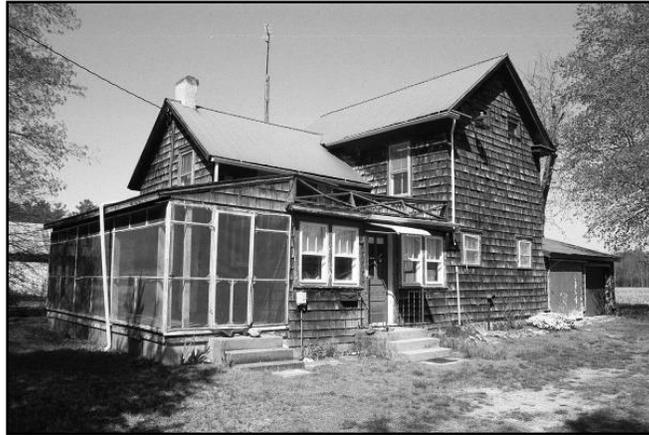
main building (.001) west and south walls,  
view to NE

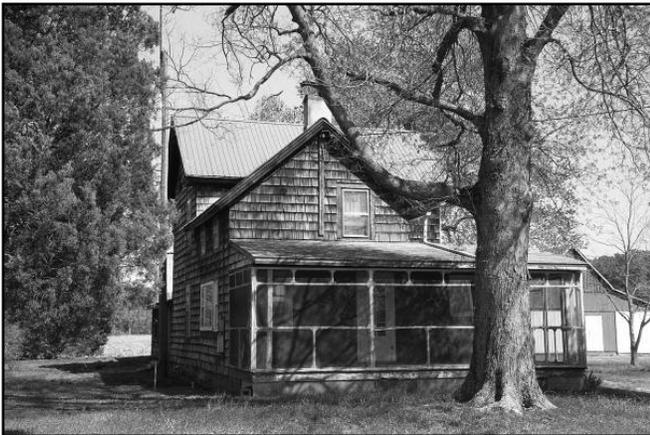
main building (.001) west wall, view to E

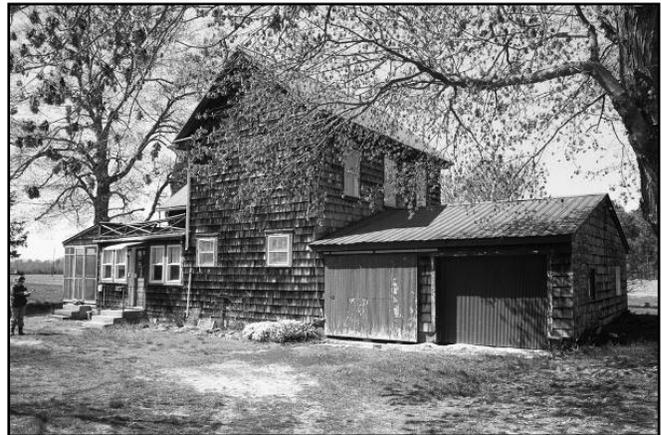
main building (.001) east wall (formerly the  
façade) and south side, view to NW

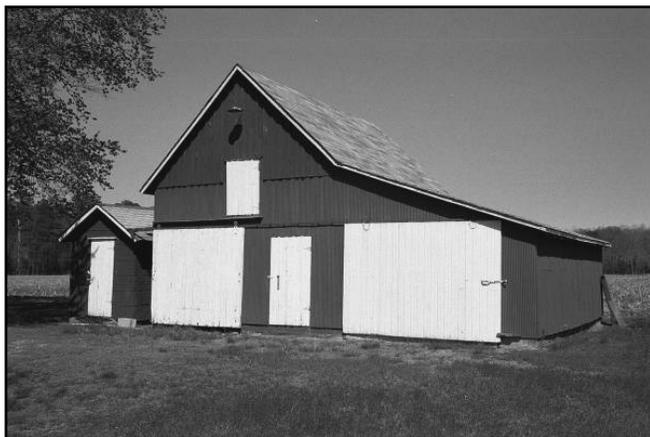
left to right: shed (.003) and barn (.002),  
view to NE

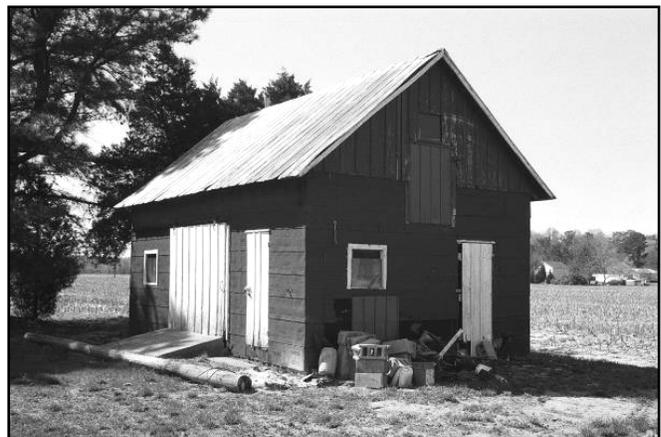
barn (.004), view to NW
