S-08577. Olden Dickerson House, 12279 U.S. 113
(PIN: 230-26.00-33.00)
(Detail Map #1)

S-08578. Theodore Walnius House, Route 113
(PIN: 23-26.00-35.01)
(Detail Map #1)

**S-08579. Gwendolyn Layton House, 12767 U.S. 113
(PIN: 230-26.00-107.00)
(Detail Map #2)**

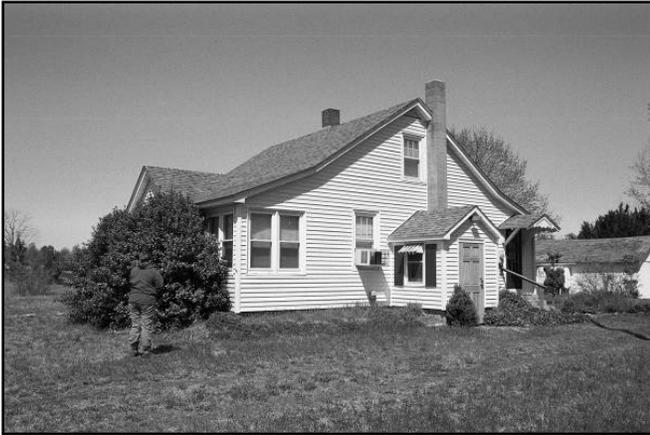
The house and its outbuildings express details of the bungalow/craftsman style. None of the buildings, however, represents an architecturally notable example of this style. The house lacks the stylistic elaboration found on significant examples and, further, it has been altered with replacement windows and siding. Therefore, JMA concurs with LeeDecker et al.'s recommendation of not eligible under Criterion C.

main building (.001) façade and south side,
view to NE

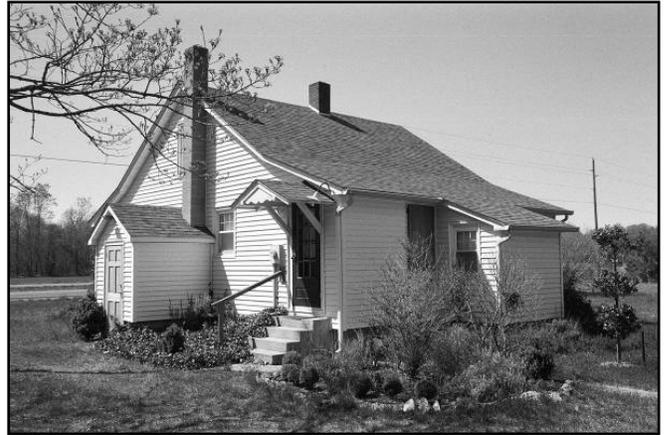
main building (.001) rear and south side,
view to NW

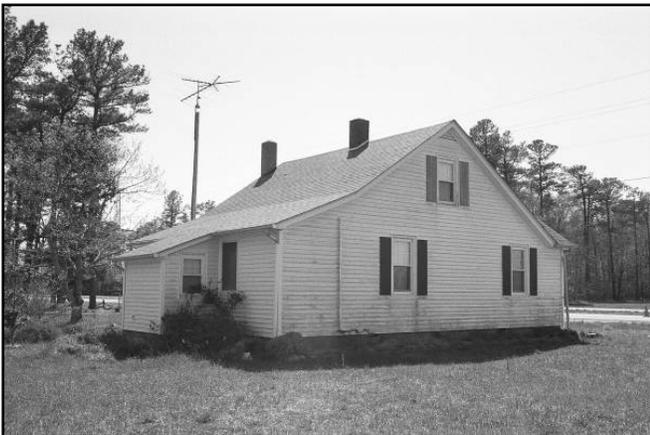
main building (.001) rear and north side,
view to SW

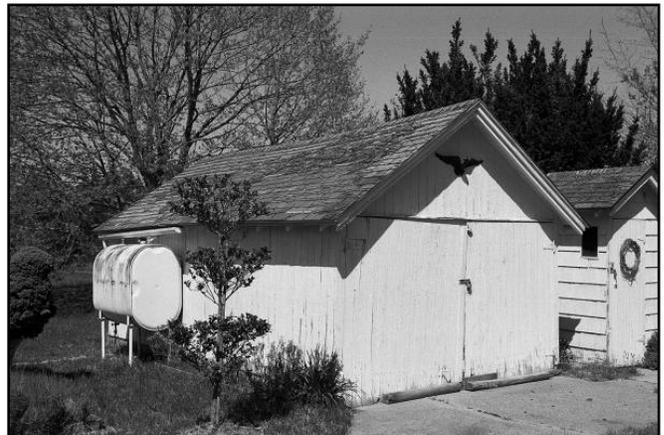
Four outbuildings extend in a line east of the house. Closest to the house is a c. 1940s gable front, wood-framed garage (.002). Its south wall contains a pair of side-hinged batten doors. The remaining walls are blank. The garage sits on a concrete-block foundation, is sheathed in vertical boards, and has a roof sheathed in asphalt shingles. This garage has exposed rafter tails.

garage (.002), view to NE

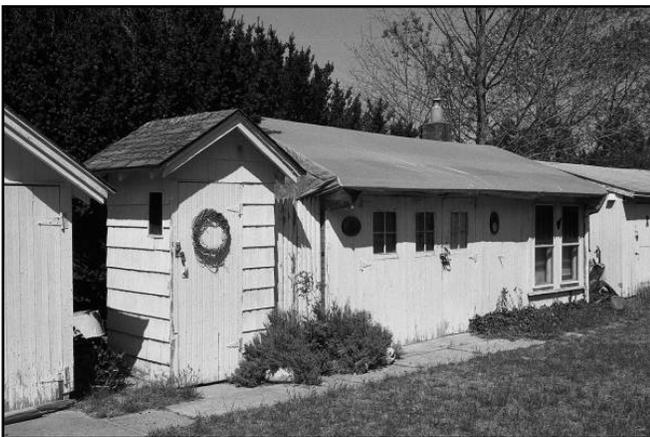
Immediately east of the garage is a c. 1940s wood-framed privy (.003). This structure, which sits on a poured concrete slab, is sheathed in wood shingles and has a roof sheathed in asphalt. A vertical wood batten door is placed in its south gable. A screened opening is placed in its west wall. The remaining two walls are blank. Its eaves are marked by exposed rafter tails.

Immediately east of the privy is a side-gabled, c. 1940s tool shed (.004). This shed sits on a concrete slab. Its front wall is sheathed in vertical wood siding, while its side walls are sheathed in bricktex. The south façade is pierced with two, four-over-one, double-hung, sash windows and tripartite sliding vertical batten doors with four-light fixed windows. The east gable end wall has a group of windows that have been boarded over, while the west wall is covered with a tarp. The rear wall is blank. A brick chimney adjoins its south gable end.

left to right: privy (.003) and tool shed (.004),
view to NE

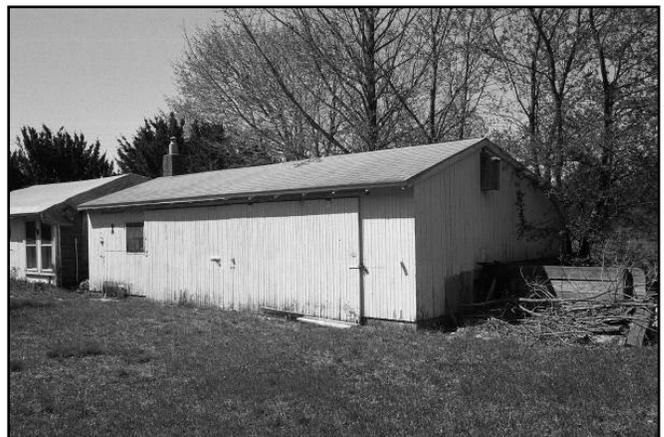
The final outbuilding is a c. 1940s oblong, wood-framed, side-gabled equipment shed (.005). All of its windows are boarded over. The shed sits on a concrete-block foundation, is sheathed in vertical boards, and has a roof sheathed in asphalt. Its south wall is pierced by a wood Dutch door and a pair of vertical board, wood, sliding doors. The east gable end has a boarded up window, while the remaining two walls are blank.

equipment shed (.005), view to NW

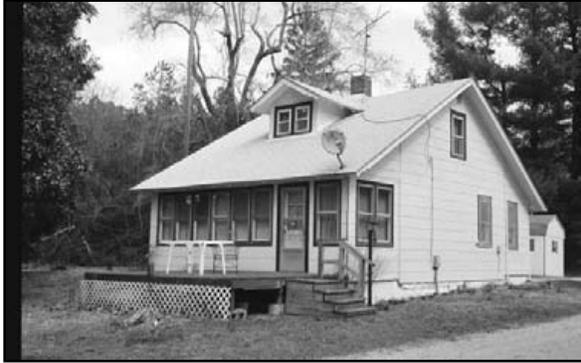
This bungalow, which has been altered by enclosure of the front porch, addition of a front deck, and probable replacement of windows, possesses neither the significance nor the integrity necessary for eligibility under Criterion C. JMA concurs with LeeDecker et al.'s recommendation of not eligible under Criterion C.

main building (.001) façade and south side, view to NE

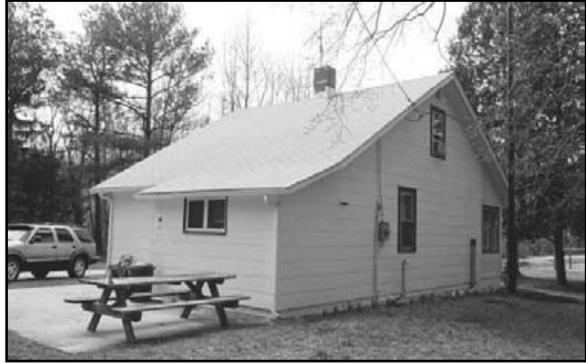
main building (.001) rear and north side, view to SW

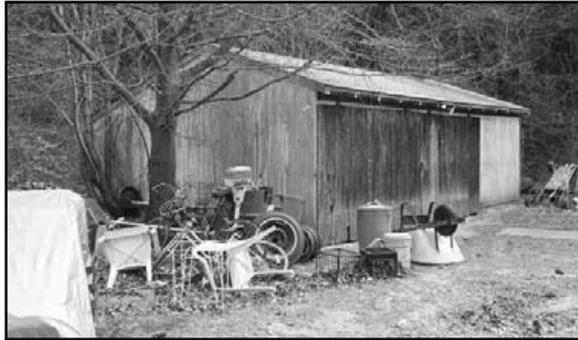
The property also includes a c. 1940 equipment shed (.002). This side-gabled, wood-framed structure is sheathed in vertical wood siding. Its west façade contains two, sliding, vertical board doors, and the south wall has a six-light awning window. The north side is blank, and the rear wall was inaccessible.

equipment shed (.002), view to SE

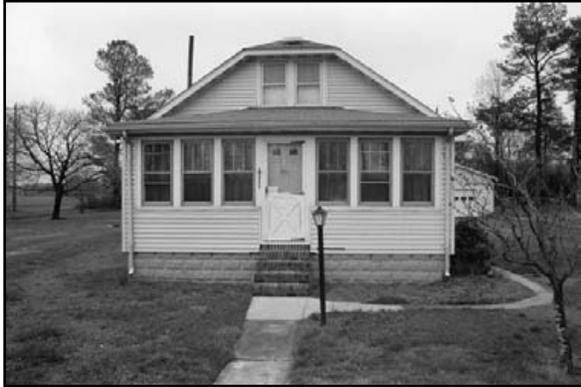
JMA concurs with LeeDecker et al. that the house lacks individual architectural distinction. Alterations include the enclosure of the front porch, construction of additions, replacement of windows, and application of new siding. Due to both lack of architectural significance and diminution of integrity, this property is recommended not eligible under Criterion C.

main building (.001) facade, view to E

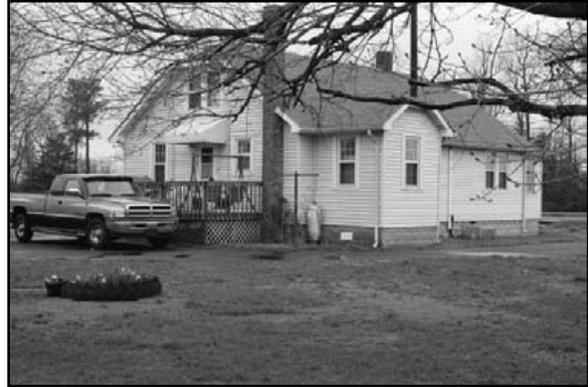
main building (.001) rear and north side, view to SW

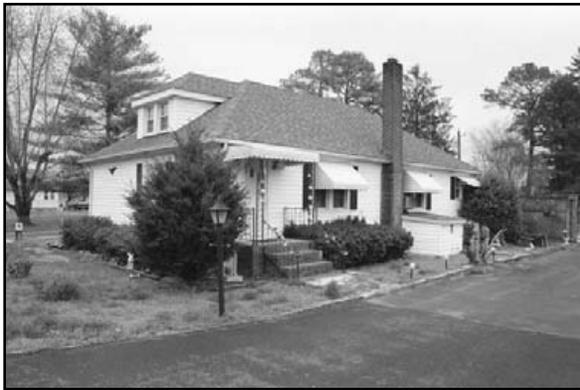
JMA concurs with LeeDecker et al. that the house lacks individual architectural distinction. Alterations include reorientation of the façade, the enclosure of the front porch, replacement of windows, and application of new siding. Due to both lack of architectural significance and diminution of integrity, this property is recommended not eligible under Criterion C.

main building (.001) original façade (on left) and south side, view to NE

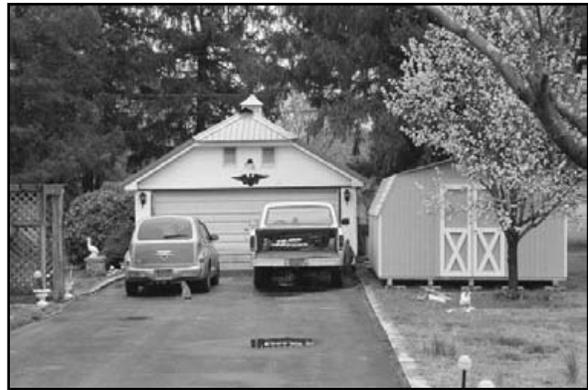
The c. 1930s garage (.002) is gabled front in orientation with a jerkinhead gable. The west façade is marked by a modern roller, fiberglass garage door. The north side is pierced by a one-over-one, double-hung vinyl-clad window and central two-panel plywood doors. The south and rear walls are blank. The garage is clad in vinyl siding, and its roof is sheathed in metal siding.

garage (.002), view to E

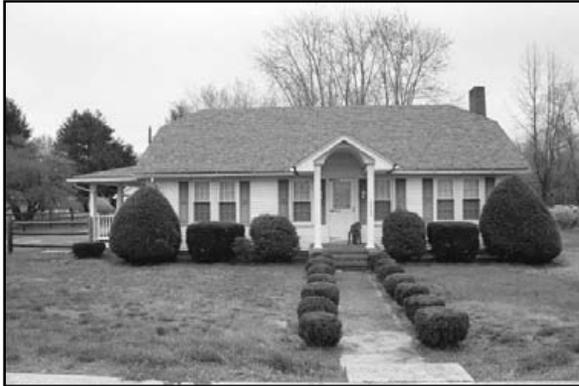
JMA concurs with LeeDecker et al. that the house lacks individual architectural distinction. Alterations include replacement of windows, and application of new siding. Due to both lack of architectural significance and diminution of integrity, this property is recommended not eligible under Criterion C.

main building (.001) façade, view to E

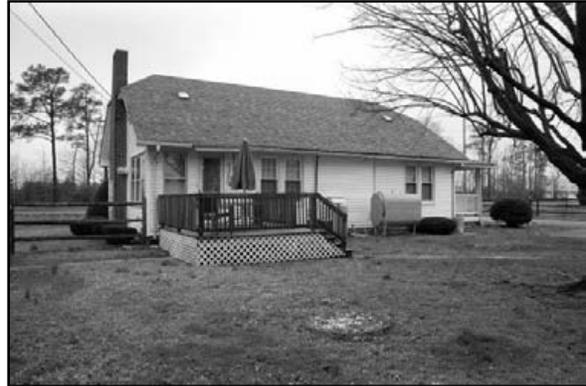
main building (.001) rear and south side, view to NW

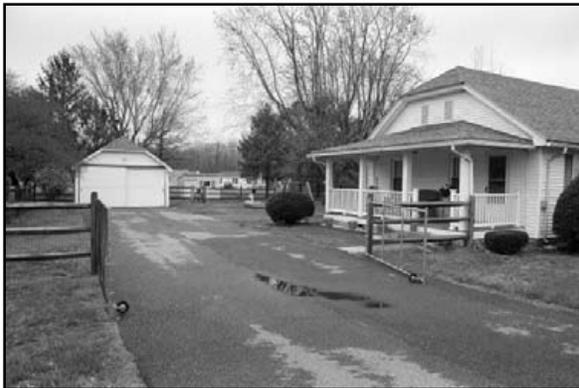
The wood-framed, c. 1930s garage (.002) is located northeast of the house at the end of paved driveway. A jerkinhead gabled front garage, its façade contains sliding beadboard doors with vinyl siding. The north side is blank, while the south side has a side vinyl-clad door. The rear wall is also blank. The garage is placed on a rusticated concrete-block foundation and is sheathed in vinyl siding.

left to right: garage (.002) and main building (.001) north side, view to SE

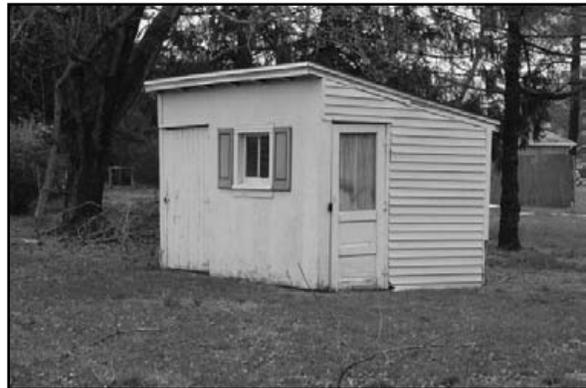
The second outbuilding, a c. 1940s, garden shed (.003), is placed east of the fence line surrounding the house. This shed-roofed shed sits on a concrete-block foundation and is sheathed in vinyl siding, bricktex, and plywood. Its west façade has a fixed, two-light window, and a beadboard batten door. The north and east walls are blank, while the south wall has a one-light, two-panel, wood and glass door.

garden shed (.003), view to NE
