Table 1. Previously Surveyed Pre-1952 Architect

Table 1 Photographic Captions

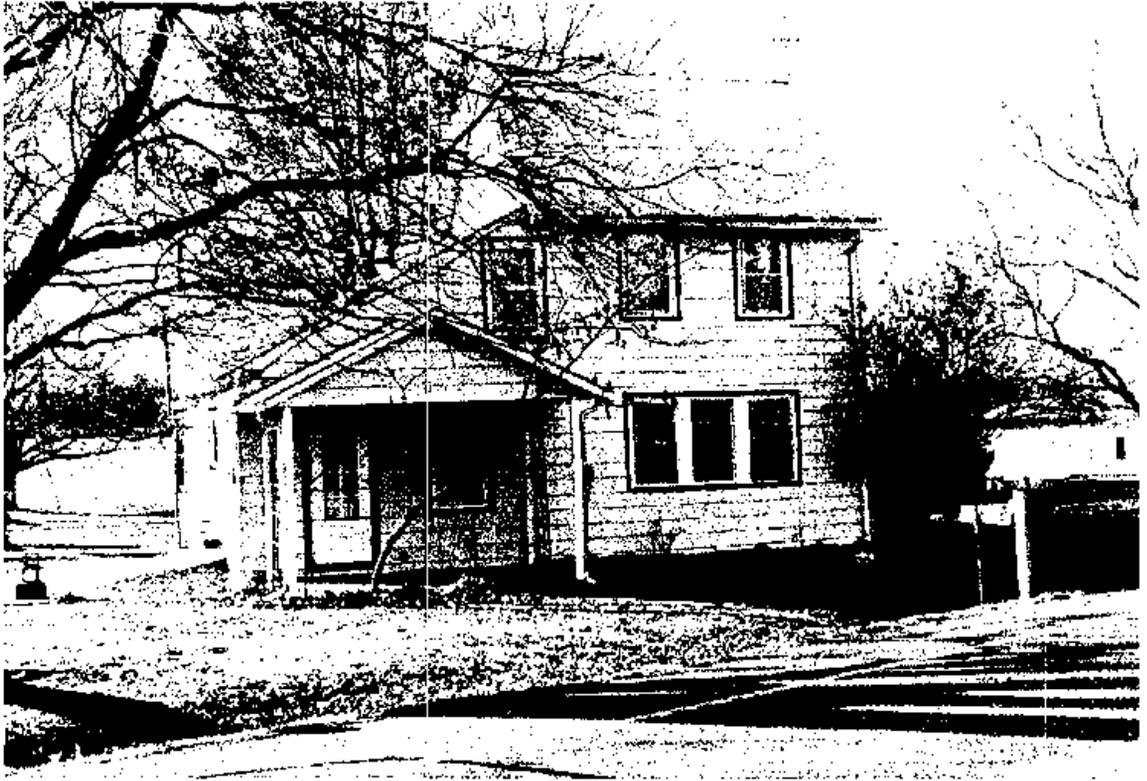
Photo 1. House, 147 Route 15 (K-1283). Northeast façade toward southwest.

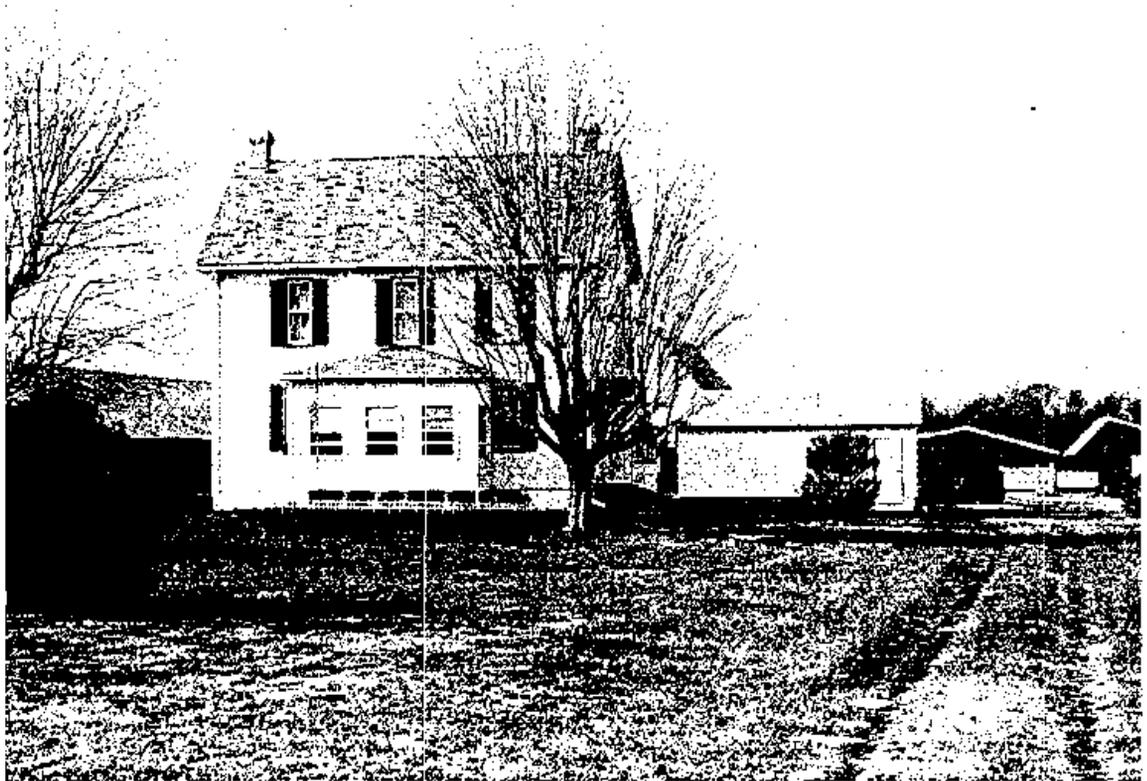
Photo 2. House, 2191 Seentown Road (K-1286). Northwest façade toward southeast.

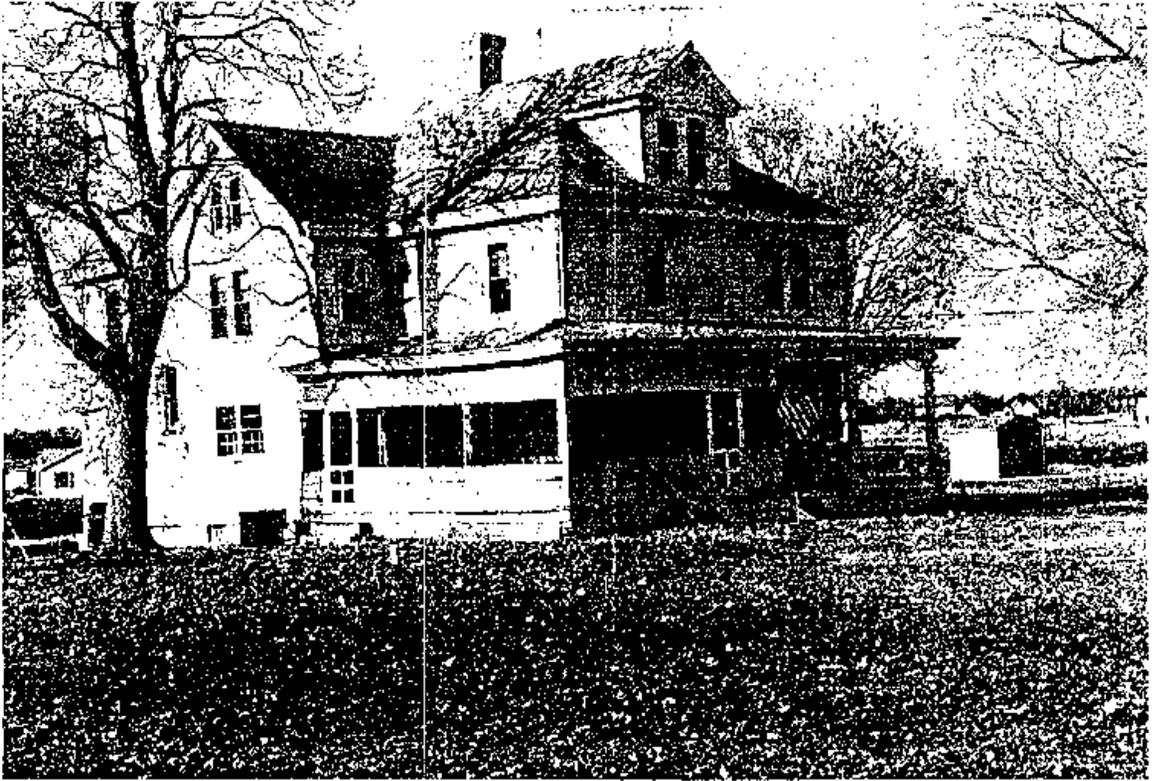
Photo 3. House, northwest side, Brenford Road (K-1289). Southeast façade and southwest elevation toward northwest.

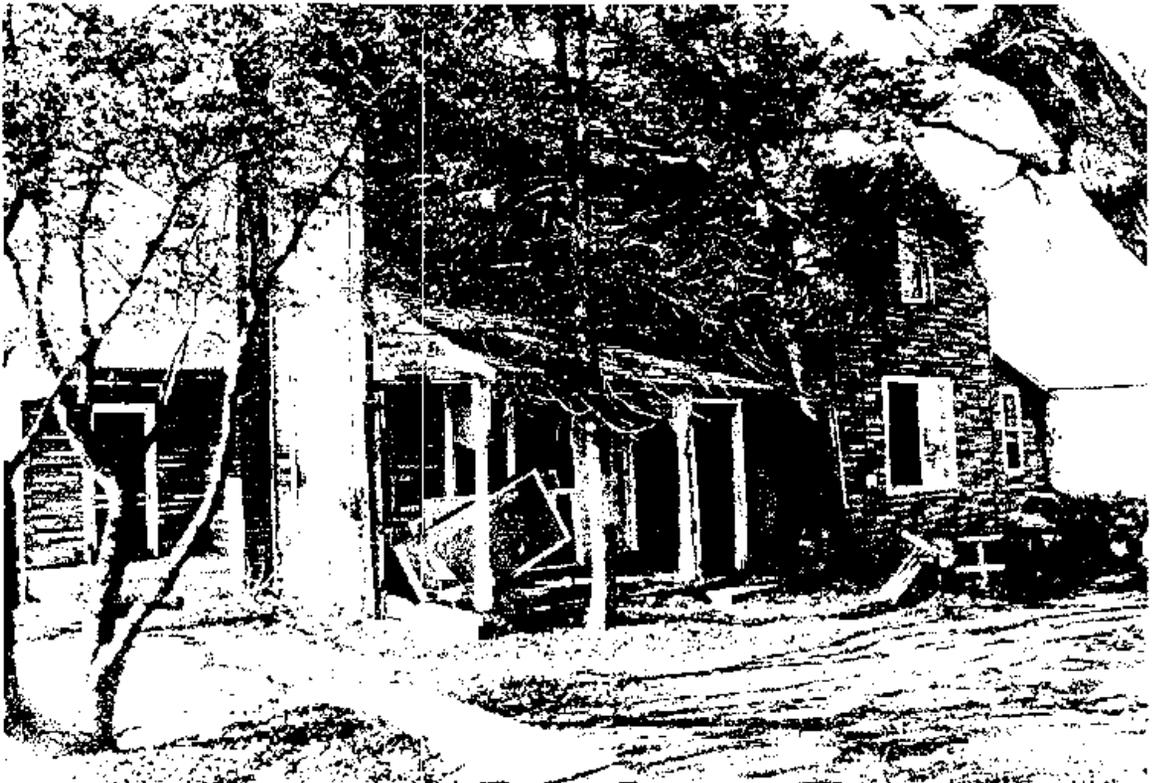
Photo 4. House, north side of Route 42, west of Moores Corner (K-1290). East façade and south elevation toward northwest.

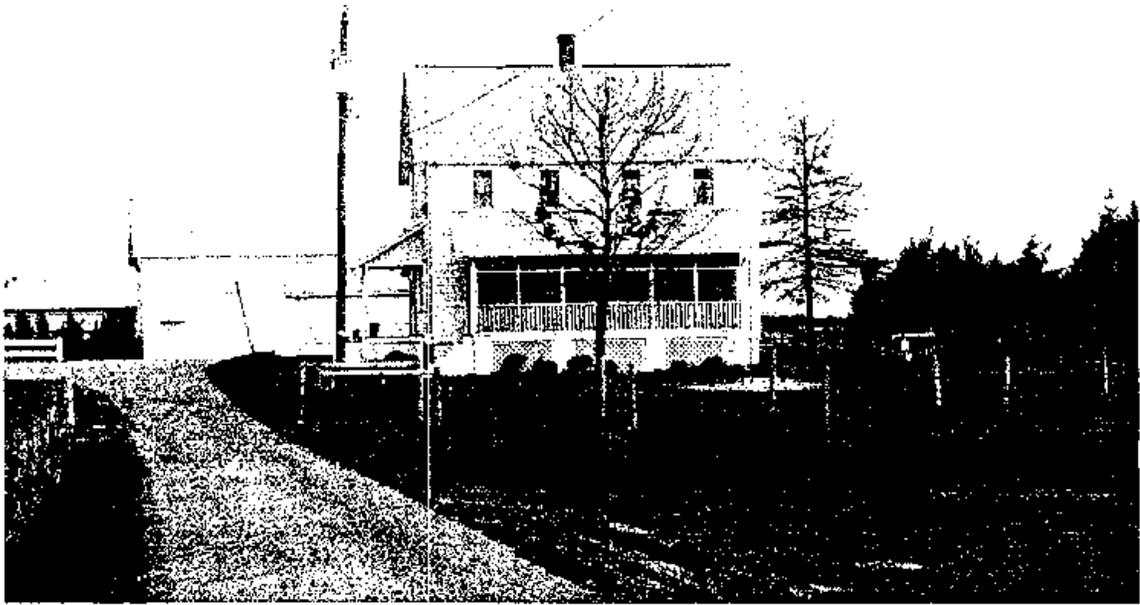
Photo 5. Farmhouse, Hickory Hill (K-1292). Southwest façade toward northeast.

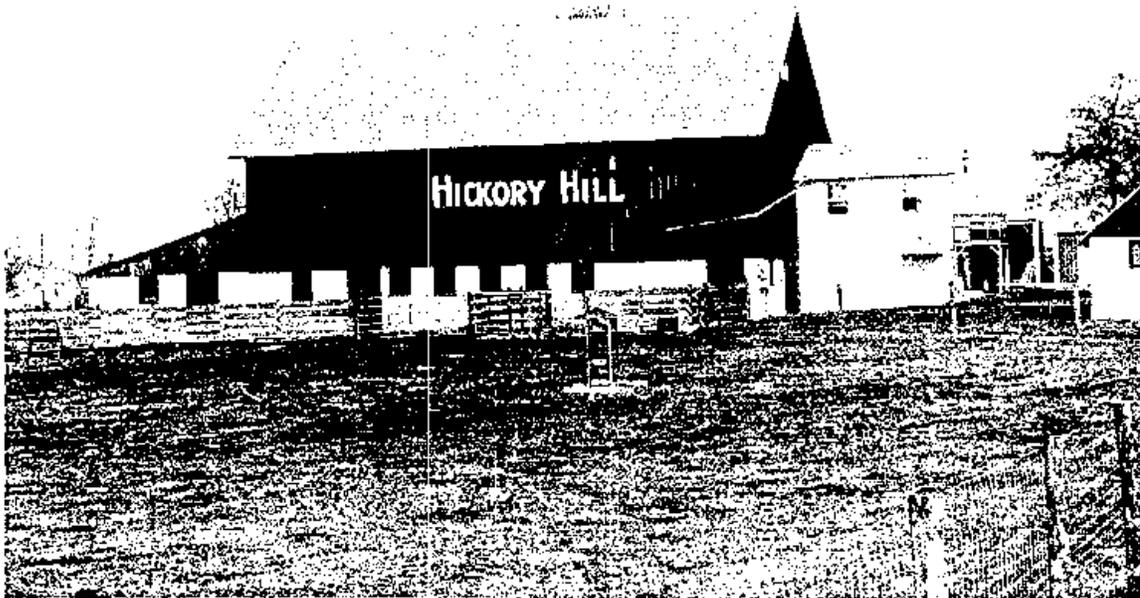
Photo 6. Barn, Hickory Hill (K-1292). Southwest and southeast elevations toward northeast.

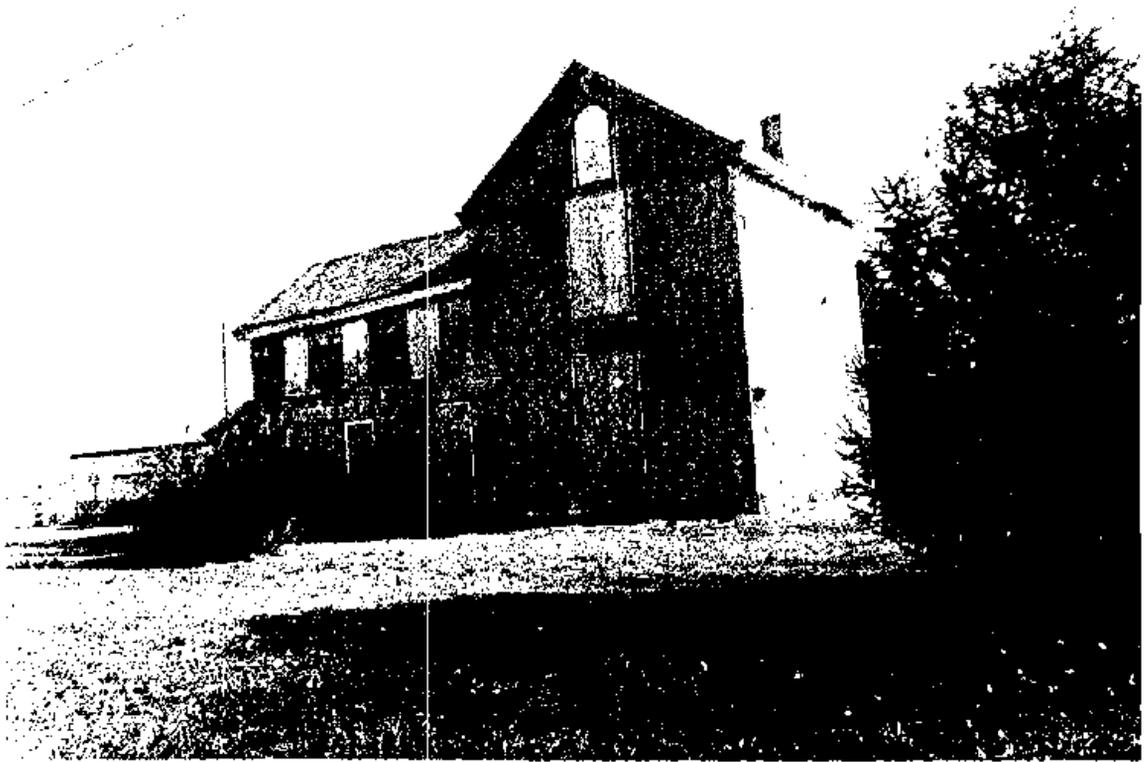
Photo 7. House, intersection of Seenytown Road and Route 42 (K-1293) Northwest and southwest elevations toward southeast.

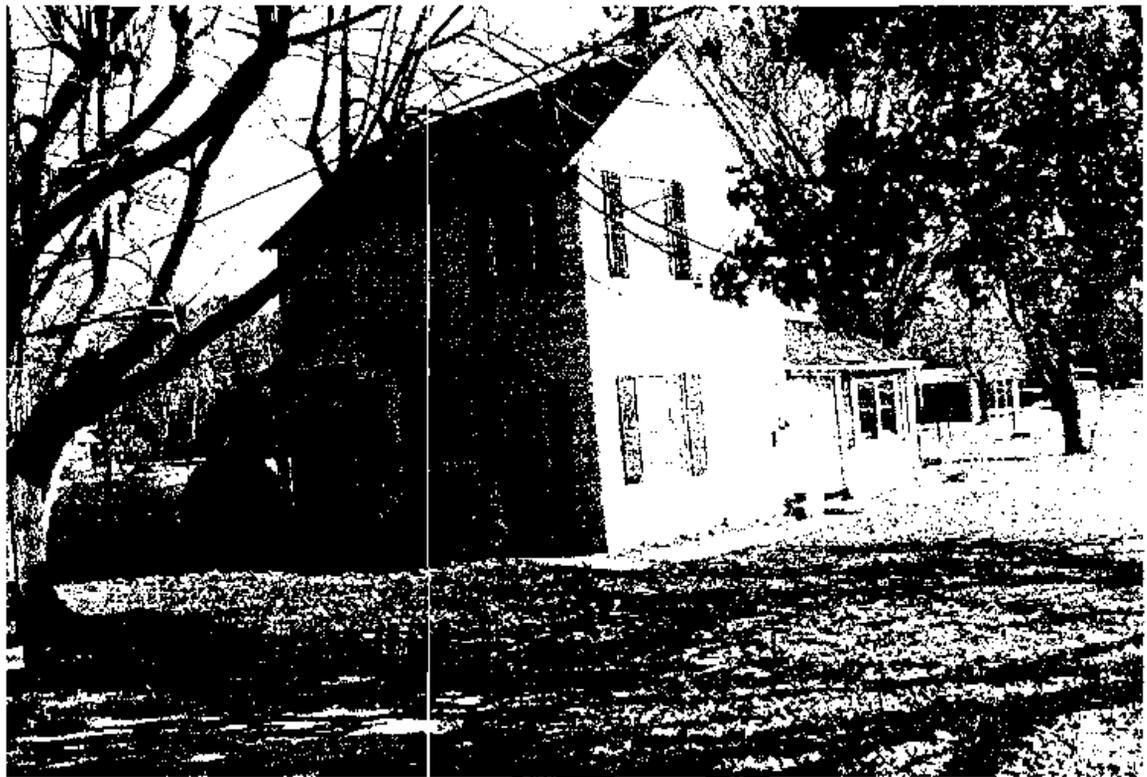
Photo 8. House, 7408 Pearsons Corner Road (K-1298). Northwest façade and southwest elevation toward southeast.

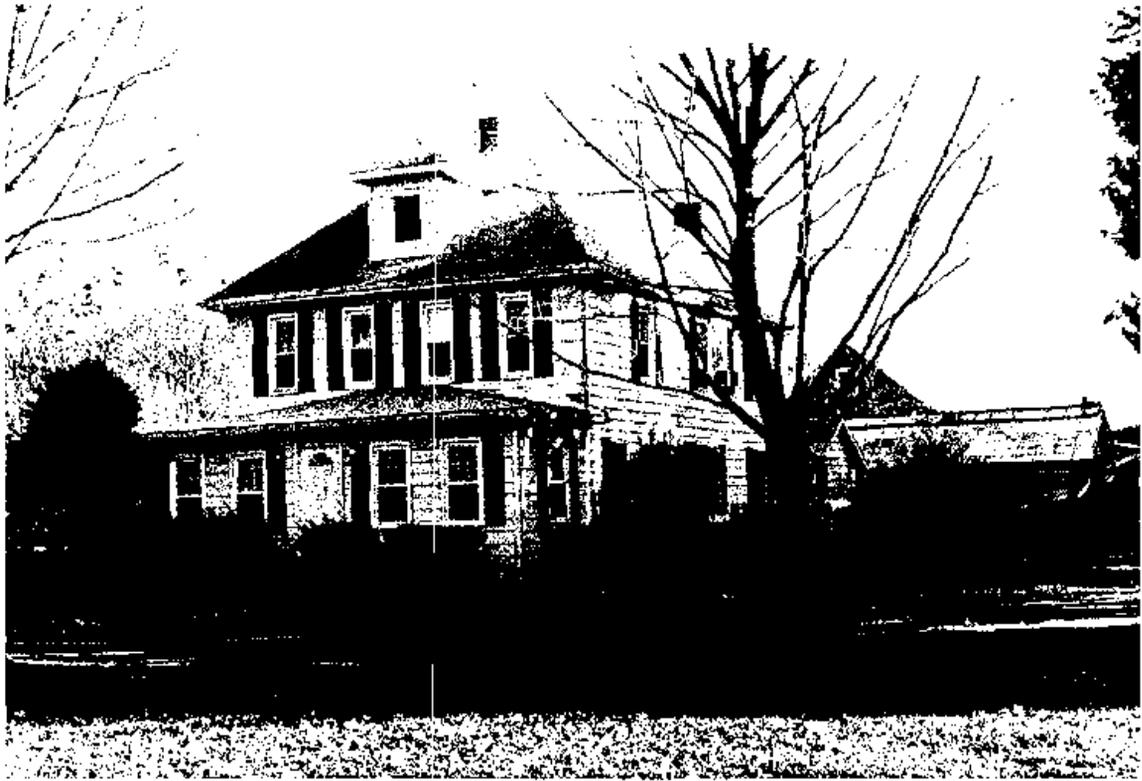
Photo 9. House, 1164 Brenford Road (K-1373). Northwest façade and southwest elevation toward northeast.

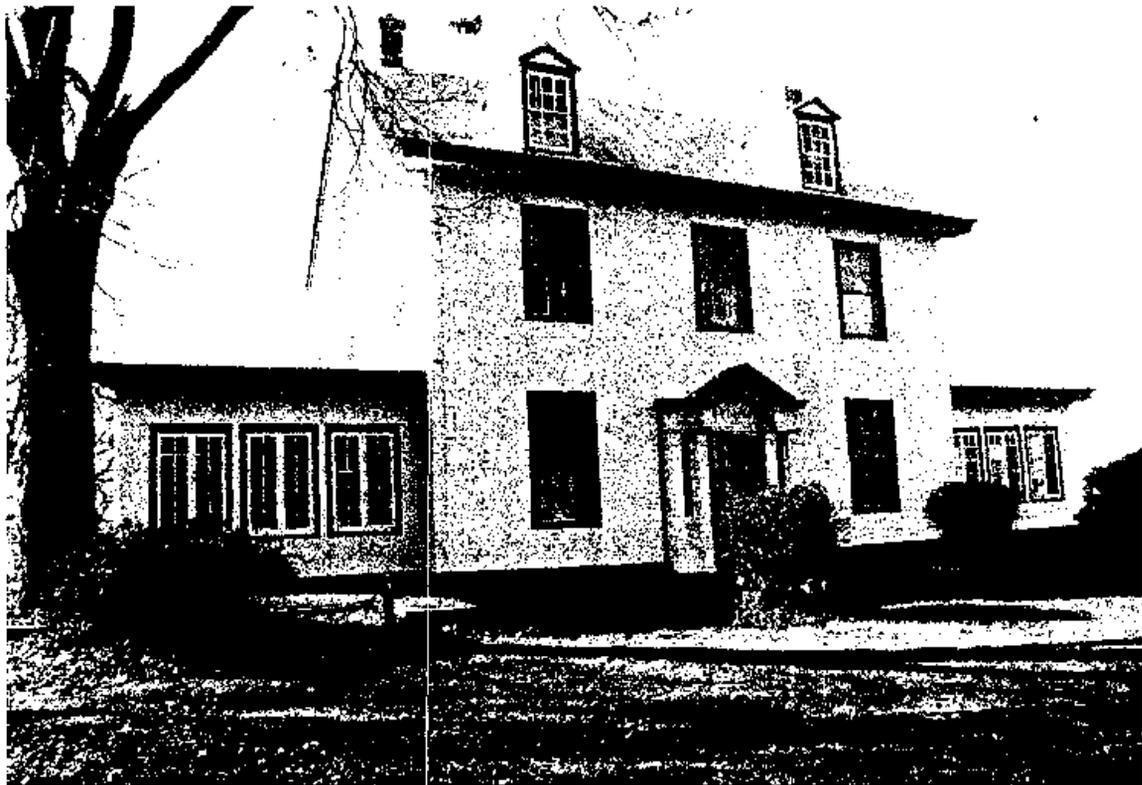
Photo 10. House located on farm at southwest corner of Lynnbury Woods Road and Salisbury Road (K-1375). Northeast façade and southeast elevation toward west.

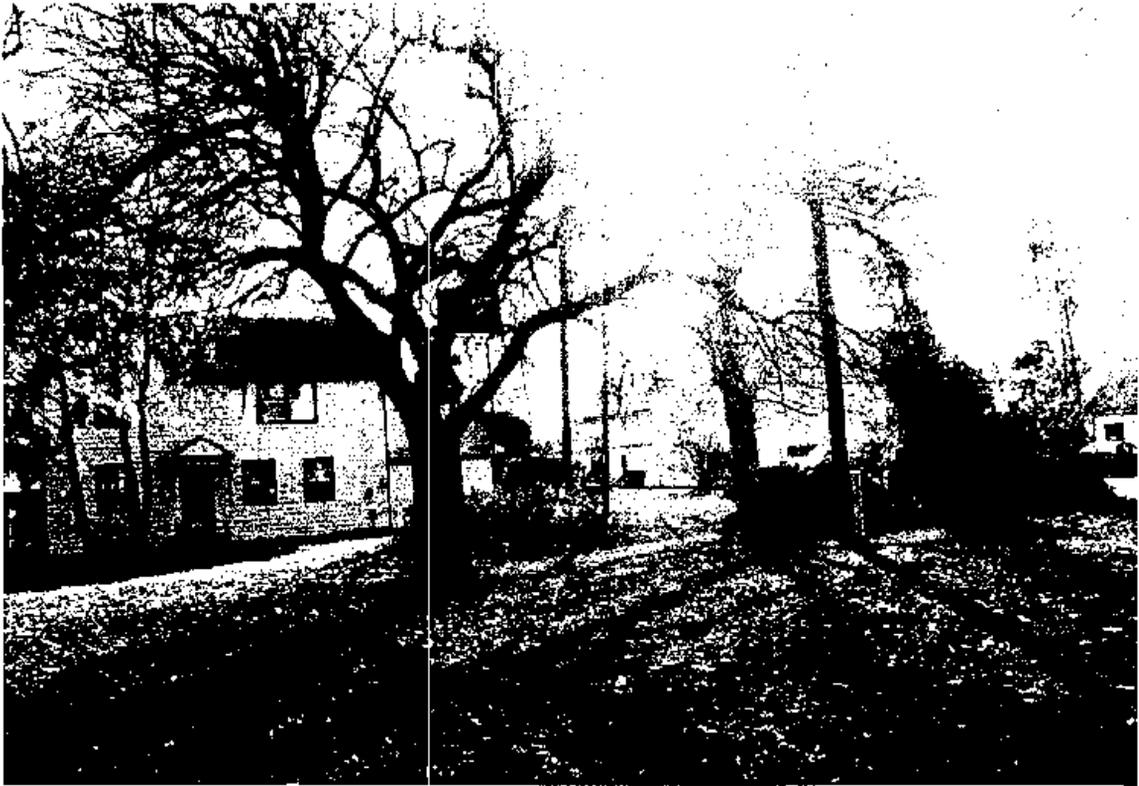
Photo 11. Secondary house and outbuildings, farm, corner of Lynnbury Woods Road and Salisbury Road (K-1375). General view toward south.

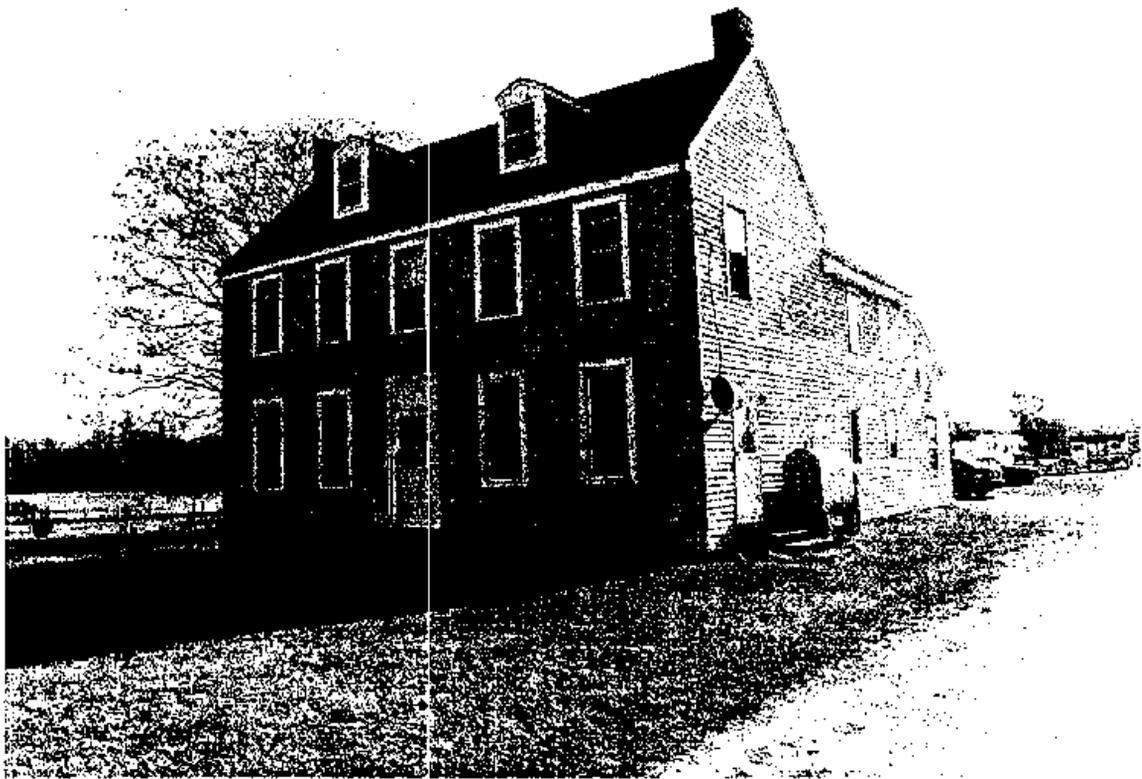
Photo 12. House, east side, Johnson Farm Lane (K-1376). Northwest façade and northeast elevation toward southeast.

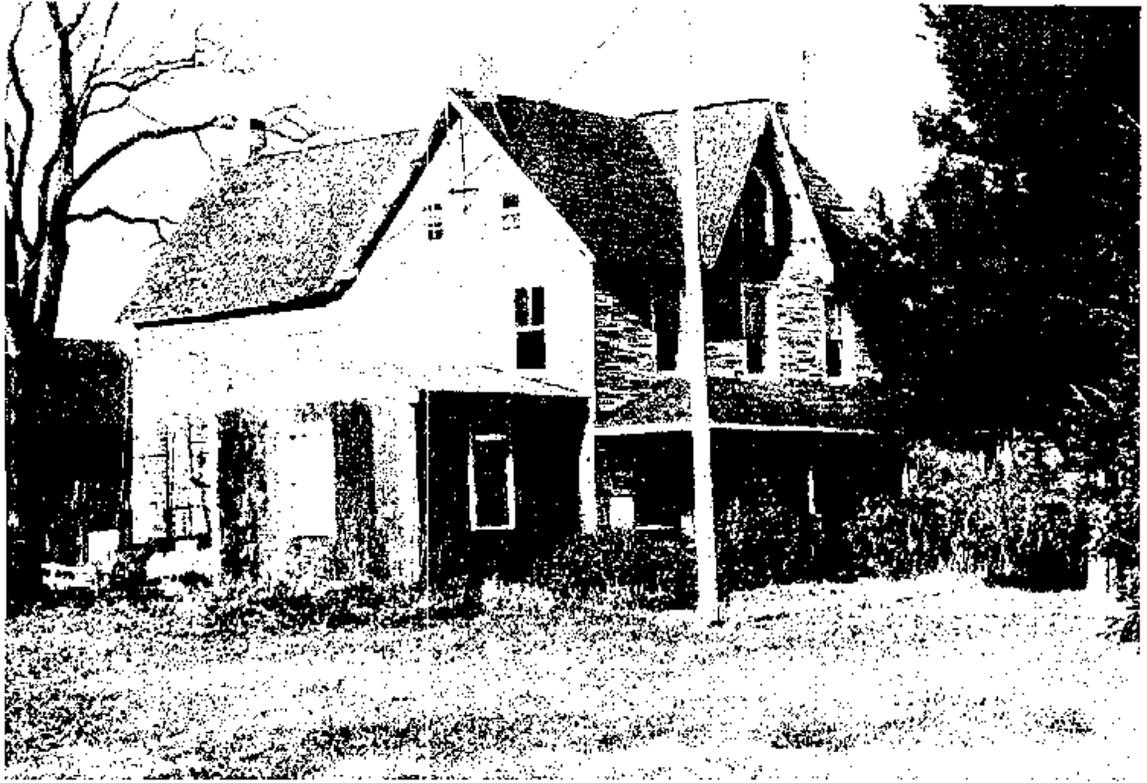
Photo 13. House, northwest side, Erenford Road (K-1385). Southeast façade and southwest elevation toward north.

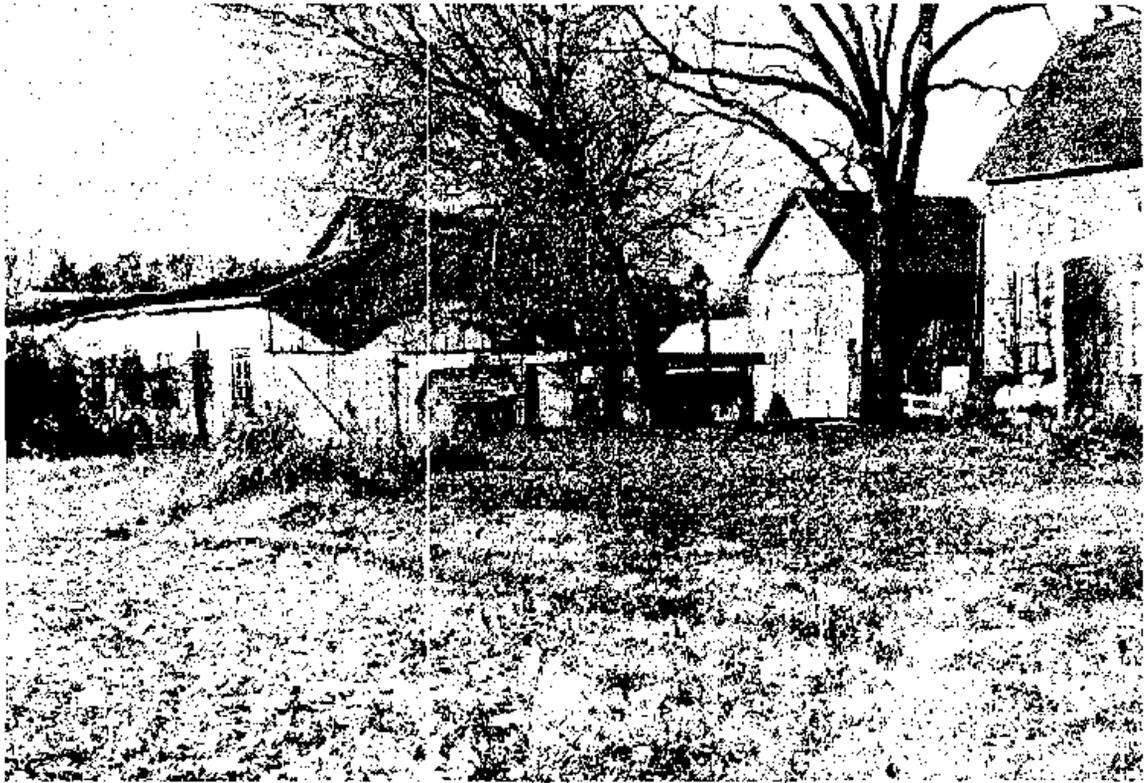
Photo 14. Outbuildings behind Brenford Road house (K-1385). General view toward northwest.

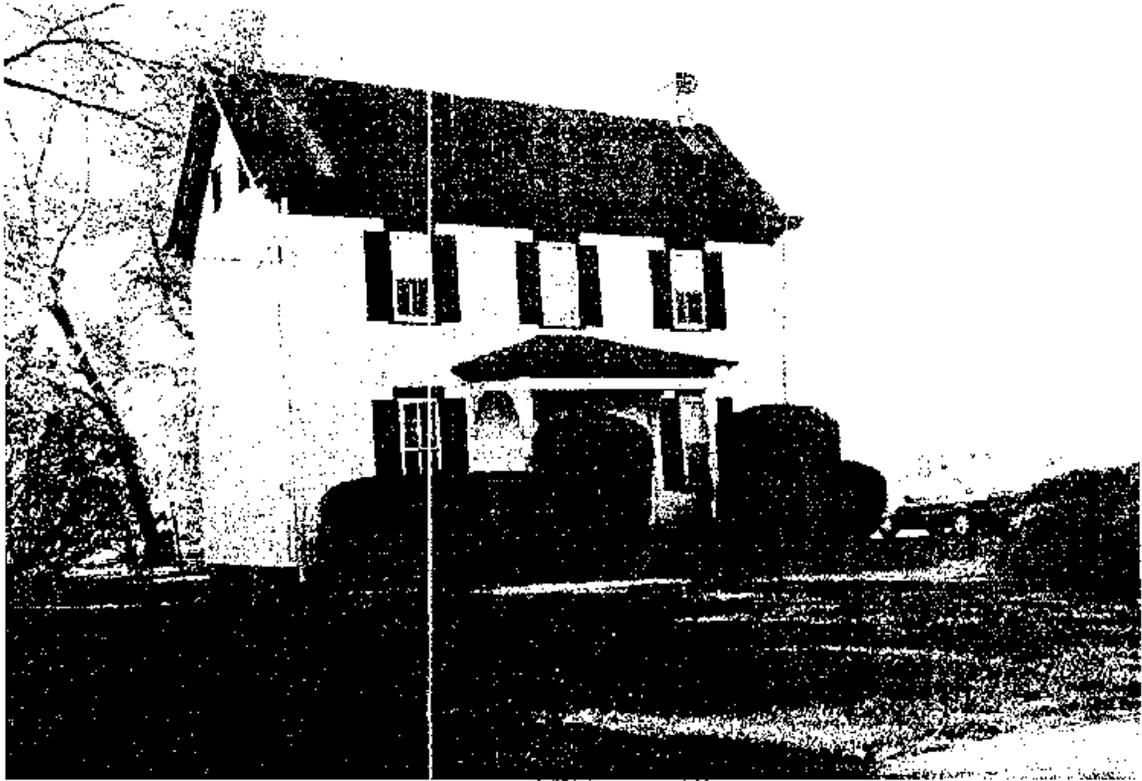
Photo 15. House, south side, Moor on Road (K-1386). North façade and east elevation toward south.

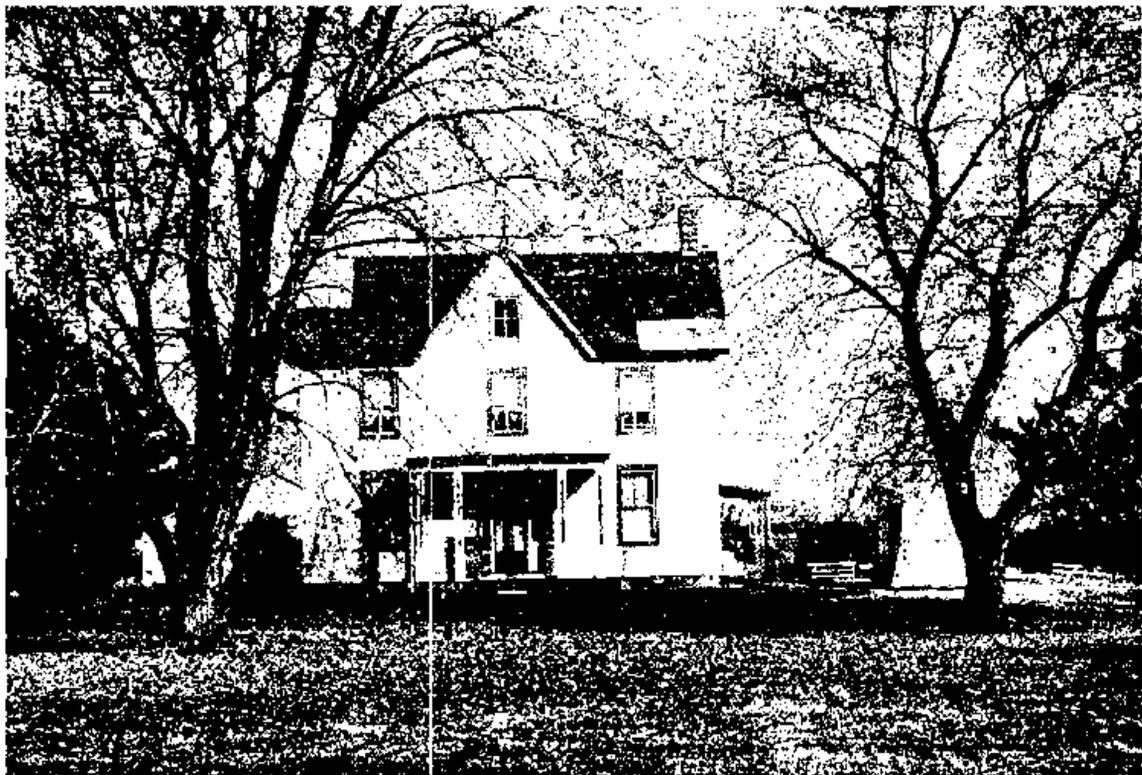
Photo 16. House, 765 Moorton Road (K-1394). South façade toward north.

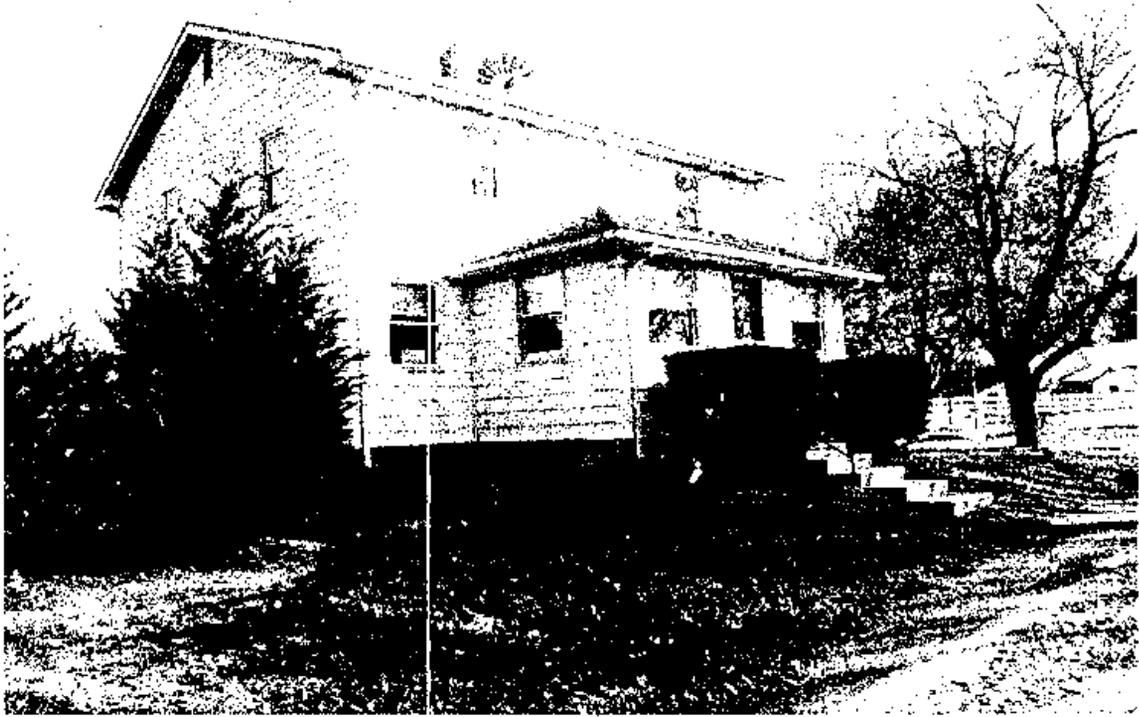
Photo 17. House, south side, Lynnbury Woods Road (K-1400). West and north elevations toward southeast.

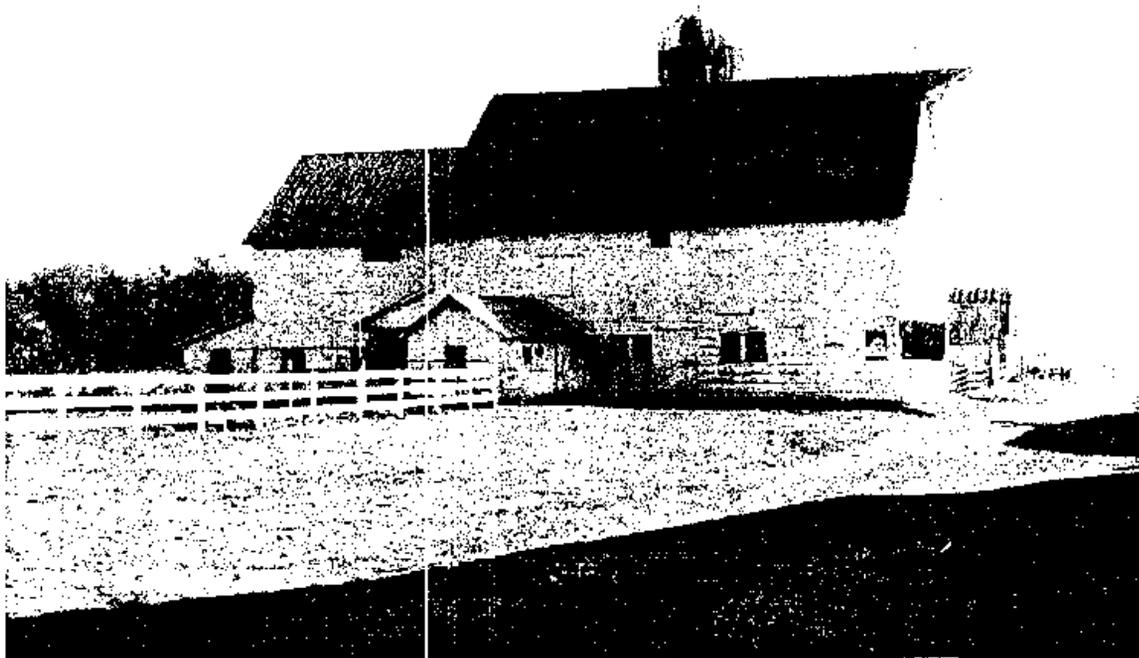
Photo 18. Barn, south side, Lynnbury Woods Road (K-1400). North and west elevations toward southeast.

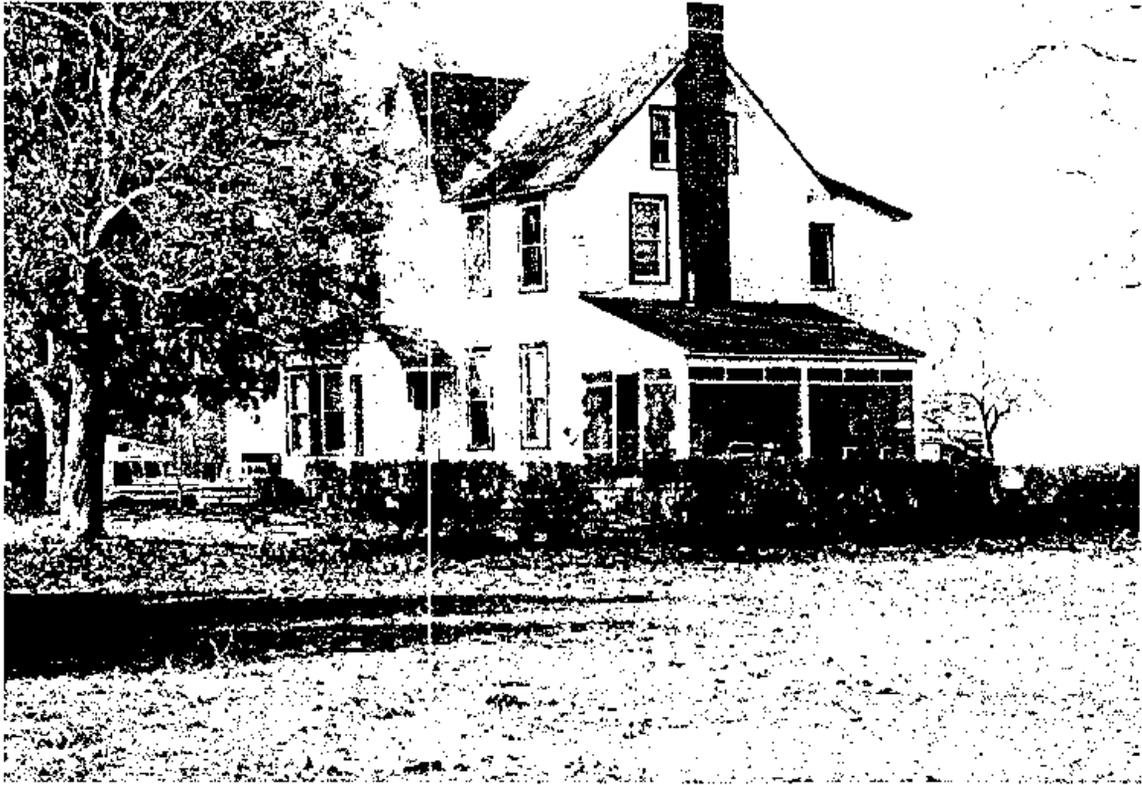
Photo 19. House, 691 Route 42 (K-1609). Southeast façade toward northwest.

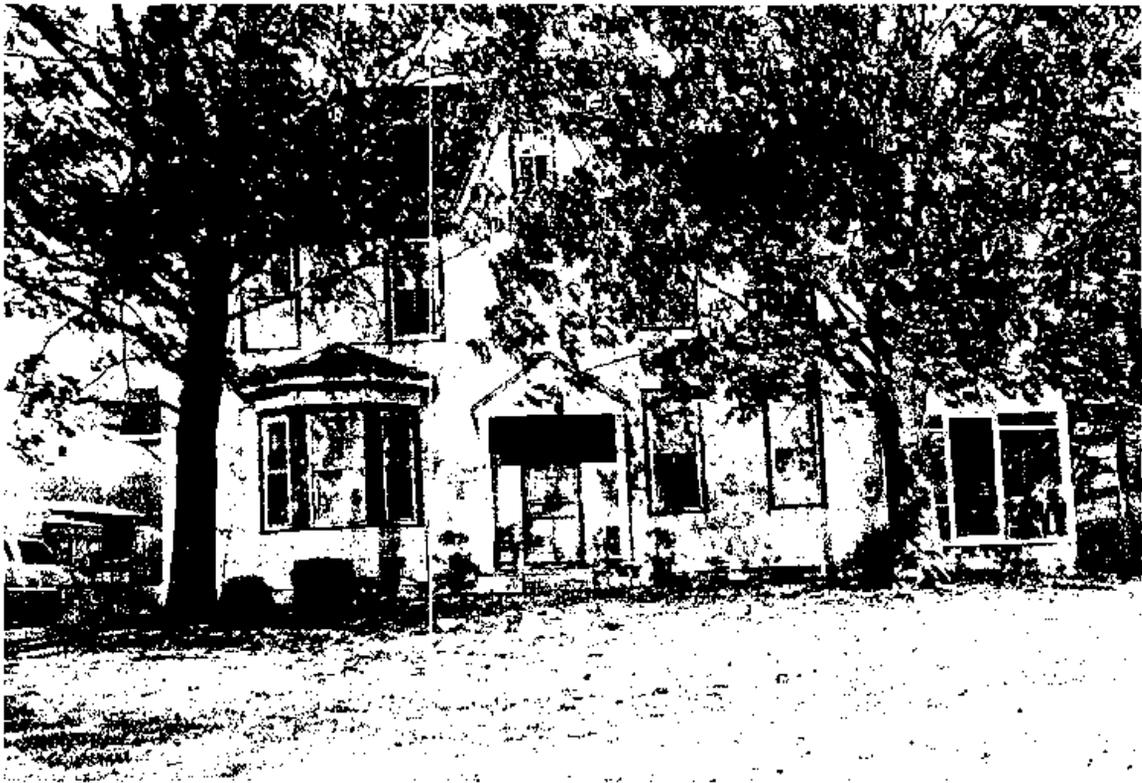
Photo 20. House, 691 Route 42 (K-1609). Southeast façade and northeast elevation toward northwest.

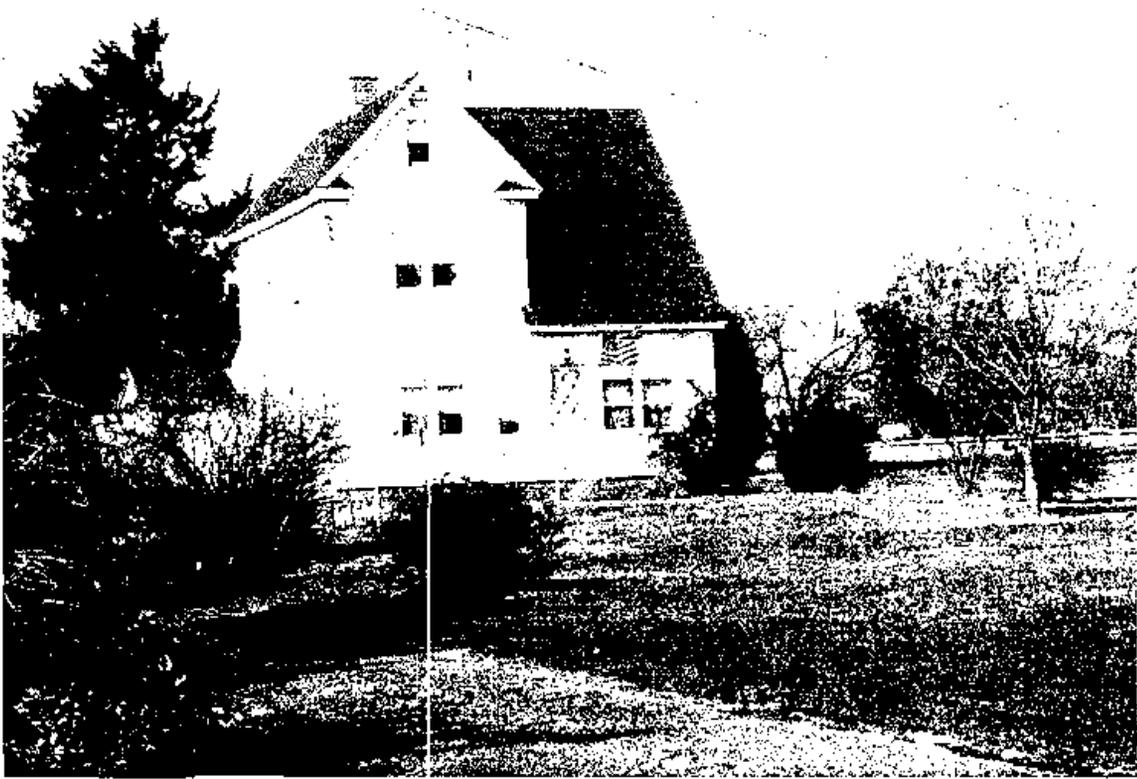
Photo 21. House, 7065-7073 Pearsons Corner Road (K-1624). Southeast elevation toward northwest.

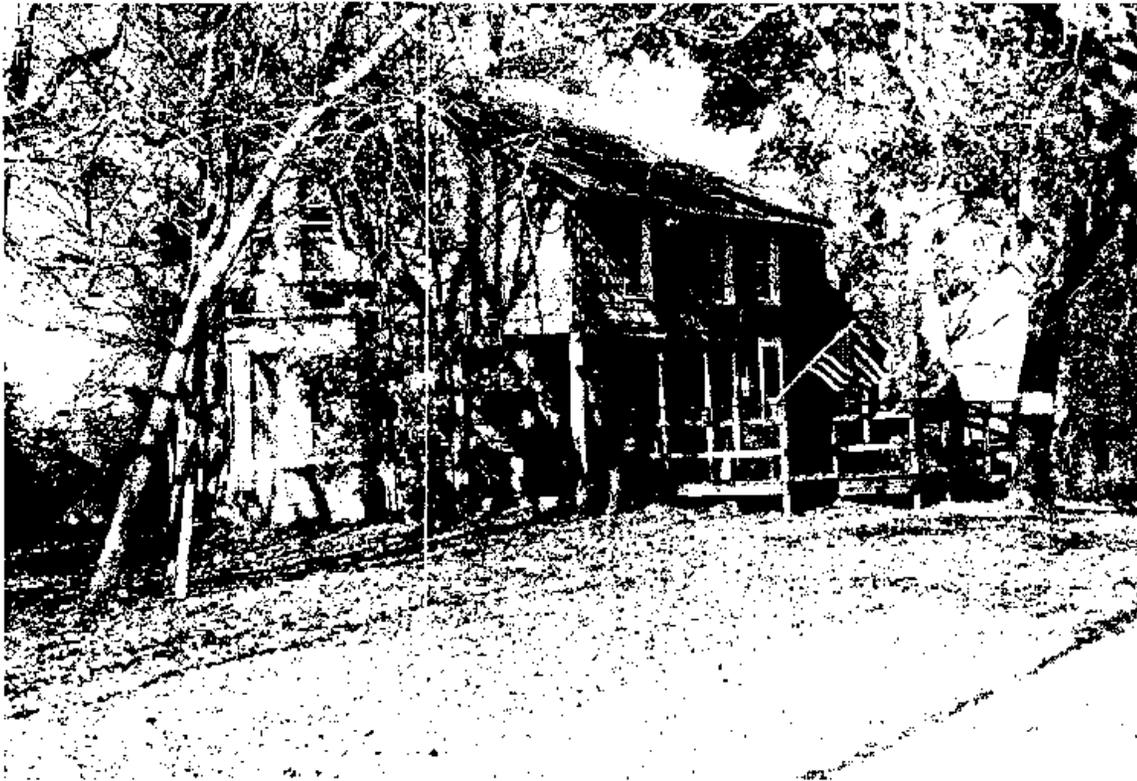
Photo 22. House, 315 Goldinger Road (K-1627). Northeast façade and southeast elevation toward northwest.

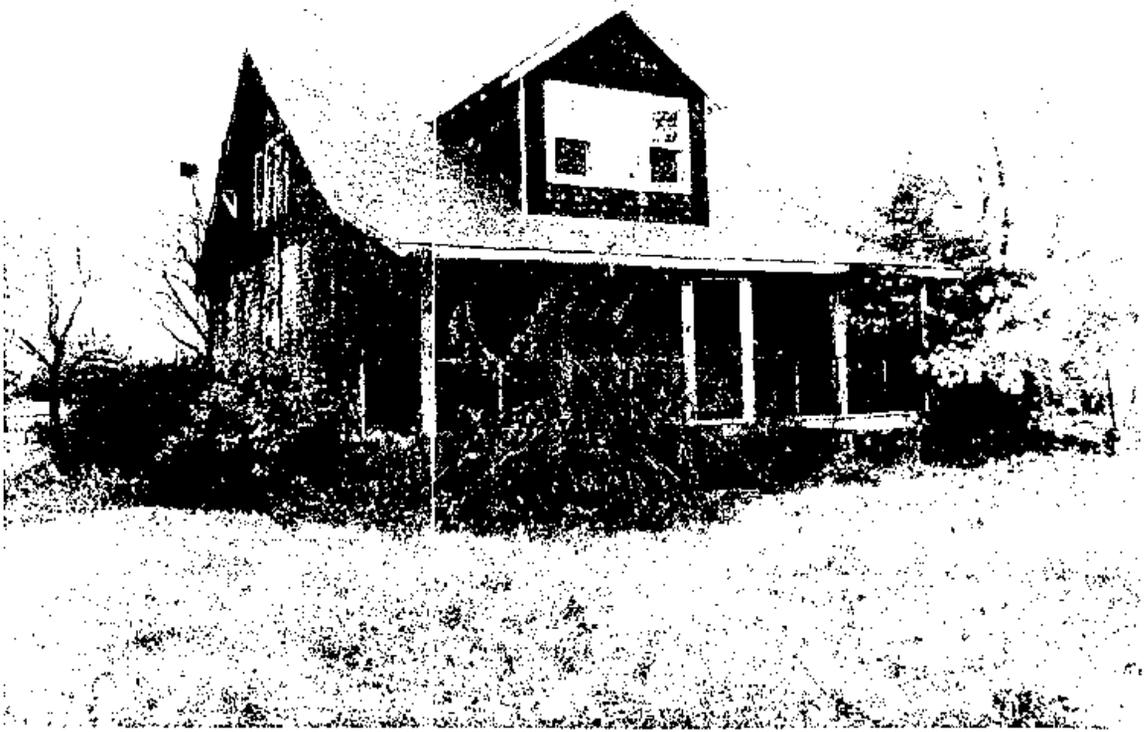
Photo 23. House, 5474 DuPont Highway (K-1771). Southwest façade and northwest elevation toward east.

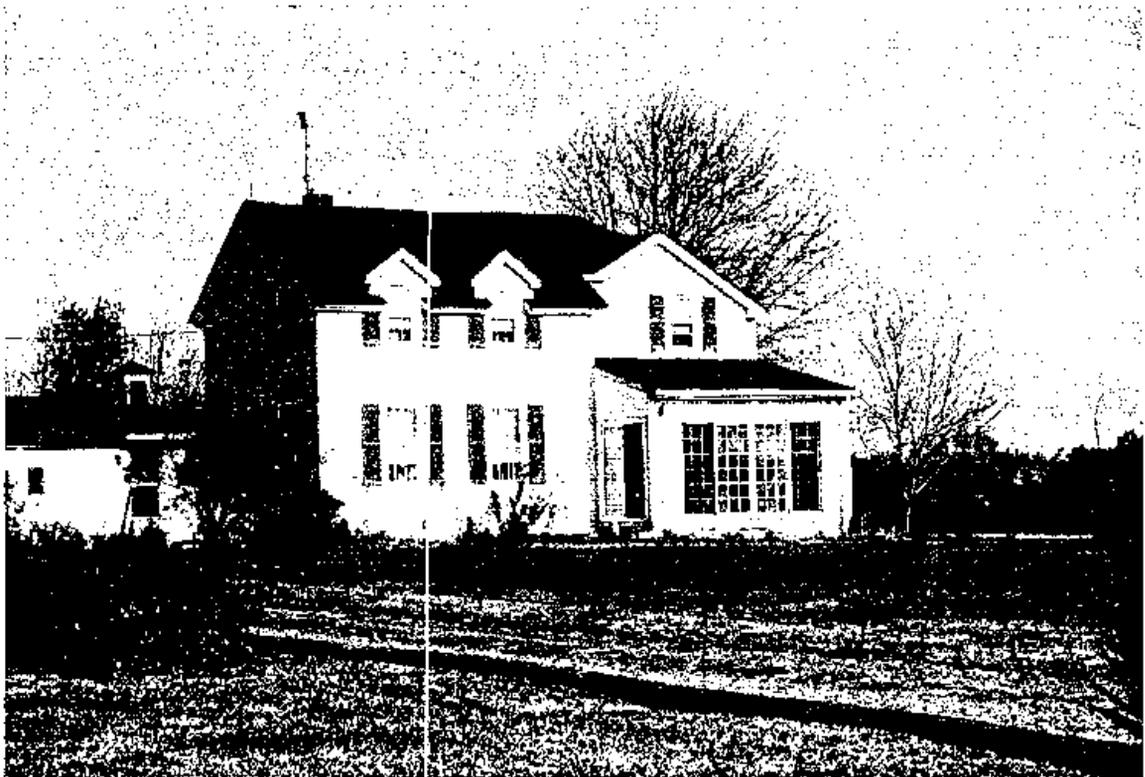
Photo 24. House, north side, Goldinger Road (K-1772). Southeast façade and southwest elevation toward north.

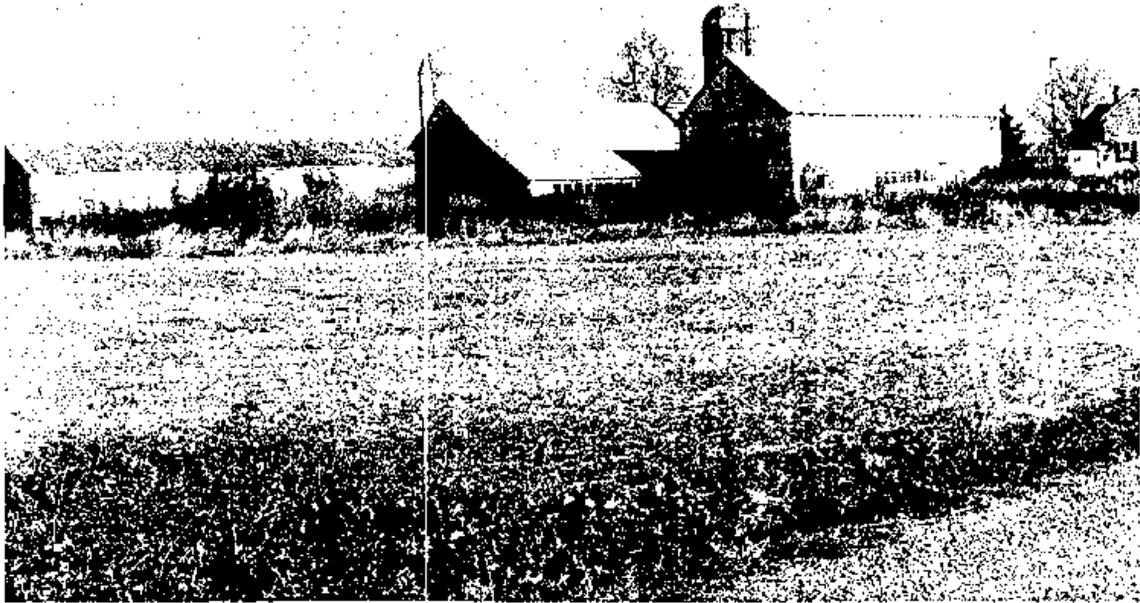
Photo 25. Barns, northwest side, Goldinger Road (K-1772). General view toward northeast.

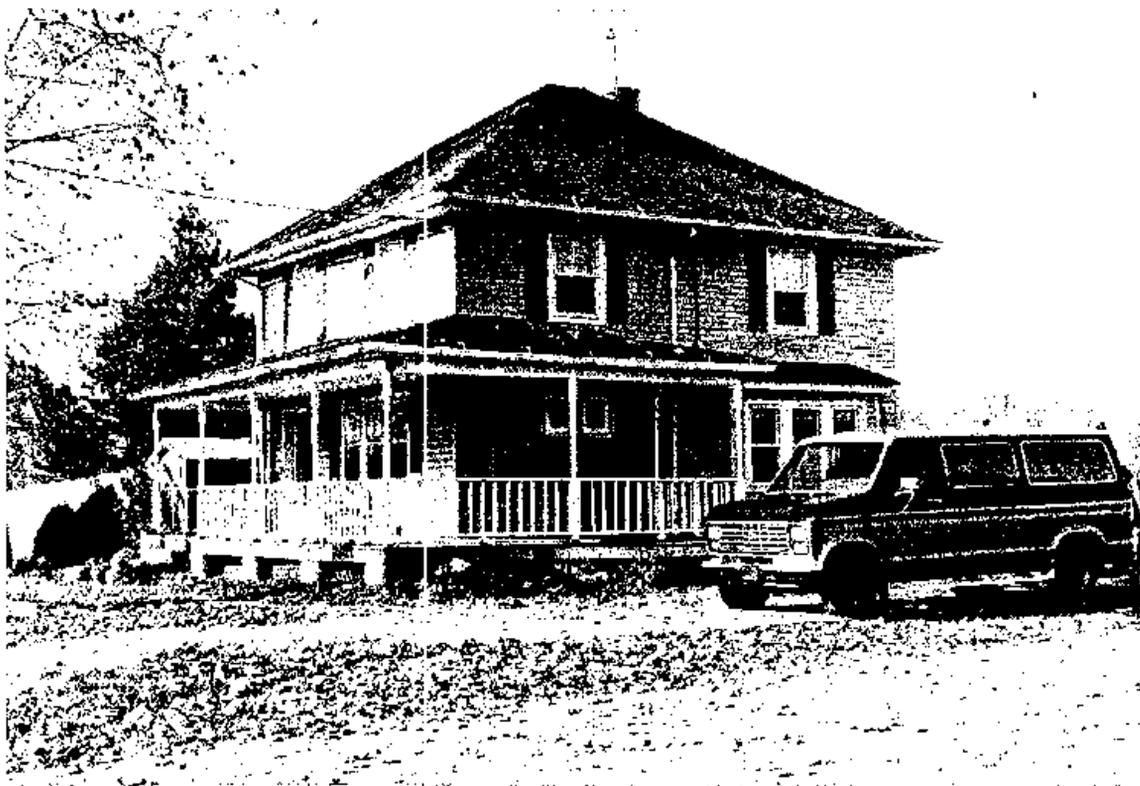
Photo 26. House, 531 Route 42 (K-3147). Southeast façade and northeast elevation toward northwest.
