Table 1. Previously Surveyed Pre-1952 Architect

Table 1 Photographic Captions

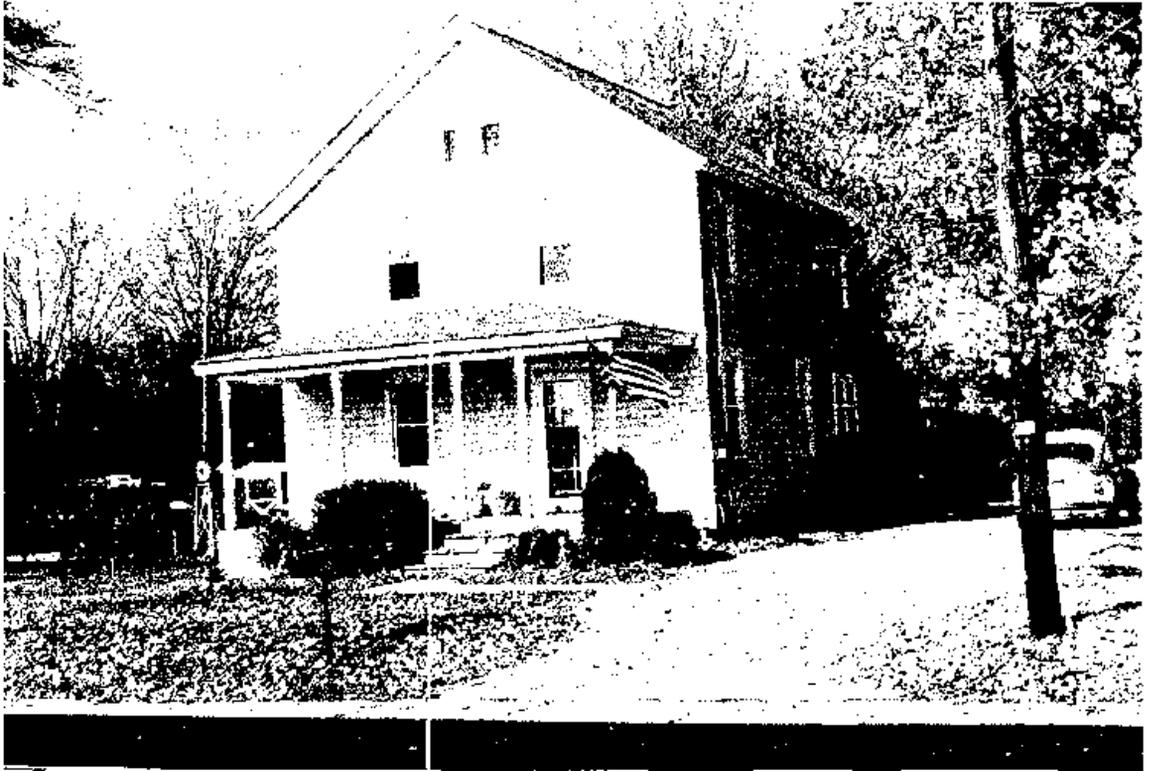
Photo 27. House, 497 Route 42 (K-3148). Southeast façade and northeast elevation toward northwest.

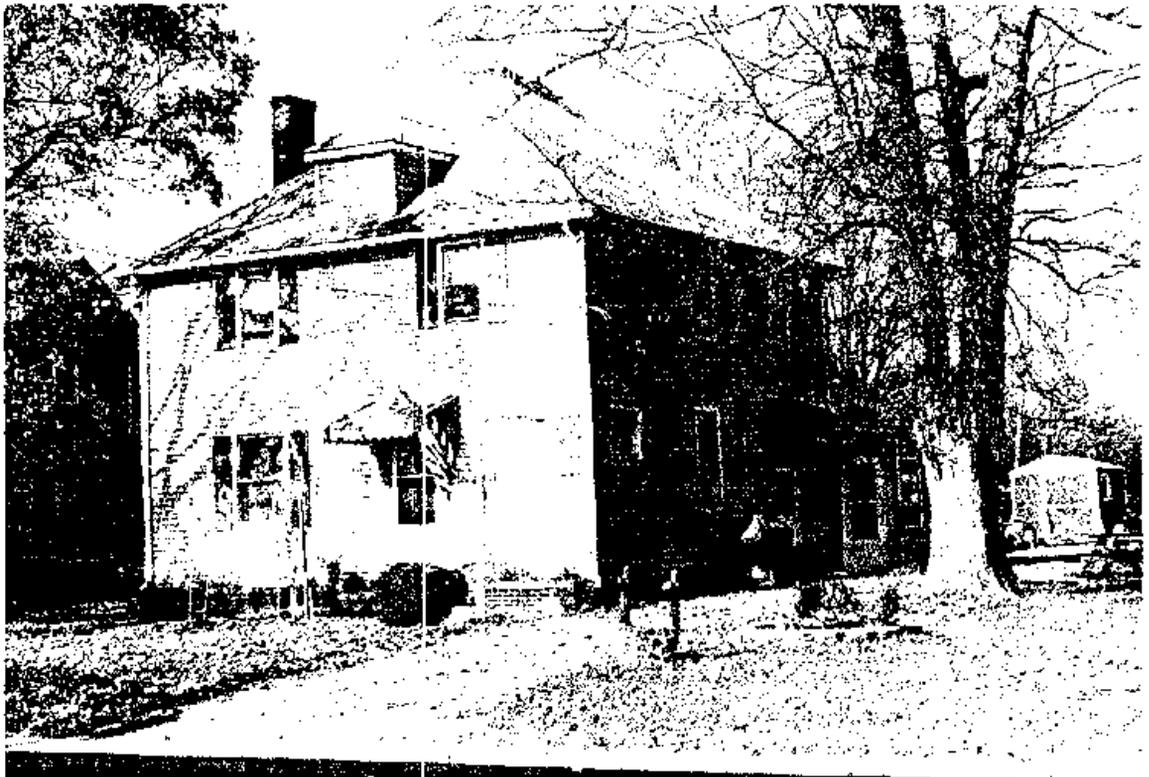
Photo 28. House, 477 Route 42 (K-3149). Southeast façade and northeast elevation toward northwest.

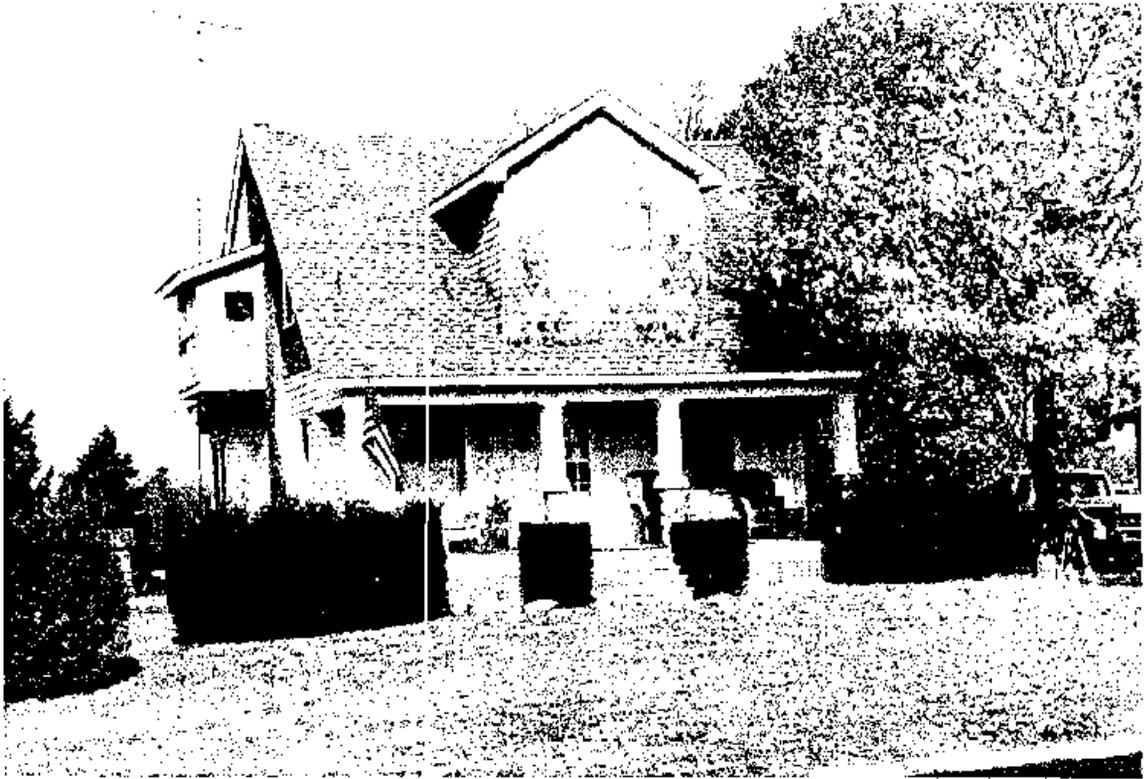
Photo 29. House, 467 Route 42 (K-3150). Southeast façade toward northwest.

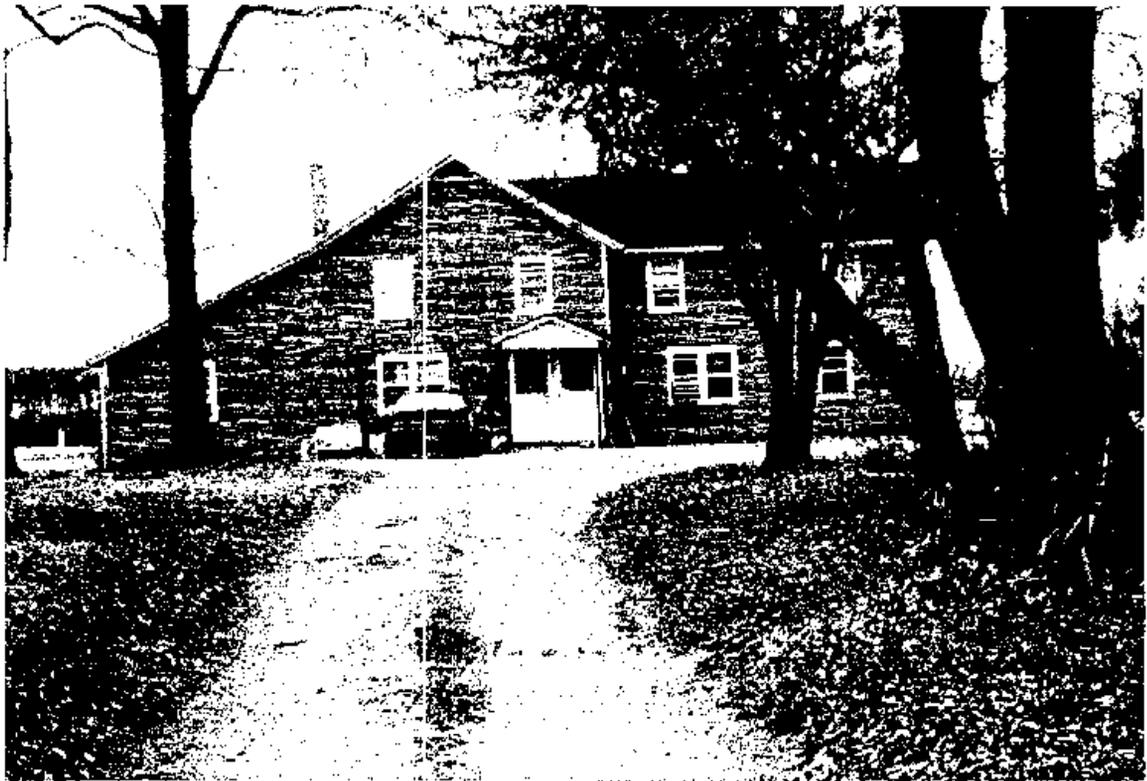
Photo 30. House, 5203 DuPont Highway (K-3151). Northeast façade toward southwest.

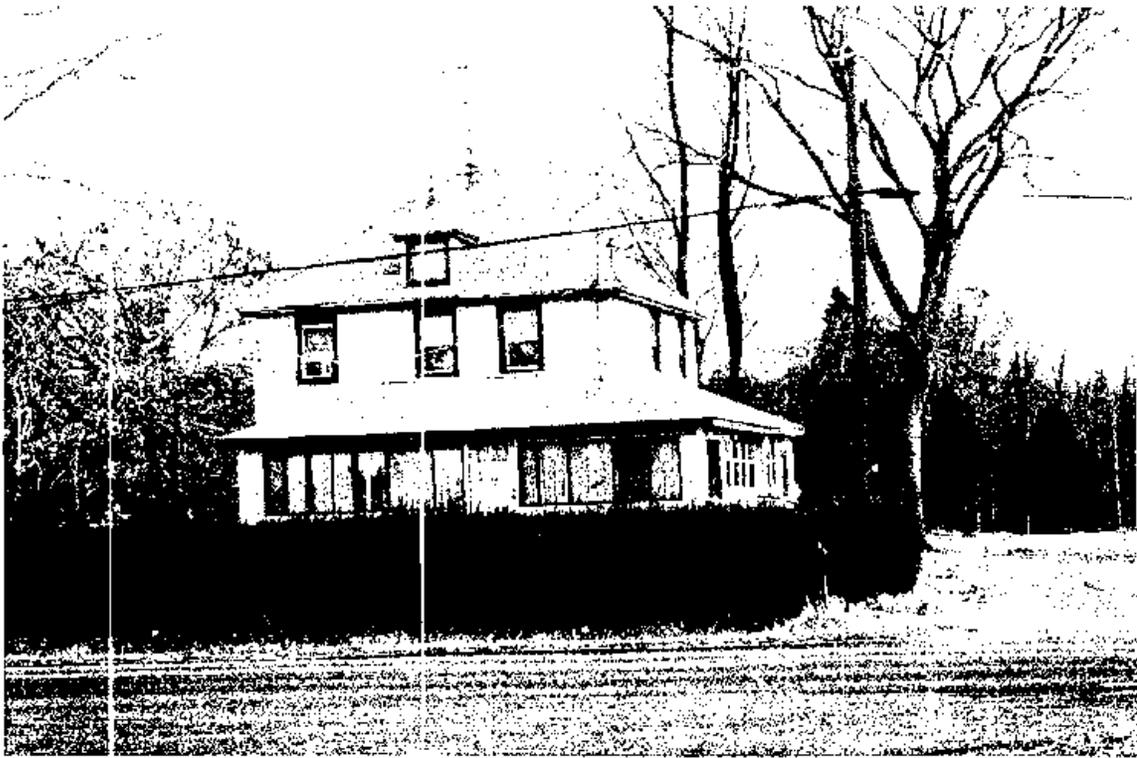
Photo 31. House, northeast side of DuPont Highway (K-3152). Southwest façade and southeast elevation toward northeast.

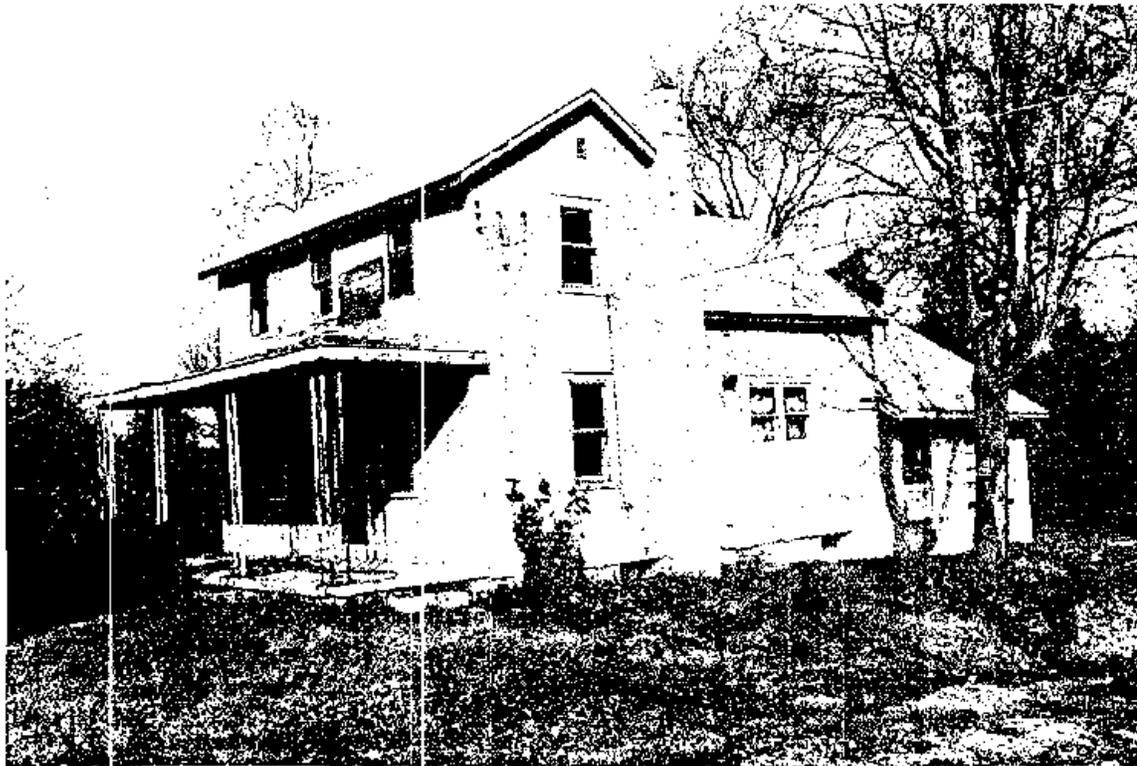
Photo 32. House, 4762 DuPont Highway (K-3153). Southwest façade and southeast elevation toward northeast.

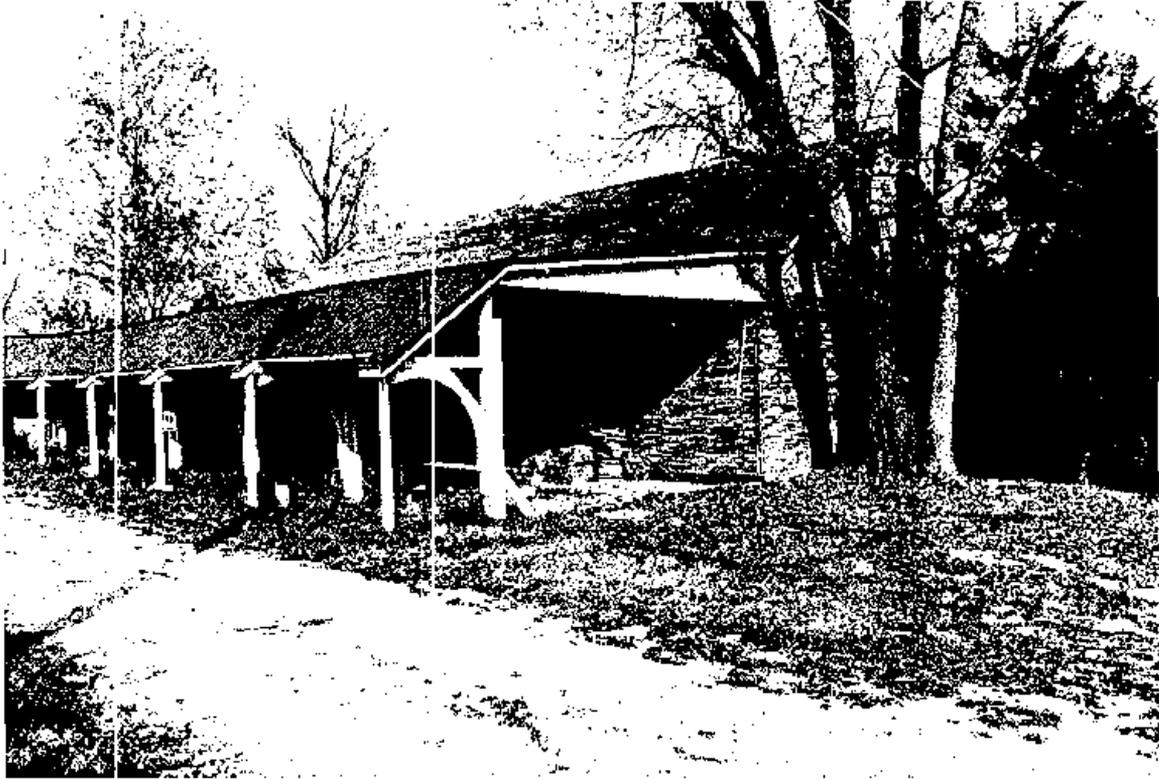
Photo 33 Produce stand, 4762 Du Pont Highway (K-3153). Southwest and southeast elevations toward northeast.

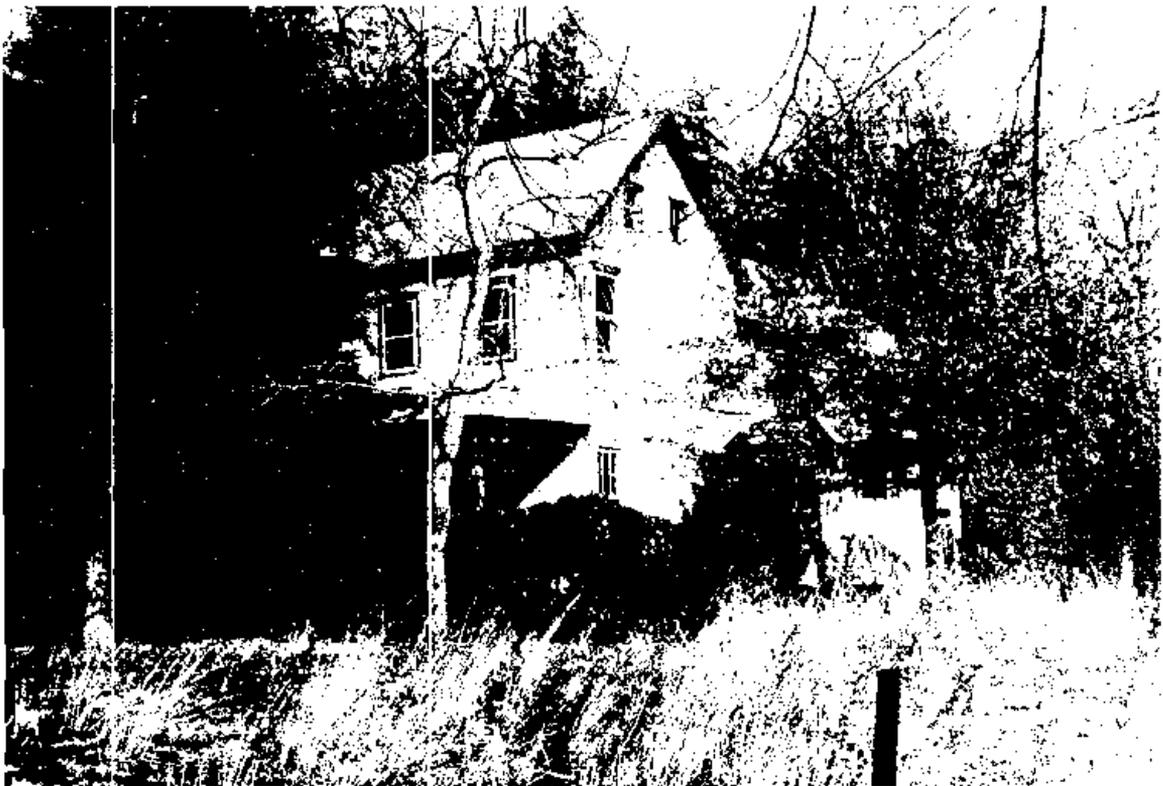
Photo 34 House, 4876 DuPont Highway (K-3154). Southwest façade and southeast elevation toward northeast.

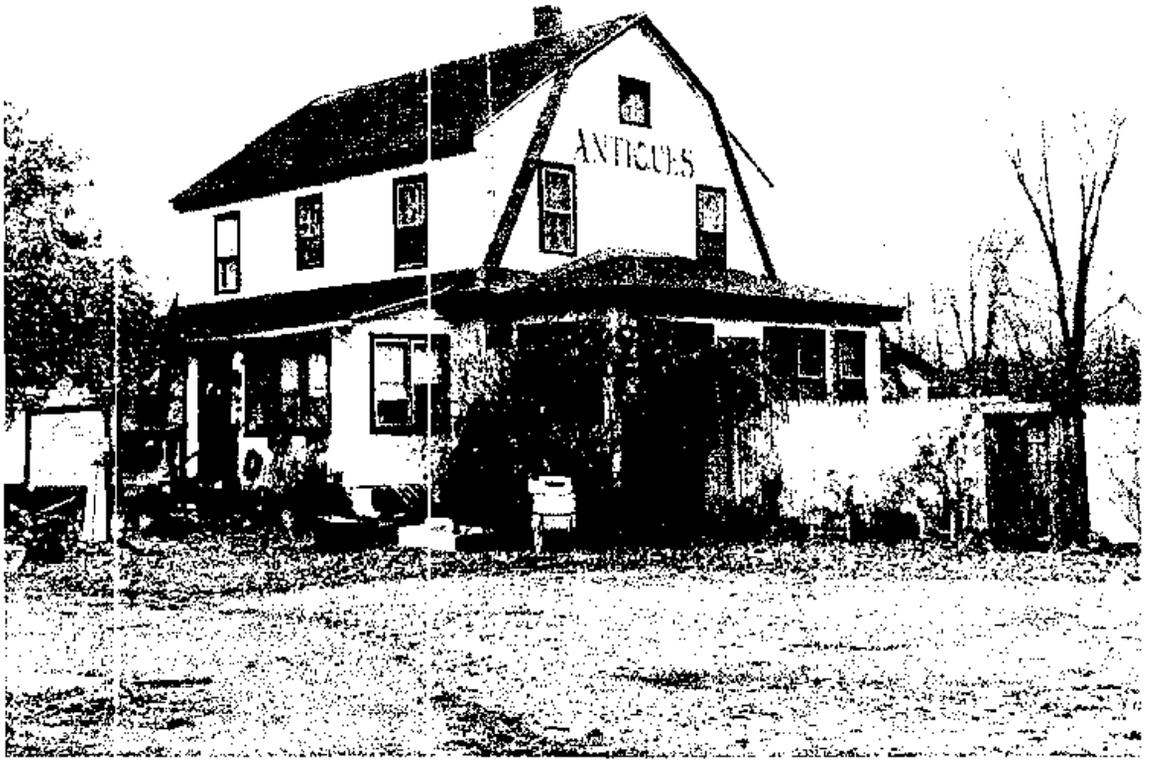
Photo 35 Sweet Memories Antiques, northeast side, DuPont Highway (K-3155). Southwest façade and southeast elevation toward northeast.

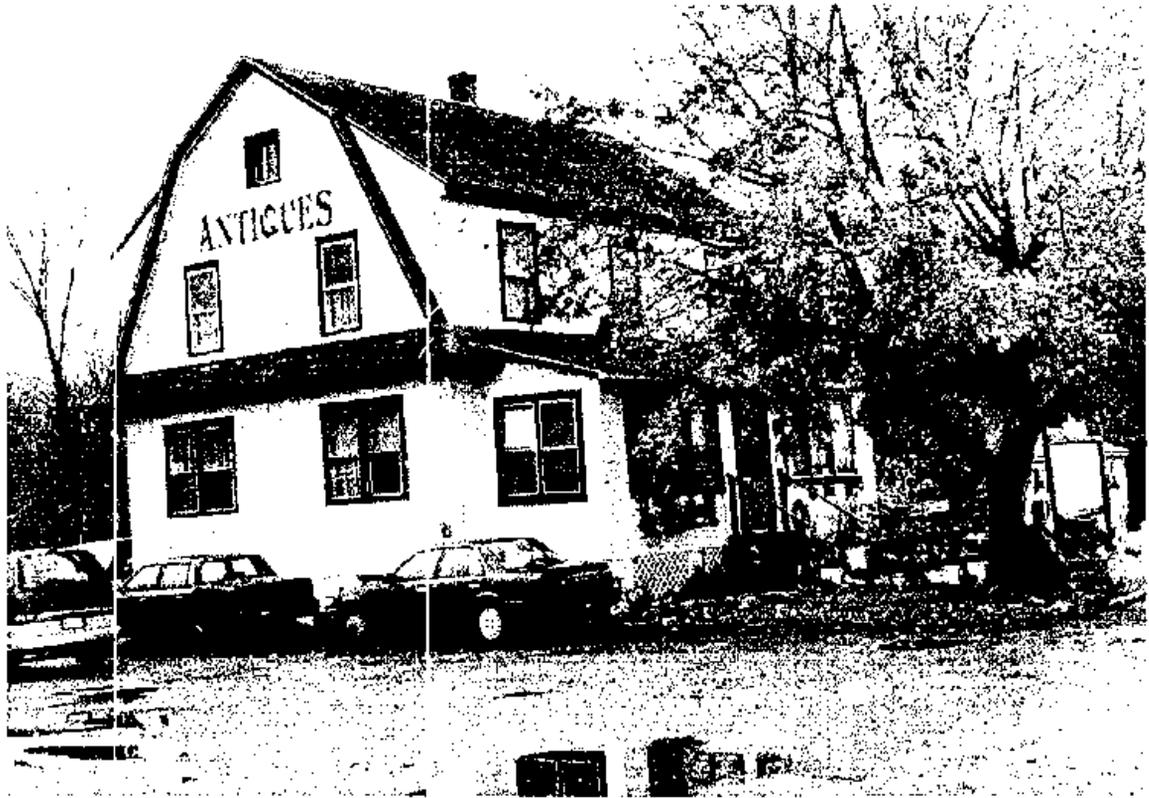
Photo 36. Sweet Memories Antiques, east side, DuPont Highway (K-3155). Southwest façade and northwest elevation toward southeast.

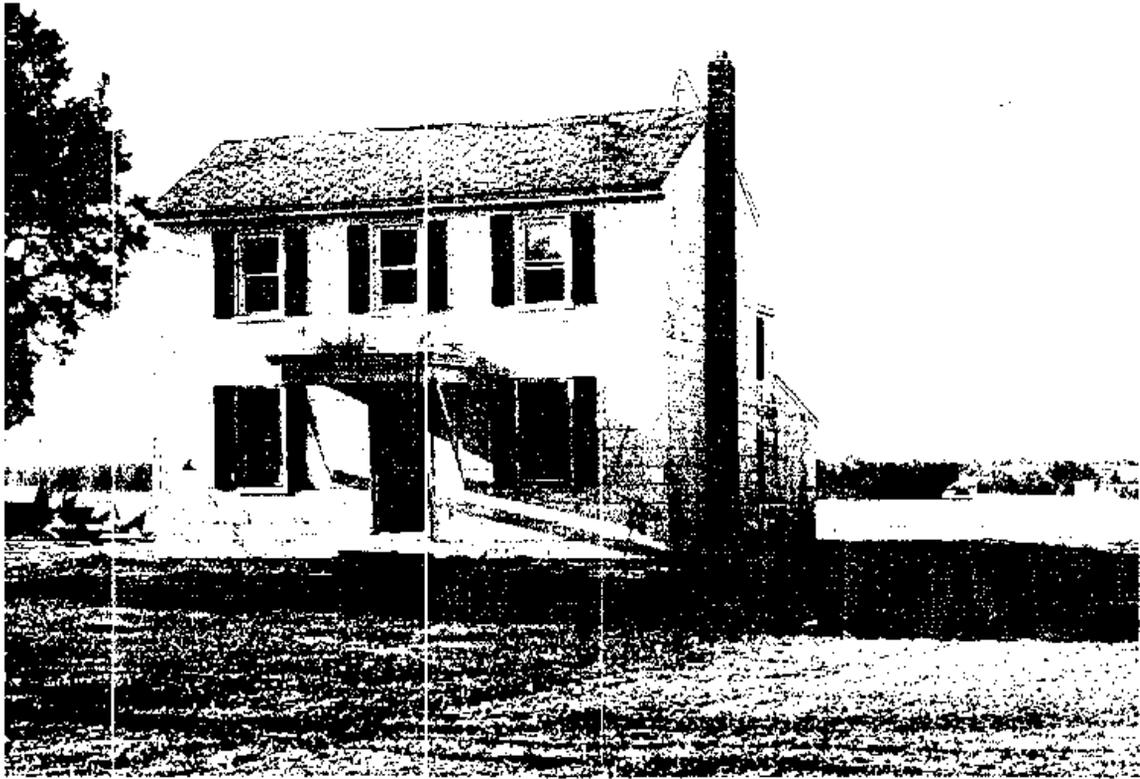
Photo 37 House, southwest side Messina Hill Road near Lynnbury Woods Road (K-3163).
Northeast façade and northwest elevation toward southwest.

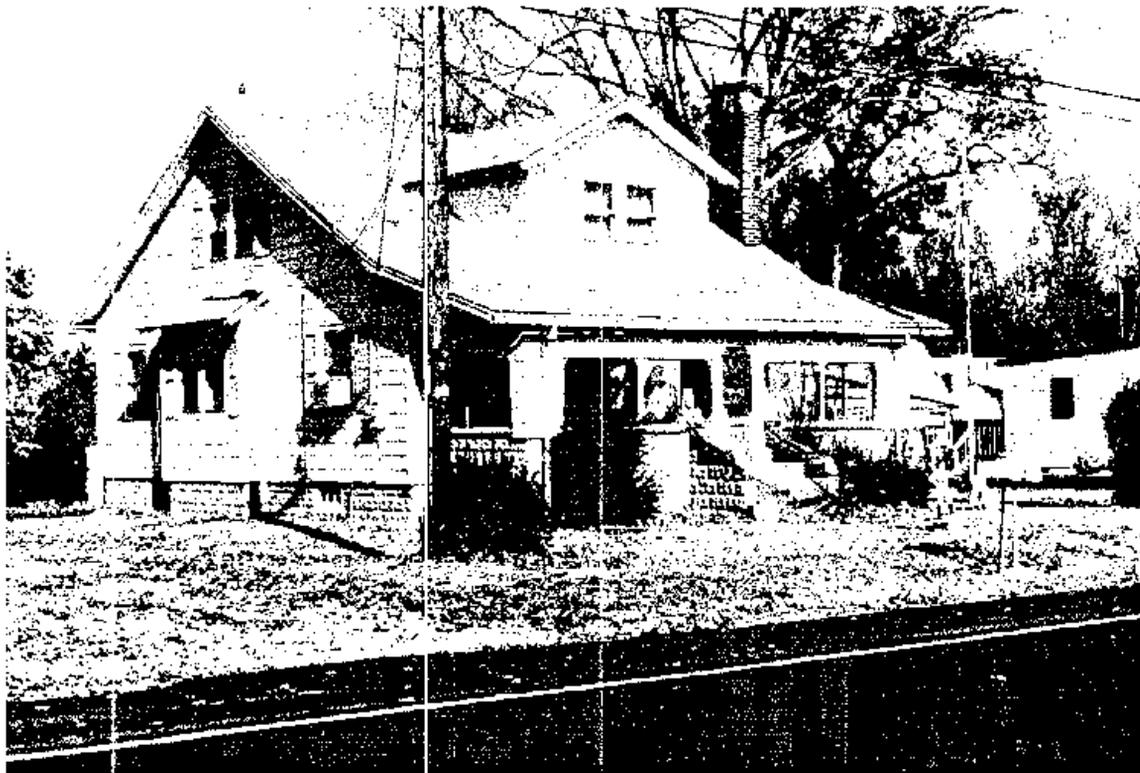
Photo 38. House, 3915 Route 42 (K-3169). Southeast façade and southwest elevation toward north.

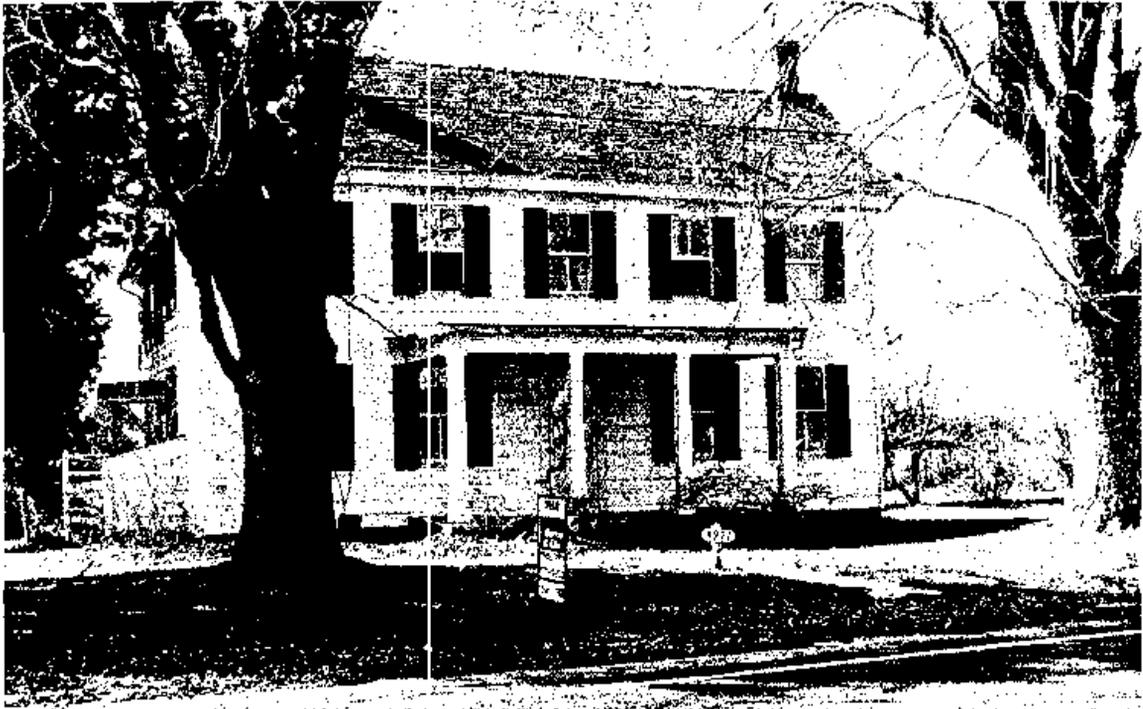
Photo 39. House, 4977 Kenton Road (K-3172). Northeast façade and southeast elevation toward west.

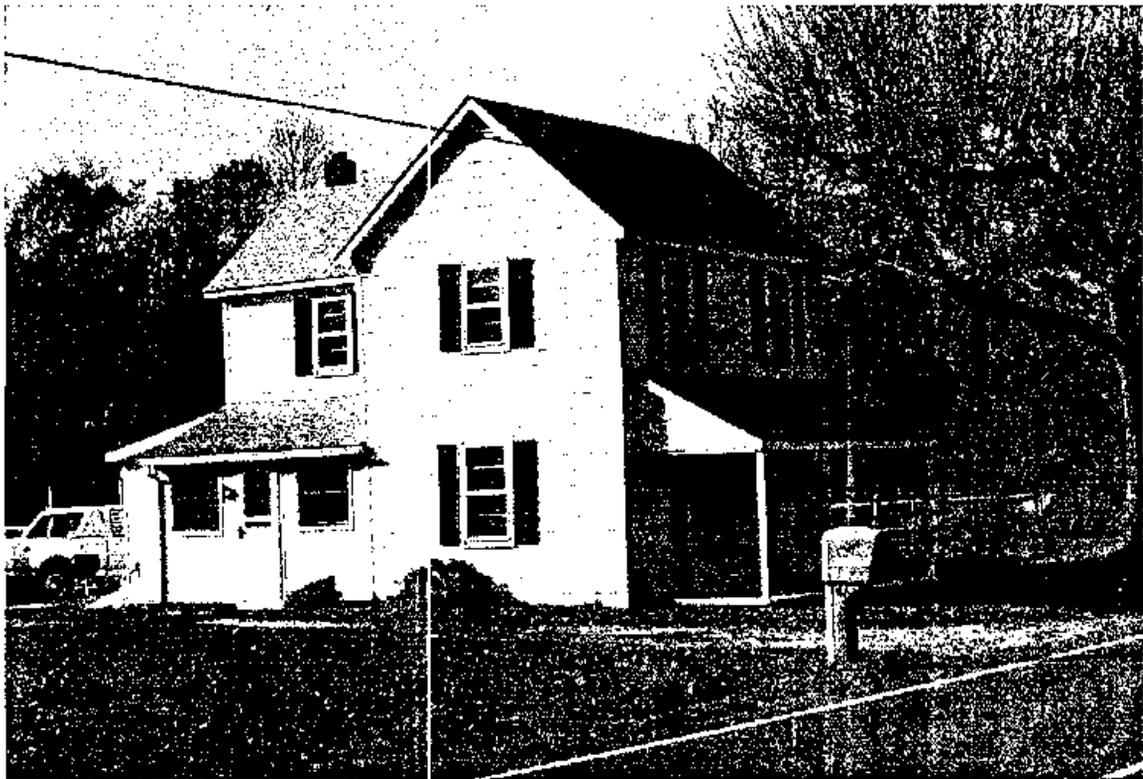
Photo 40. House, 4693 Kenton Road (K-3173). Northeast façade and southeast elevation toward northwest.

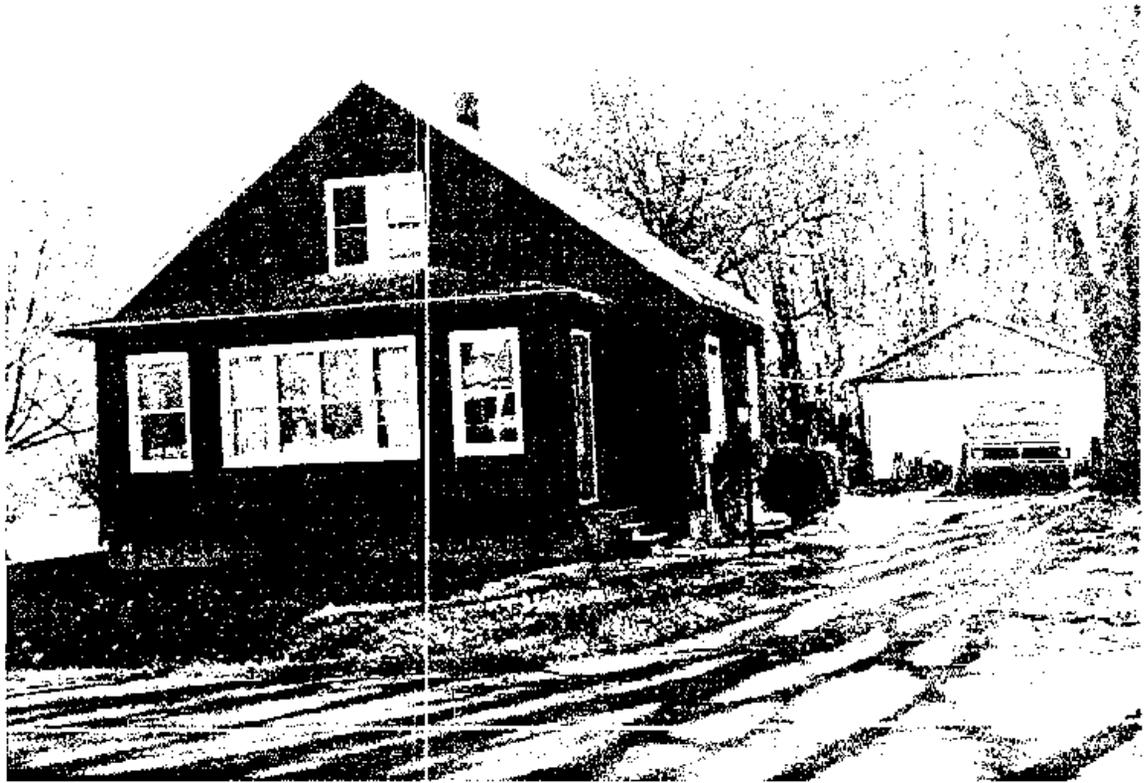
Photo 41. House, southeast side of Route 42 (K-6312). Northwest façade and southwest elevation toward southeast.

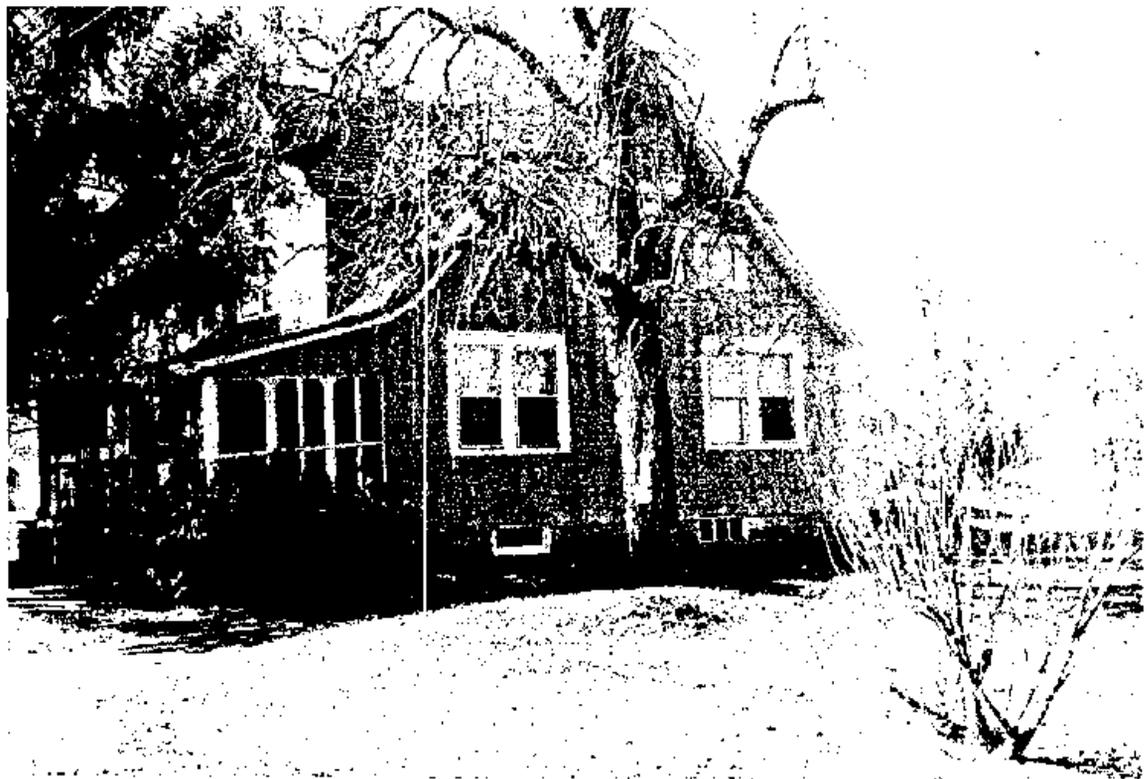
Photo 42. House, 3807 Route 42 (K-6374). Northeast and southeast elevations toward west.

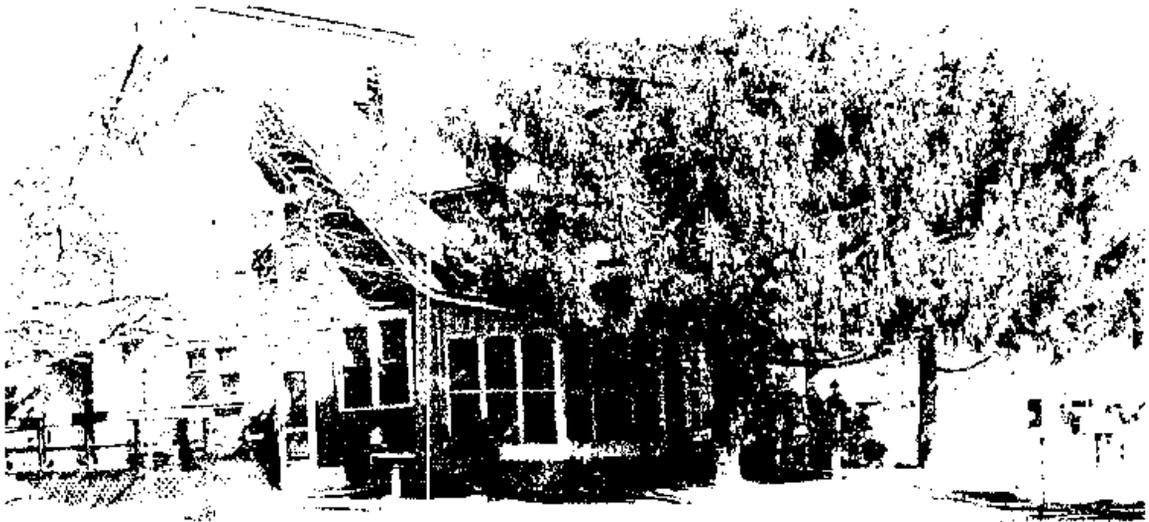
Photo 43. House, 3807 Route 42 (K-6374). Southeast and southwest elevations toward northeast.

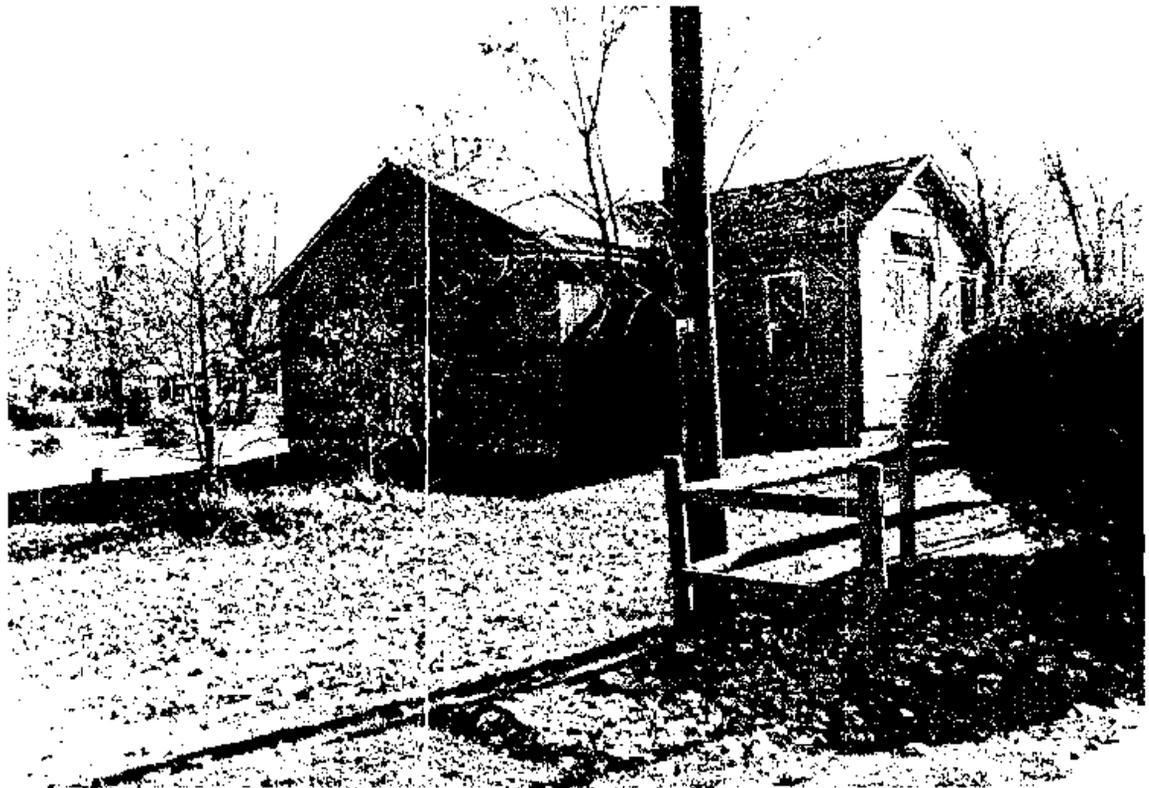
Photo 44. House, southeast side. Route 42 (K-6375). Northwest and southwest elevations toward southeast.

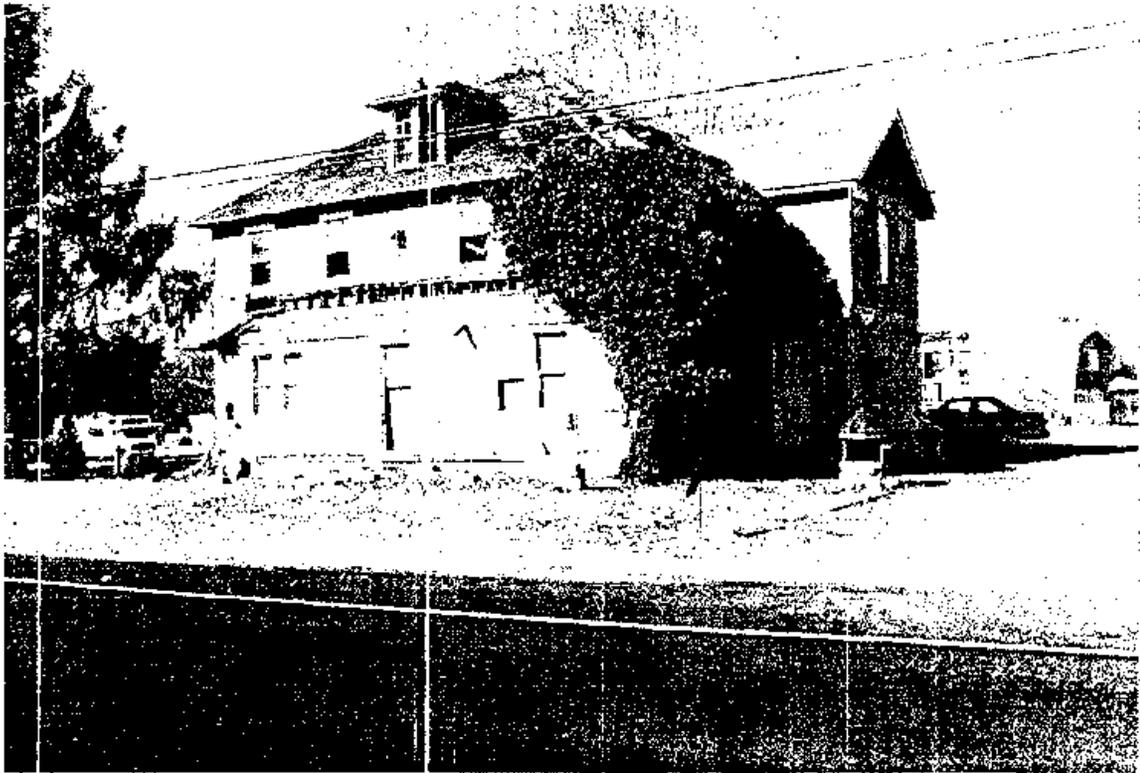
Photo 45. House, 3735 Route 42 (K-6376). Southeast façade and northeast elevation toward northwest.

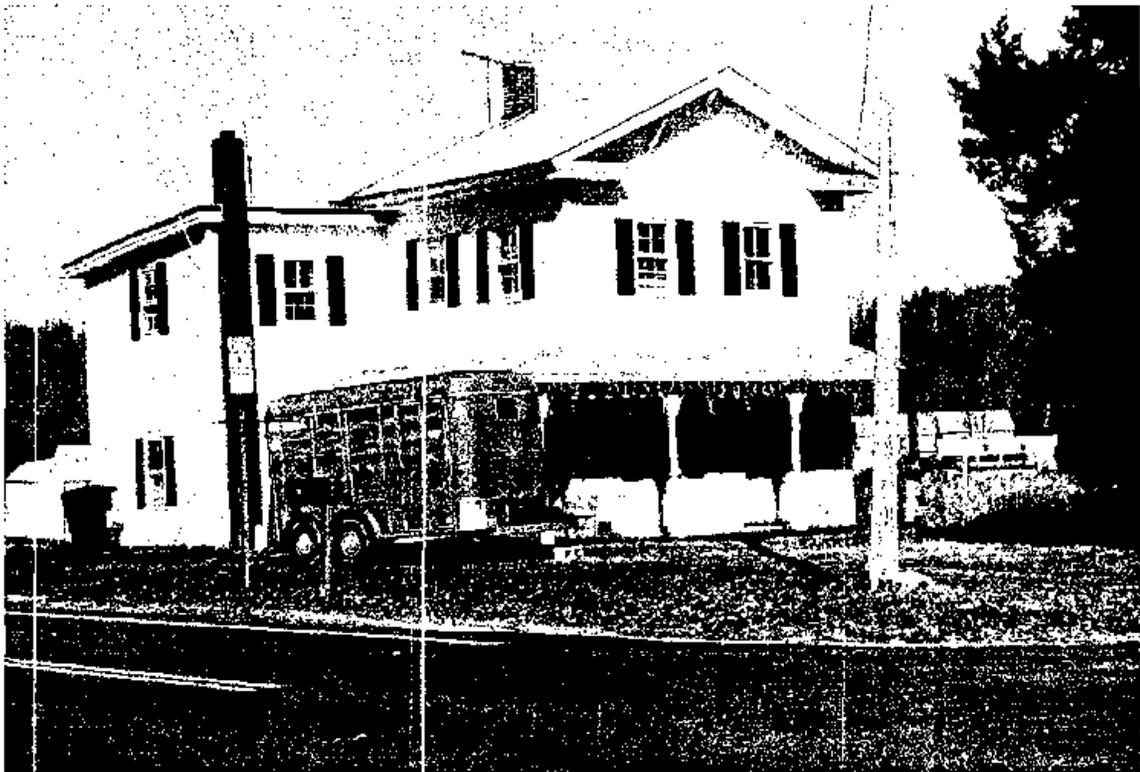
Photo 46. House, 4984 Kenton Road (K-6377). Southeast façade and southwest elevation toward northeast.

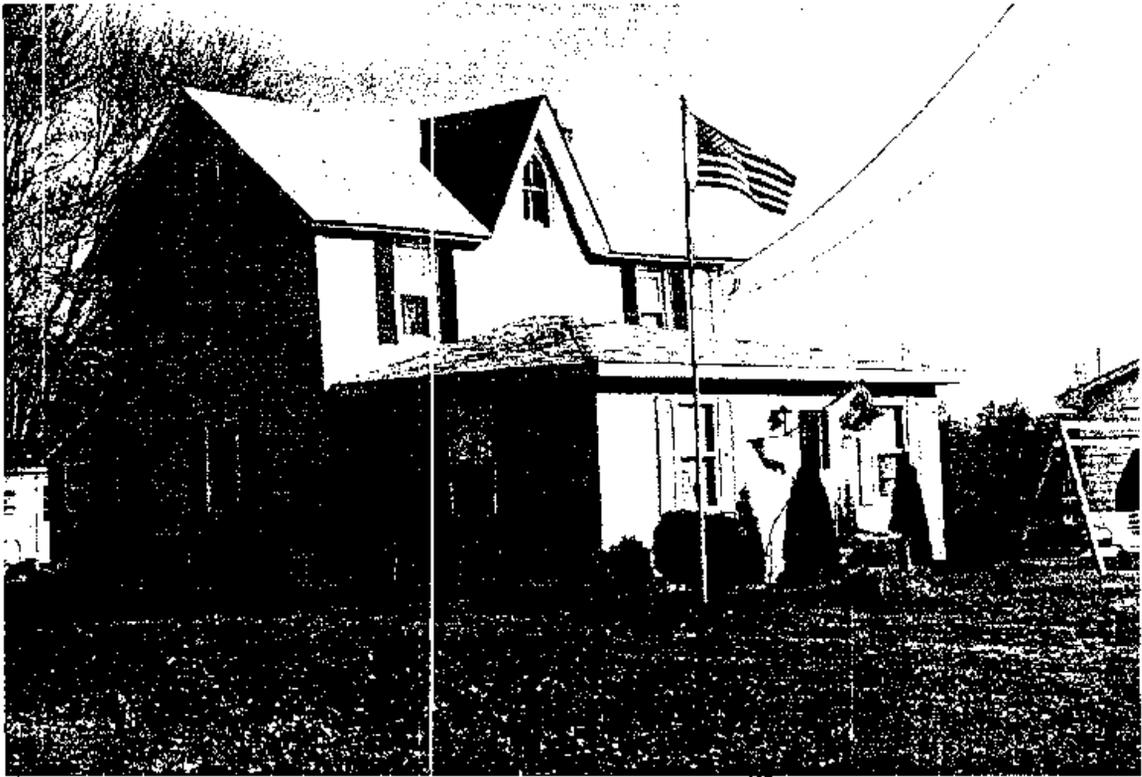
Photo 47. House, 4526 Kenton Road (K-6380). Southwest façade and northwest elevation toward southeast.

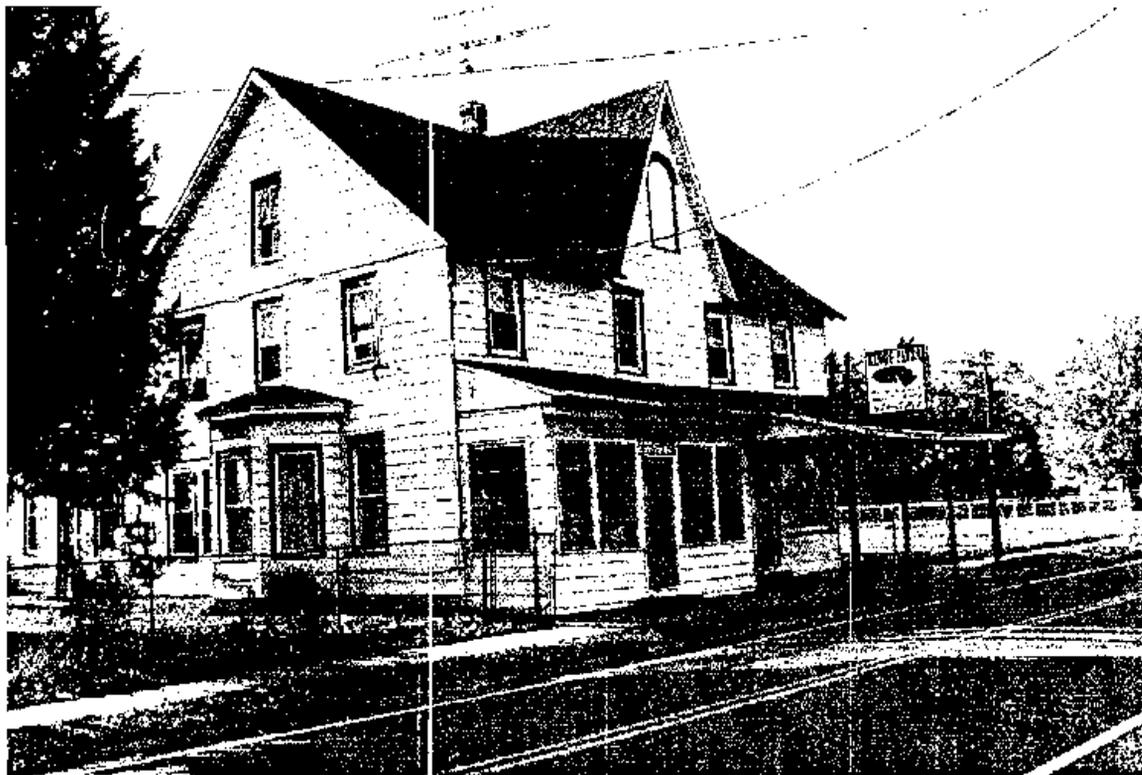
Photo 48. Kings Pizza, west side of Commerce Street, Cheswold (K-6709). Northeast façade and southeast elevation toward northwest.

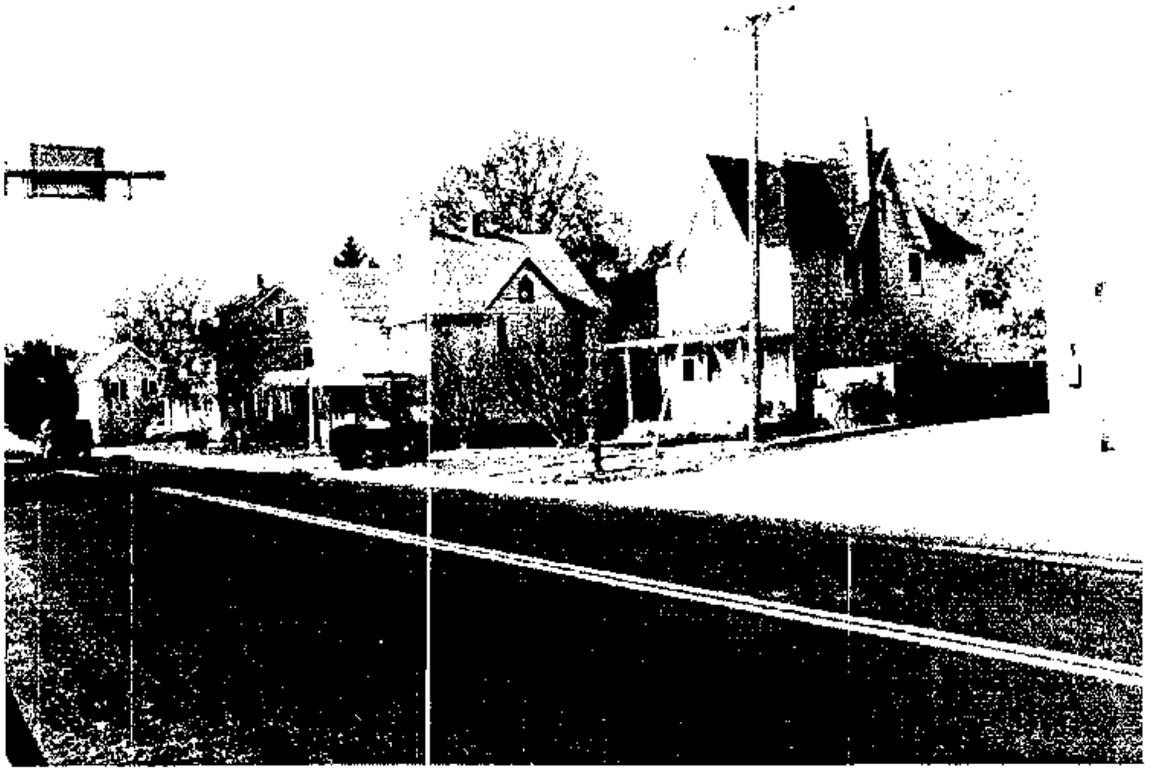
Photo 49. View of northwest side of Route 42, west of the firehouse, Cheswold (K-6709).
Toward west.

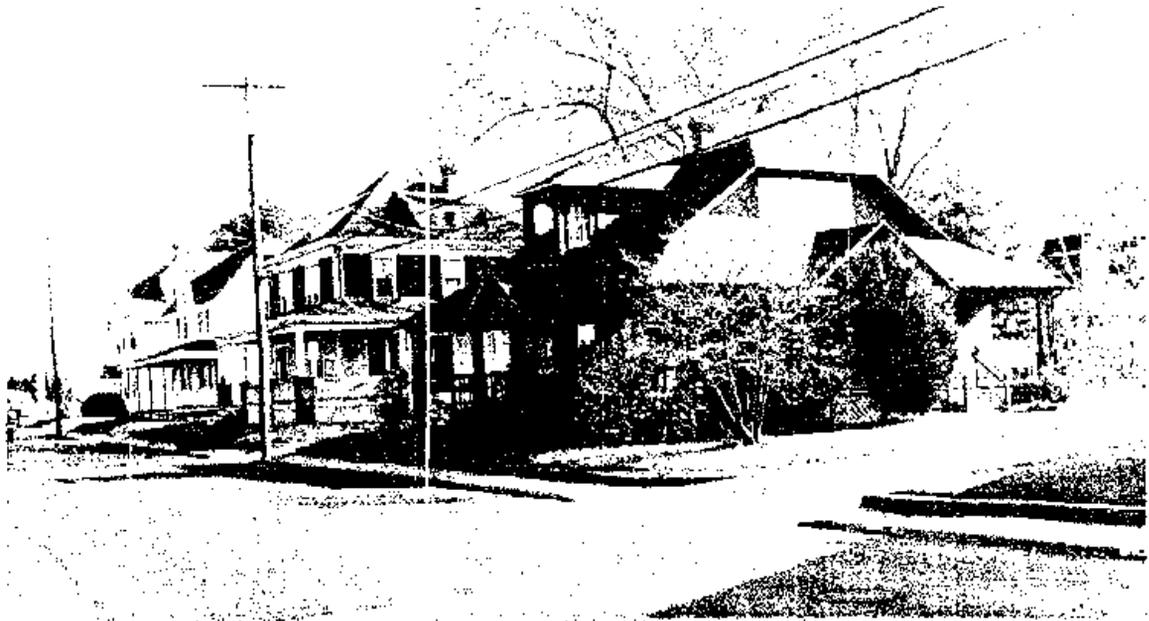
Photo 50. View of southeast side of Route 42, east of the post office, Cheswold (K-6709).
Toward southeast.

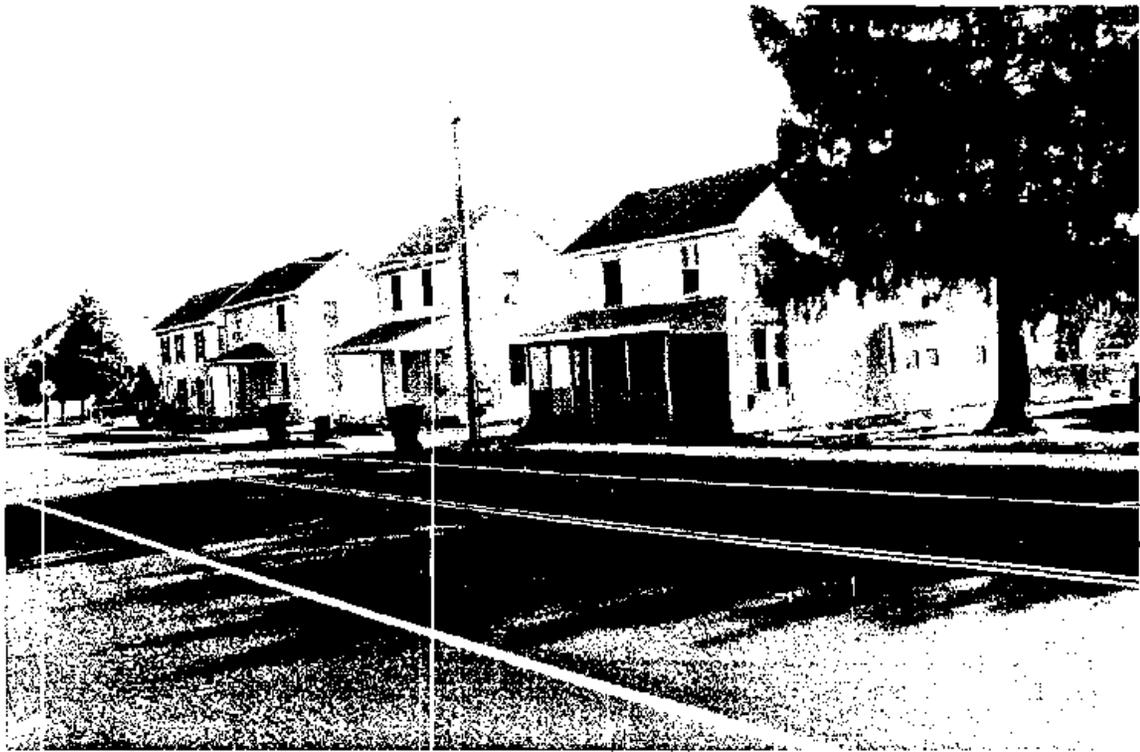
Photo 51. View of southeast side of Route 42, Cheswold (K-6709). Toward southeast.

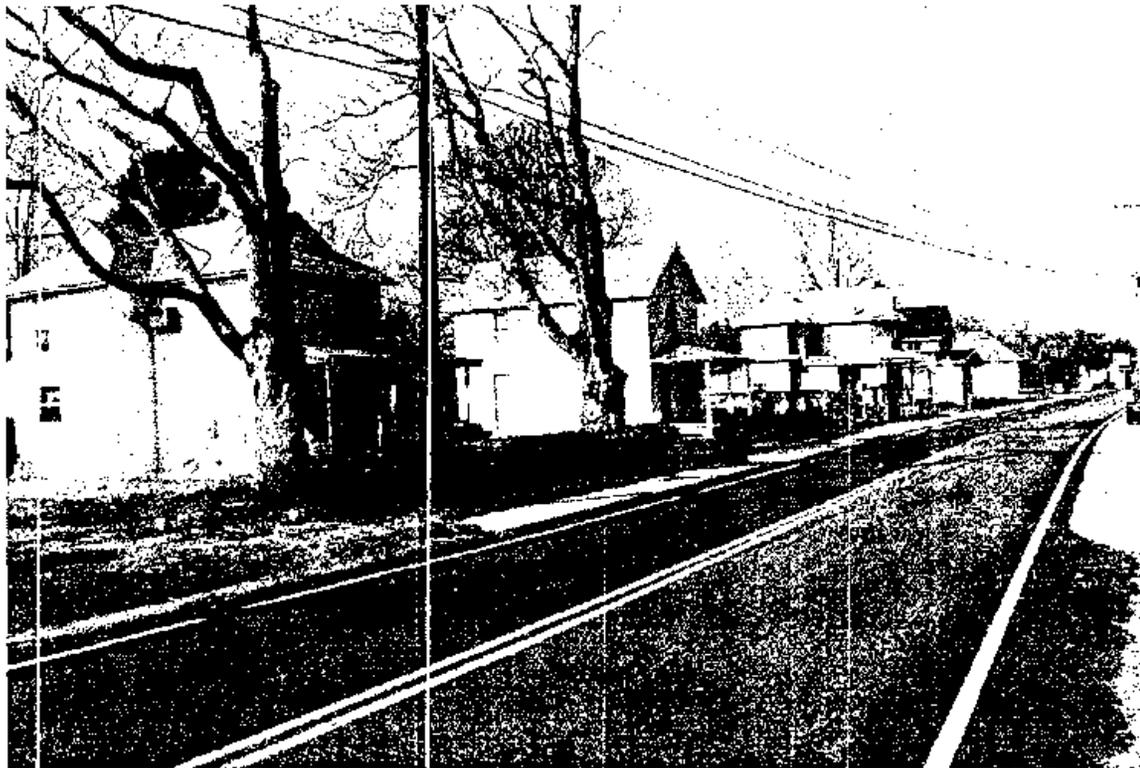
Photo 52. View of southeast portion of Cheswold (K-6709) on Salisbury Road/Commerce Street. Toward northwest.
