Table 1. Previously Surveyed Pre-1952 Architect

Table 1 Photographic Captions

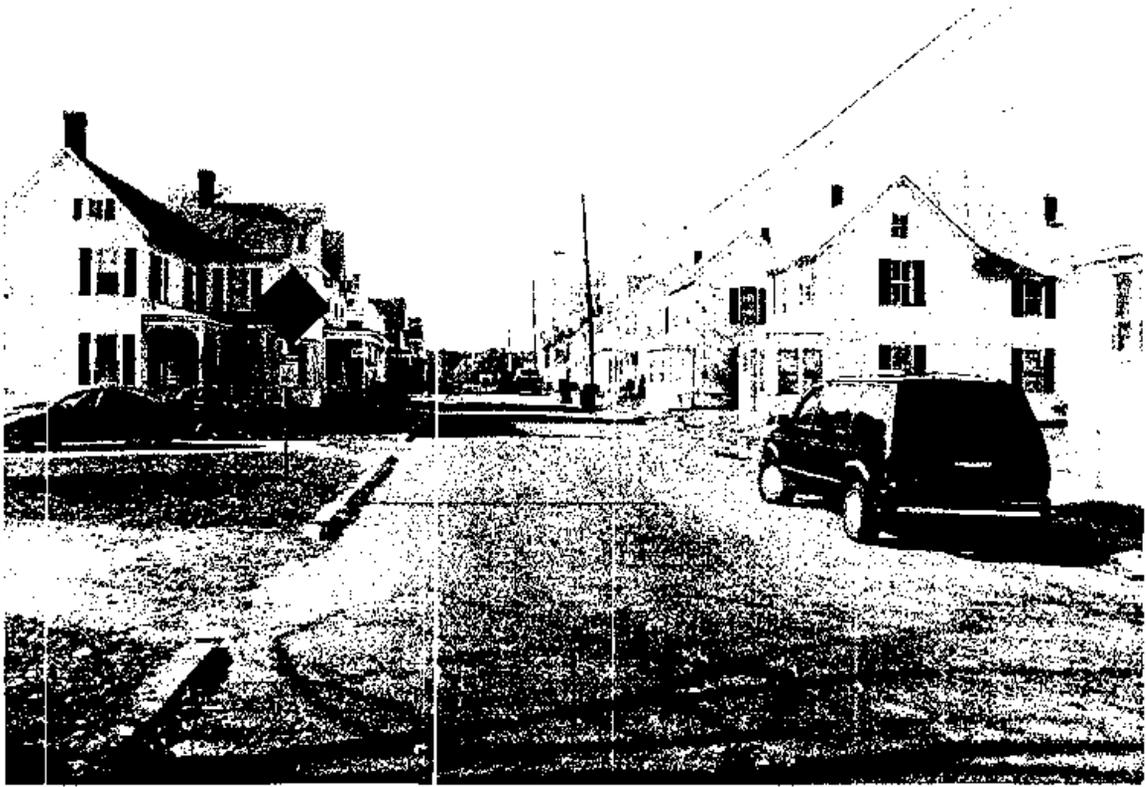
Photo 53. New Street streetscape, Cheswold (K-6709). Toward southwest.

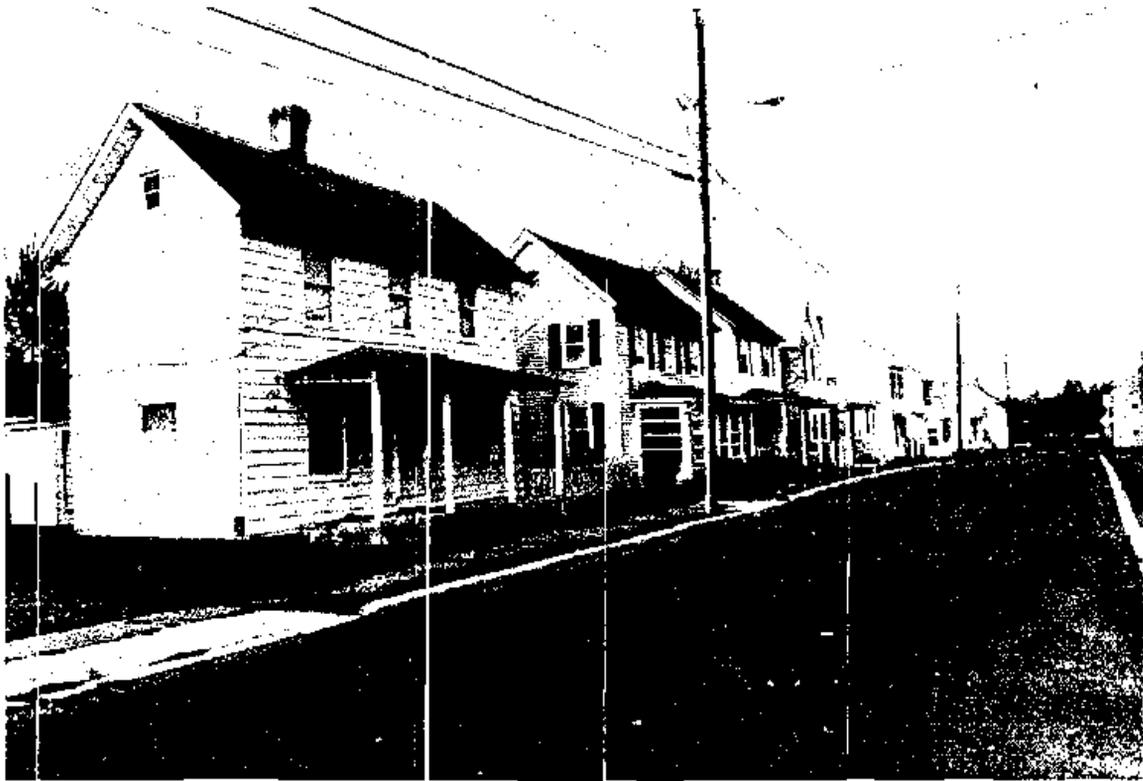
Photo 54. General view of southeast side of New Street, Cheswold (K-6709), toward southwest.

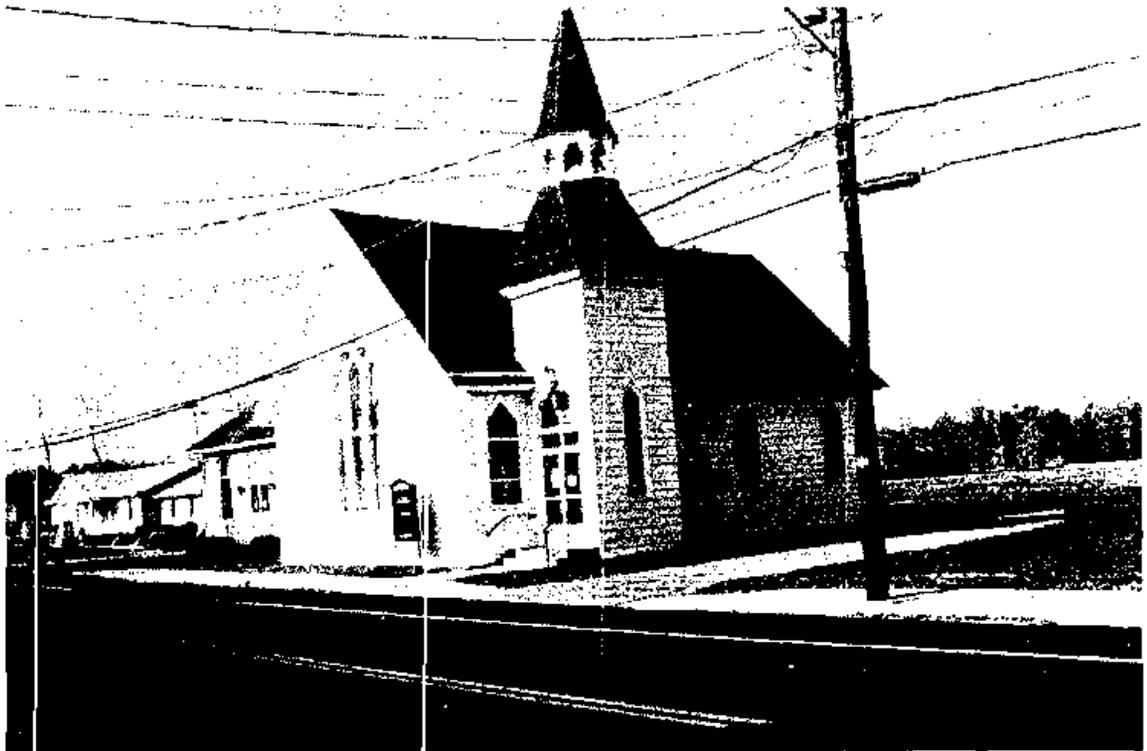
Photo 55. Cheswold United Methodist Church. Northwest side, Route 42. Southeast and northeast elevations toward northwest.
