ARCHITECTURAL RESOURCES: DESCRIPTION AND EVALUATION

INTRODUCTION

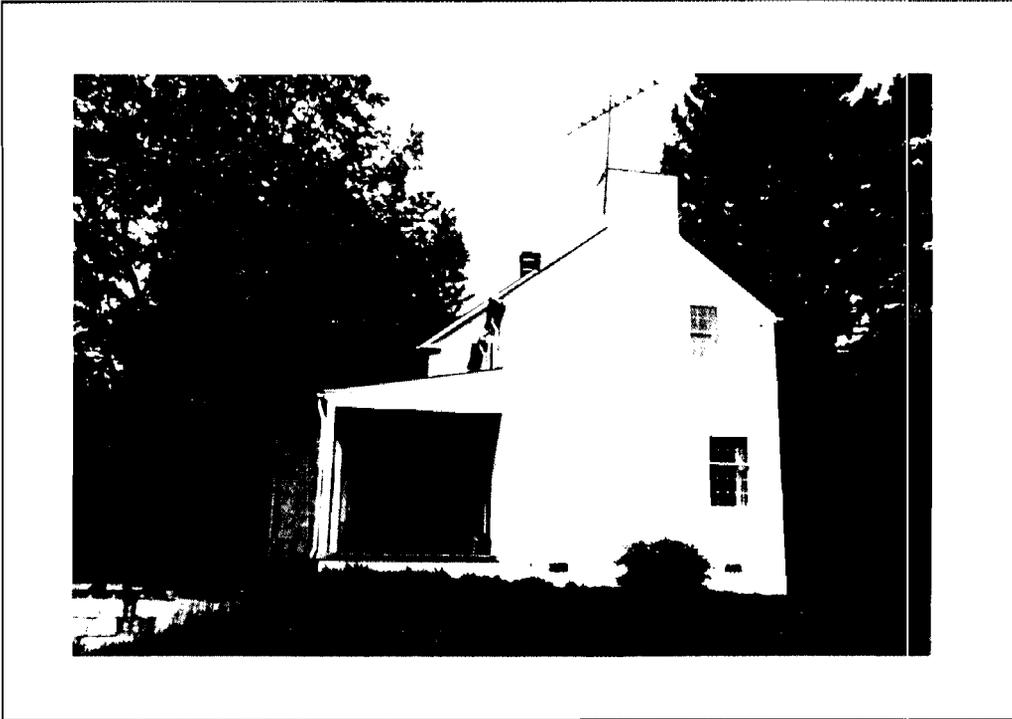
Description: This property consists of a dwelling, a bank barn, and four other outbuildings situated on two parcels. The dwelling, which lies about 200 feet west of Centerville Road, is an L-plan, cross-gable, frame building with 1½- and 2-story elements, which appears to date from the mid-nineteenth century (Plates 1 and 2). The structure rests on a stone foundation, and is clad with stucco. Its roof is covered with asphalt shingles. The east elevation has five bays, the two southernmost of which are within the cross gable. The cross gable has an interior brick chimney on the west end of its ridge. The west elevation of this cross-gabled section has a 1½-story addition which appears to date to the mid-twentieth century. This addition has an interior concrete-block chimney. Windows are a combination of wooden 6/6 double-hung with 1½-inch wooden surrounds as well as wooden casements, and one first-story bay window on the south elevation side. The east elevation has the date of 1957 painted on it. The owner, Mrs. Meryl Lovett, states that this signifies the date when she and her husband made major renovations to the house, including the removal of the previous asbestos siding, which they replaced with stucco, as well as the addition of the rear ell section and replacement of all windows.

PLATE 1: William Lowther Farm House, View to East

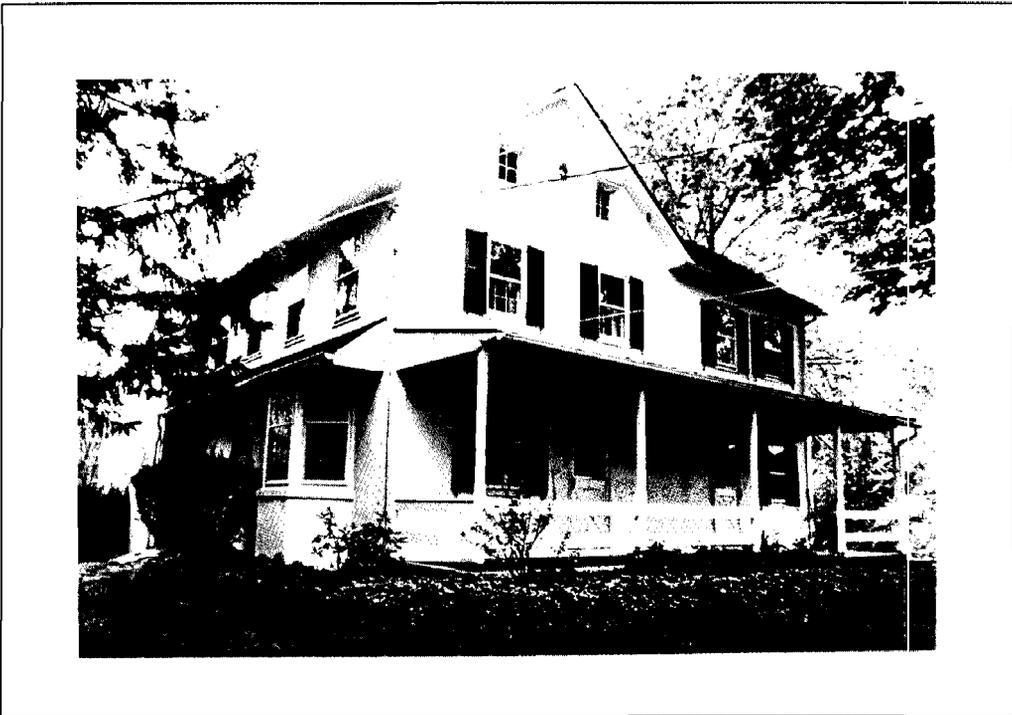
PLATE 2: William Lowther Farm House, View to West

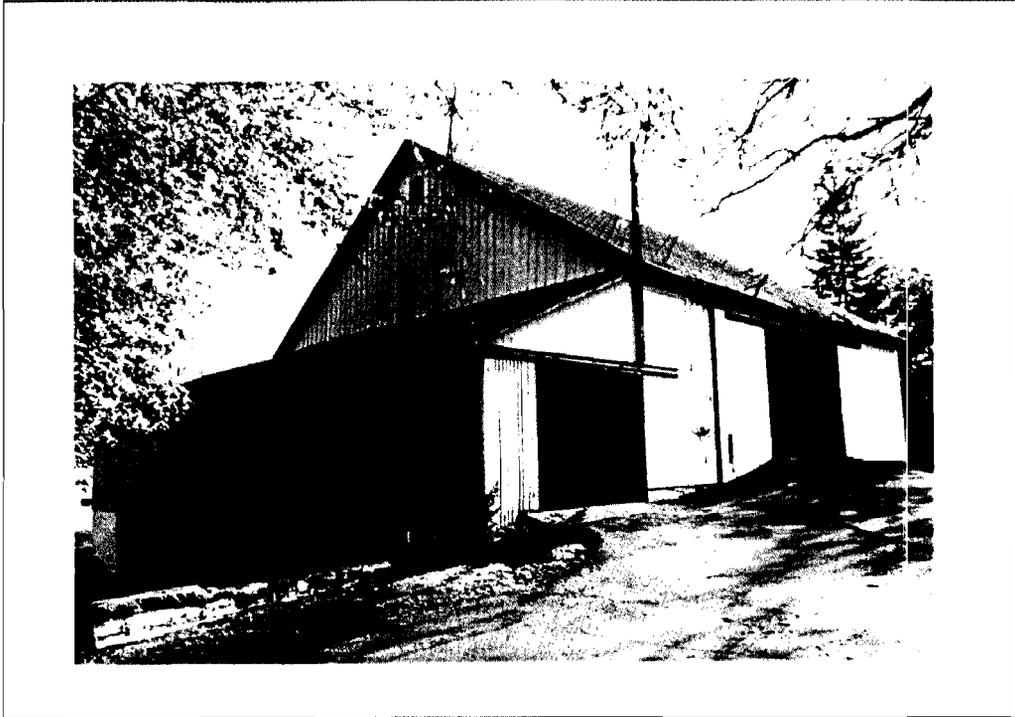
The most prominent secondary resource on the property is a mid- to late nineteenth-century frame barn which fronts Centerville Road (Plate 3). This structure is a bank barn, which has a lower section which appears to have accommodated livestock at one time. The barn's lower section is accessible at ground level on the south, east, and west elevations, and has a stone foundation to a height of approximately nine feet. The stone foundation is set into an earthen bank on the north elevation, where an asphalt drive meets the upper-level entrance. The barn is a gabled structure with a combination of board and batten siding and vertical board siding. The barn's main roof has asphalt shingles, but a shed-roofed section on its east elevation has cedar roof shingles. A notable feature on the east elevation is an obelisk-shaped stone pillar which supports the upper level. A 10x10-inch wooden post extant to the north of this pillar may have replaced a similar pillar. The interior of the barn reveals that the majority of floor joists and heavy timbers have been replaced within the last 50 years, and a small concrete-block wall has replaced some of the original stone foundation on the west elevation.

PLATE 3: William Lowther Farm House Barn, View to Southwest

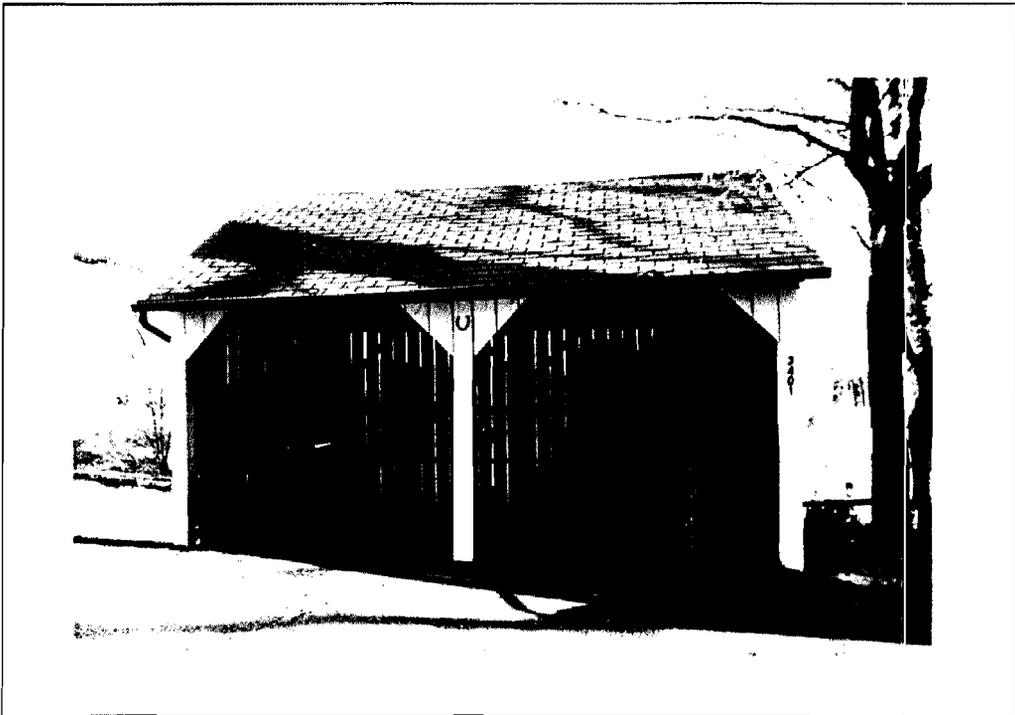
North of the barn is an open bay garage/storage shed (Plate 4). This structure's south elevation opens to the asphalt drive. It is a simple side-gabled frame building with a stone foundation. It is clad with vertical board siding, most of which has recently been replaced. The roof has asphalt shingles. West of the barn, but east of the dwelling, stand two outbuildings. The first is a gabled frame storage shed with stone foundation, vertical board siding, and asphalt-shingled roof which appears to date from the mid- to late nineteenth century, and the second is a shed-roofed chicken coop with a concrete foundation, board and batten siding, and asphalt-shingled roof which appears to date from the early twentieth century (Plates 5 and 6). South of the barn lies a two-bay, side-gabled shed set on a concrete slab. Its roof is clad with asphalt shingles. Its walls are clad with a combination of board and batten siding, and two-inch vertical wood strips set approximately one inch apart for ventilation. This shed appears to date from the early to mid-twentieth century (Plate 7).

PLATE 4: William Lowther Farm House Garage, View to North

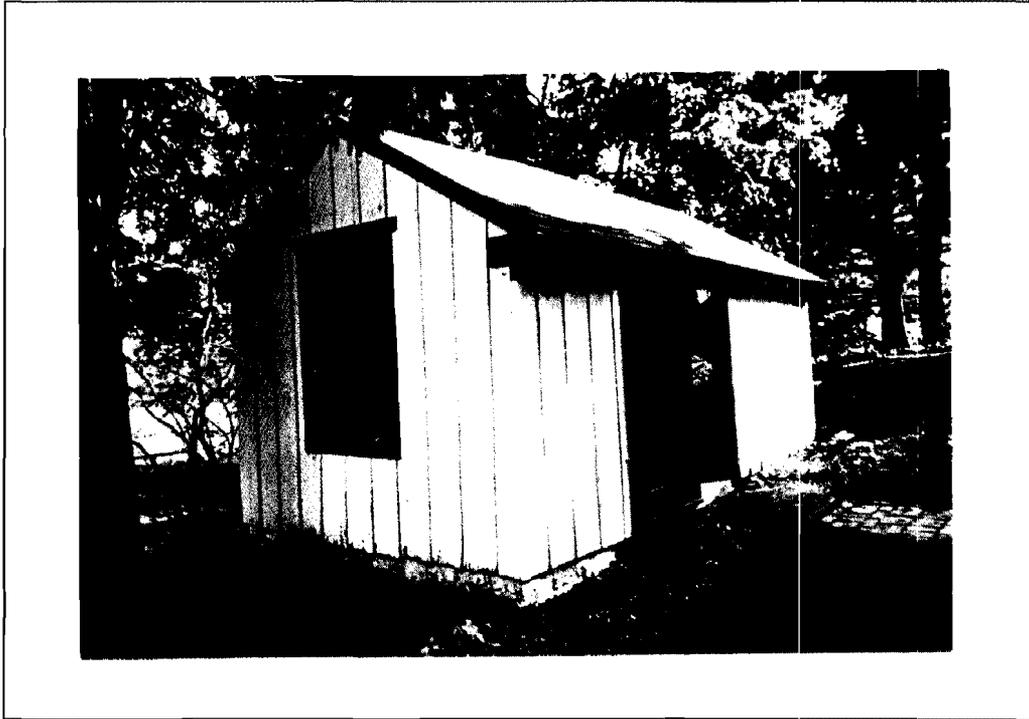
PLATE 5: William Lowther Farm House Shed, View to West

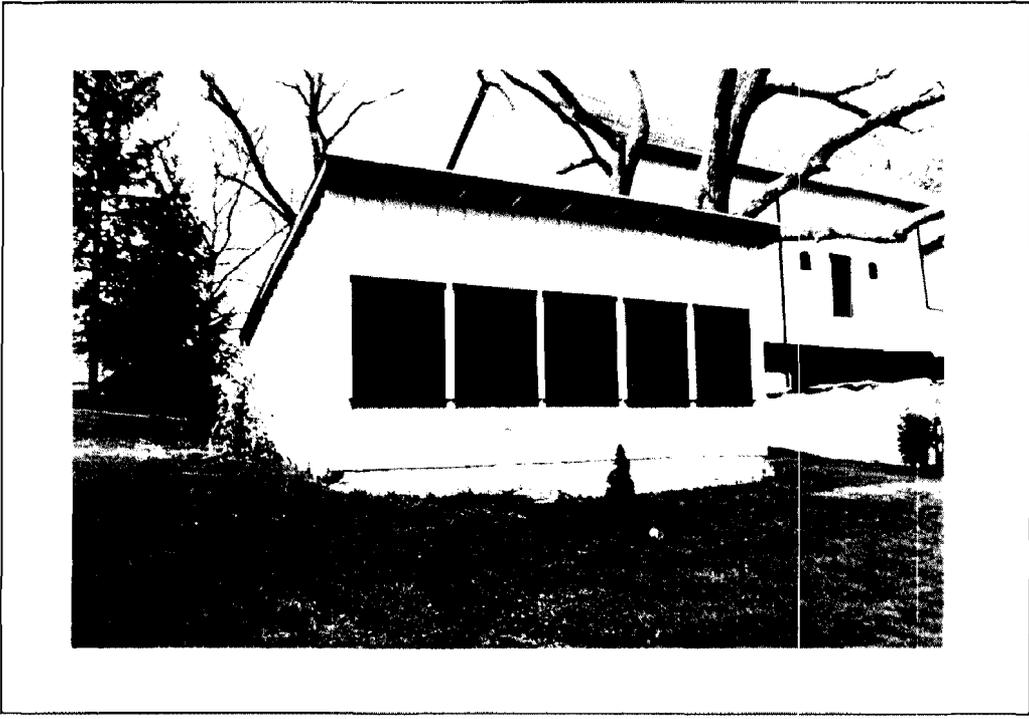
PLATE 6: William Lowther Farm House Chicken Coop, View to North

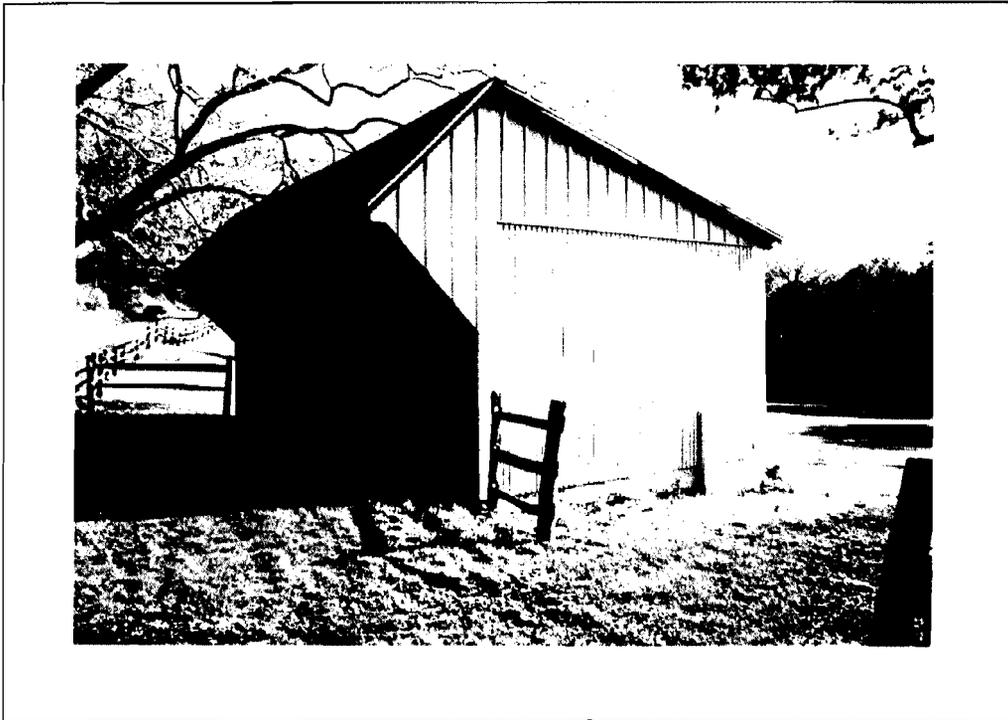
PLATE 7: William Lowther Farm House Shed, View to South

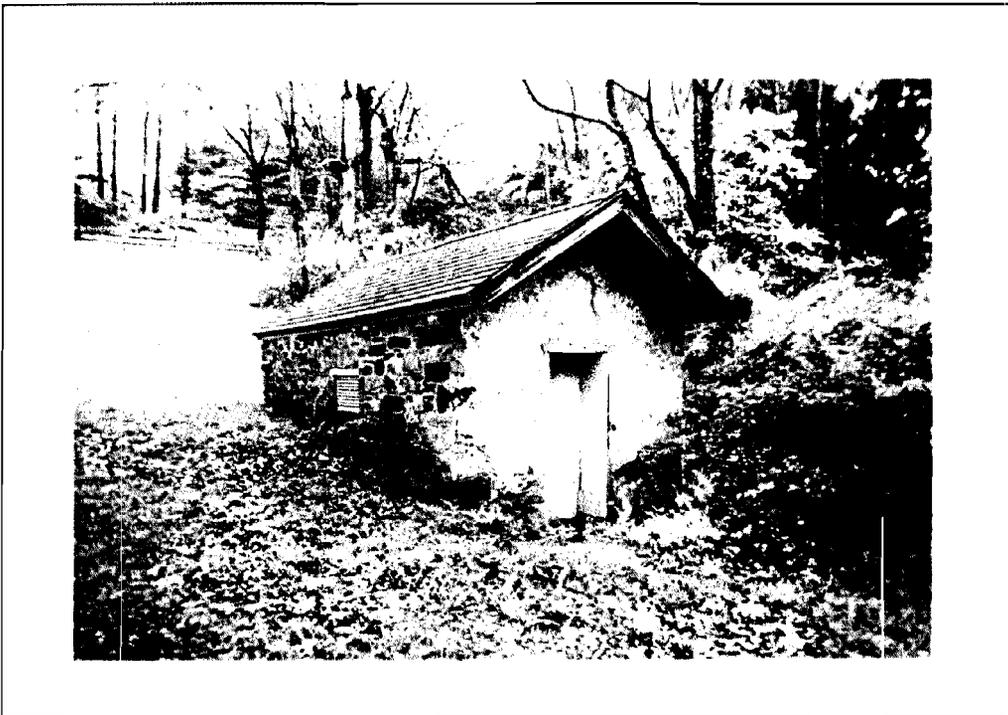
A springhouse is located several hundred feet south of the house, barn, and other outbuildings. The structure, built of uncoursed rubble, has a gabled roof with asphalt shingles. The springhouse appears to date from the mid- to late nineteenth century (Plate 8).

PLATE 8: William Lowther Farm House Springhouse, View to Southeast

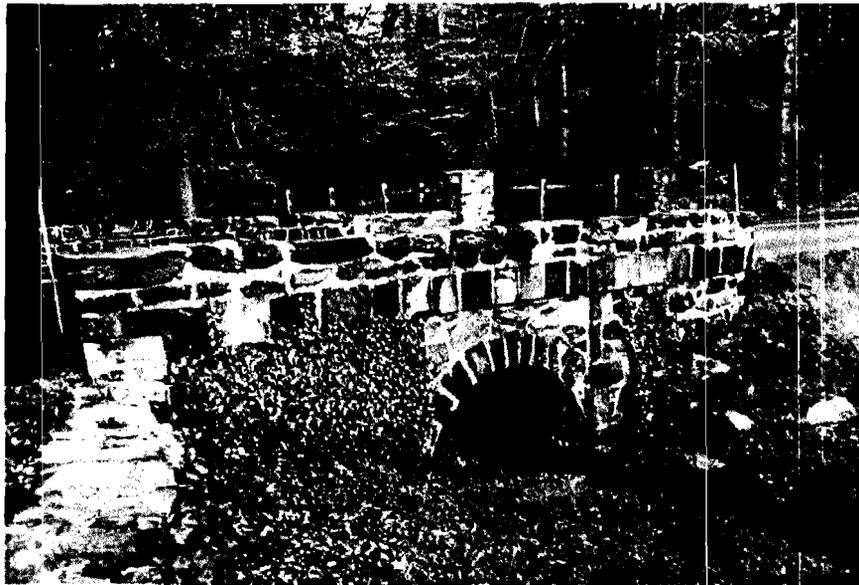
Description: This bridge carries Centerville Road over a small stream approximately 1,800 feet north of its intersection with Barley Mill Road (Plate 9). It is a stone, single-arch bridge measuring about 23 feet long and 28 feet wide. DeIDOT bridge inspection files give very little information as to the construction of this or similar bridges in the area, beyond indicating that the abutments are constructed of reinforced concrete (DeIDOT Bridge Inspection Files). The bridge is most likely a concrete structure with stone facing. The bridge has a single barrel arch with cut voussoirs and oversized keystone. Stone parapets rise approximately two feet above the road surface. The southern corner of the west parapet has a concrete cornerstone with the designation 136-A. The bridge appears to date from the mid-1930s.

PLATE 9: Bridge No. 136-A, View to East
