**S-11472. Store, 18283 DuPont Boulevard
(PIN: 135-6.00-6.00)
(Detail Map #6)**

**S-11473. Former Dwelling, 18245 DuPont Boulevard
(PIN: 135-6.00-8.01)
(Detail Map #6)**

**S-11474. Dwelling, 18932 Redden Road
(PIN: 135-6.00-10.03)
(Detail Map #5)**

S-11475. Dwelling, 18942 Redden Road
(PIN: 135-6.00-11.00)
(Detail Map #5)

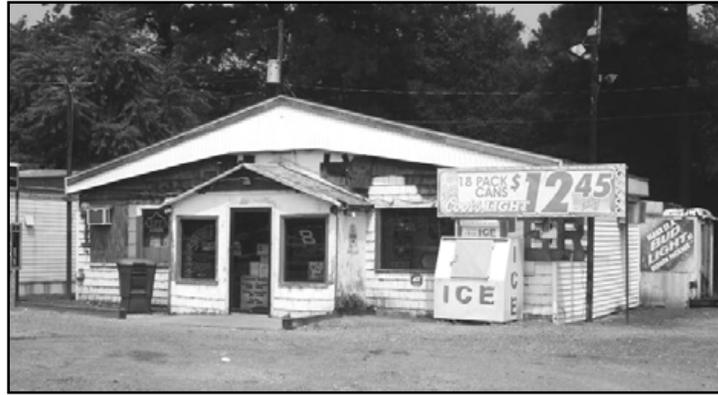
The building was evaluated under Criterion C as a vernacular roadside commercial building. Of relatively recent construction, this simple rectangular building does not possess architectural significance. Further, it has been resided, and additions have been attached to the front and rear walls, diminishing its integrity. Lacking both significance and integrity, the property is recommended not eligible under Criterion C.

main building (.001), façade, view to NE

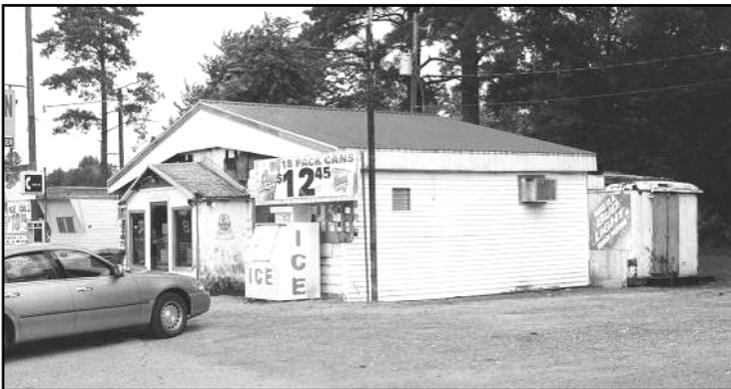
main building (.001), façade and south side, view to NE

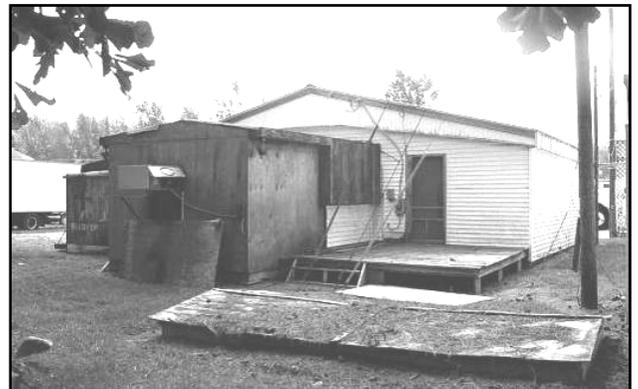
main building (.001), rear, view to SW

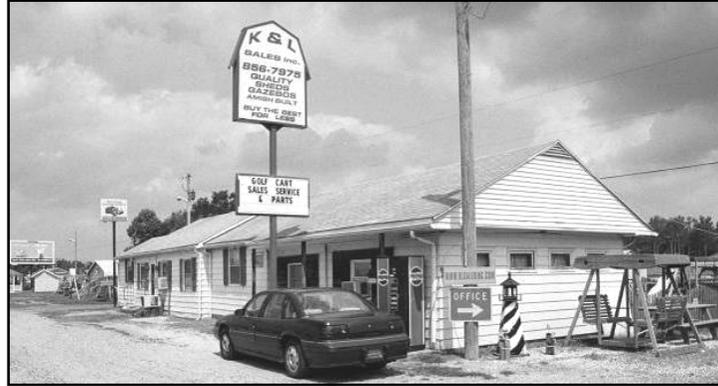
As indicated in the research design, ranch houses were simple, rapidly built, inexpensive architectural types that generally do not possess the architectural distinction necessary to be eligible for listing on the National Register. Moreover, this example has been substantially altered by the construction of a large shed-roof addition on the back, and by major fenestration changes to the façade to accommodate its current commercial function. Overall, this property lacks the integrity necessary to convey any architectural significance it may have once possessed and it is recommended not eligible under Criterion C.

main building (.001), façade and southeast side, view to N

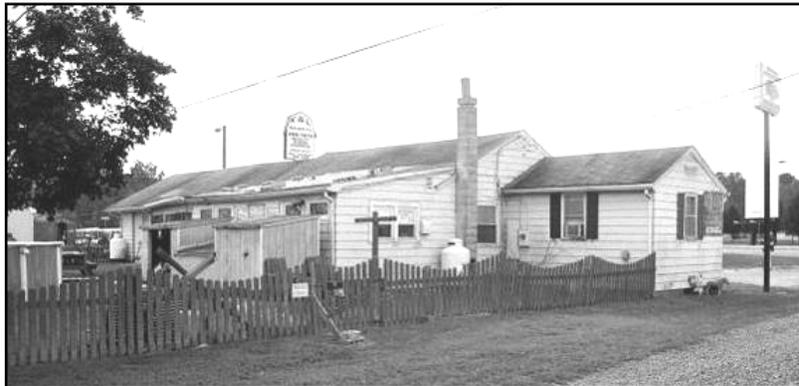
main building (.001), rear and northwest side, view to S

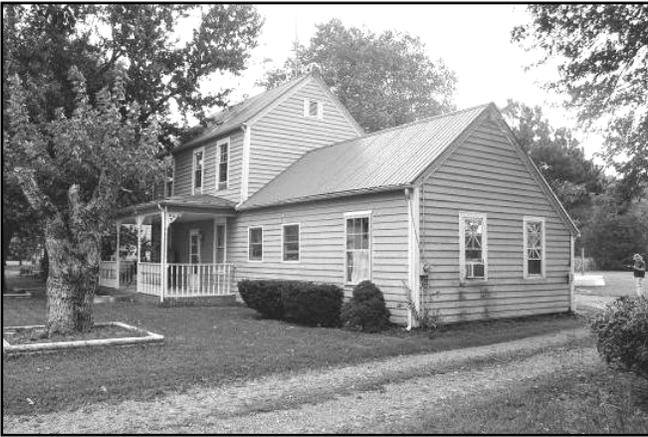
house type, however, eligibility would likely require more than retention of integrity. This building is not an outstanding example of its type. Furthermore, alterations include the application of modern siding to the exterior, window replacement, and the construction and attachment of additions to the side and rear façades. This property is recommended not eligible for inclusion in the National Register under Criterion C.

main building (.001) façade and southwest side, view to ESE

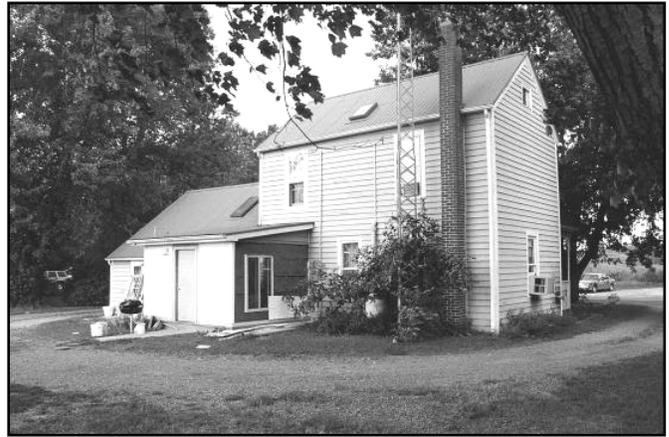
main building (.001) rear and northeast side, view to NW

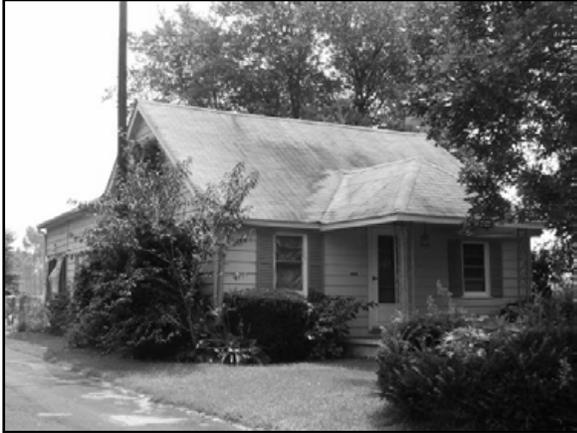
To meet eligibility, examples of the Cape Cod property type should be better preserved than the average Cape Cod in a particular area and exhibit diagnostic elements of the building type. This would include elaborated entrances, symmetrical fenestration with multi-light, double-hung sash windows, ornamental shutters, and symmetrical, often pedimented, front dormers. If the example was designed by an architect or based on a published plan, and if it possessed all of its diagnostic elements, it would likely meet eligibility. This property is not an outstanding example of the Cape Cod style. In addition, several alterations have occurred, including the application of replacement siding and the replacement of all the windows. This property is recommended not eligible for inclusion in the National Register under Criterion C.

main building (.001) façade and northeast side, view to SW

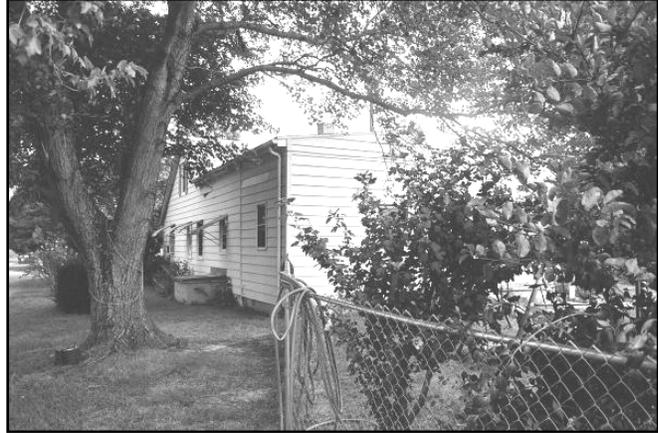
main building (.001) rear and southwest side, view to NE

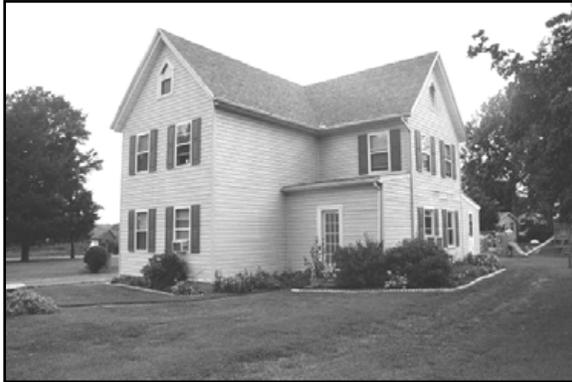
This house has undergone numerous alterations including the application of vinyl to the exterior, the replacement of the windows and doors, and the construction and additions of rear and front

additions. Its integrity of design, materials, and workmanship has all been lost. For these reasons, this dwelling is recommended not eligible for inclusion in the National Register under Criterion C.

main building (.001) façade and northeast side, view to NW

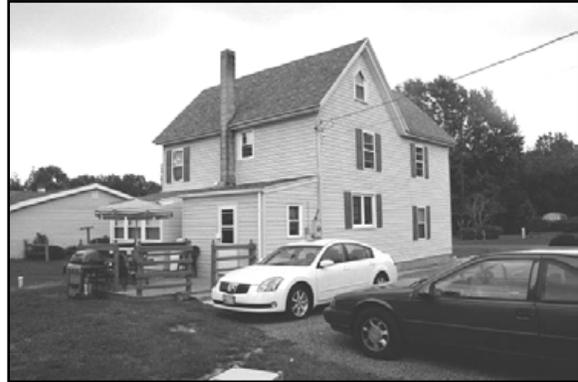
main building (.001) rear and southwest side, view to SE
