**S-10440. Dwelling, 10817 DuPont Highway  
(PIN: 230-19.00-91.00)  
(Detail Map #1)**

**S-10442. Dwelling, 10489 South DuPont Boulevard  
(PIN: 330-12.00-15.00)  
(Detail Map #7)**

**S-11464. Dwelling, Milton-Ellendale Road (Route 16)**  
**(PIN: 230-26.16-7.00)**  
**(Detail Map #2)**

**S-11465. Dwelling, Sharons Road**  
**(PIN: 230-26.00-105.01)**  
**(Detail Map #2)**

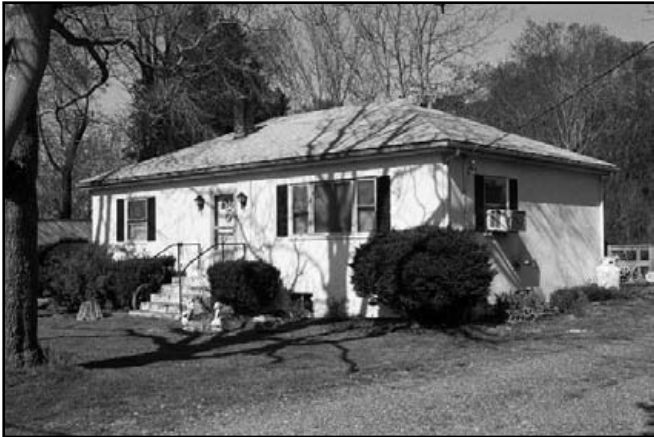
main building (.001) façade and south side, view to NE

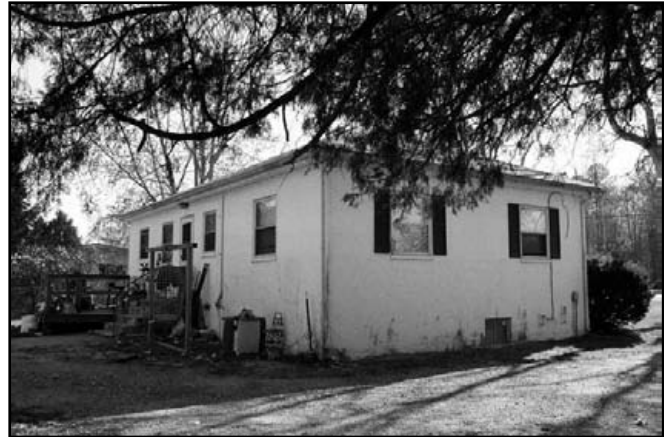
main building (.001) rear and north side, view to SW

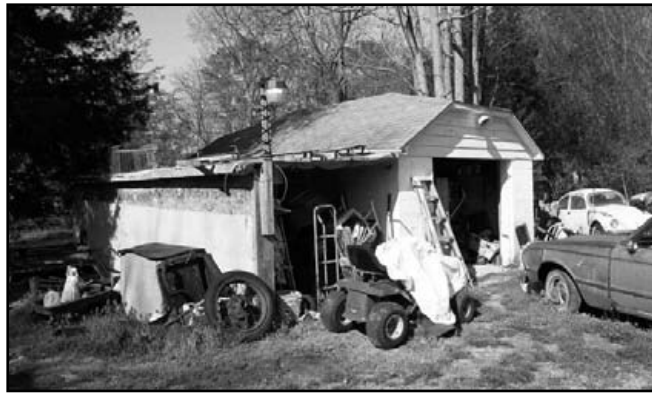
A c. 1940s-1950 garage (.002) is placed northeast of the house. This hipped roof, concrete-block building with a shed-roofed is set on a concrete slab. Its south façade is pierced by a garage door opening, now missing the door. The original west wall is obscured by the shed-roofed addition. The remaining walls are blank.

garage (.002), view to NE

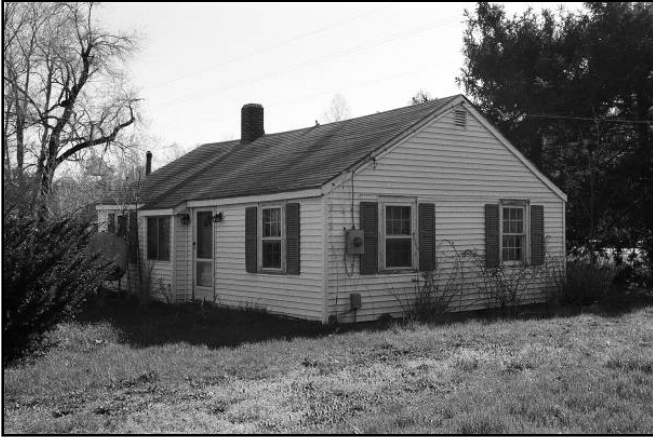
main building (.001) façade and south side,  
view to NE

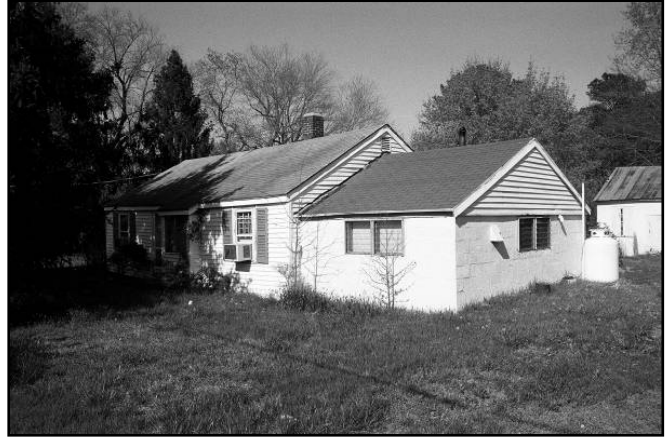
main building (.001) rear and north side,  
view to SW

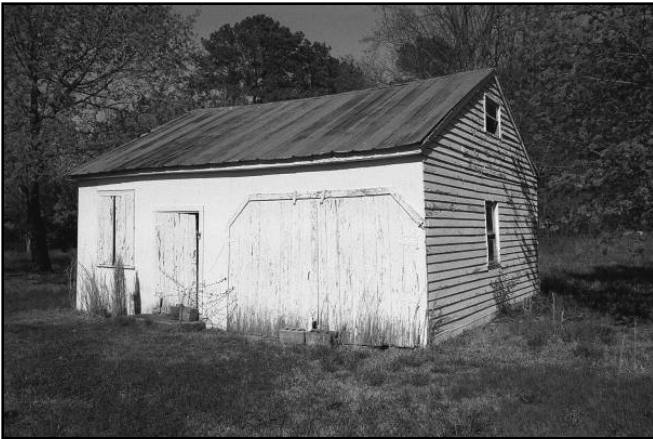
A single-story, c. 1940, side-gabled barn/garage (.002) is placed east of the main house. Its west façade is fenestrated with a single diamond-light, casement window, probably salvaged from elsewhere. Doors consist of a batten entry door and paired batten garage doors. The north gable end contains a broken out four-light window in the first floor and a three-light window in the second floor, while the south wall contains one-over-one, double-hung sash windows in the first and second stories. The rear wall is blank. The building sits on a concrete slab, while the walls are sheathed in horizontal wood siding and fiberboard.

garage (.002), view to NE

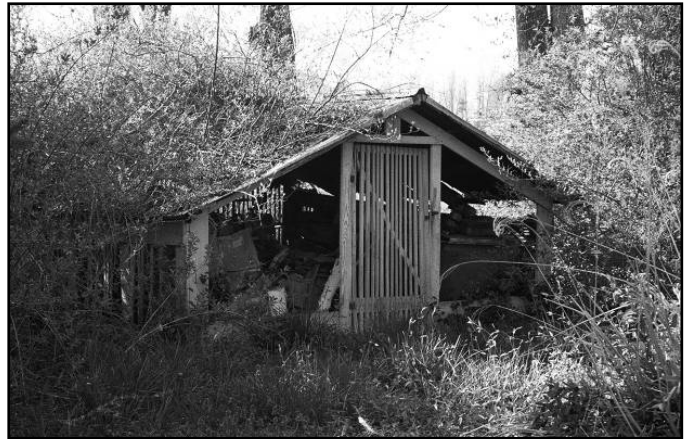
The second outbuilding is located north of the house and may represent the remnants of a c. 1950 chicken colony house (.003). Its side panels or walls are missing. Its east wall contains a slatted wood door, while the remaining walls are either not present or blank. The walls were originally constructed of wood slats.

chicken colony house (.003), view to NW

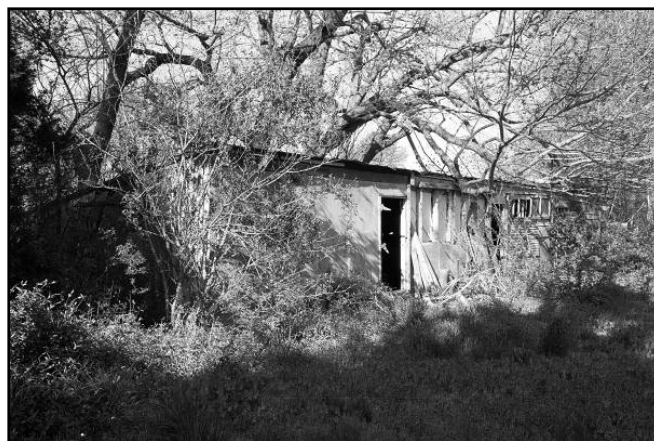
The final outbuilding is a c. 1950s, shed-roofed chicken house (.004). This wood-framed building has been patched with a variety of more modern materials. The east end of the building has collapsed. The south façade wall is marked by screened openings, and five wood batten doors. The east end was not accessible due to its collapse, while the west wall contains a salvaged, fixed, leaded-glass sash. The north wall was inaccessible. The chicken house is clad in horizontal wood siding, fiberboard, and metal.

chicken house (.004), view to NE

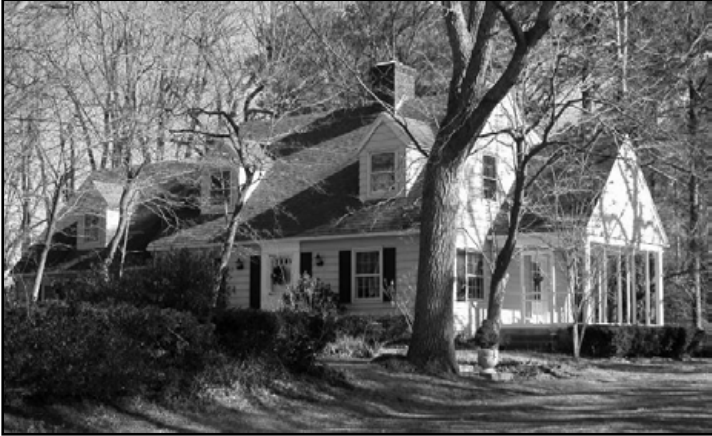
main building (.001), façade and south side, view to NE

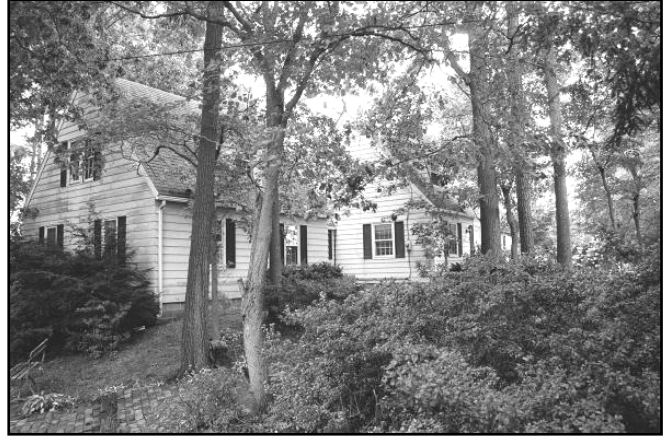
main building (.001), façade and north side, view to SE

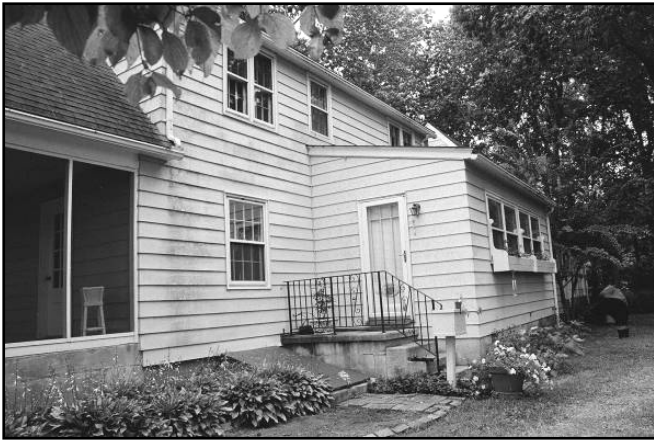
main building (.001), rear, view to NW

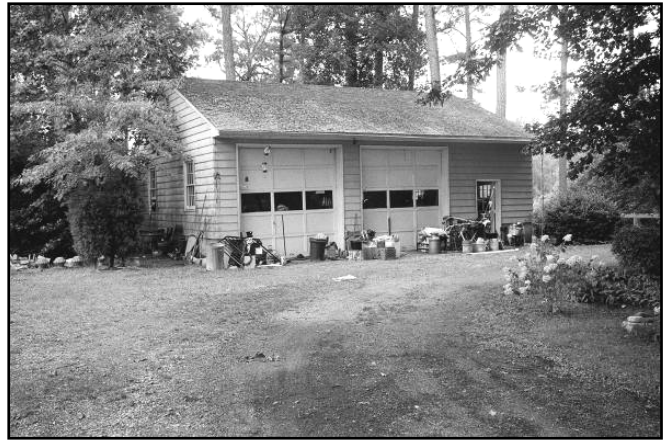
The c. 1948 garage (.002) is a two-car, wood-framed, side-gabled block. Its west façade contains two wood-and-glass roll-down garage doors and a side entry door. The side walls are fenestrated with two, eight-over-eight, double-hung sash windows, while the rear wall is fenestrated with a single, eight-over-eight window. The garage sits on a concrete-block foundation and is sheathed in aluminum siding.

garage (.002), view to SE

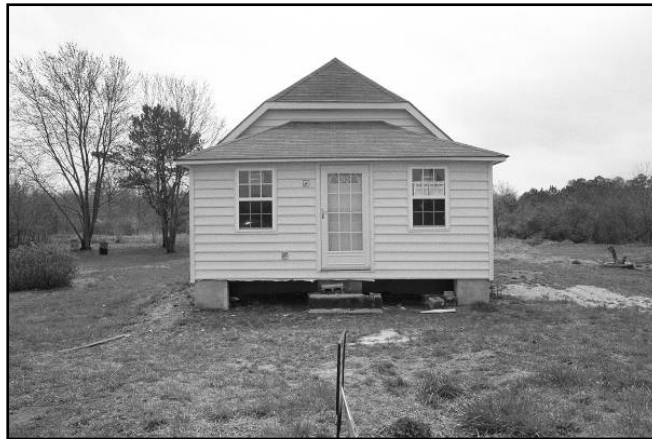
The house was recently renovated. Alterations to the house include new siding, windows, doors, the enclosure of the front porch, construction of a large rear addition, and probable construction of a new foundation.

main building (.001) façade, view to S

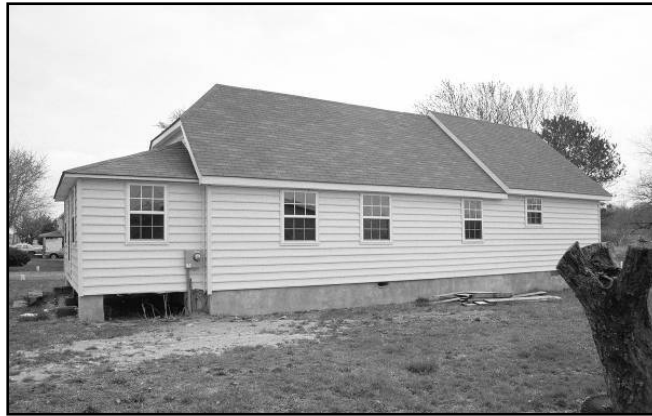
main building (.001) west side, view to E

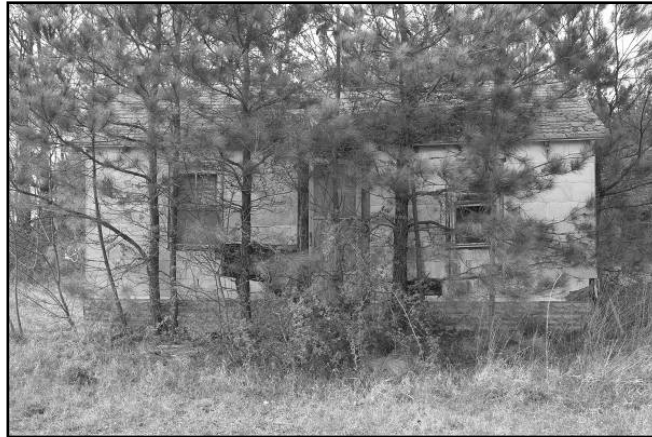
The house is a simple, deteriorated example of a World War II-era cottage. As indicated in the research design, this represents a common property type and few examples possess architectural significance. Therefore, it is recommended not eligible under Criterion C.

main building (.001) façade, view to NW

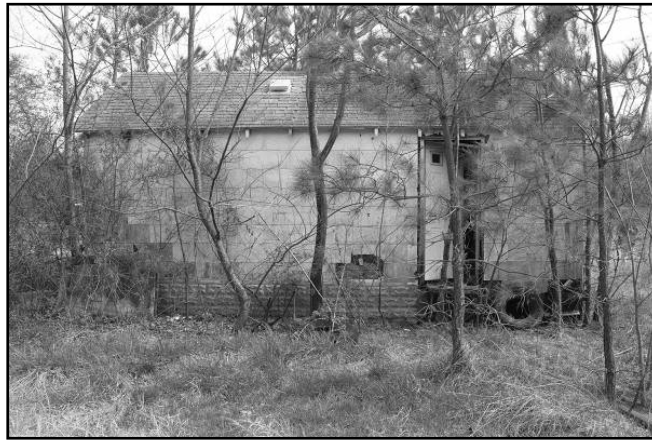
main building (.001) rear, view to SE
