RAIL CORRIDOR EXISTING CONDITIONS DATA:

DELAWARE RTT/RWT FACILITIES MASTER PLAN
KENTMERE TRACK
EXISTING CONDITIONS MARCH 2006

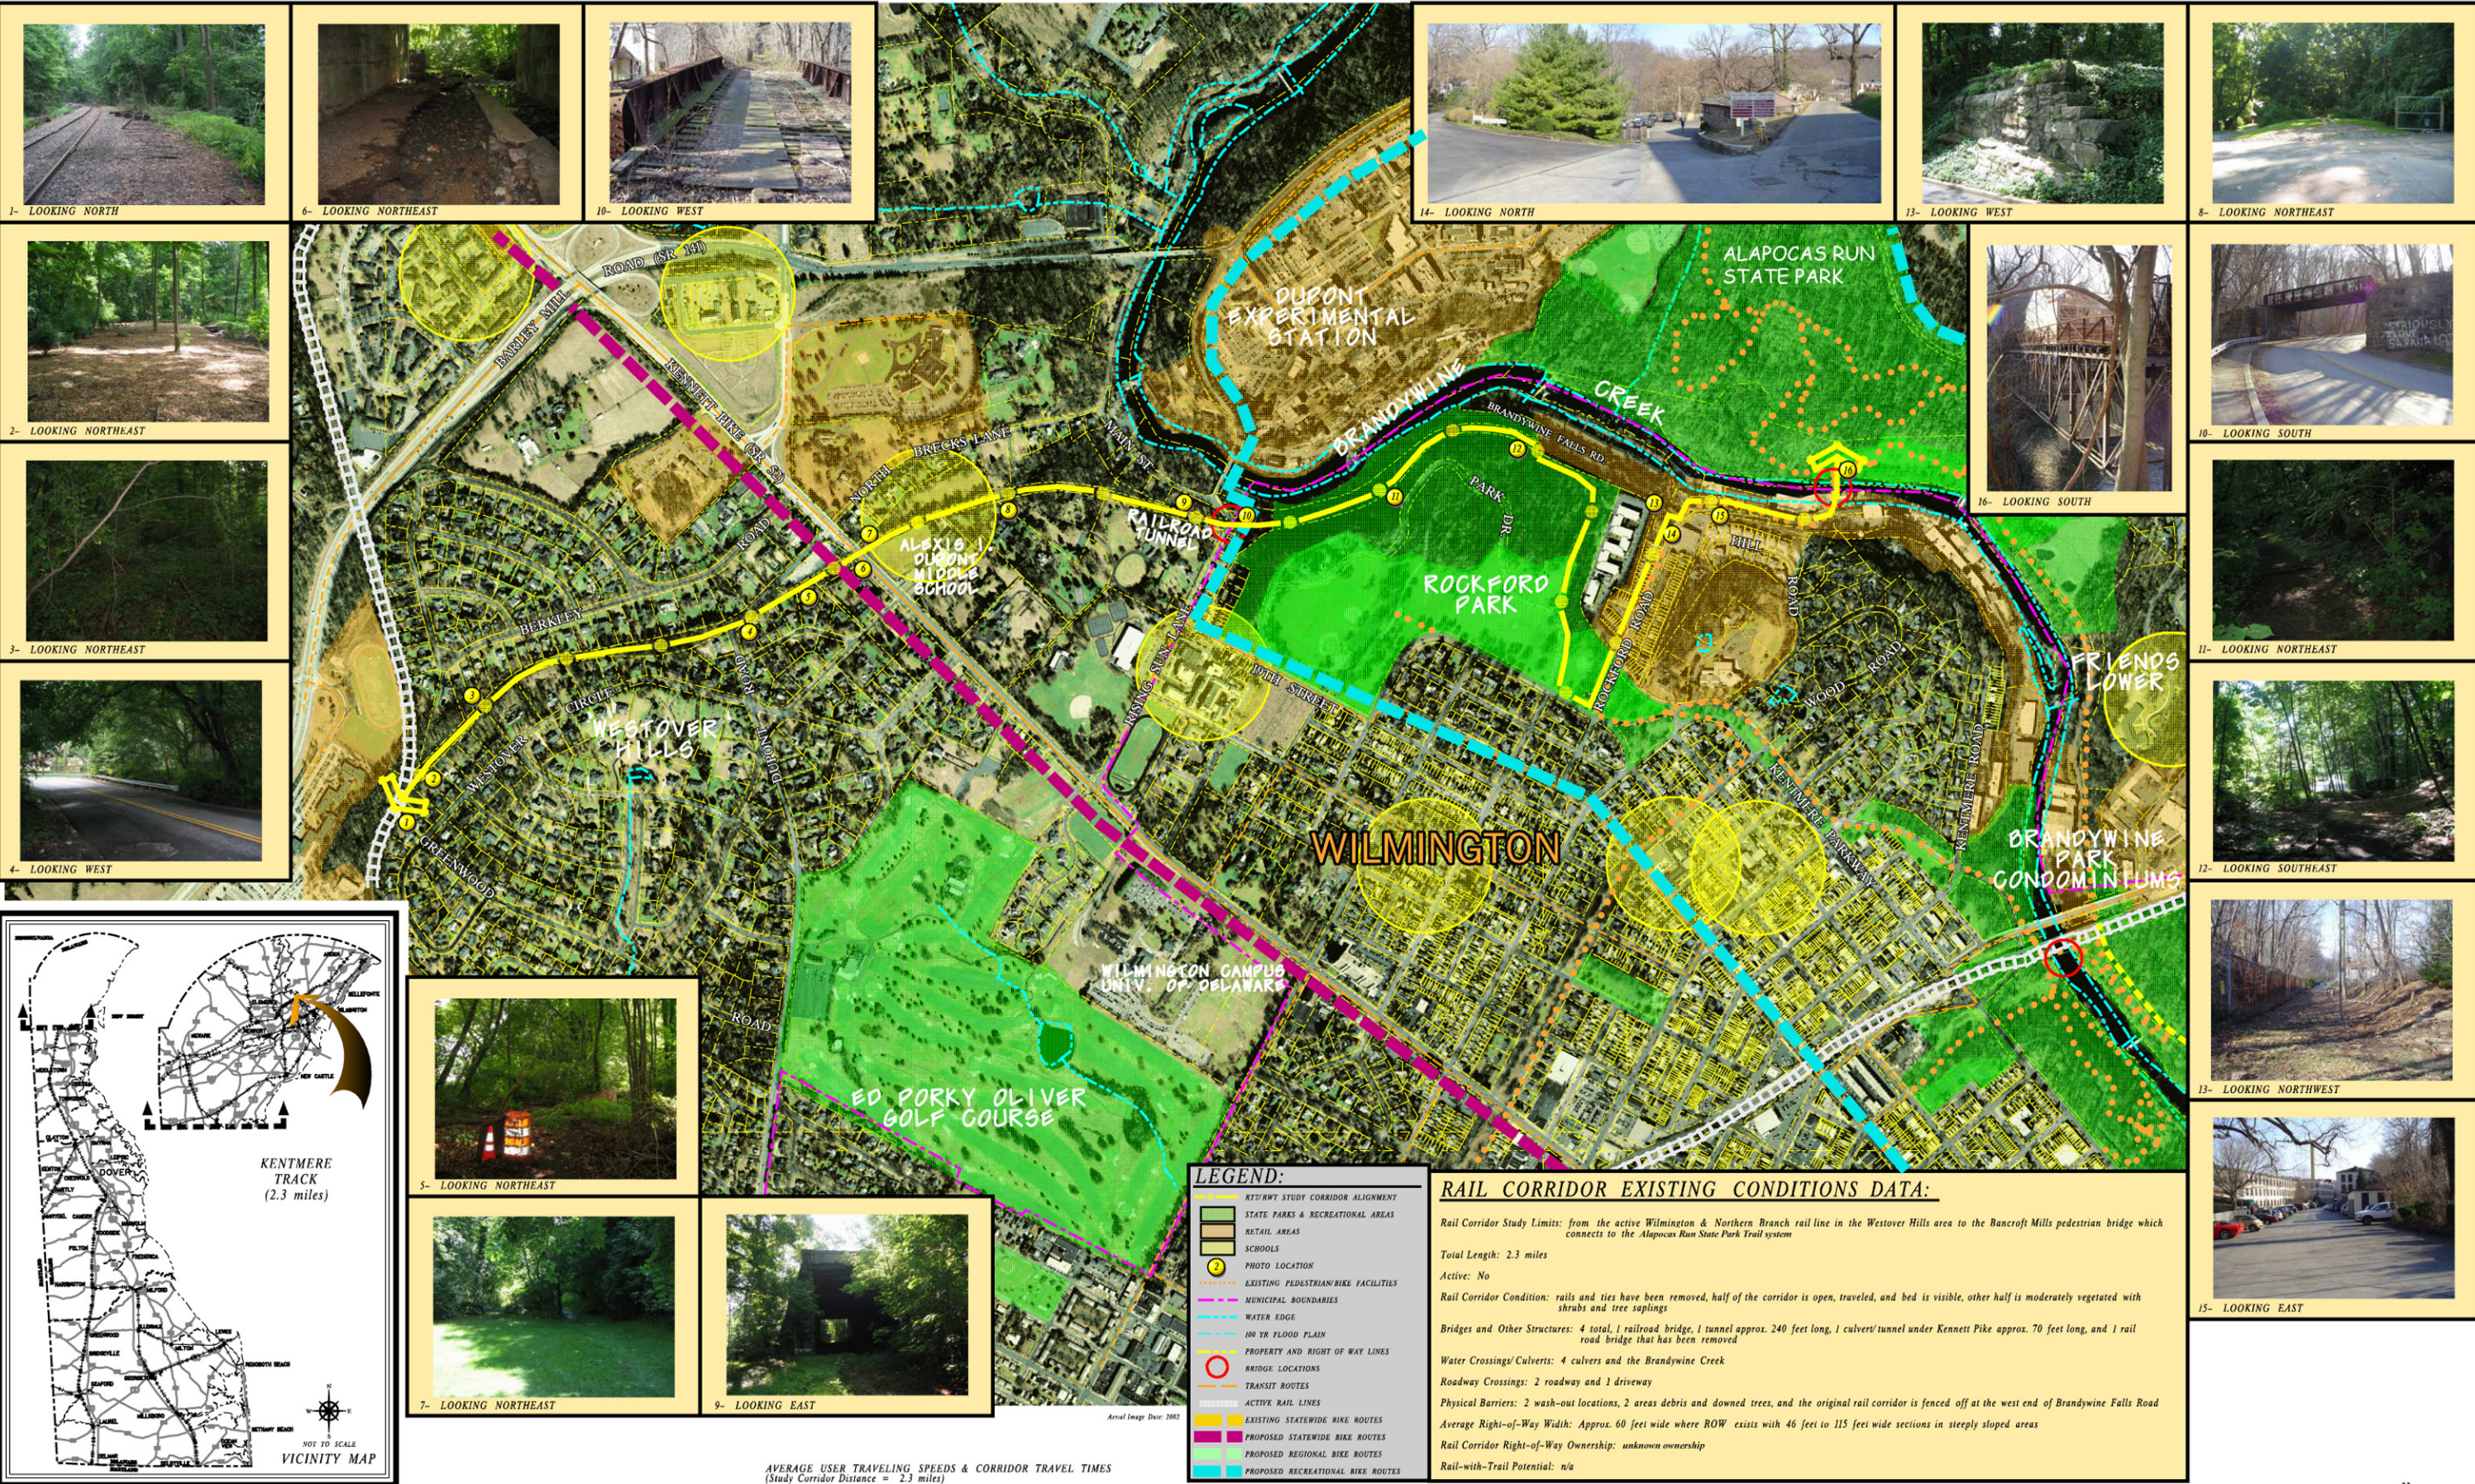
Rail Corridor Study Limits: from the active Wilmington & Northern Branch rail line in the Westover Hills area to the Bancroft Mills pedestrian bridge which connects to the Alapocas Run State Park Trail system

Rail Corridor Condition: rails and ties have been removed, half of the corridor is open, traveled, and bed is visible, other half is moderately vegetated with shrubs and tree saplings

Bridges and Other Structures: 4 total, 1 railroad bridge, 1 tunnel approx. 240 feet long, 1 culvert/tunnel under Kennett Pike approx. 70 feet long, and 1 rail road bridge that has been removed

Water Crossings/Culverts: 4 culverts and the Brandywine Creek

Roadway Crossings: 2 roadway and 1 driveway

Physical Barriers: 2 wash-out locations, 2 areas debris and downed trees, and the original rail corridor is fenced off at the west end of Brandywine Falls Road

Average Right-of-Way Width: Approx. 60 feet wide where ROW exists with 46 feet to 115 feet wide sections in steeply sloped areas
