For Preliminary Planning
Purposes Only

DELAWARE RTT/RWT FACILITIES MASTER PLAN
MILTON - LEWES LINE (WESTERN SECTION)
EXISTING CONDITIONS MARCH 2006

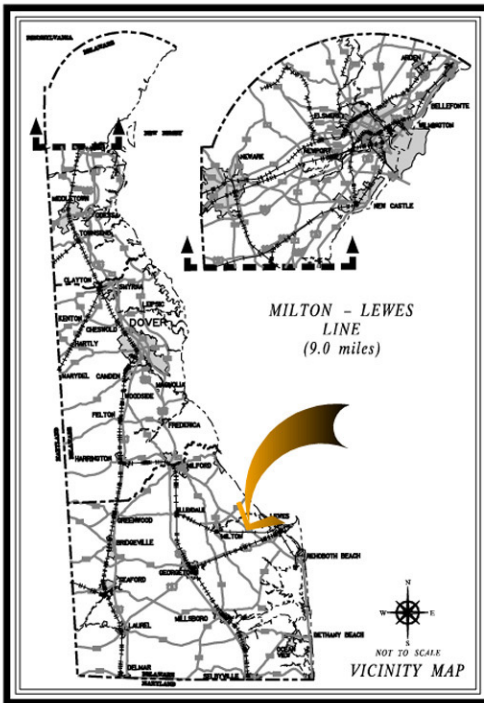
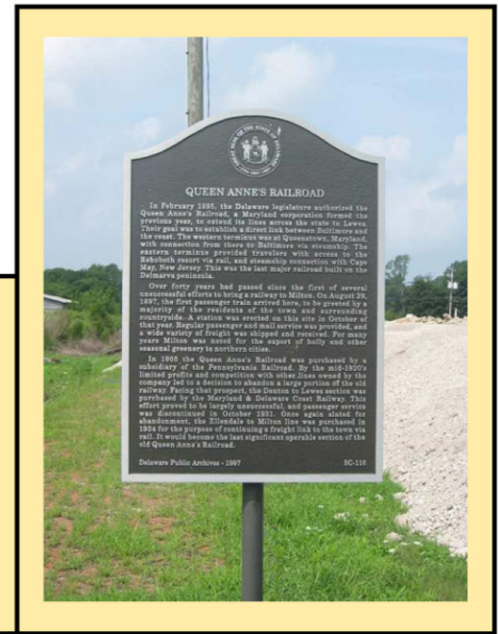
Rail Corridor Study Limits: from the Cannery Village Center area (east terminus of Ellendale-Milton study corridor) to the east terminus in Lewes near the 4th Street and Marina Drive intersection

Rail Corridor Condition: rails and ties have been removed, rail bed is not evident along most of the corridor, many wooded segments of the corridor are very heavily vegetated with mature trees

Bridges and Other Structures: 4 bridges along corridor, all have been removed

Water Crossings/Culverts: 4 small rivers and streams and approx. 12 culverts

Roadway Crossings: 17 roadway and 6 driveways

Physical Barriers: 4 water crossings with removed bridges and 3 dwellings/ structures
