# DELDOT'S SYSTEMIC SAFETY IMPROVEMENT PROGRAM

## HIGH FRICTION SURFACE TREATMENTS

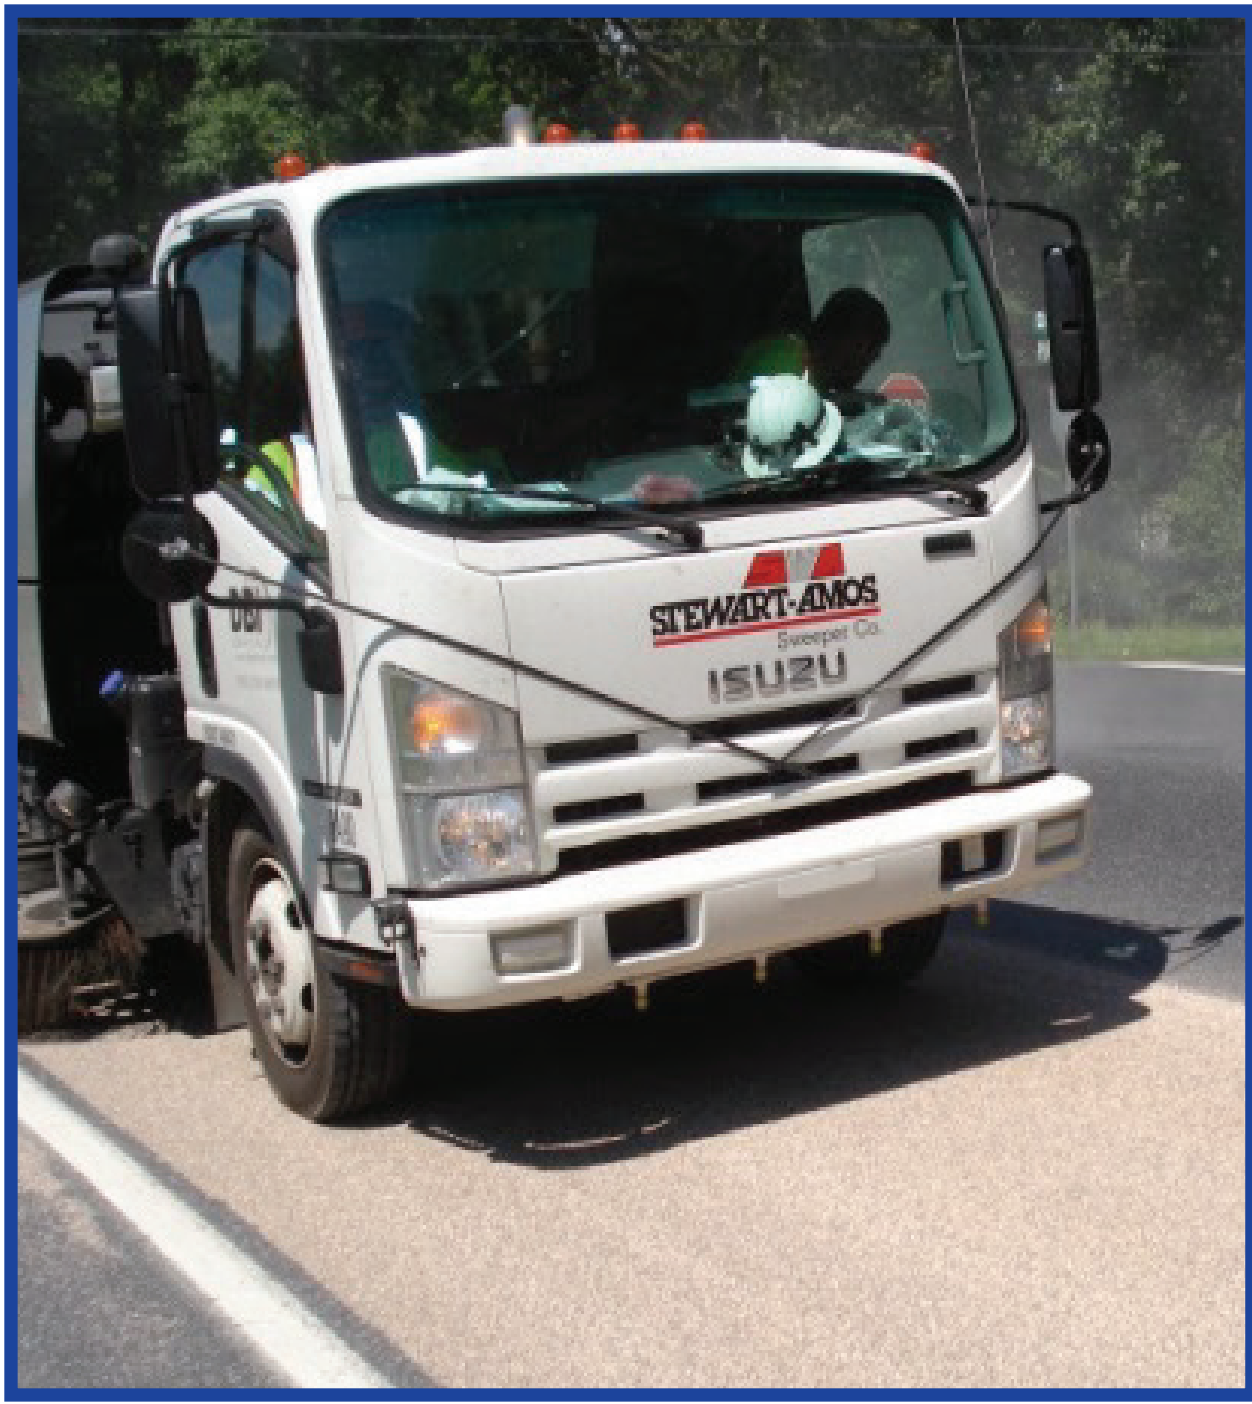
DelDOT uses an epoxy resin binder that holds the aggregate firmly in position. DelDOT uses a calcined bauxite aggregate that is the most common type of aggregate used in HFST treatments across the country.

HFST is a type of ultra-thin pavement overlay that utilizes an epoxy resin binder and a high-quality aggregate. The binder material is applied to a section of pavement and the aggregate is spread over the binder material. The aggregates are polish-resistant and abrasion-resistant, resulting in an improved pavement friction and longer-lasting overall friction. HFST is beneficial in areas where high friction demand is needed, such as within curves, on downgrades, and on approaches to intersections where vehicles must come to a stop.

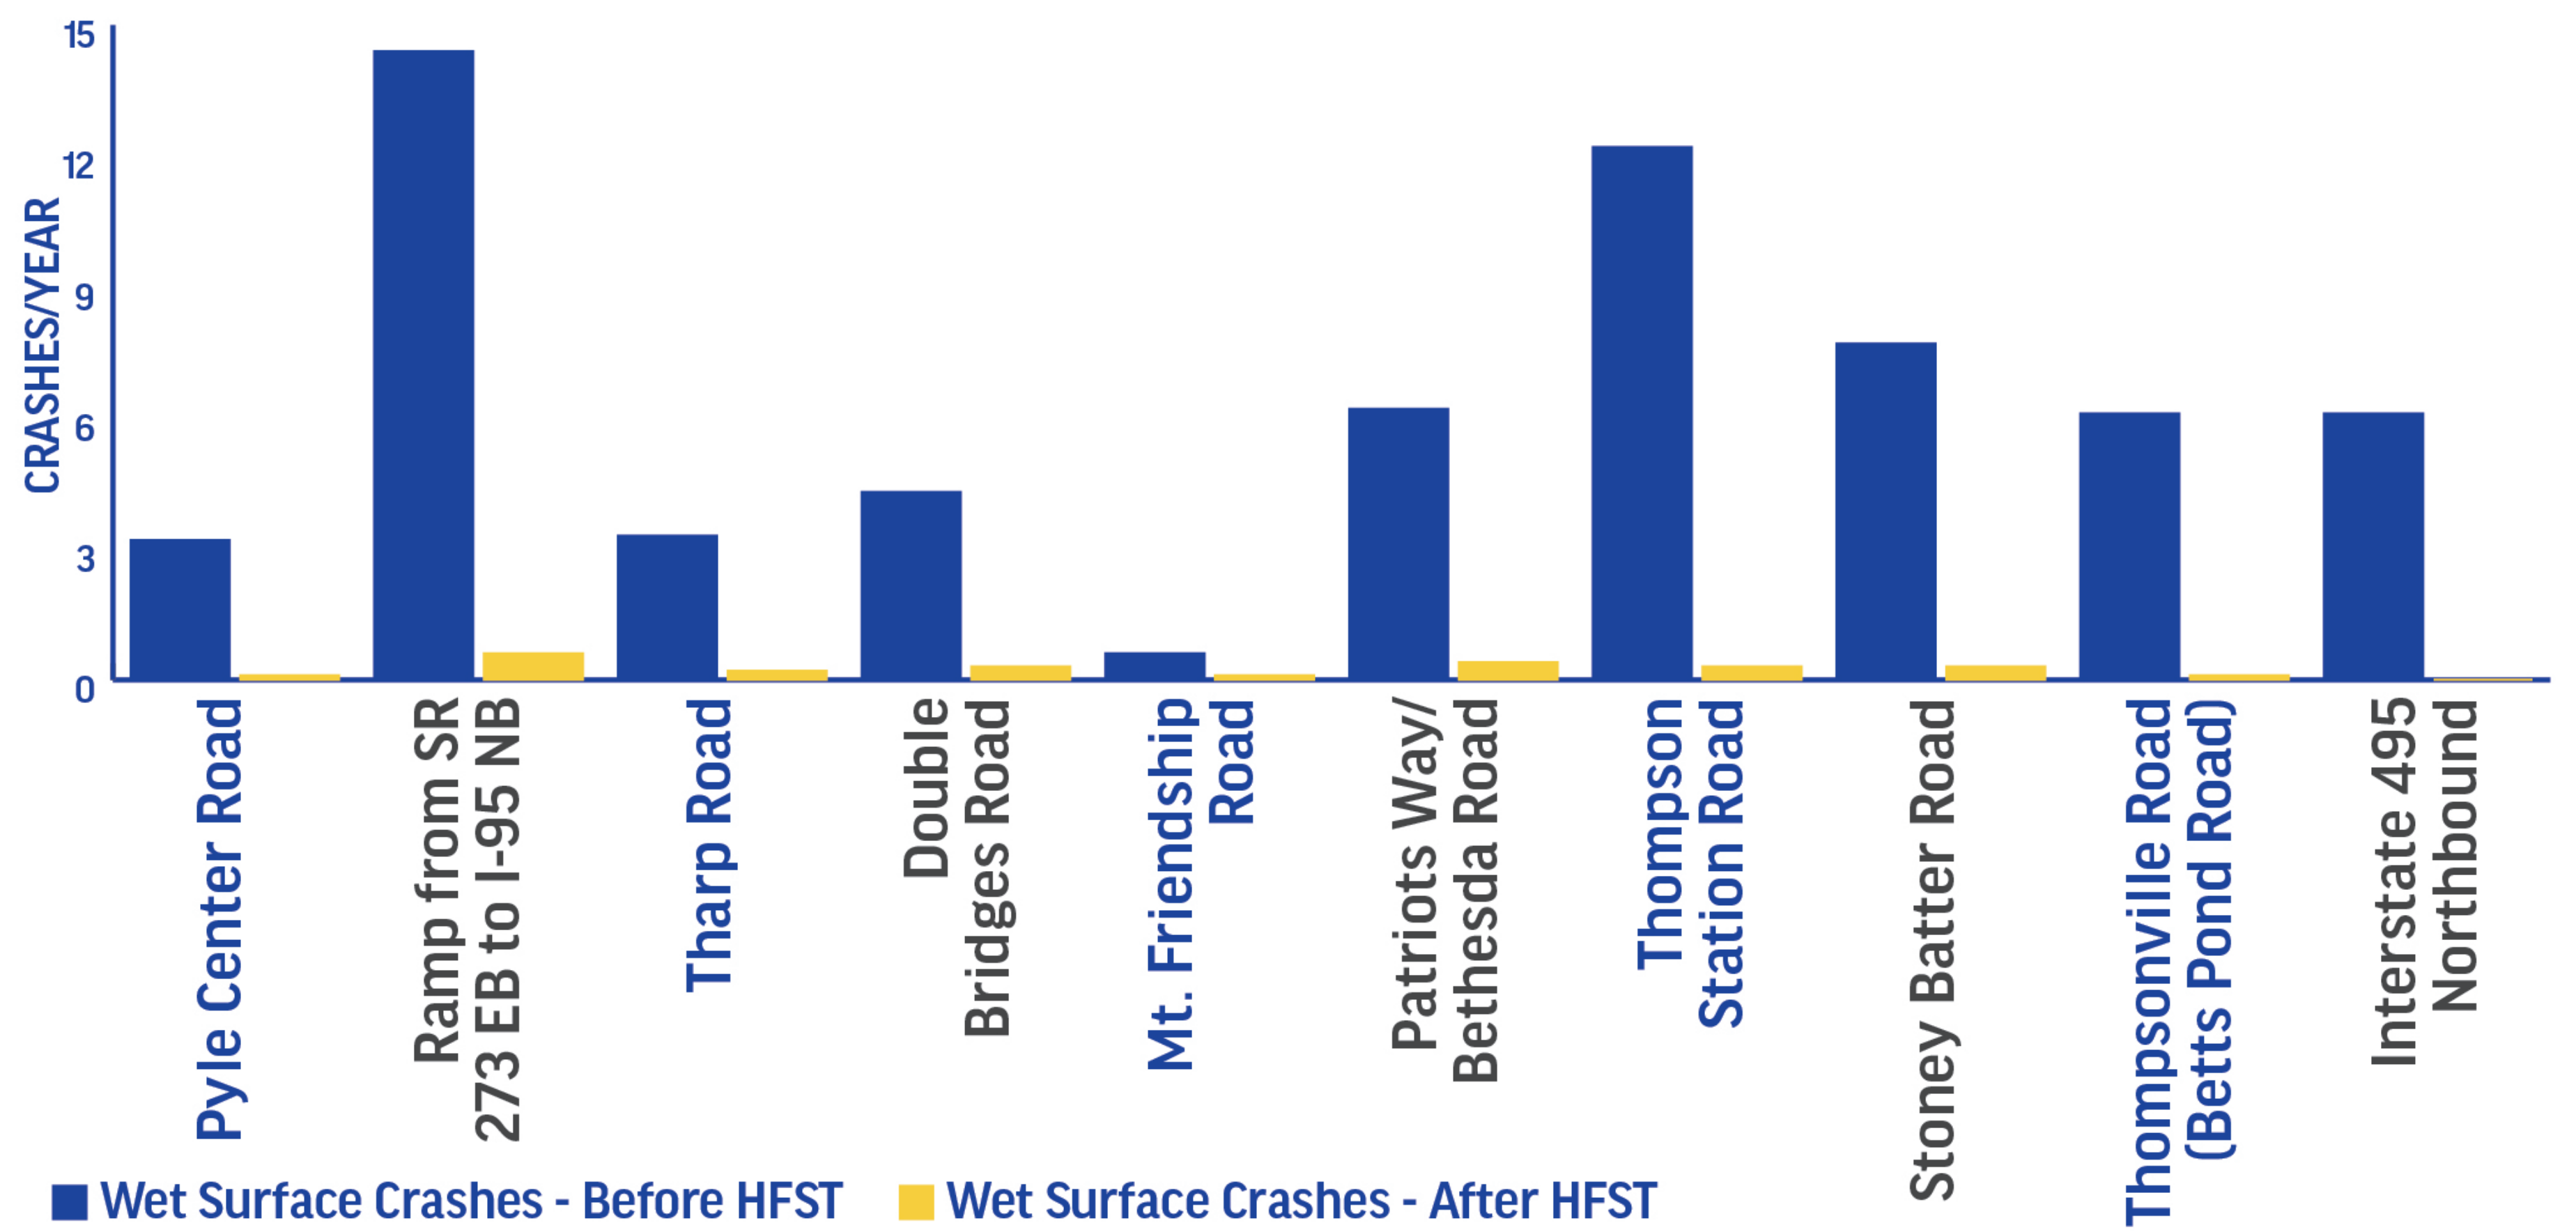
### COMPARISON OF WET SURFACE ANNUAL CRASH RATES

- At 16 of 44 locations, **zero wet-surface crashes** were reported during the after period (which ranges from approximately 1 to 10 years).
- The **total number of wet-surface crashes** per year decreased at all of the locations and by an overall average of **91%**.
- The **total number of crashes** per year decreased at 93% of the locations and by an overall average of **80%**.
- The **total number of roadway departure crashes** per year decreased at 43 of the 44 locations evaluated and by an overall average of **84%**.

**Crash Experience:** HFST applications have been implemented on 44 locations since 2015. Crash data, before and after HFST treatment, has been reviewed to determine the effectiveness of HFST. The results indicate the following:
