## MILL CREEK BRIDGE CROSSING AREA

The Mill Creek bridge crossing area is described in this section. The information provided includes a description of the natural setting and sedimentary stratigraphy. Discussions of local history and the bridge crossing's potential for containing cultural resources are also presented. The magnetometer survey results, field evaluation findings, and assessment of historical significance are provided along with recommendations concerning further work.

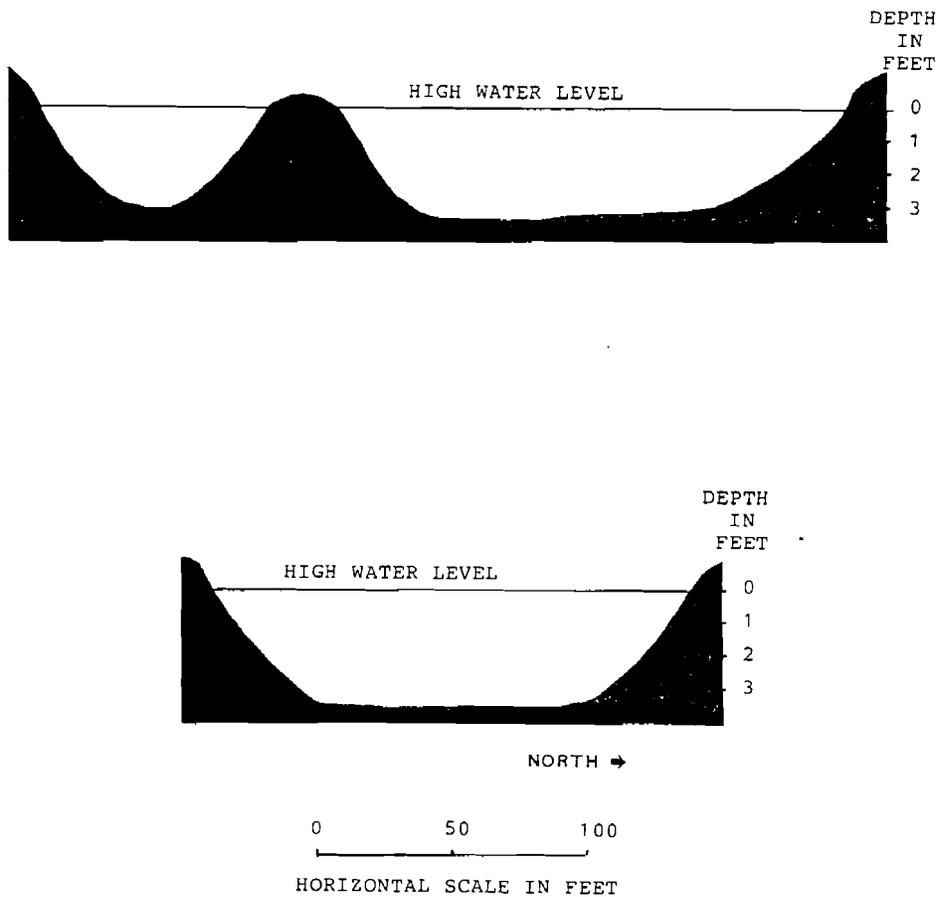
**FIGURE 86**  
**Bathymetric Cross Section of Mill Creek Project Area**

The present day bottom of Mill Creek at the bridge crossing is virtually flat. Bathymetric cross sections at two locations in the project area are shown in Figure 86. The submerged topography indicates that the naturally deeper portions of the watercourse have been filled to a smooth levelness by the deposition of alluvial sediments. This is characteristic of tidal streams that have undergone heavy silt deposition under low energy current conditions.

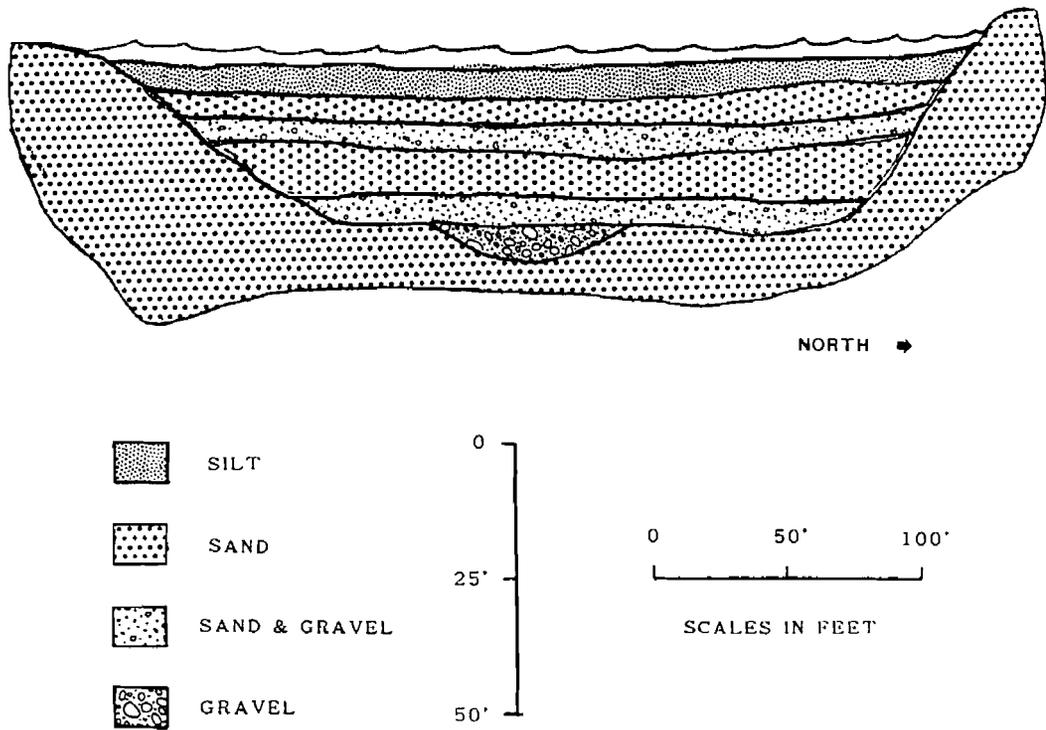
**FIGURE 87**  
**Stratigraphic Profile of the Mill Creek Project Area**

Figure 87 is a schematic cross section of the sediment stratigraphy in Mill Creek based on the soil borings. The vertical scale has been exaggerated to make the sediment strata more readily visible.

The natural subsoil in this vicinity is sandy. Into that subsoil, the ancient ancestral valley of Mill Creek was cut by erosion. The ancient channel was about forty feet below the present water level and is evidenced by a deposit of gravel. The gravelly bottom of the ancient stream indicates that it was a fast-flowing upland watercourse.

Superimposed over the gravel deposit is a sequence of four sand and sandy gravel strata. These sediments indicate the deposit in the stream bed of alluvial materials during a period of fluctuating water flow energy levels. That fluctuating flow was probably of lesser energy than the stream flow that left the deepest gravel deposit. The sand strata probably represent lower energy stream flows than the sandy gravel strata. Capping the uppermost sand stratum is a deposit of silt. This layer was deposited when the stream evolved into its lowest energy level, which was a tidal flow. That situation resulted when rising sea level caused this part of Mill Creek to become inundated.

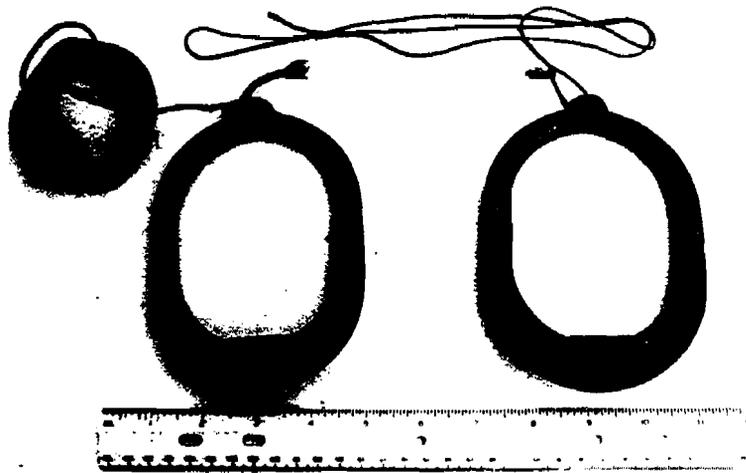
FIGURE 92  
Lead Decoy Weights from Mill Creek

The decoy weights are illustrated in Figures 92 and 93. They are oval in shape with a hole at the top for attaching a line to the decoy and a protruding lip on both sides of the base. The protruding lip near the base was made to lodge in the waterway bottom to prevent the decoy from drifting.

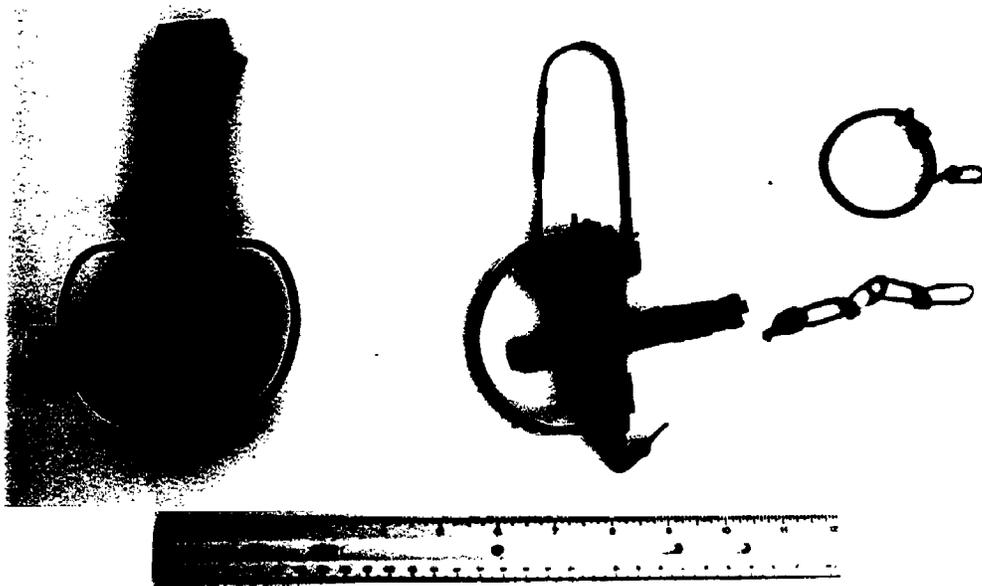
FIGURE 94  
Smooth-Jawed Leghold Trap from Site 7A-K-112

The small mammal trap was a steel smooth-jawed leghold trap, of a type known as the "Newhouse" trap (Bateman 1971). It is illustrated in Figure 94. It consisted of two semi-circular smooth jaws that are snapped together by a powerful spring. The trap is sprung when an animal steps onto the pan between the open jaws and activates the spring by means of a lever. This variety of trap is made to take game by securing a limb in contrast to the body-gripping Conibear trap described earlier (see Figure 79).

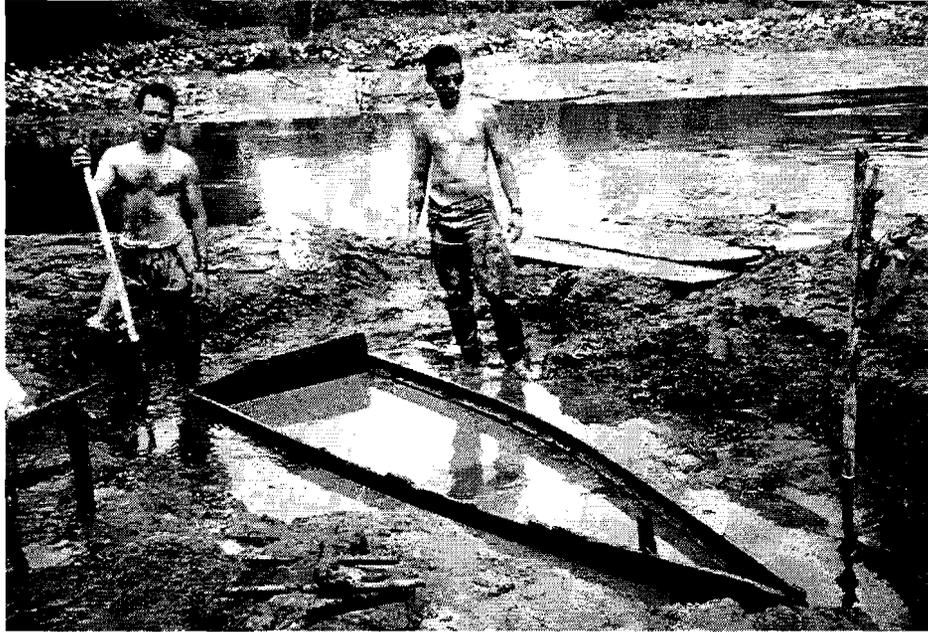
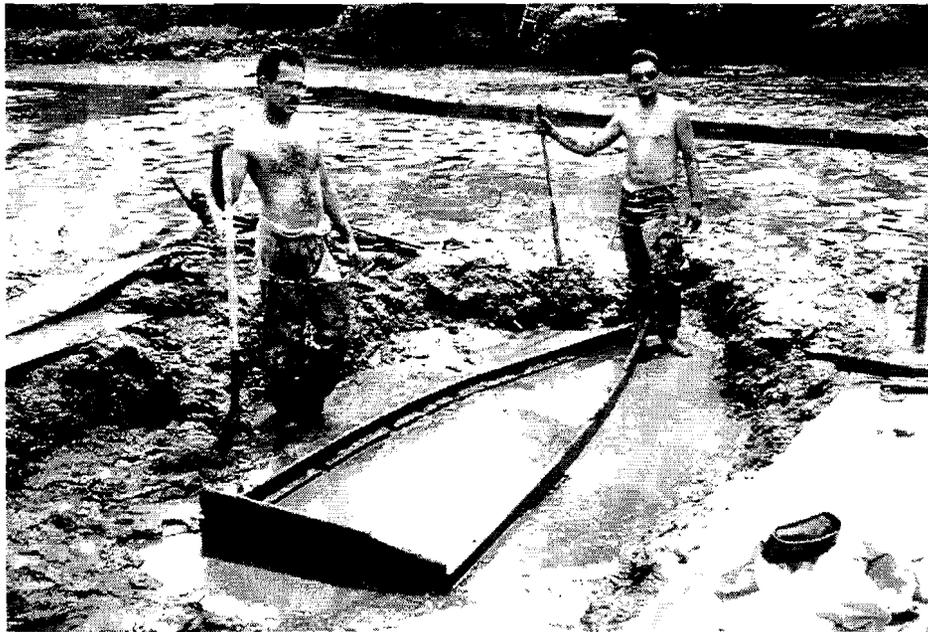
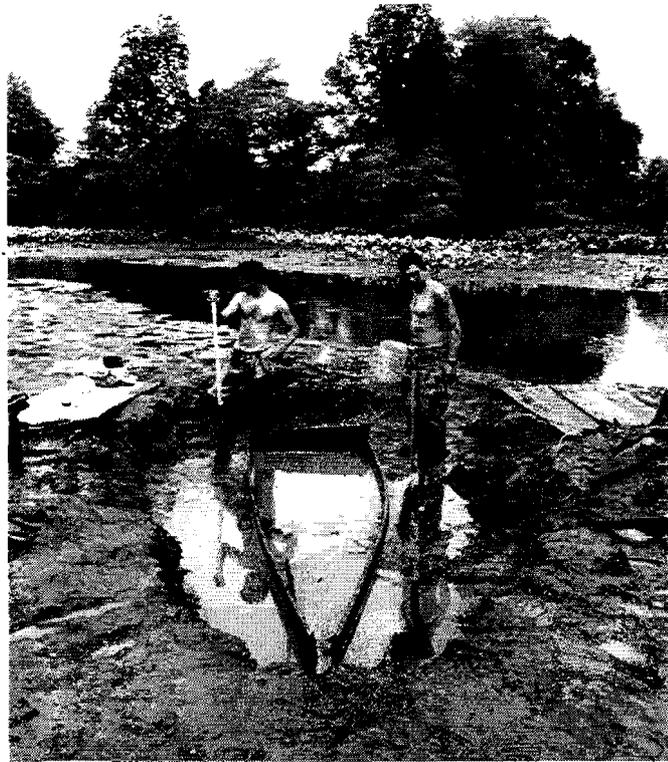
The row boat from Site 7K-A-113 was found to be 10'10" long with a maximum beam of 3'1" (Figures 96, 97, 98). Its bow came to a point and at its stern there was a square transom, giving its outline a somewhat triangular shape (Figures 99, 100, 101). A slight outward bulge along its sides amidships gave it a more boat-like shape. It was built of mechanically-sawn lumber.

The vessel was rectangular in cross section. The sides rose vertically from the bottom. It was an open boat without decking.

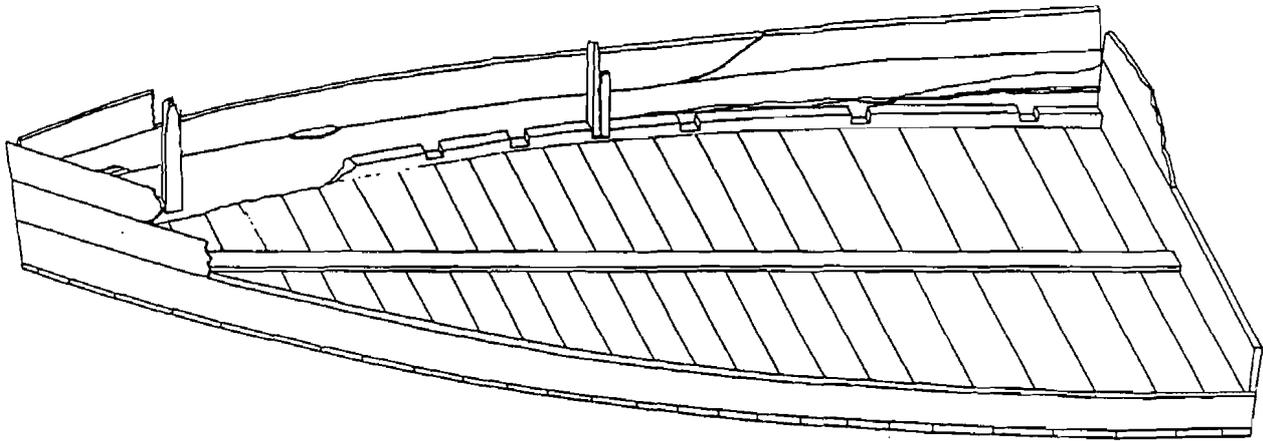
FIGURE 100  
Side View of Mill Creek Boat

The vessel's main longitudinal member was an interior keel 10'4" long measuring 1" tall by 2.5" wide. It lay along the centerline inside the boat. There was no exterior keel on the outside bottom. The boat's traverse bottom planks were fastened to the bottom of the interior keel (Figure 102).

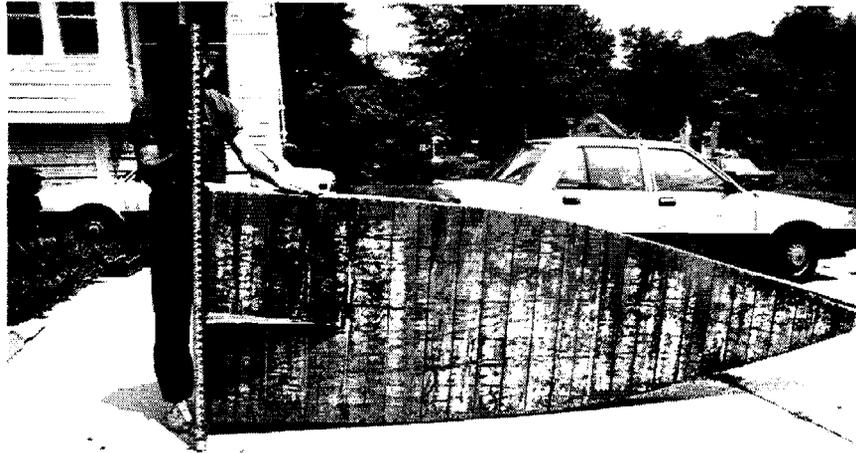
**FIGURE 102**  
**Bottom of Mill Creek Boat**

The lowest side planks were fastened at the base to the outside edges of the bottom planks. On the inside of the joint between the bottom and sides, there was a chine log on both port and starboard for reinforcement. A representative illustration of the position of the chine log in a flat bottomed boat is provided in Figure 103. The chine logs in this vessel were single timbers measuring 1" wide by 2" tall by 10'6" long. They were notched to receive the vessel's vertical frames.

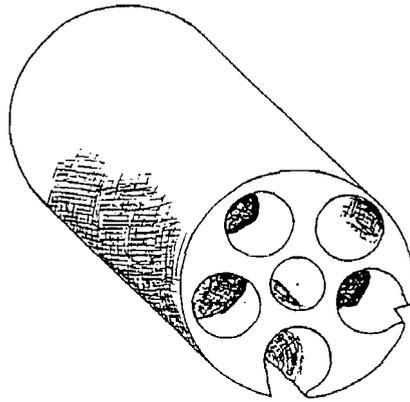
FIGURE 110  
Revolver Pistol Cylinder from Mill Creek Target # 16

Several artifacts that were used for domestic or personal purposes were found. These included a brass doorknob (Figure 106), two fragments of a knife with a handle bearing a ribbed design (Figure 108), the metal casing of a lipstick, and the cartridge cylinder of a revolver pistol (Figure 110).

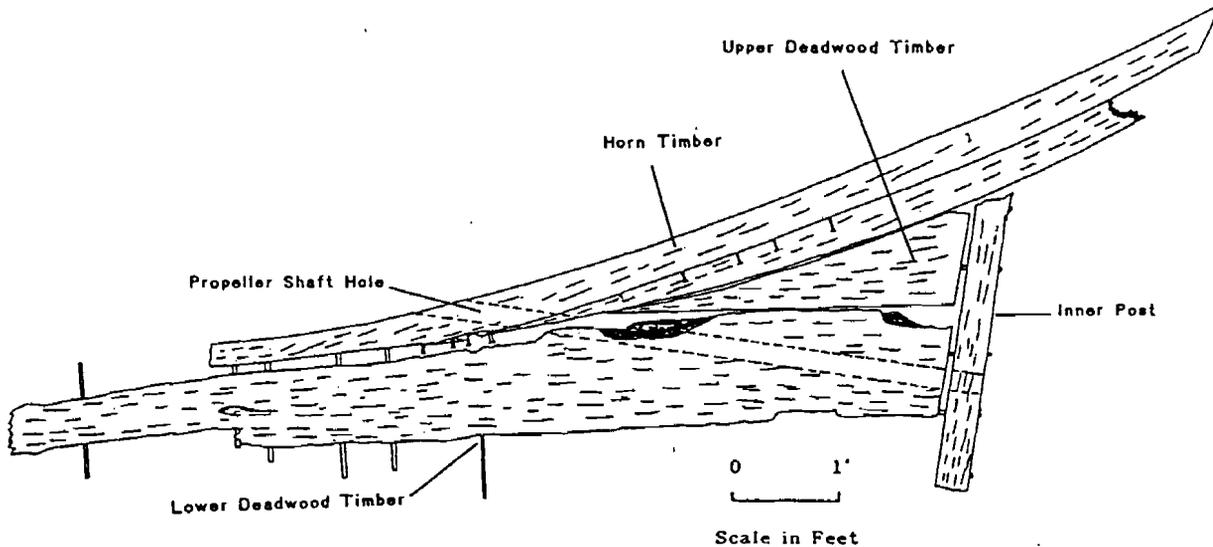
**FIGURE 115**  
**Mill Creek Shipwreck Assemblage**

The four timbers present in this assemblage consisted of the following: horn timber, upper deadwood timber, lower deadwood timber, and inner post (Figure 115). The keel timber that had been attached to the underside of this hull section was missing. The vessel's hull planks were also missing, but several of the wire nails and square shanked boat spikes used to fasten them to the skeg area remained embedded in the intact assemblage.

The main member of this articulated skeg assemblage was the horn timber. It measures 9'1" long and had a maximum height of 7". The horn timber was curved in shape to follow the upswept lines of the vessel's stern. Both of its butt ends were beveled.

The horn timber was rabbeted on its underside for attachment of the hull's bottom planks. Several square shanked boat spikes and common wire nails remained embedded in the horn timber, showing where the bottom planks had been fastened. The rabbeted portion started 24" from the forward end of the horn timber and had an overall length of 73". It was beveled flush at its forward end and rose gradually in height to a maximum of 4" tall at the point where it ended at the hole for the rudder post. Whether or not the rabbeting continued sternward of the rudder post was unclear due to poor preservation of the wood there. The horn timber's rabbeting was 3" wide on both the port and starboard sides.

At a distance of 11.5" from its stern end, the horn timber was pierced by a circular hole 3" in diameter to accommodate the vessel's rudder post. When found, this hole contained an iron pipe 3" in diameter which served as the bearing sleeve for the vertical rudder post (Figures 116, 117). This pipe was fitted with a hexagonal nut at its upper end to prevent it from slipping downward.

Towards its forward end, the horn timber was pierced by a circular hole 2" in diameter to receive the vessel's propeller shaft and shaft bearing sleeve. At its forward end, it was bevel-cut to fit flush with the lower deadwood timber to which it was fastened with drift bolts. The drift bolts extended through the deadwood and into the keel, which was missing from this assemblage.

The inner post was pierced with a hole 2" in diameter to receive the propeller drive shaft. The exterior (sternward) face of the shaft hole was bracketed by four fastening holes (two above and two below) which appear to have used for attaching a metal bearing plate. When found, two of the fastening holes contained wooden pegs, one above and one below the shaft hole. The other holes were empty but identical to the two holes containing the wooden pegs. It appears that the shaft plate had been affixed using wooden pegs exclusively. The propeller shaft hole was not precisely aligned with the vessel's centerline. The inner post had been worn through on the starboard side.

The vessel's fastenings consisted of iron drift bolts, spikes, and nails. The drift bolts were 0.5" in diameter and from 10" to 16" long. Both flat head wire nails and square shanked boat spikes were used for attaching the hull's bottom planks to the horn timber and lower deadwood timber. The square shanked boat spikes were 4.5" long and the nails were 4" in length. They were spaced 1.5" to 8" from each other, most commonly using a spacing of 2" to 3.5". While most of the spikes were aligned fairly evenly, several were offset. This offsetting appears to be evidence of repairs to the hull during the vessel's operational career.

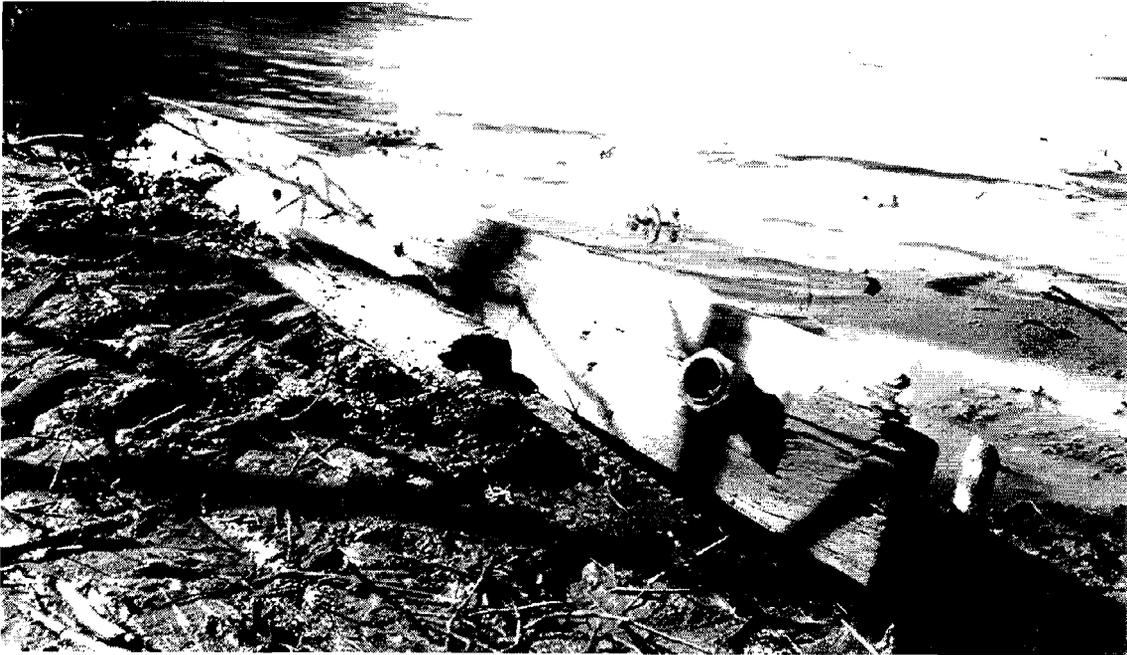
**FIGURE 116**

**Photograph Showing Mill Creek Shipwreck Assemblage Rudder Post Pipe**

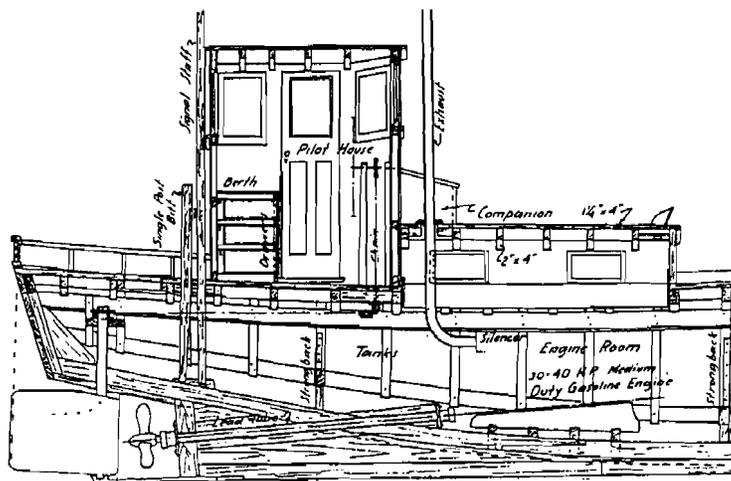
FIGURE 118

Position of the Skeg on Early 20th Century Work Boat Hulls
