Gawthrop Hall
(CRS # N-14422.02)

Detailed Building Description

Gawthrop Hall
 Facade (east) - Elevation
 (CRS# N-14422.02)

CULTURAL RESOURCE SURVEY
MAIN BUILDING FORM

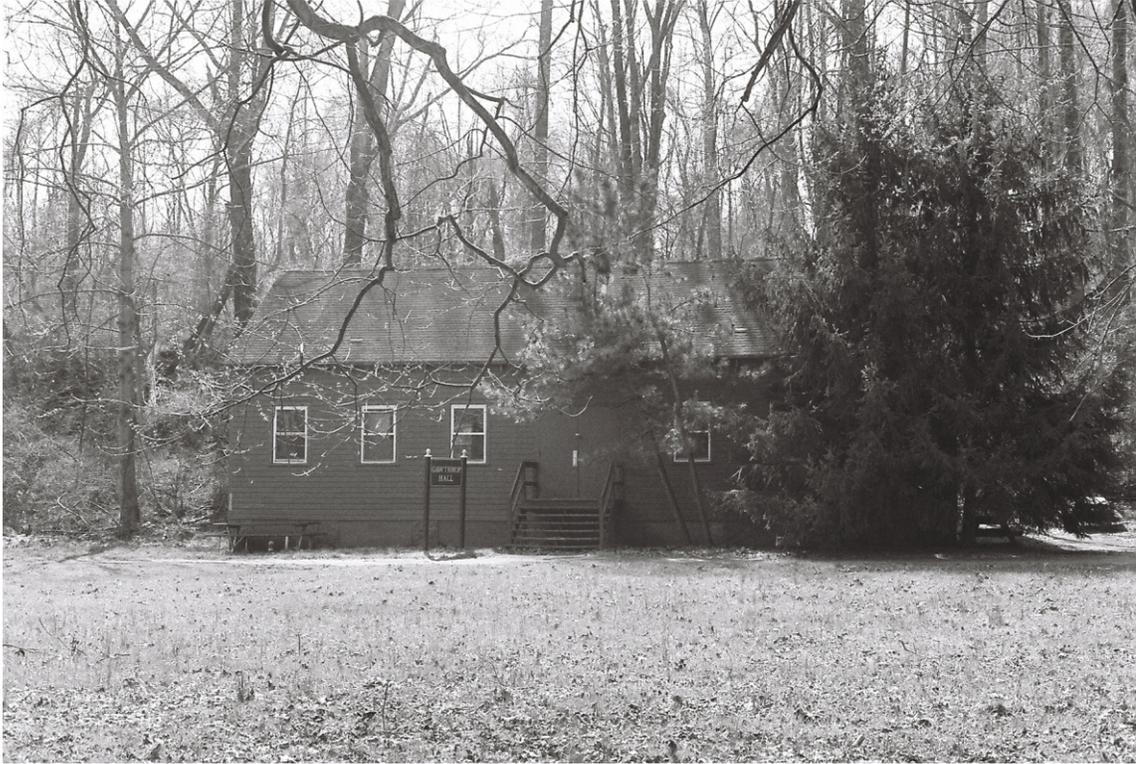
Plate 01: View looking west at the east facade elevation.

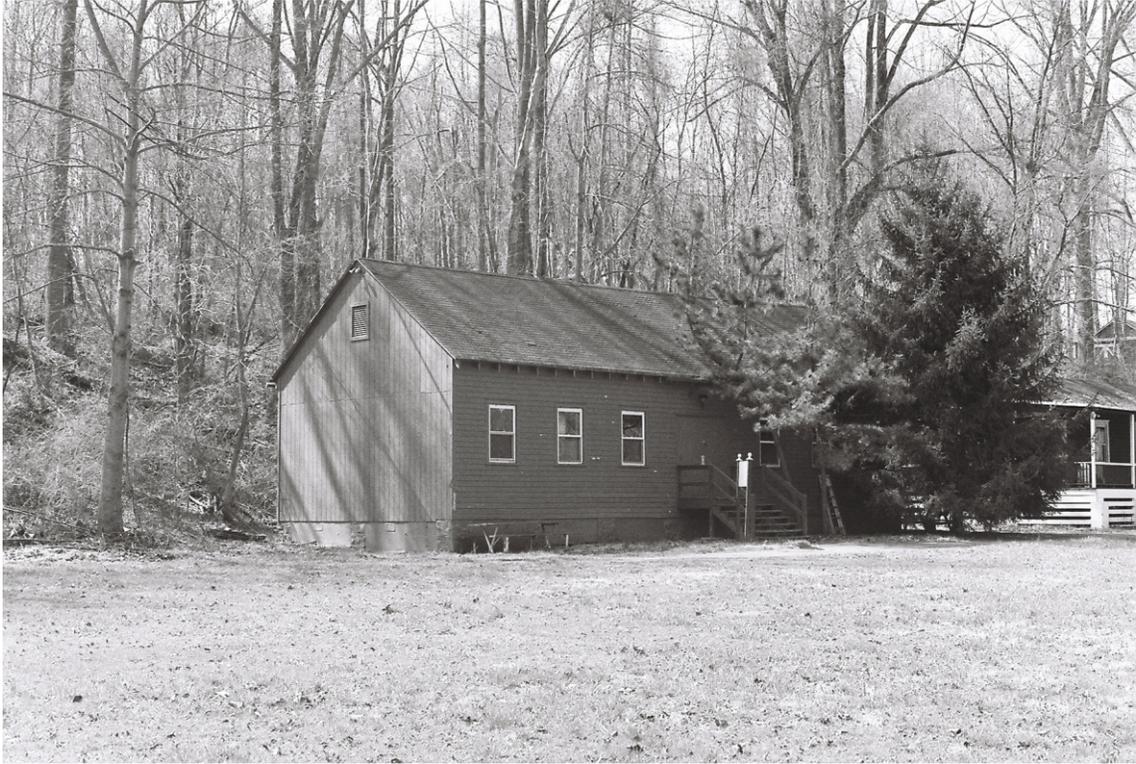
Plate 02: View looking northwest at the south side and the east facade elevations.

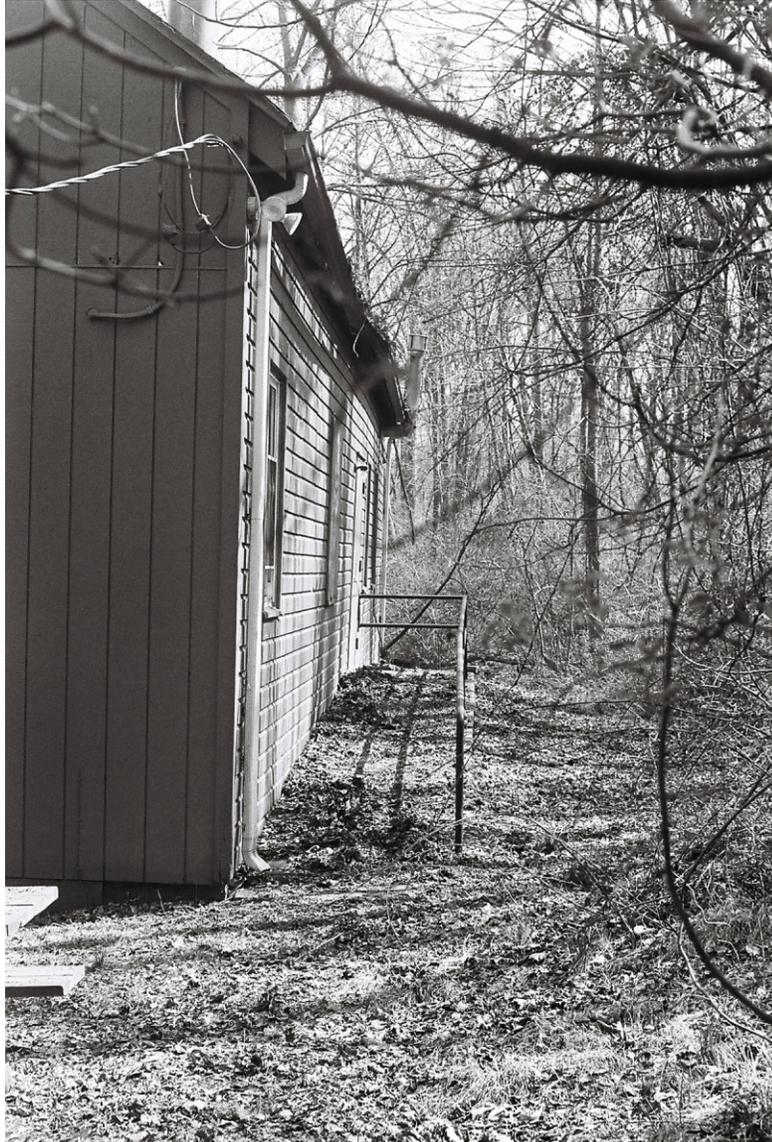
- The centrally located door is a steel safety door set flush with the handicap accessible ramp.
- The concrete handicap ramp starts at the north end of the west elevation and extends 33 feet to the door.

Plate 03: View looking south at west rear elevation. Note handicap access ramp.

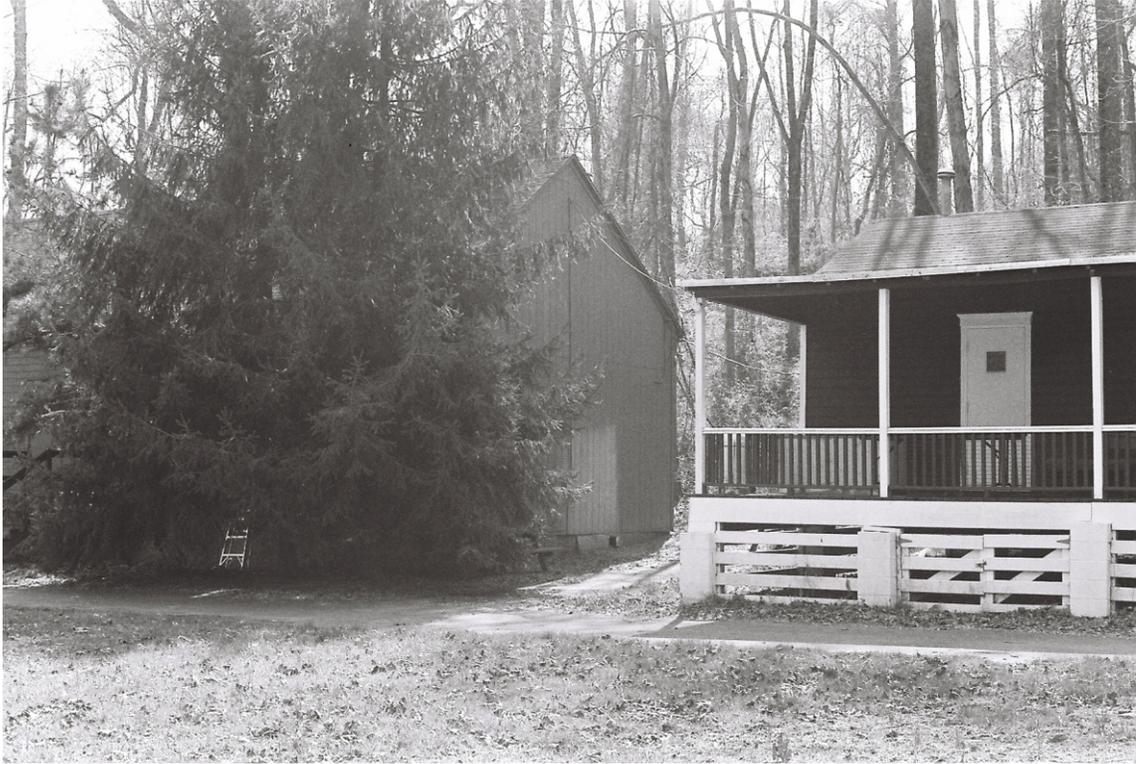
Plate 04: View looking southwest at the north side elevation.

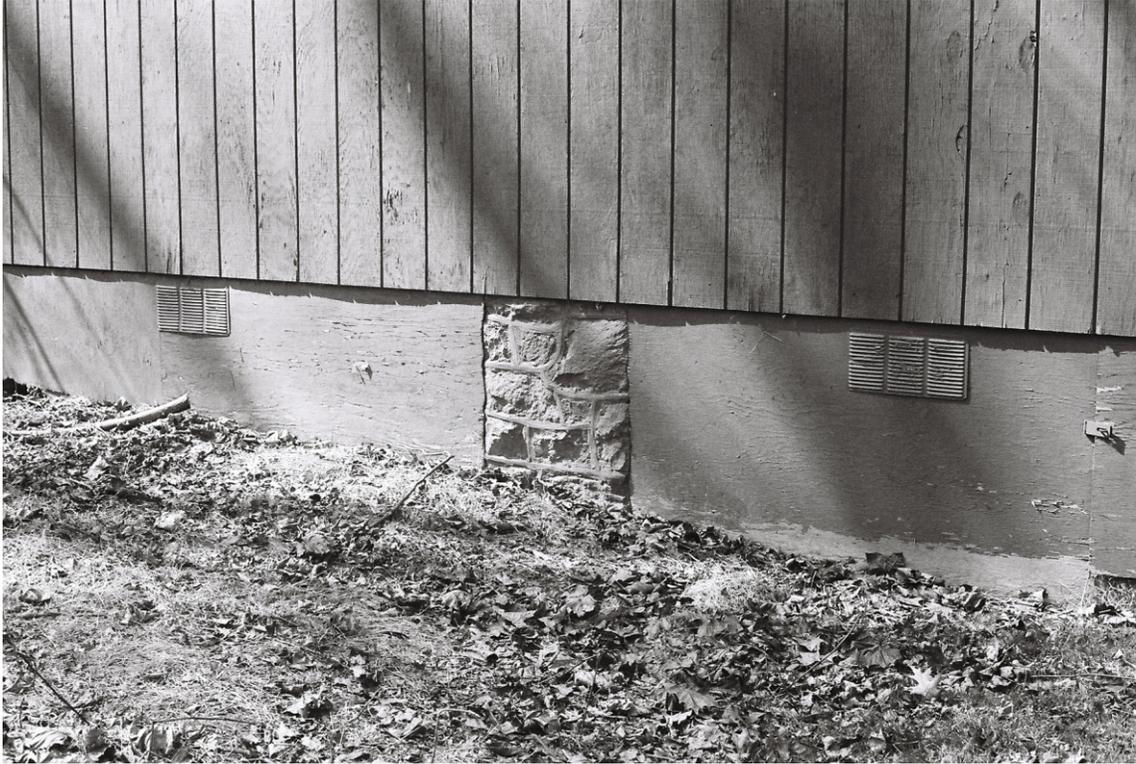
- The east elevation is supported by seven stone pillars, three to north of door, three to the south of door, and a large stone pillar below door.
- The smaller pillars range between 24 and 25 inches wide.
- The large central pillar is 121 inches wide.
- The pillars are spaced between 59 and 72 inches apart.

Plate 05: Detail of stone pier with razed joints.

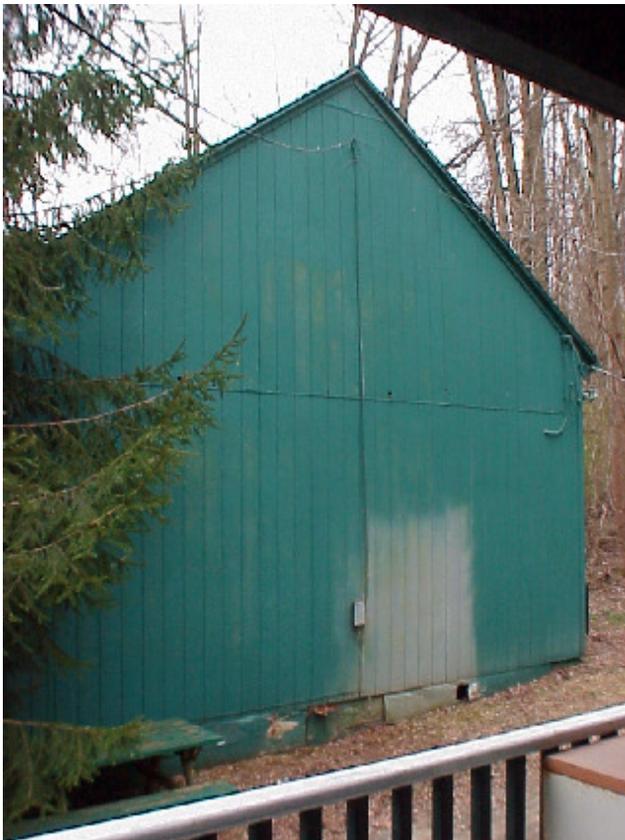
- The north elevation is 24 feet long.
- There are no windows, doors, or other openings on the north elevation.
- There are parallel horizontal strips of 1-inch moulding set at eight feet apart at the junction between the sheets of sidings. One is near the top of the gable and one is 35 inches below the gable.
- There is a 1x4 inch fascia board below the roofline.
- Phone service is attached near the top of the gable.
- Electric service is attached in the lower right (west) portion of the gable.
- The north elevation rests on three piers which range from 24 to 25 inches wide.
- The piers vary in height between 21 inches in the east to only 4 inches in the west.
- There is an aluminum vent in the center of each plywood crawl space cover.

Plate 02: View looking south at north elevation.

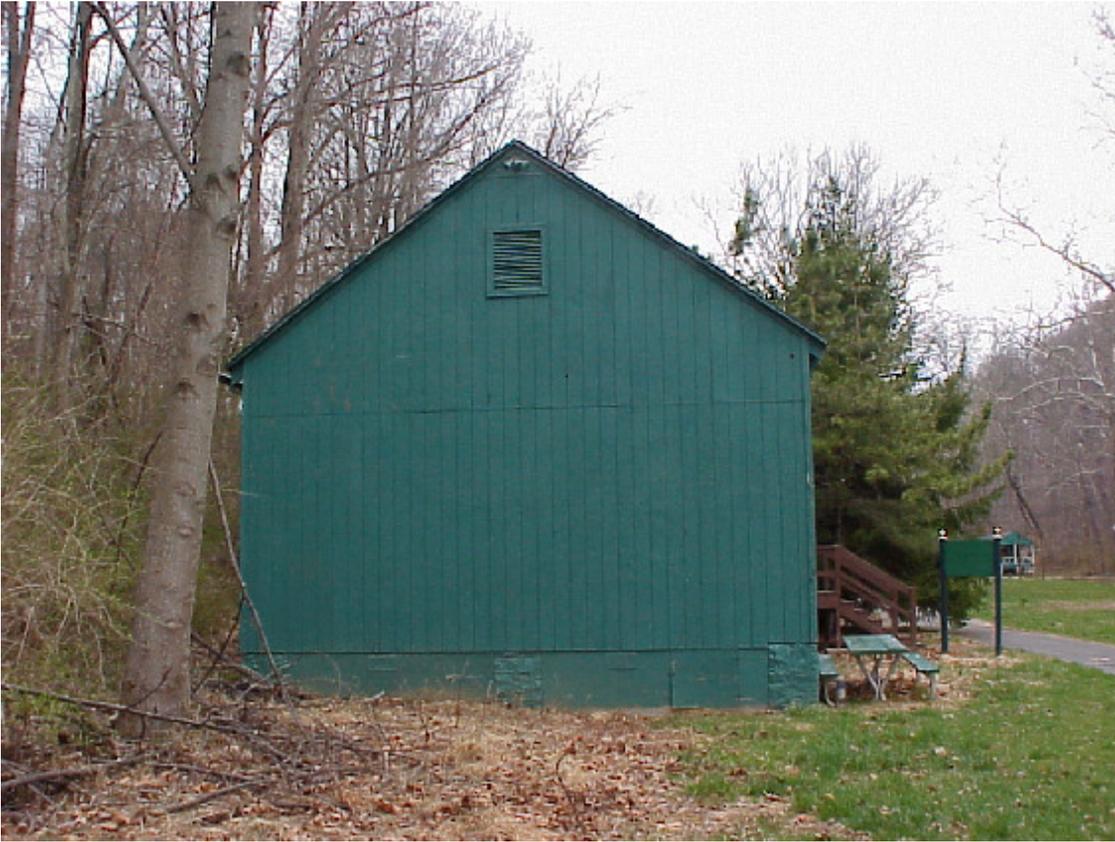
- The south elevation is 24.1 feet long.
- There are parallel horizontal strips of 1-inch moulding set at eight feet apart at the junction between the sheets of sidings. One is near the top of the gable and one is 35 inches below the gable.
- There is a 1x4 inch fascia board below the roofline.
- There is a wooden louvered vent in attic.
- There is a pair of floodlights at the top of the gable.
- The south elevation rests on three piers which are 24 inches wide.
- The height of the piers varies between 38 inches in the east to 23 inches in the west.
- The piers are set at 105 inches and 111.5 inches apart.
- There is an access door to the crawl space between the east and middle pier.
- The access door is plywood.
- While examining the crawl space, it was noted that all of the pillars are stone.

Plate 03: View looking north at south elevation.

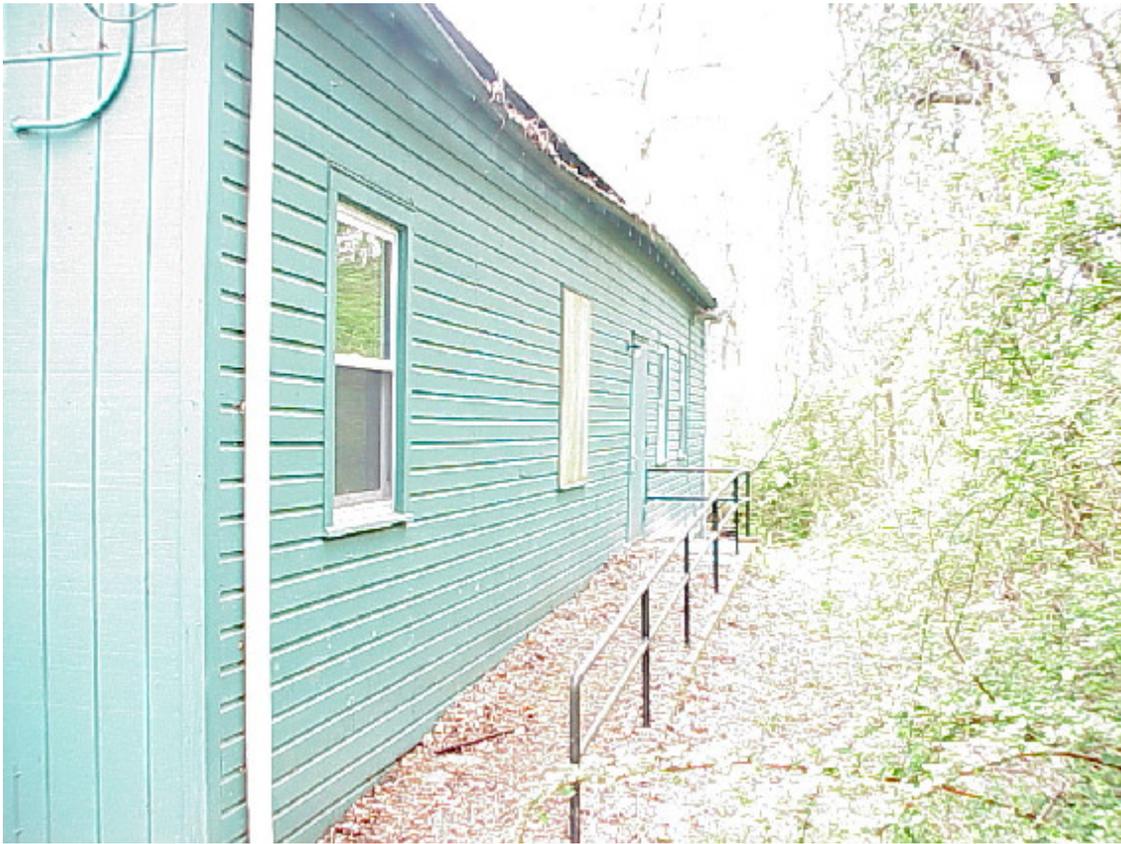
- The ramp has a gentle slope with a flat platform at the door.
- The handrail is made of welded pipe.
- There is a gas valve south of the southern most window.

Plate 05: View looking south along west elevation. Note handicap access ramp.

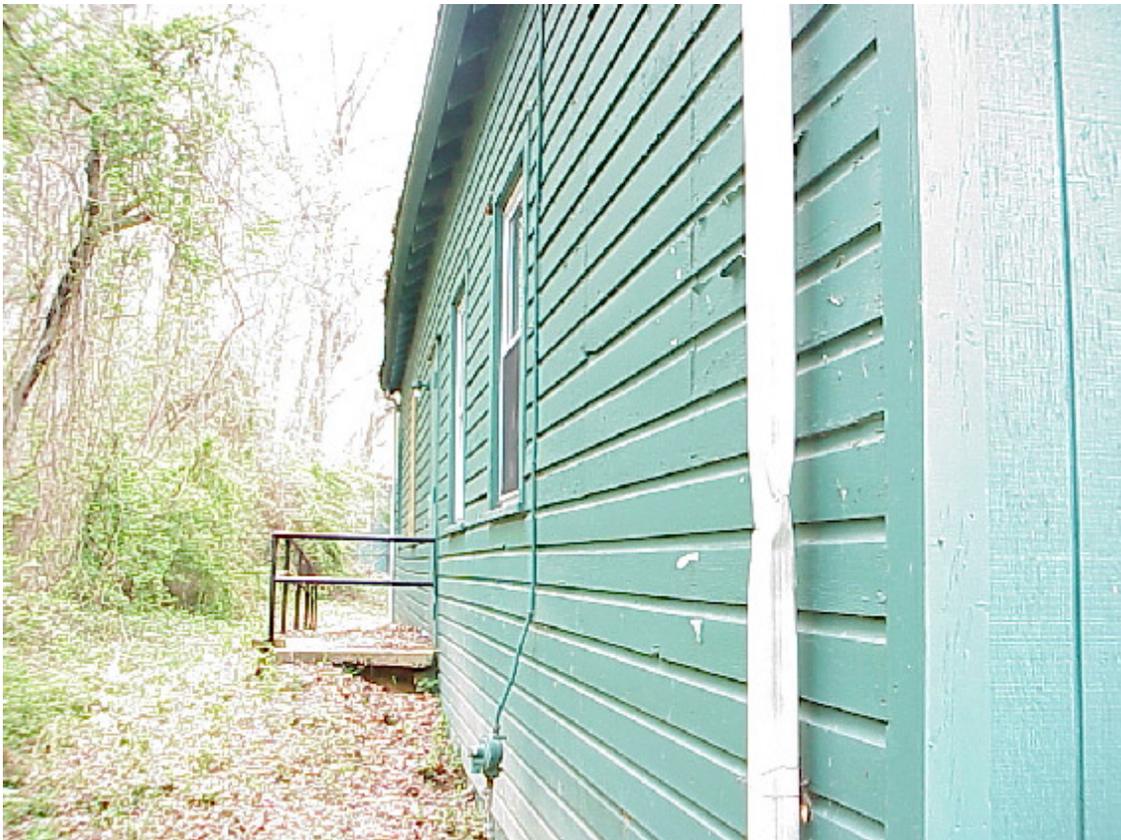
Plate 06: View looking north at west elevation. Note handicap access ramp.

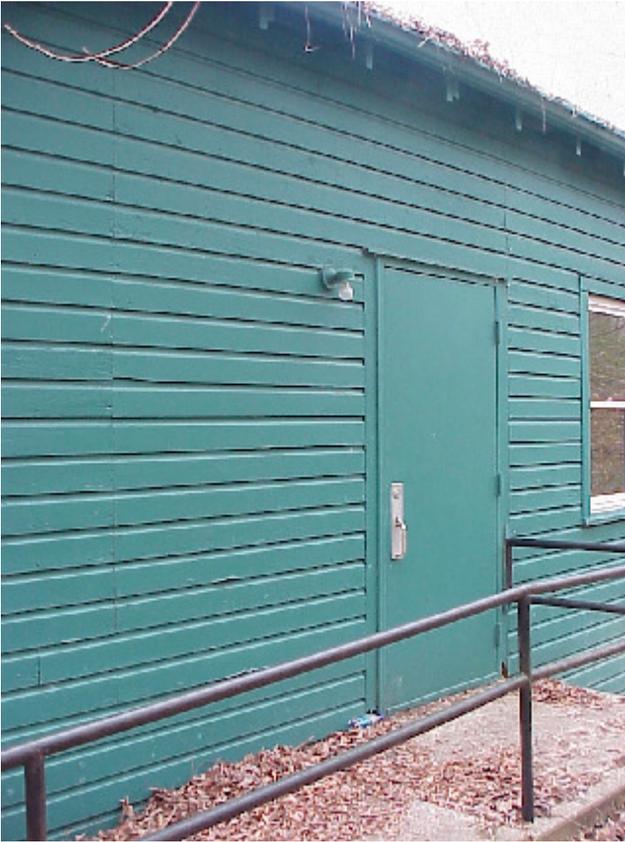
- There is a single steel-safety door almost centered in the west elevation.
- The steel-safety door is a replacement for a former double door.
- There is an incandescent light fixture mounted near the upper right of the door.

Plate 07: Detail of location of former doorway. Present door is to photo right.

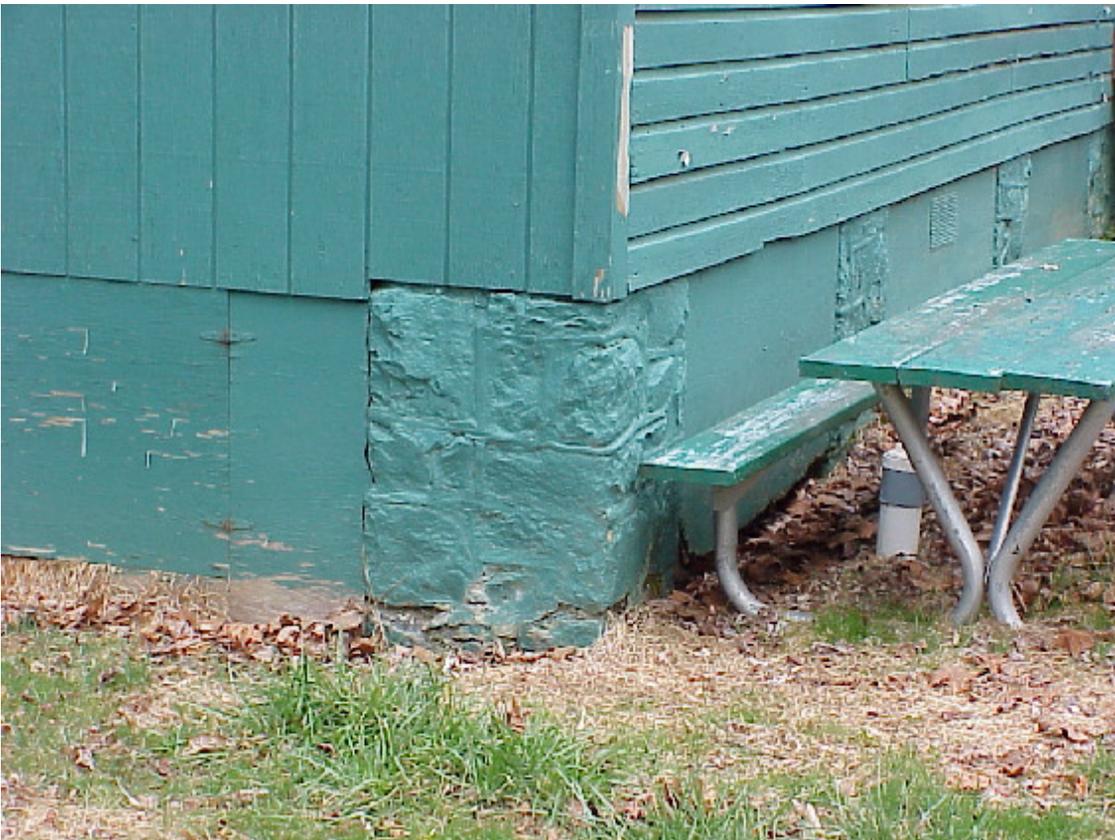
Plate 08: Detail of raised mortar joints on stone piers.

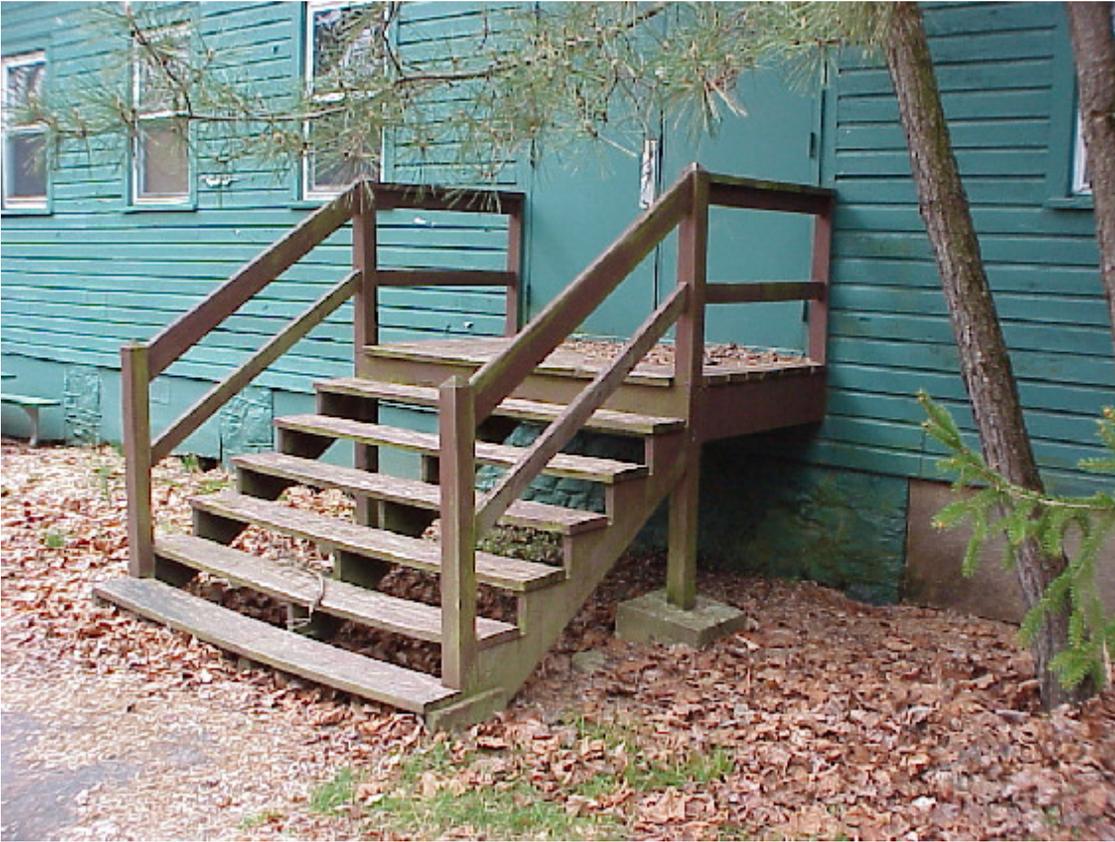
- The stair and the landing are 84 inches north south.
- The landing is 49.5 inches east west.
- The treads are 9.5 inches front to back.
- The height of the risers varies between 6 and 6.5 inches.
- The landing and stairs extend out 108 inches from the building.
- The posts are 4x4 inch boards.
- The posts and the bottom of the steps rest on poured concrete pads.
- The handrail for the steps is a 2x6 inch board. The middle railing and the handrail for the landing are made from 2x4 inch boards.

Plate 09: Detail of profile of stairs.

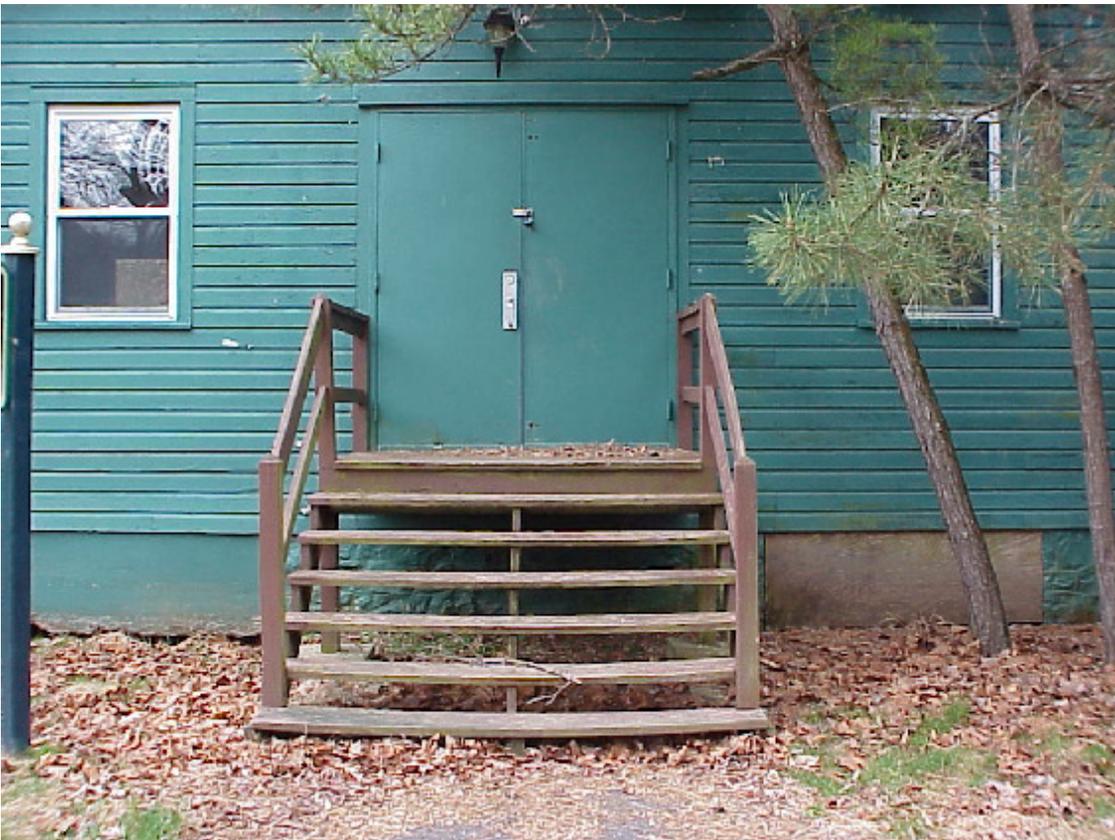
In front of the double doors is a set of six steps and a landing made of unfinished pressure-treated lumber.

Plate 10: Detail of stairs. Note double door.

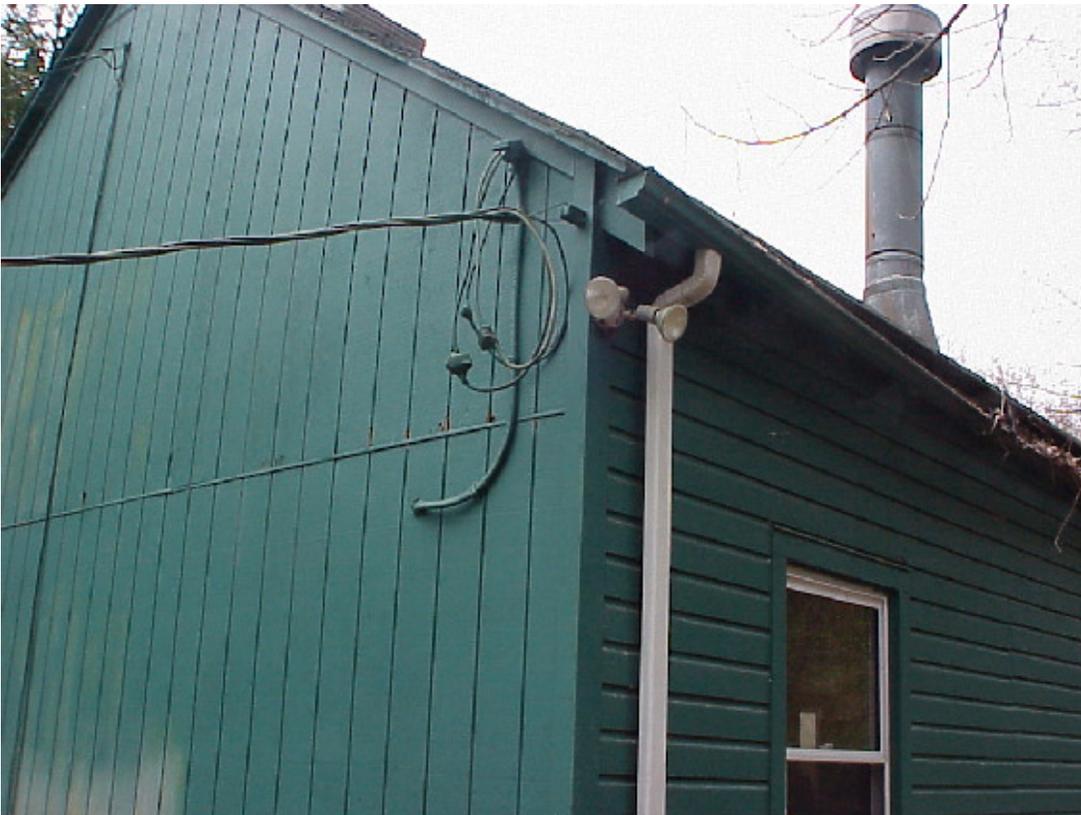
The east and west elevations are covered with simple drop siding. The north and south elevations (the gable ends) are covered with vertical-channel wood siding. The roof is covered with coursed asphalt shingles. The eaves are open with exposed rafters. The rafters are made of 2x10 inch boards. The building sits on mosaic to coursed rubble piers with raised joints. The space between the piers is covered by plywood. The building, piers, doors, and window frames are painted hunter green. Previously the building was painted grey. The windows are replacements. The windows are double glazed one-over-one double sash vinyl clad windows with screens.

Plate 12: Detail of north and west elevations. Note the simple drop siding on the west elevation and the vertical channeled siding on the north elevation. Note the modern chimney.

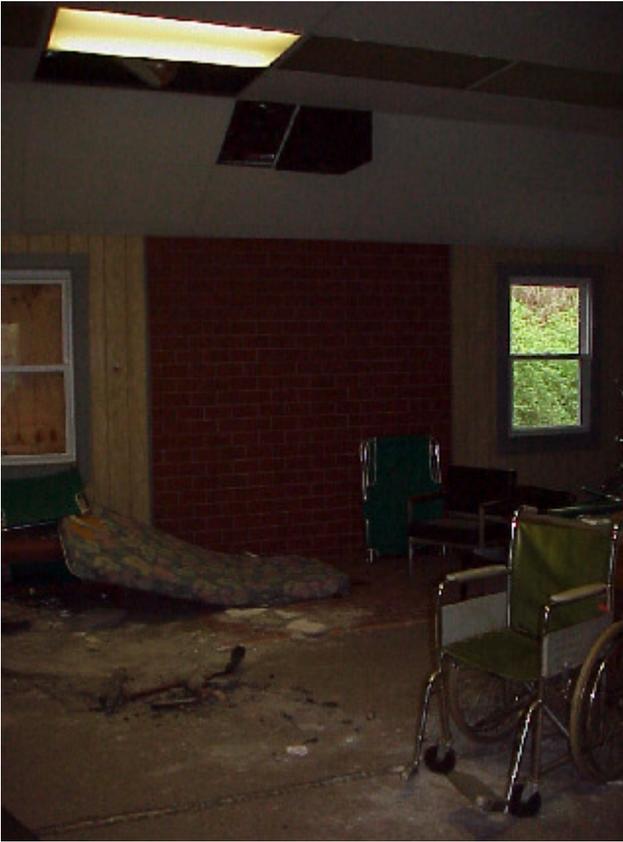
- On west wall, between the north windows is a fire back panel of faux brick 96 inches north south and 94 inches high.
- On the floor in front of the fire back is a faux brick hearth that is 96 inches north south and 74 inches east west.

- The brick hearth once supported a metal conical fireplace (c. 1960-70s).
- The window and door casings are painted grey.
- The floor is covered with a mostly grey indoor/outdoor wall-to-wall carpet.

Plate 15: Detail of faux brick fire back and faux brick hearth with 1970s circular fireplace in a shambles.

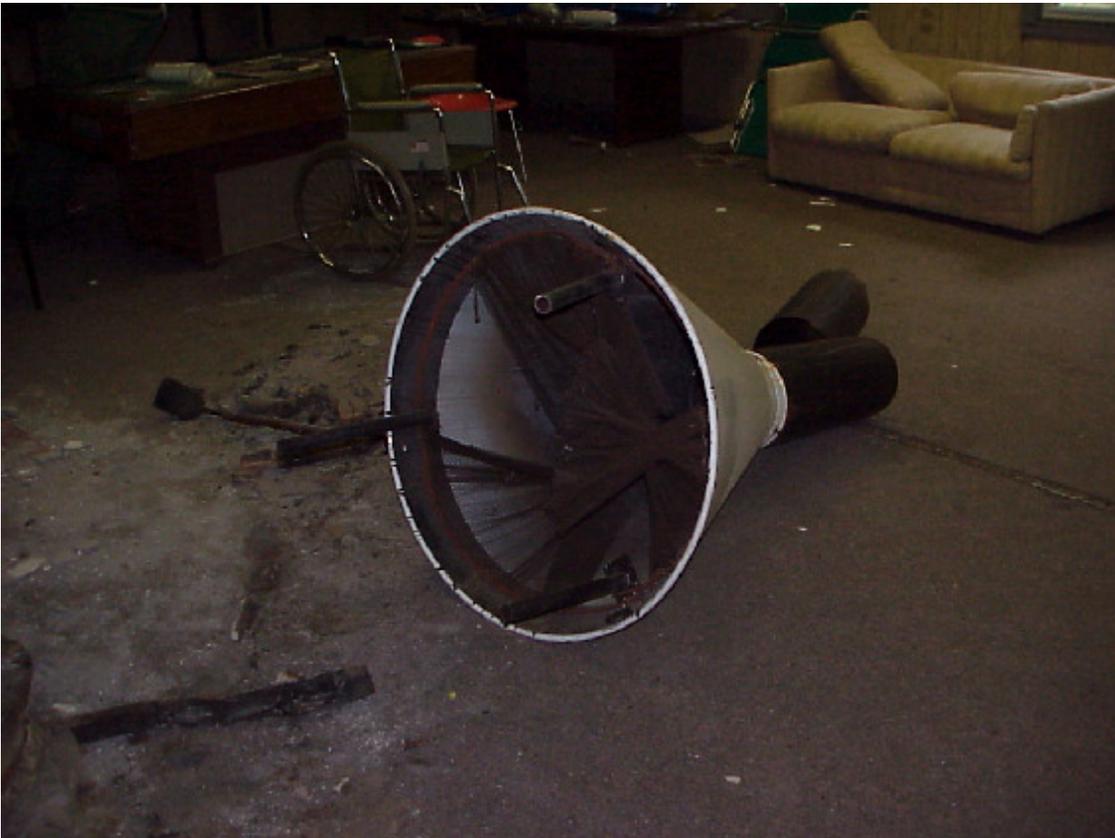
Plate 16: Detail of 1970s circular fireplace.

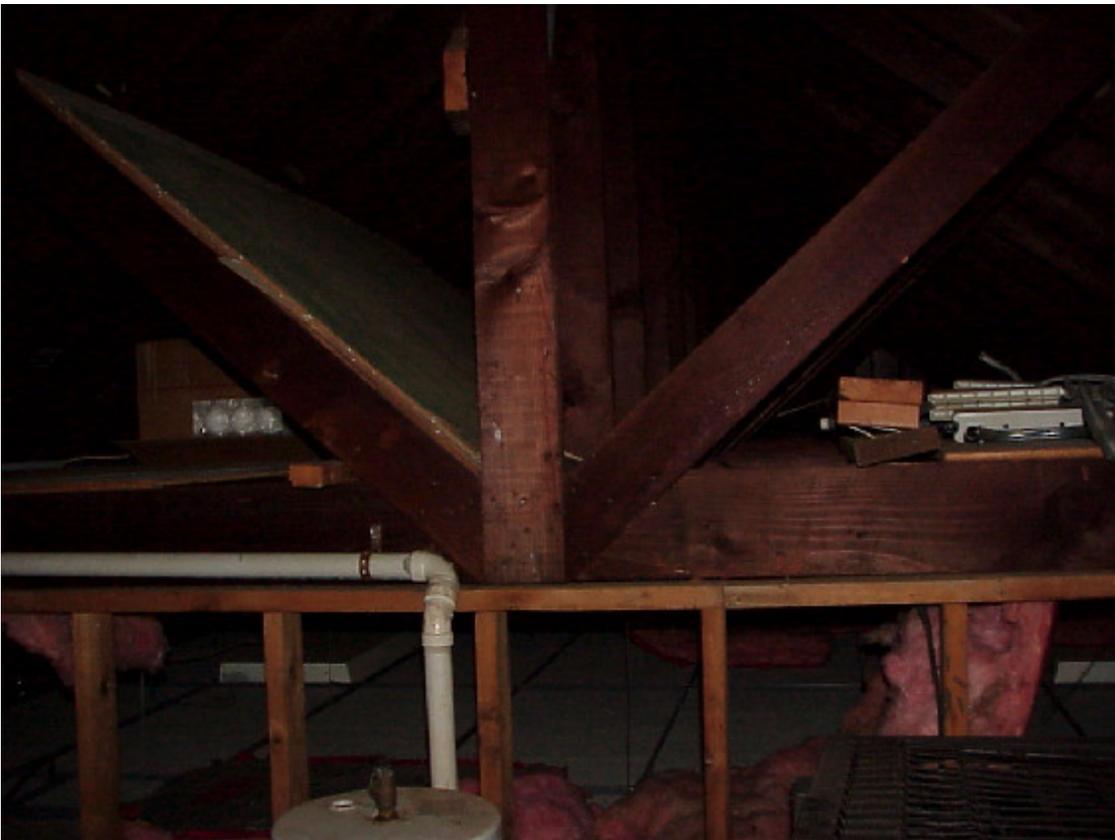
Plate 26: Detail of exposed rafters.

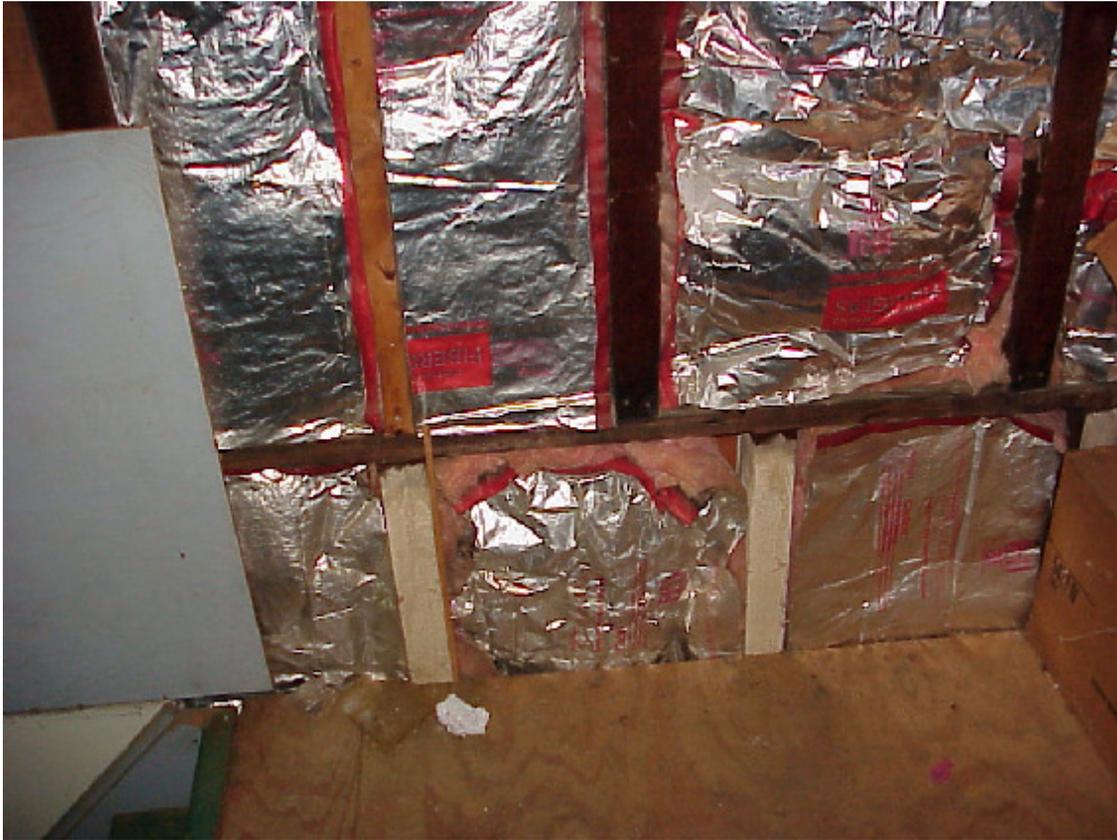
- Room 5 is 23.5-feet east west and 9.4-feet north south.
- The attic floor is plywood.
- The door covering the stairs to the attic is a grey painted 4x8 foot sheet of plywood backed with rigid foam insulation.
- The exposed balloon framing on the southern gable wall is made with 2.5x3.5 inch boards set on 24-inch centers.
- The rafters have tie beams, king posts, and struts.
- The rafters and tie beams are made of 2x8 inch boards.
- The king posts and struts are made of 2x6 inch boards.
- There is a vapor barrier between studs and exterior walls
- The exterior vertical paneling is made of 7.5-inch boards.
- The vent is framed with 4x4 inch boards and has an interior plywood shutter.
- The balloon framing for the east and west wall is made of 2.5 x 3.5 inch boards on 22-inch centers.
- There is foil backed fiberglass insulation between the studs.

Plate 27: Detail of exposed framing along south gable end. Note insulation is between framing and siding.

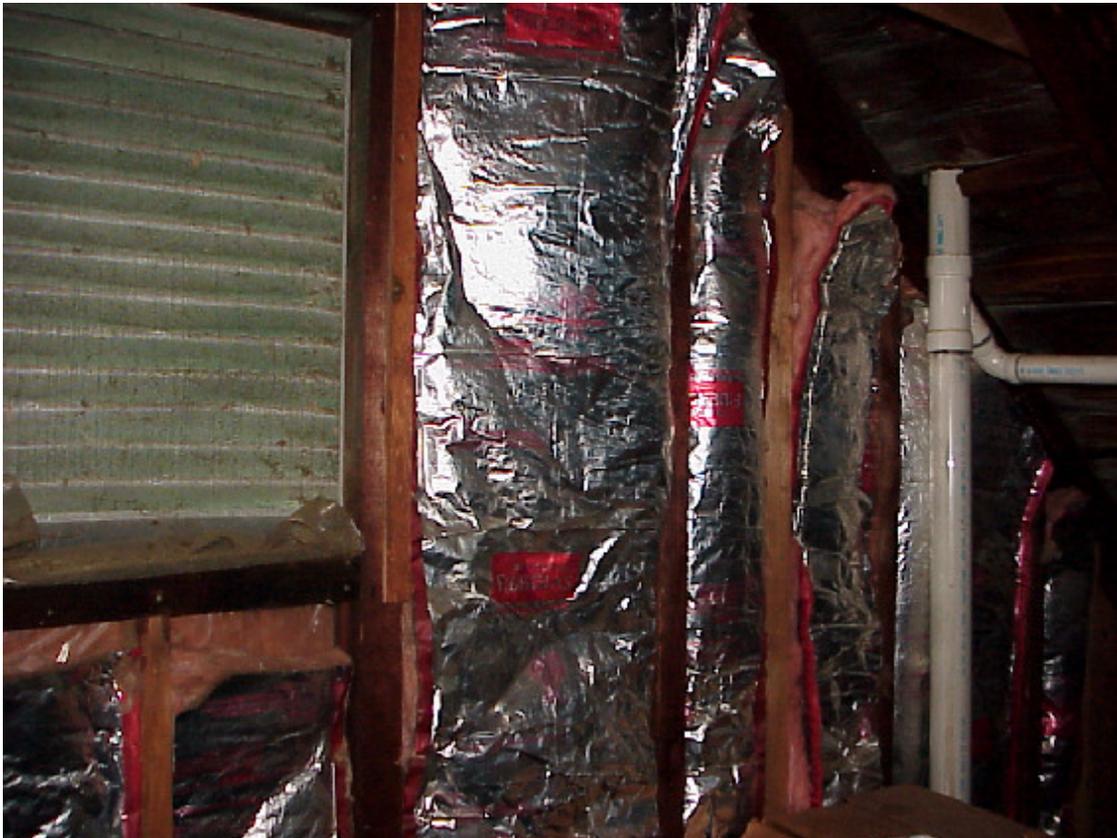
Plate 28: Detail of attic vent and exposed framing along south gable end.

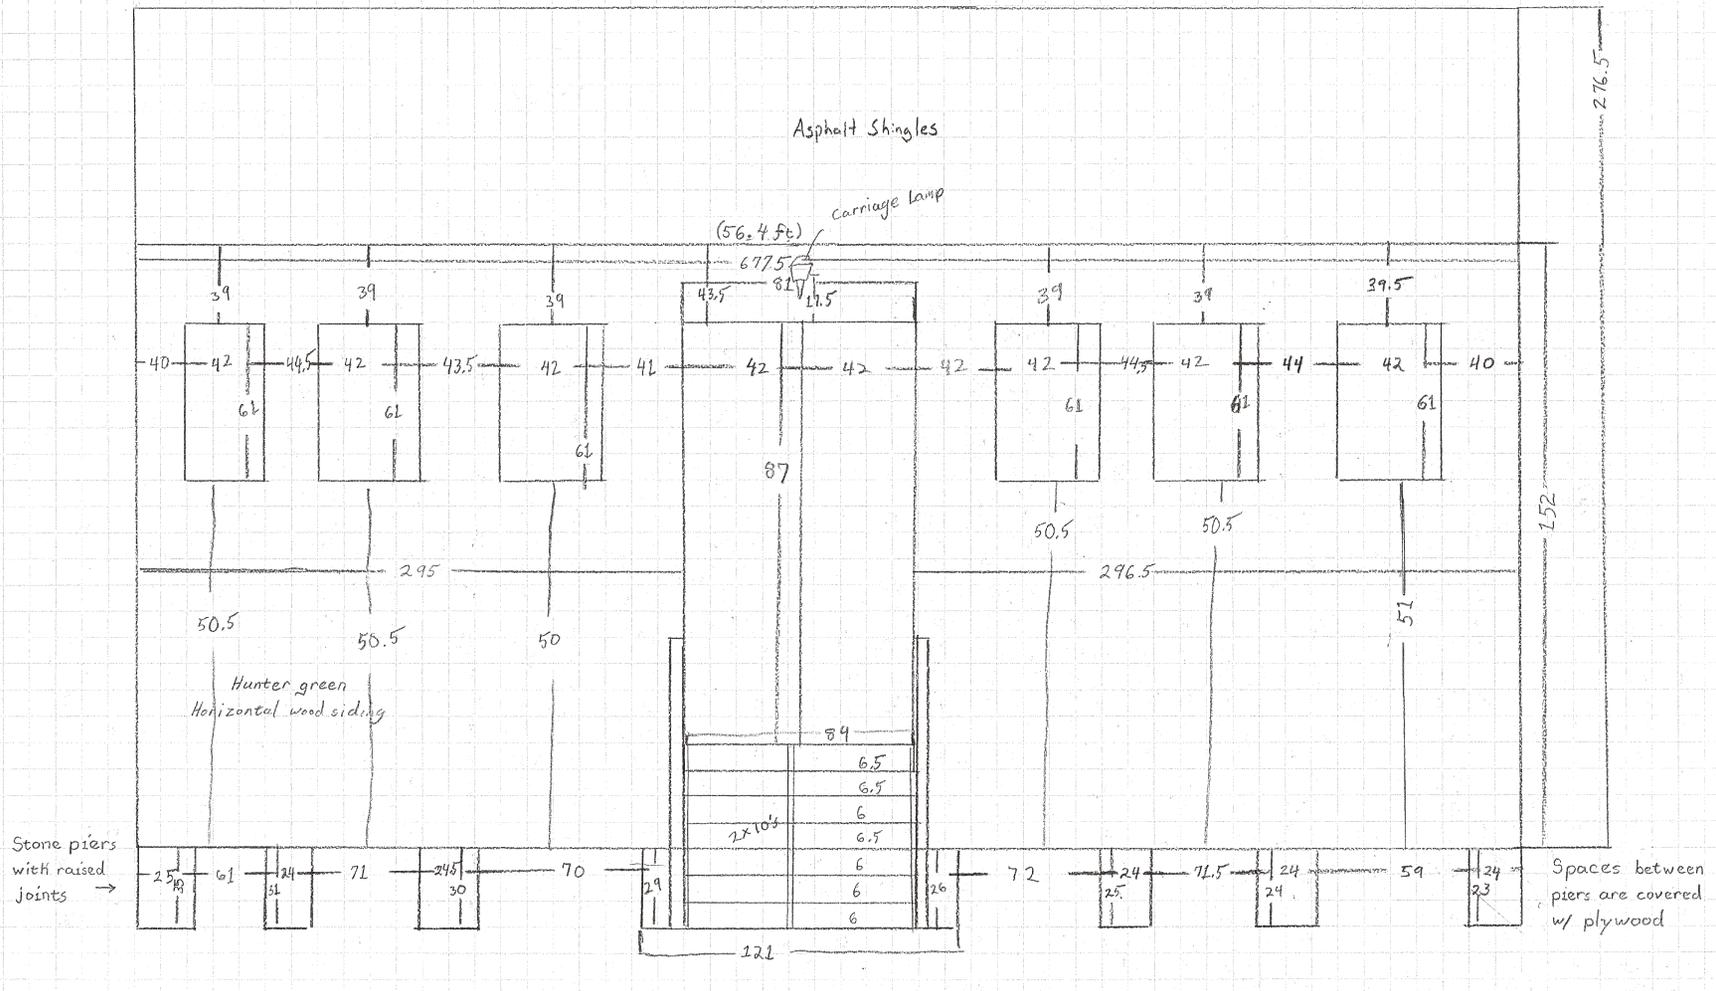
- The east elevation is 31.7 feet long.
- There are six windows and one double steel-safety door on the east elevation.
- The fenestration is symmetrical with three windows on each side of the central double door.
- There is a carriage light above door.
- There is a gutter above the door only.

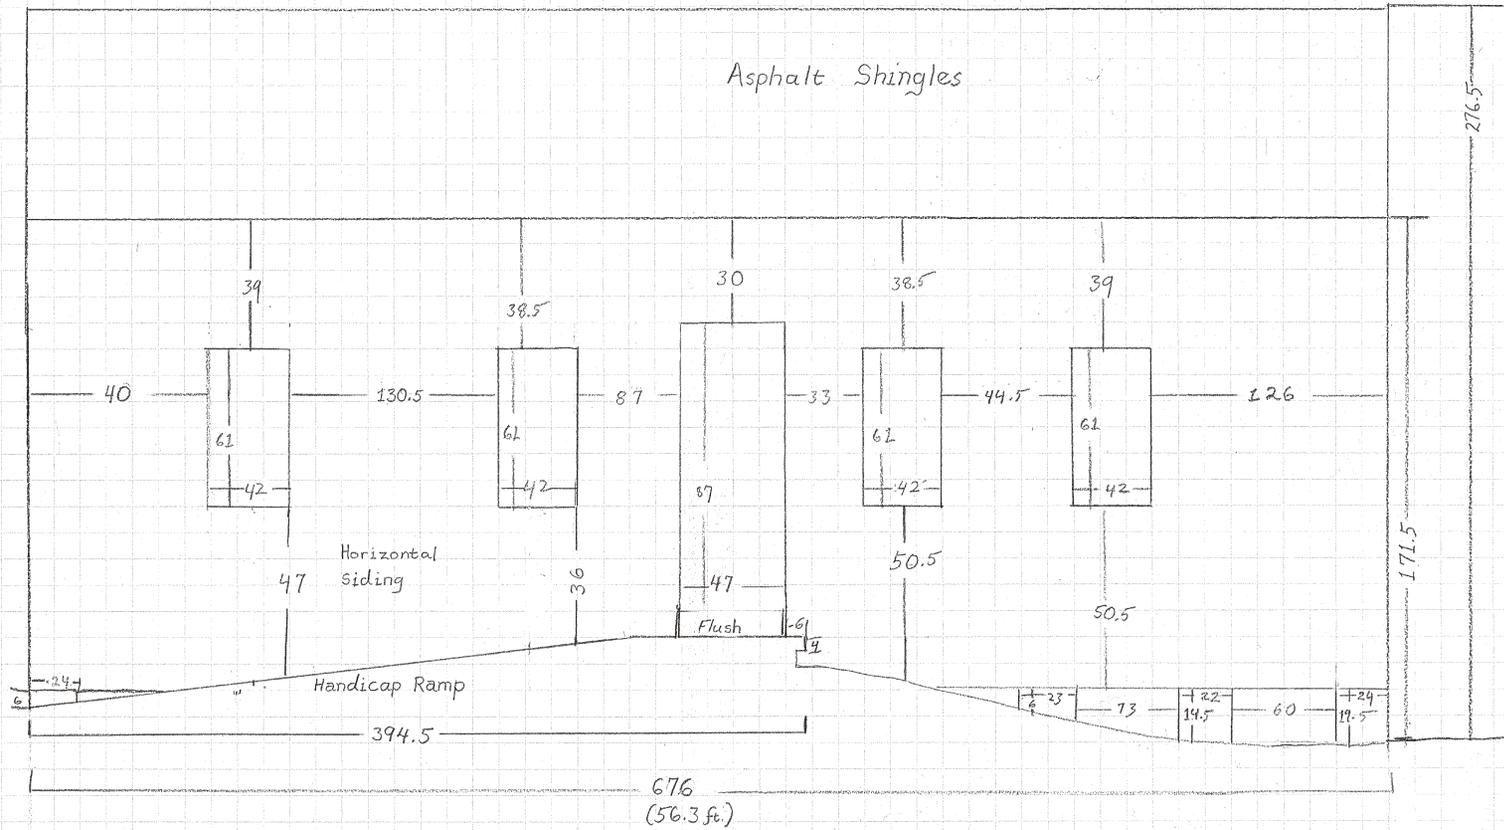
Gawthrop Hall
Rear (west) - Elevation
(CRS# N-14422.02)

- The west elevation is 56.3 feet long.
- There is a gutter which extends the entire length of the west elevation.
- There are down spouts at the north and south end of the building.
- There are four windows and one door on the west elevation.
- There are two windows north and two windows south of the door.
- There is evidence of two former windows that have been covered with siding.

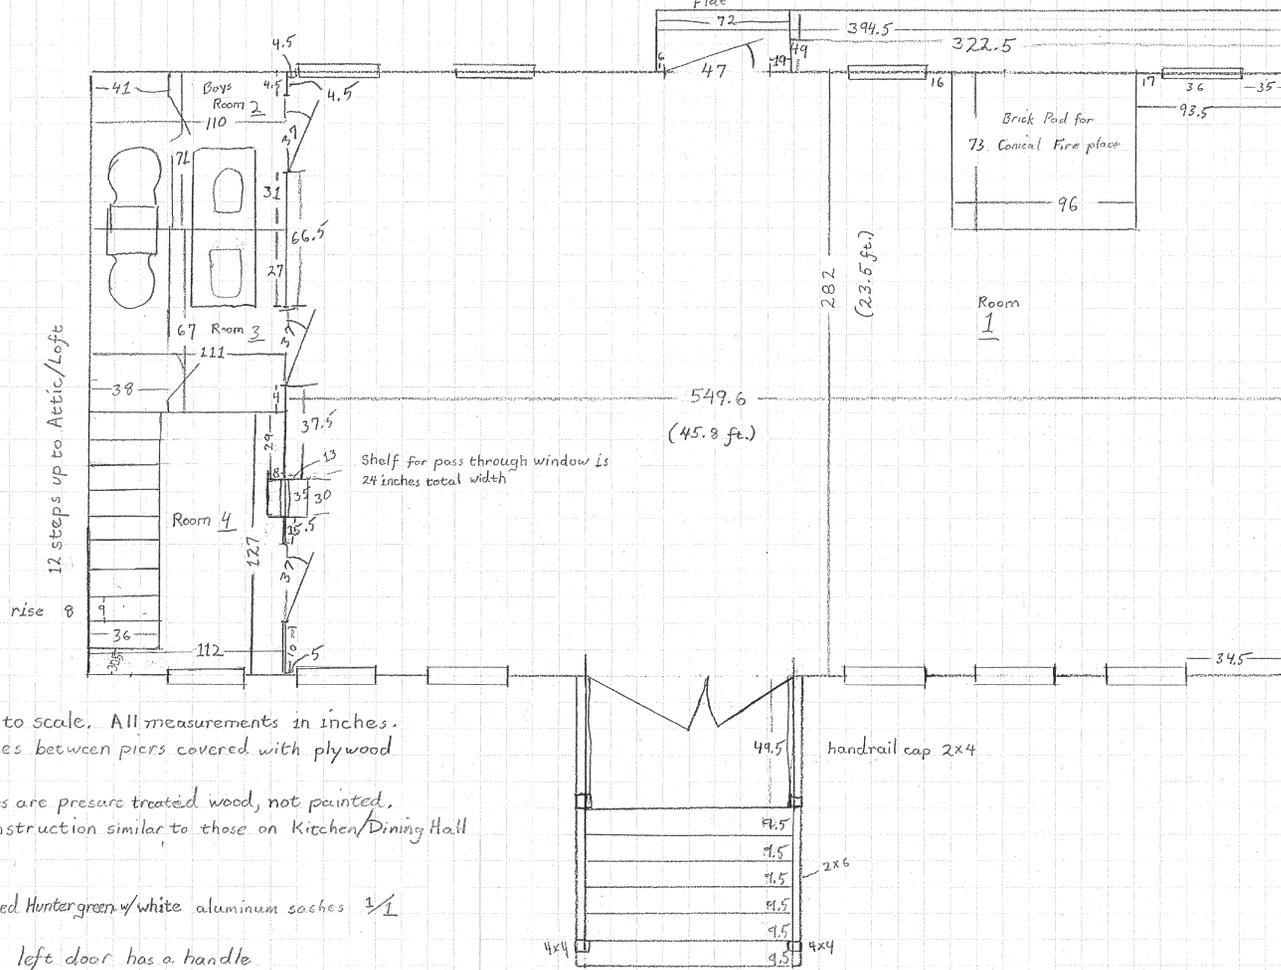
<p>Camp Wright (TP 08-025.00-011) 3850 Mill Creek Road Mill Creek Hundred New Castle County, DE</p>
<p>Gawthrop Hall Floor Plan (CRS# N-14422.02)</p>

Pass through Window
36 Offground
32" wall
30x30 opening

Welded railing, black for handicap access 1 3/4" d
45" from wall
29.8' Long

Acoustic tile lining and drop ceiling w/ recessed fluorescent lighting
Masonite faux wood paneling indoor/outdoor carpet

- Notes:
- Not to scale. All measurements in inches.
 - Spaces between piers covered with plywood
 - Stairs are pressure treated wood, not painted, construction similar to those on Kitchen/Dining Hall
 - Painted Huntergreen w/white aluminum sashes 3/1
 - Only left door has a handle
