Gawthrop Hall
(CRS # N-14422.02)

Detailed Building Description

Gawthrop Hall
 Facade (east) - Elevation
 (CRS# N-14422.02)

CULTURAL RESOURCE SURVEY
MAIN BUILDING FORM

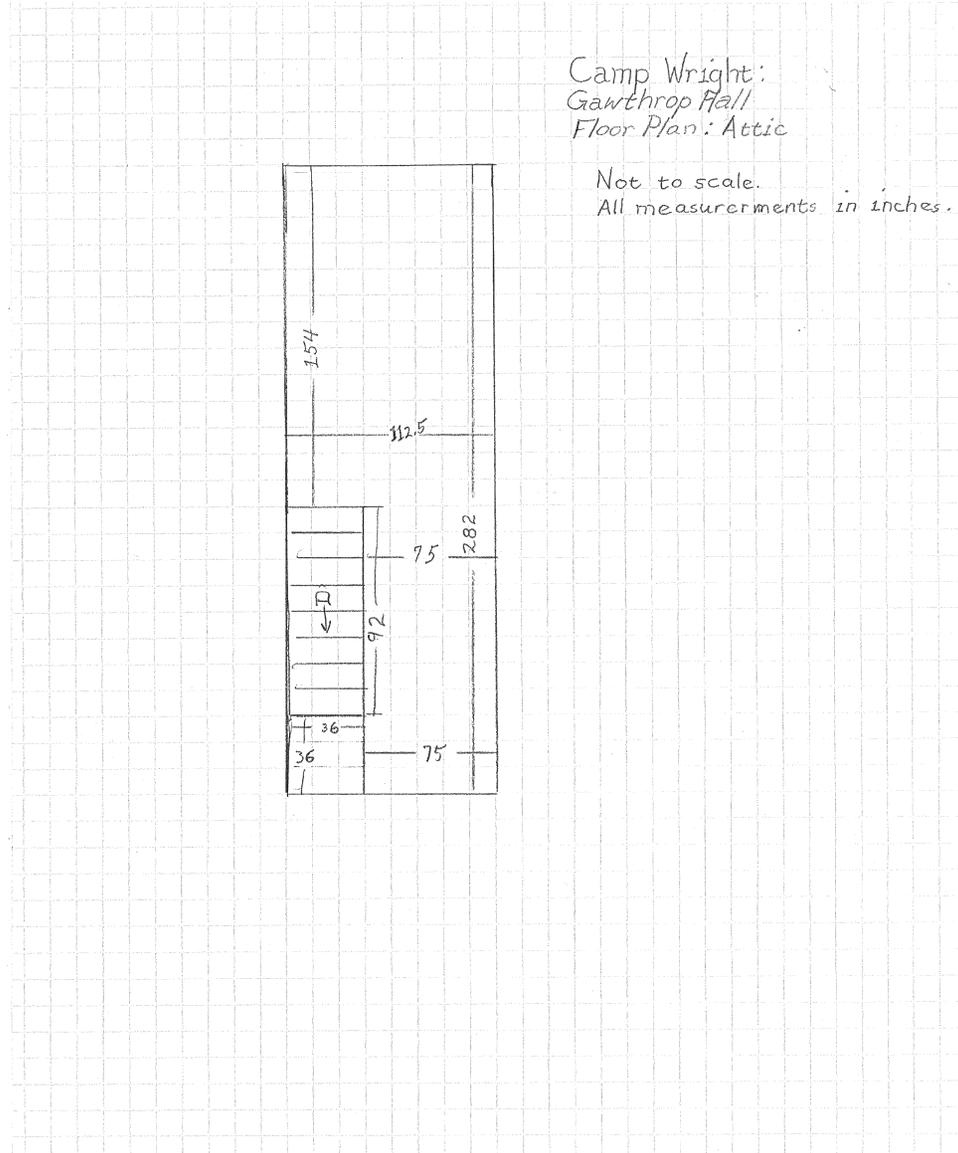
Gawthrop Hall
Floor Plan - Attic
(CRS# N-14422.02)

- Room 5 is 23.5-feet east west and 9.4-feet north south.
- The attic floor is plywood.
- The door covering the stairs to the attic is a grey painted 4x8 foot sheet of plywood backed with rigid foam insulation.
- The exposed balloon framing on the southern gable wall is made with 2.5x3.5 inch boards set on 24-inch centers.
- The rafters have tie beams, king posts, and struts.
- The rafters and tie beams are made of 2x8 inch boards.
- The king posts and struts are made of 2x6 inch boards.
- There is a vapor barrier between studs and exterior walls
- The exterior vertical paneling is made of 7.5-inch boards.
- The vent is framed with 4x4 inch boards and has an interior plywood shutter.
- The balloon framing for the east and west wall is made of 2.5 x 3.5 inch boards on 22-inch centers.
- There is foil backed fiberglass insulation between the studs.

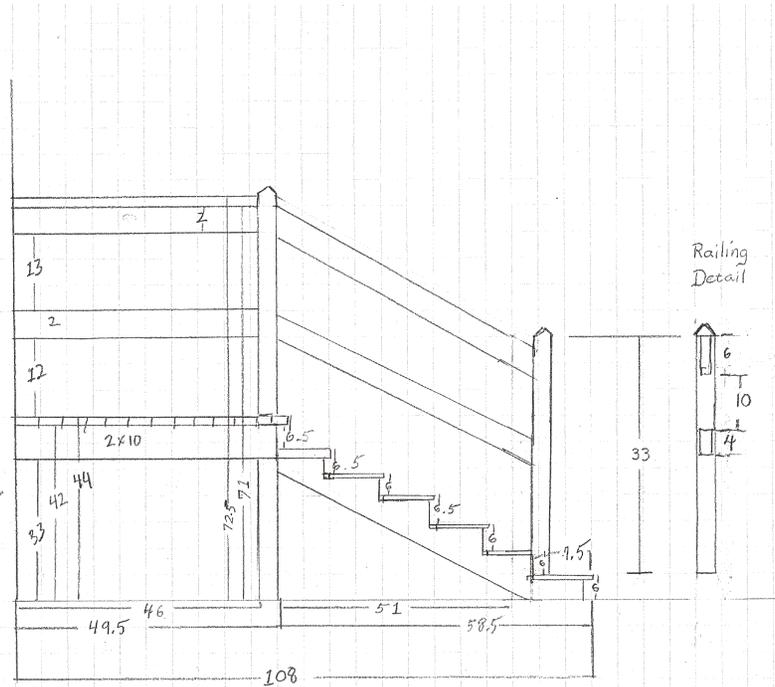
Gawthrop Hall
Detail - Stair
(CRS# N-14422.02)

Notes: Not to scale
6 steps and 1 landing
Treads: L 84 ; W 9.5 ; T 1 3/4
Riser: 6 or 6.5
Supported by 3: 2X12.

Pressure Treated, not painted.
Front post sits on the back of the first step
Support posts for landing sit on concrete pad.
