NATIONAL REGISTER ELIGIBILITY STUDY: ROCK
MANOR, WILMINGTON, DELAWARE

ROCK MANOR WILMINGTON, DELAWARE

*Historic Preservation Group
Kise Franks & Straw
Philadelphia, Pennsylvania*

04 March 1991

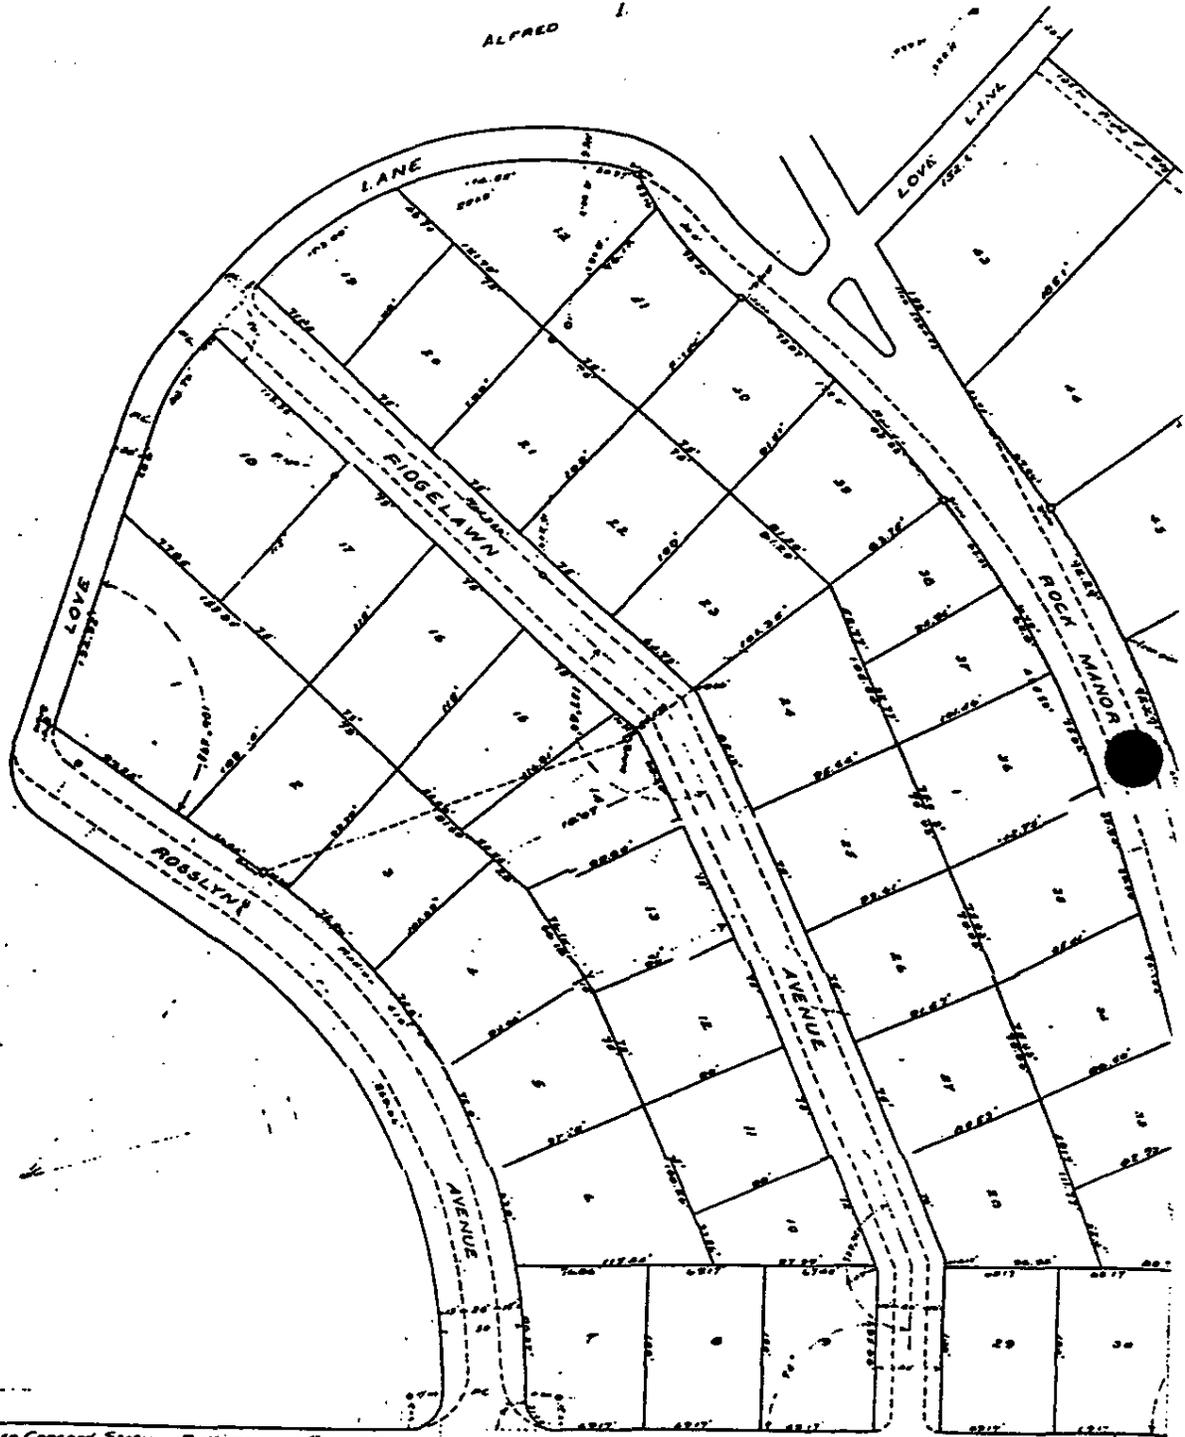
FIGURE 4
 Plan of Rock Manor

This was an unsuccessful 1912 attempt by Alfred I. DuPont to subdivide and develop land previously owned by Eliza Harvey (who attempted a similar but smaller subdivision). Lots previously purchased of Harvey (i.e. Mayer's lots) are not depicted here, but are situated north of Rock Manor Avenue.

In its earliest incarnation, Rock Manor was a potentially unique subdivision, concerning layout and location. A rare, curvilinear plan depicted in Price's 1912 atlas (see Appendix B), as well as Rock Manor's location outside the city's limits in a relatively undeveloped area, initially qualified the subdivision as different from the majority of suburban Wilmington subdivisions. However, it's integrity has been hobbled by two factors that preclude eligibility-status as a district: a) the various plans never came close to fruition and only a fragment was developed, and b) that resultant product was entirely reoriented in the mid-1960s when the connector road was introduced.

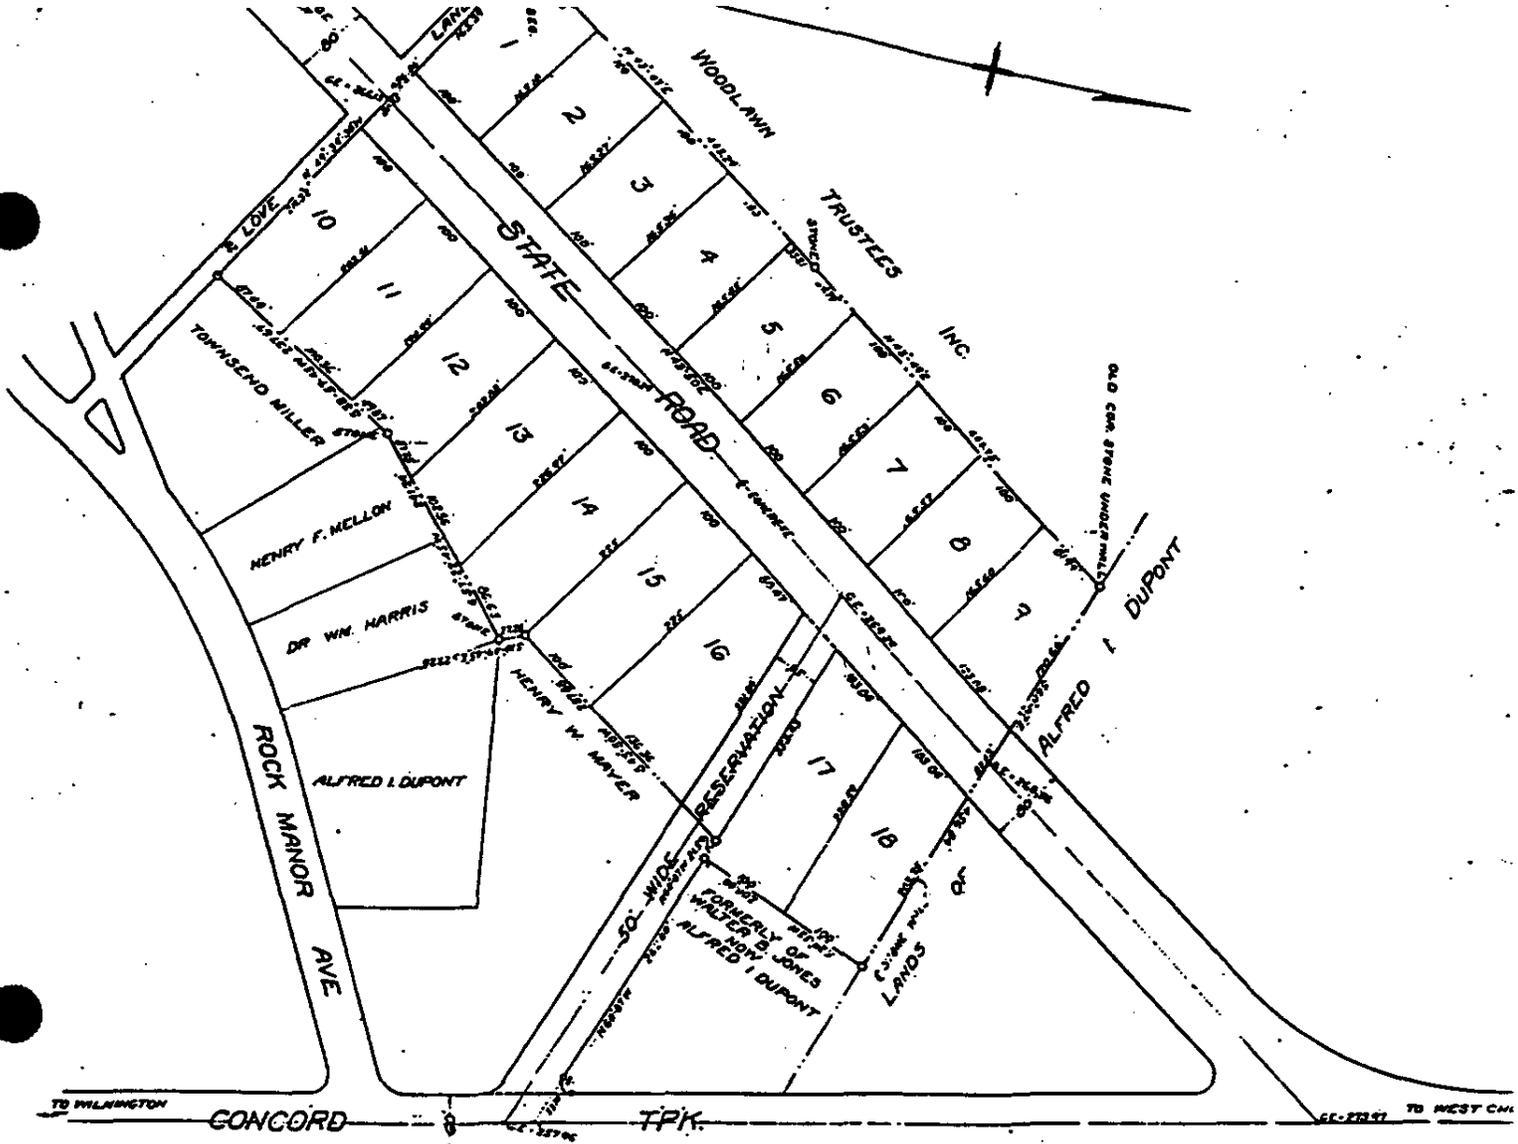
FIGURE 5
 Mayer's Subdivision

PLAN OF PART OF
ROCK MANOR
 PROPERTY OF HENRY W. MAYER
 AREA 0.994 ACRES
 BRANDYWINE MD - NEW CASTLE CO - DELAWARE
 SCALE 1"=60' MARCH 30, 1935.

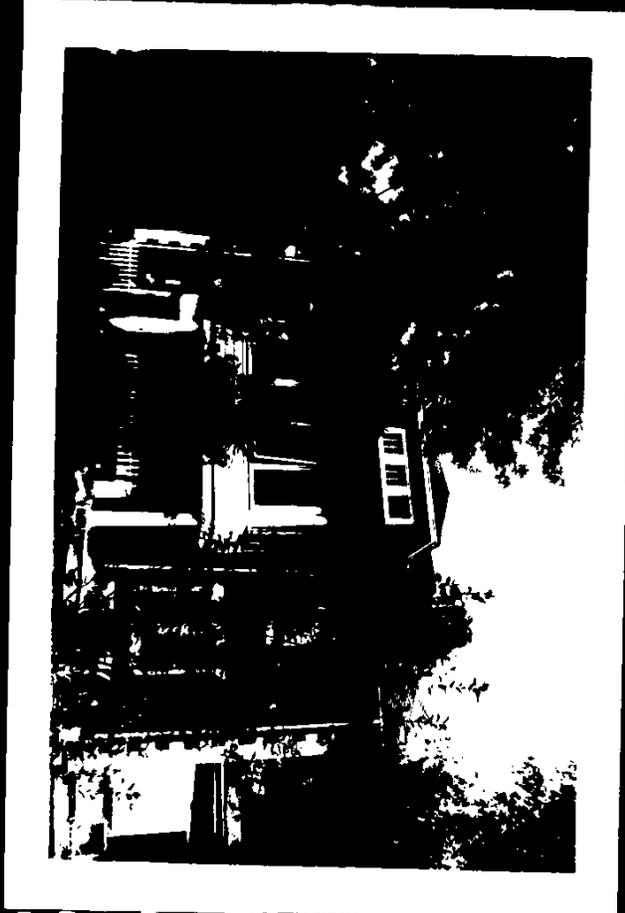
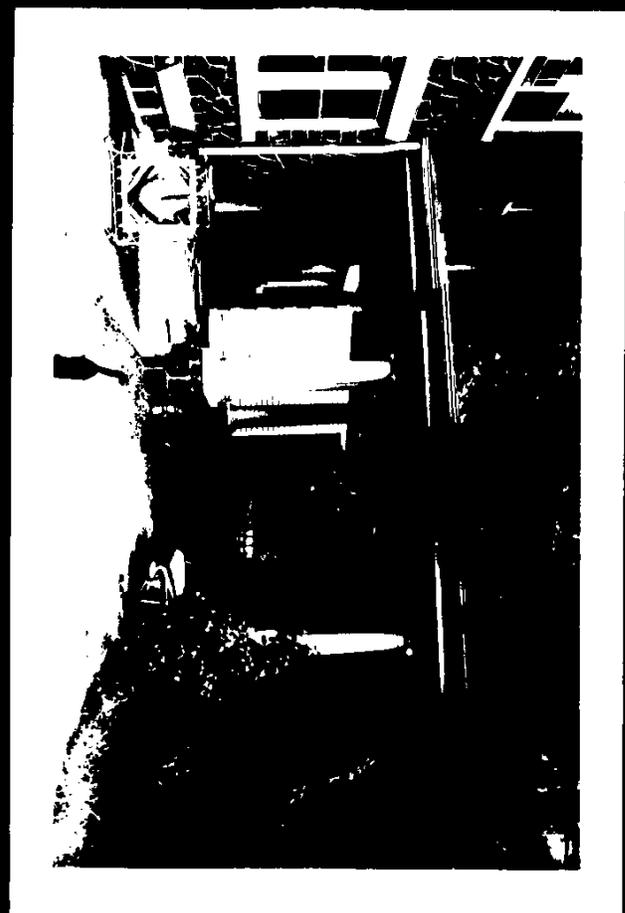
Photo 14

Rock Manor
1 Rock Manor Avenue
Wilmington, DE 19803
N-12673
View: Porch/entrance, south facade
July 1990

The integrity of this c. 1913 American Foursquare structure is fair because a) its eastern elevation has been slightly altered by the enclosing of a porch on what had originally been the primary facade and b) the setting has been altered by the introduction of a roadway, causing the porte cochere entrance and driveway of the structure to be reoriented. However, the structure is significant for its high-style interior, which retains many of its original unaltered decorative elements. The structure appears eligible for the National Register under Criterion C. Photos 6-25.

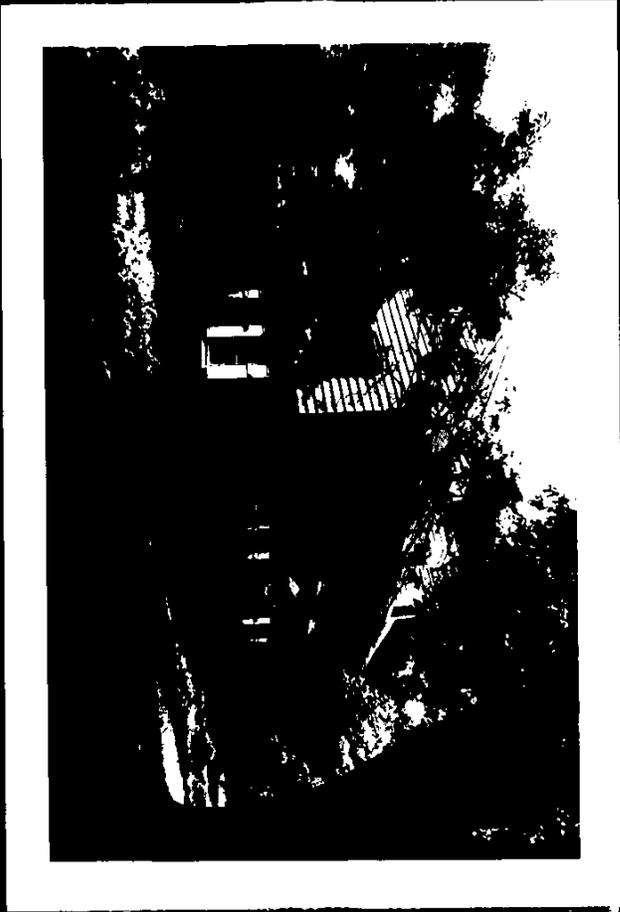
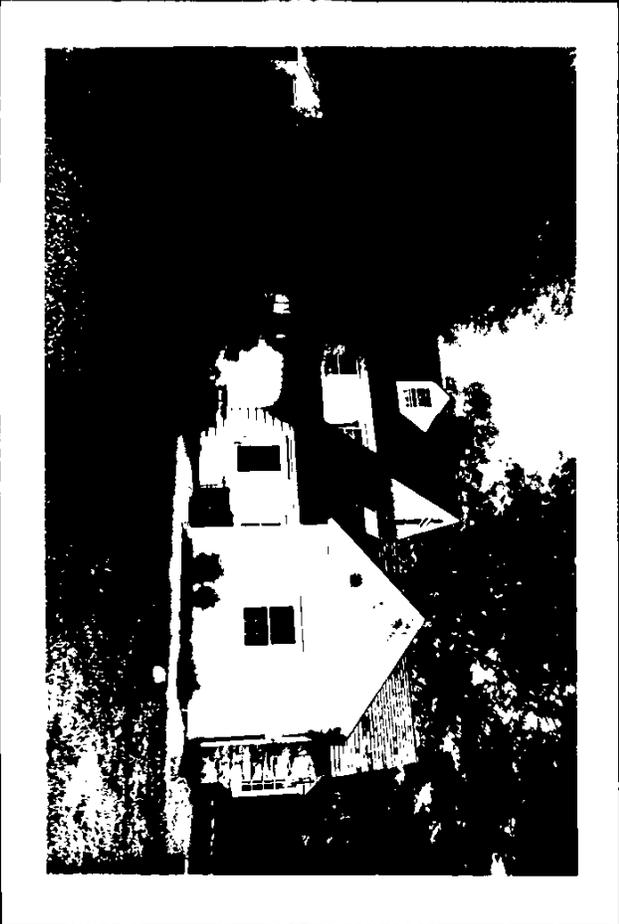
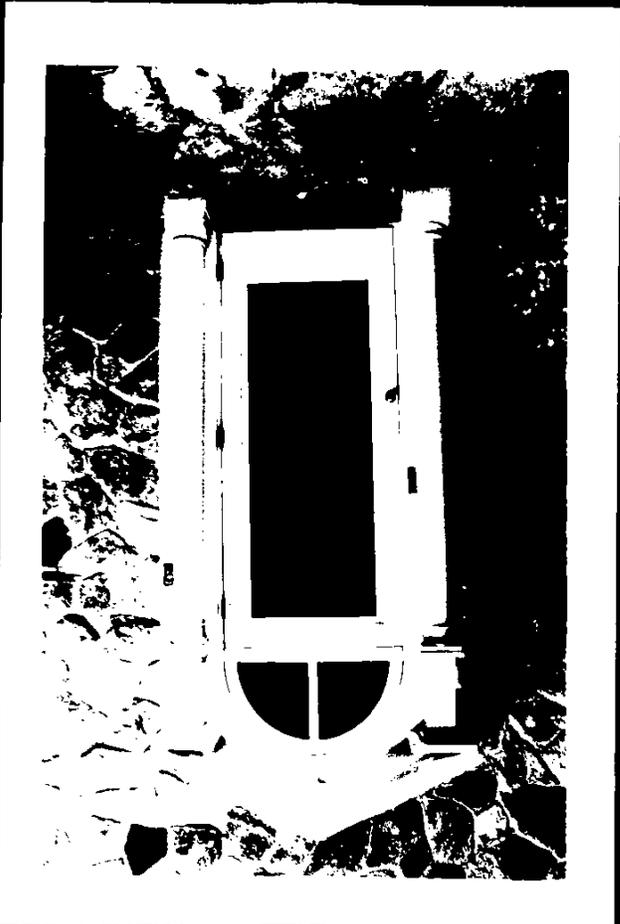
Photo 58

Rock Manor
100 Augustine Cut-off
Wilmington, DE 19803
N-12677
View: Front doorway
July 1990

The integrity of this c. 1935 Neo-Colonial structure is low: the former garage was enclosed and a new garage was constructed, as well as a rear addition. The structure is a fairly high-style design, incorporating some custom, as opposed to stock, items. As a typical suburban dwelling, from which more important examples or precedents exist, this structure does not appear eligible for the National Register. Photos 57- 64.
