1.0 INTRODUCTION

Geomorphological investigations and standing structures research have been completed by Skelly and Loy, Inc. personnel in conjunction with the proposed Delaware Department of Transportation (DelDOT) Bridge 146 Retaining Wall project located in Bridgeville, Sussex County, Delaware (Figure 1).

1.2 Project Description

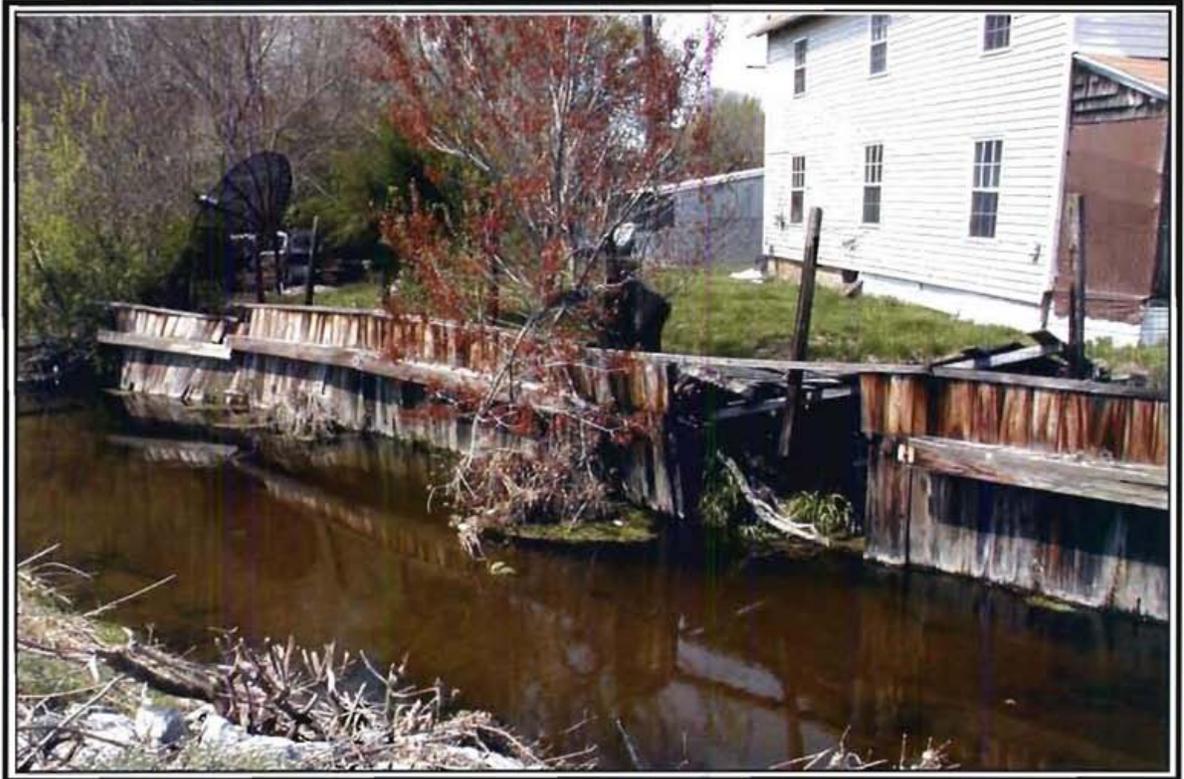
Photograph 1. View of the project APE showing the failing retaining wall, facing northwest.

The proposed work includes the removal of a failing retaining wall adjacent to Bridge 146, and in lieu of its reconstruction, the sloping back of the stream bank to avoid future slumping/erosional problems. The project APE is located northwest of the existing bridge and has been determined to be a portion of the lot on which the failing retaining wall is located (Photograph 1). In addition to the retaining wall, a house (S-4387) is present on the lot (Photographs 2, 3, and 4). This house (S-4387) has been determined to be structurally unsound and will be razed by DelDOT as part of the project. In response to the removal of the retaining wall, razing of the house (S-4387), and sloping of the stream bank, discussions between DelDOT, the U.S. Army Corps of Engineers, and the Delaware State Historic Preservation Office (SHPO) resulted in the

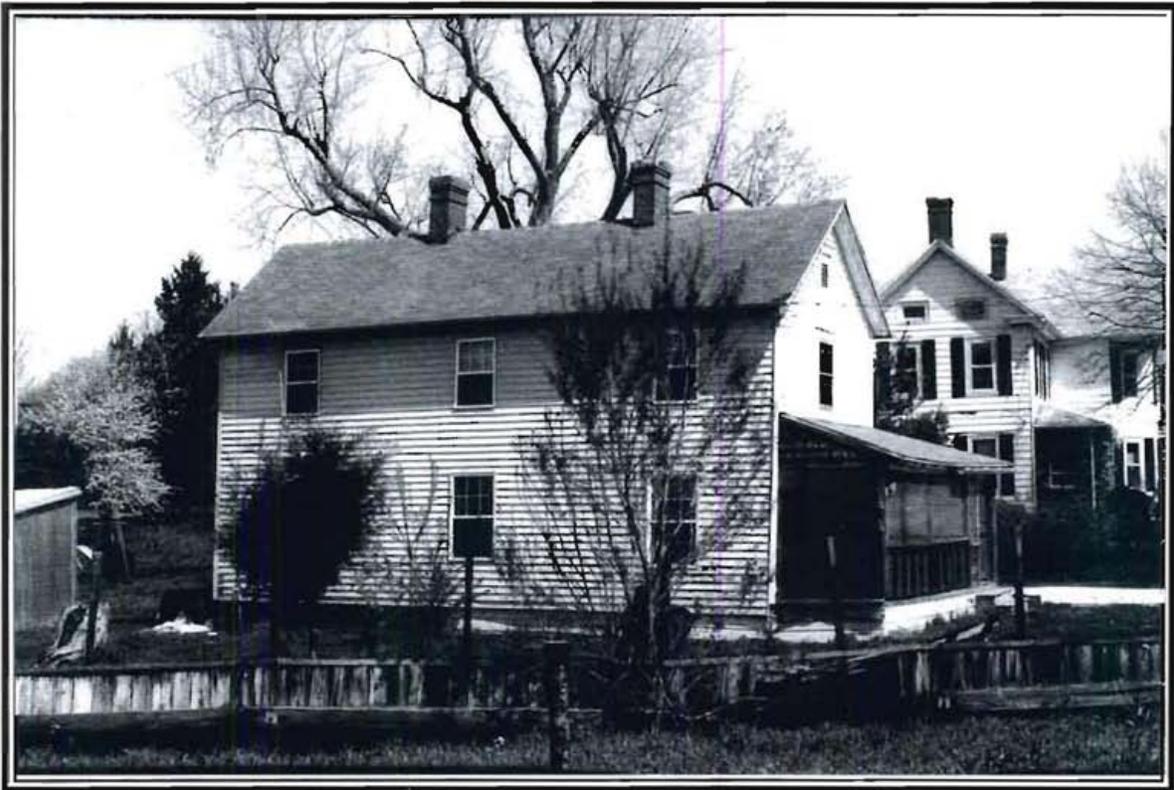
Photograph 2. View of the south and east elevations of the house (S-4387), facing north. Note failing retaining wall at bottom of photograph.

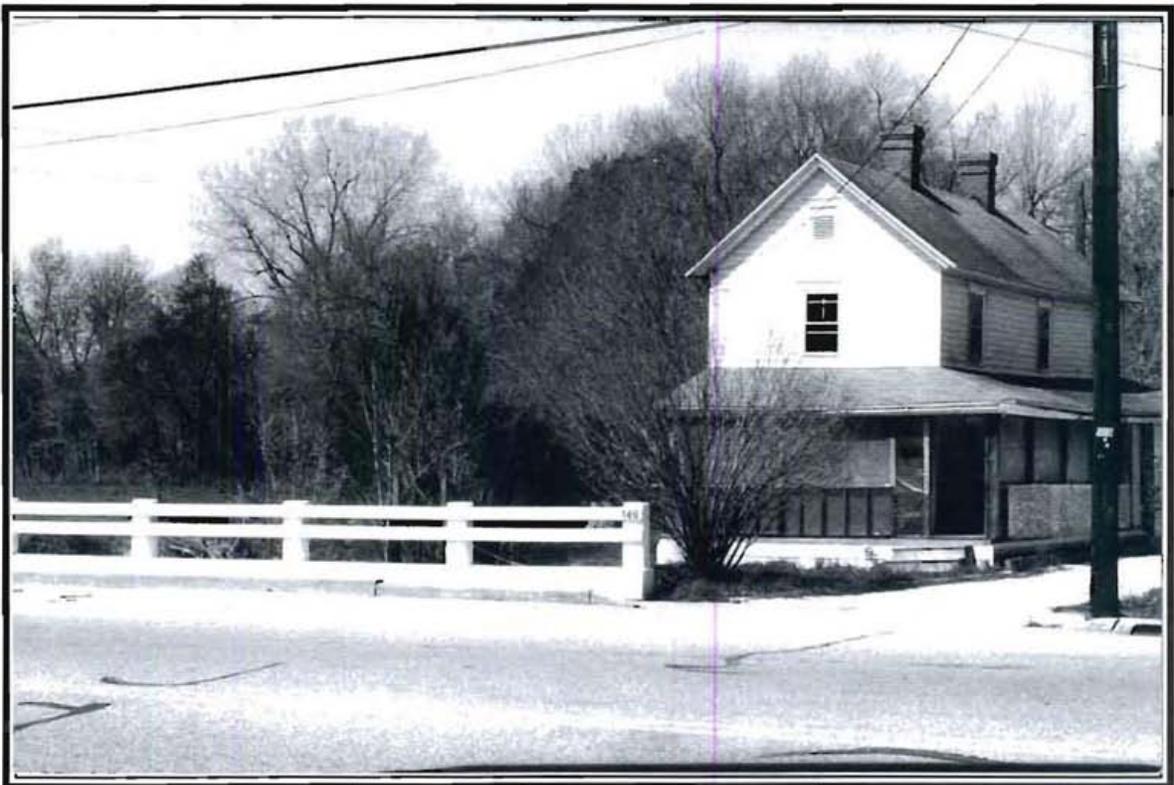
Photograph 3. View of the north and east elevations of the house (S-4387), facing north. Note Bridge 146 at left bottom of photograph.

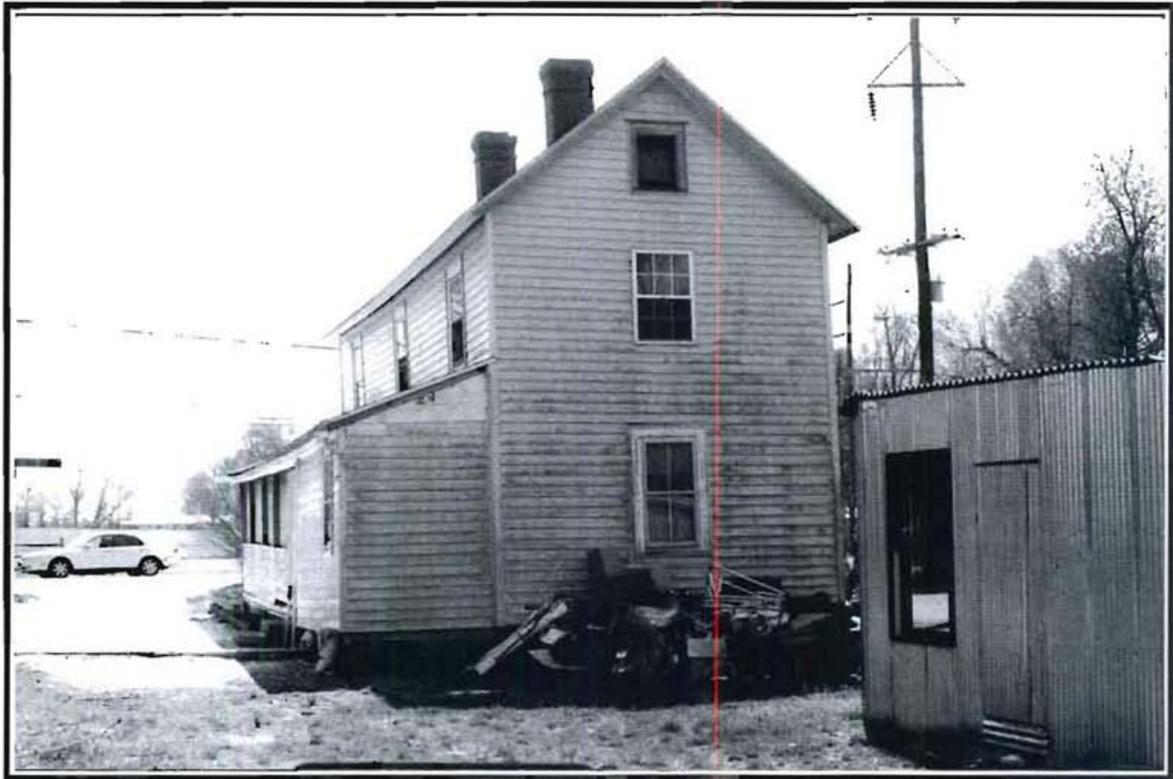
*Photograph 4. View of the north and west elevations of the house (S-4387), facing north.
Note small shed at right of photograph.*
