Final: National Register Evaluation for Twin Arched Pipes

Known as Bridge 2-158A on Chestnut Grove Road over Cahoon Branch

In association with State Contract T201107204 and Federal Aid EBROS-K158(01)

August 2012

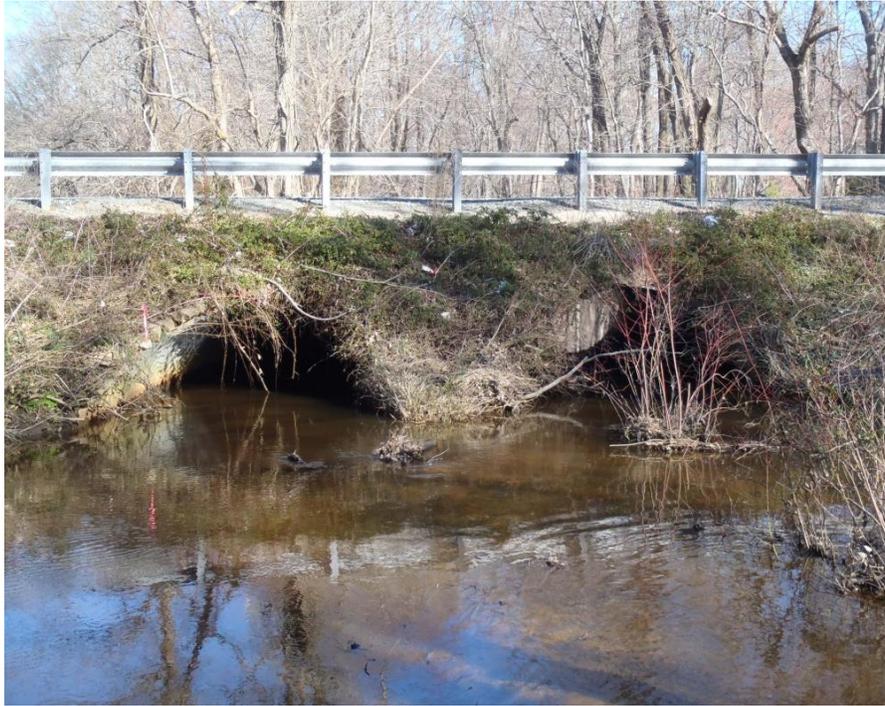
South Elevation

Twin corrugated metal pipes (arched), supported by stacked sand cement riprap.

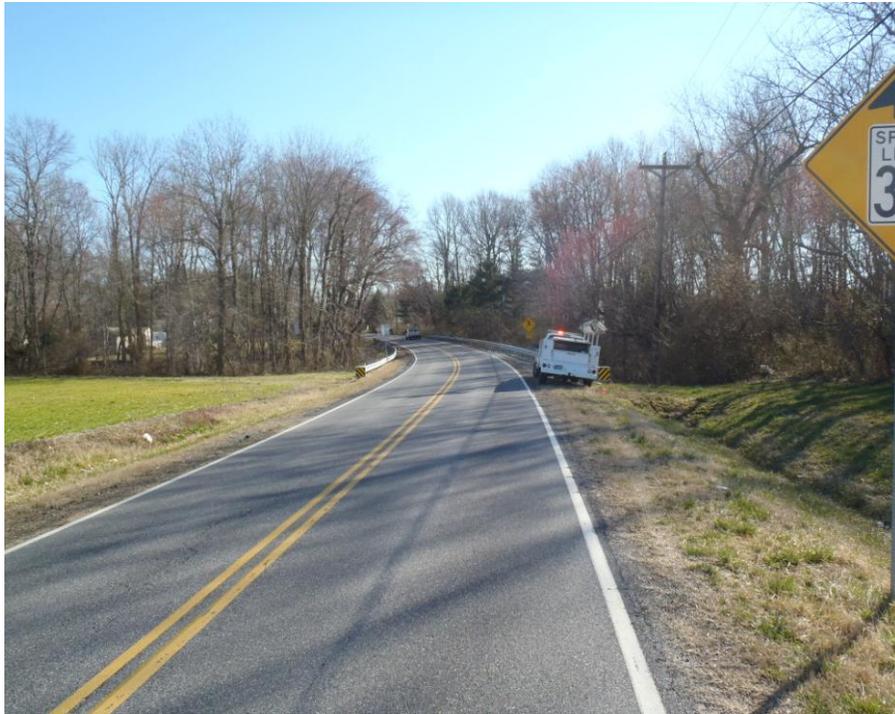
West Approaches

Wire rope guard fence (guardrail) has been upgrade to galvanized W-steel with steel posts and lengths extended in approach distance. The travel surface shoulders have been widened and improved.

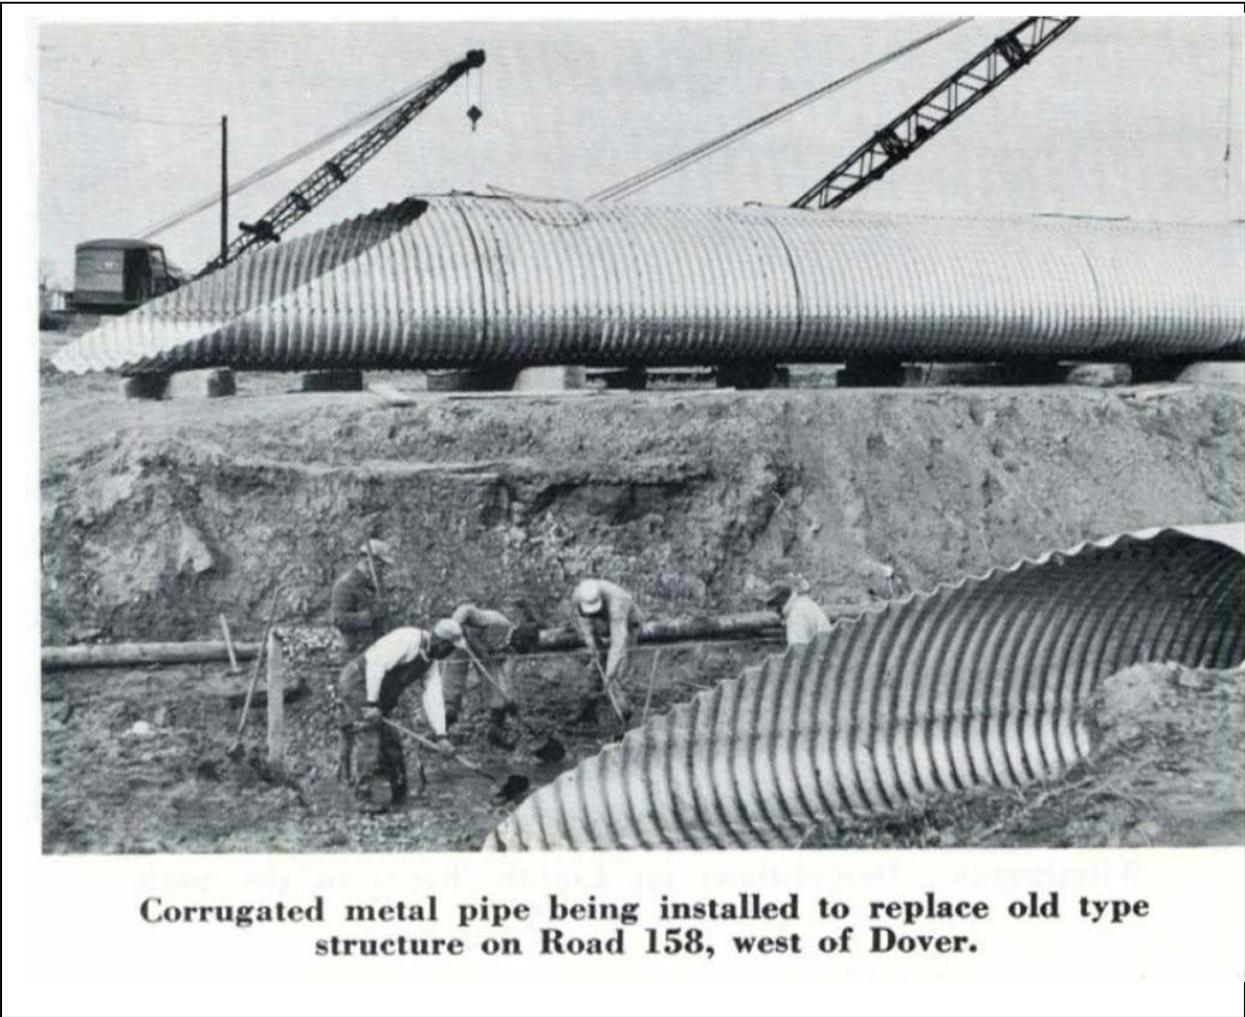
Above: State Contract 1927 from DelDOT's 1962 Annual Report. The following last 3 pages are from the contract that include tile page, the construction sheet at location, and shop drawing with dimensions.

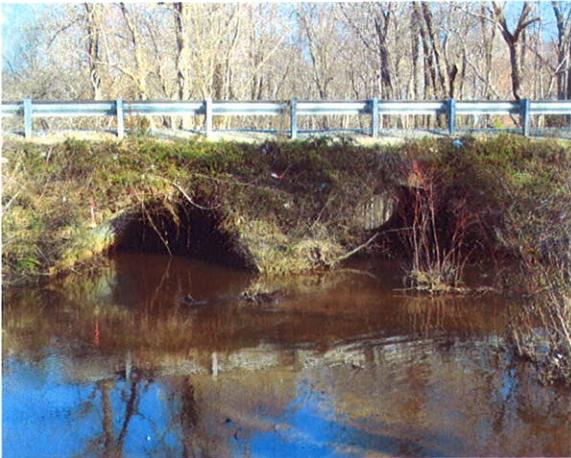
1: south elevation

INTEGRITY: The twin metal pipes has deteriorate and will be replaced
