I. Introduction

The following report discusses the results of the background research and geomorphological evaluation performed by McCormick Taylor, Inc, for the proposed replacement of State Bridge 503 over the Norfolk Southern Railroad and the proposed Levels Road culvert associated with the new alignment of Levels Road in Appoquinimink Hundred, New Castle County, Delaware (*Figure 1*). The objective of these studies was to assess the probability of locating archaeological sites within the area of potential effects and to provide an archaeological fieldwork methodology for the two projects.

A. Project Descriptions

1. State Bridge 503 over the Norfolk Southern Railroad/St. Anne's Church Road

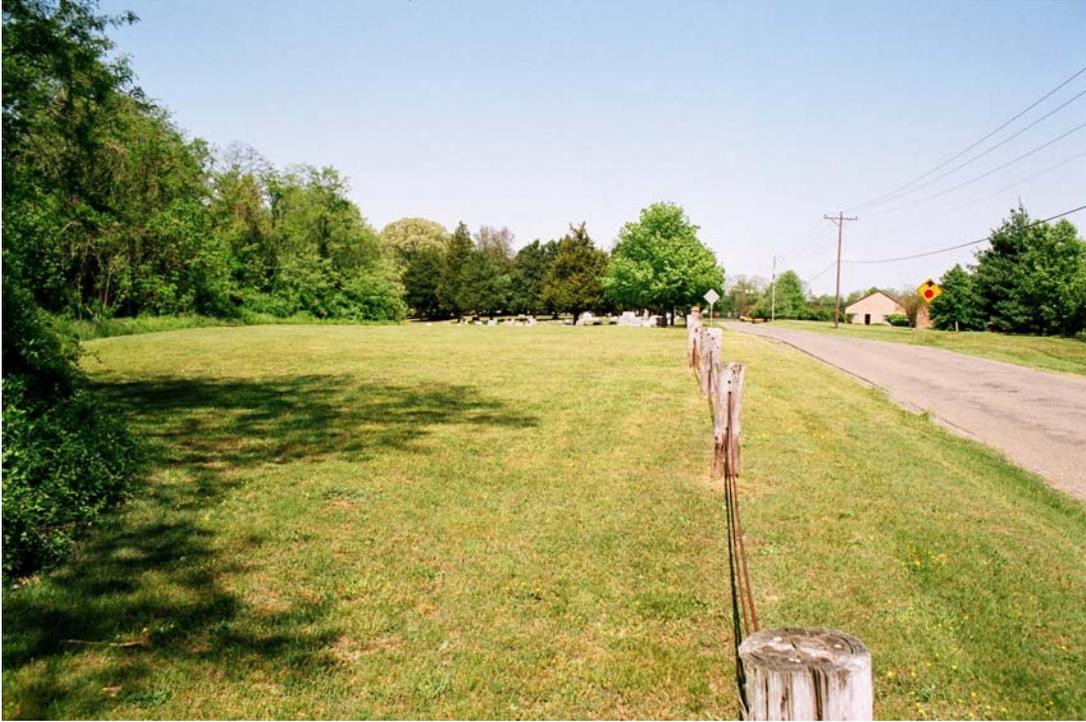
Photograph 1: Lawn west of the St. Anne's Church Cemetery in the northeast quadrant, facing northeast.

The northeastern quadrant of the Area of Potential Effect (APE) is positioned on two distinct landforms. The far eastern portion of the project will impact a small portion of upland landform, currently in lawn, located approximately 300 feet west of the Old St. Anne's Church Cemetery (*Figure 2, Photograph 1*). Between this upland and the existing Norfolk Southern rail line, the APE abruptly drops onto to the wooded T1 terrace of Deep Creek, and extends westward to the disturbed Norfolk Southern Railroad right of way (*Figure 2, Photograph 2*).

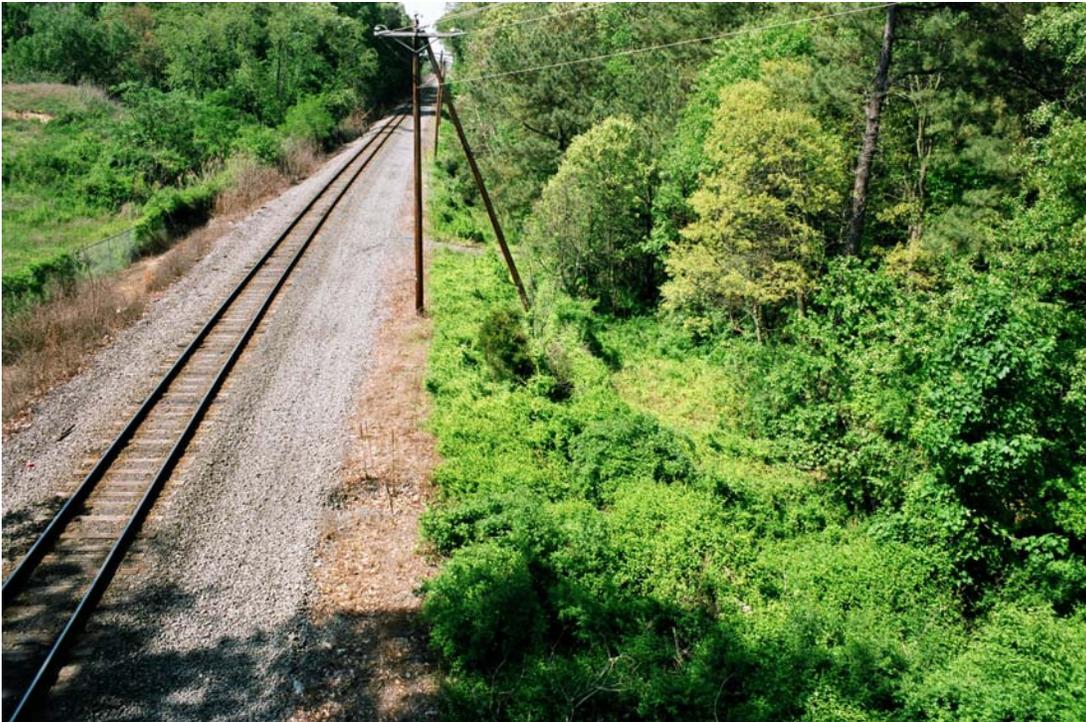
Photograph 2: T1 floodplain in the northeast quadrant, facing north.

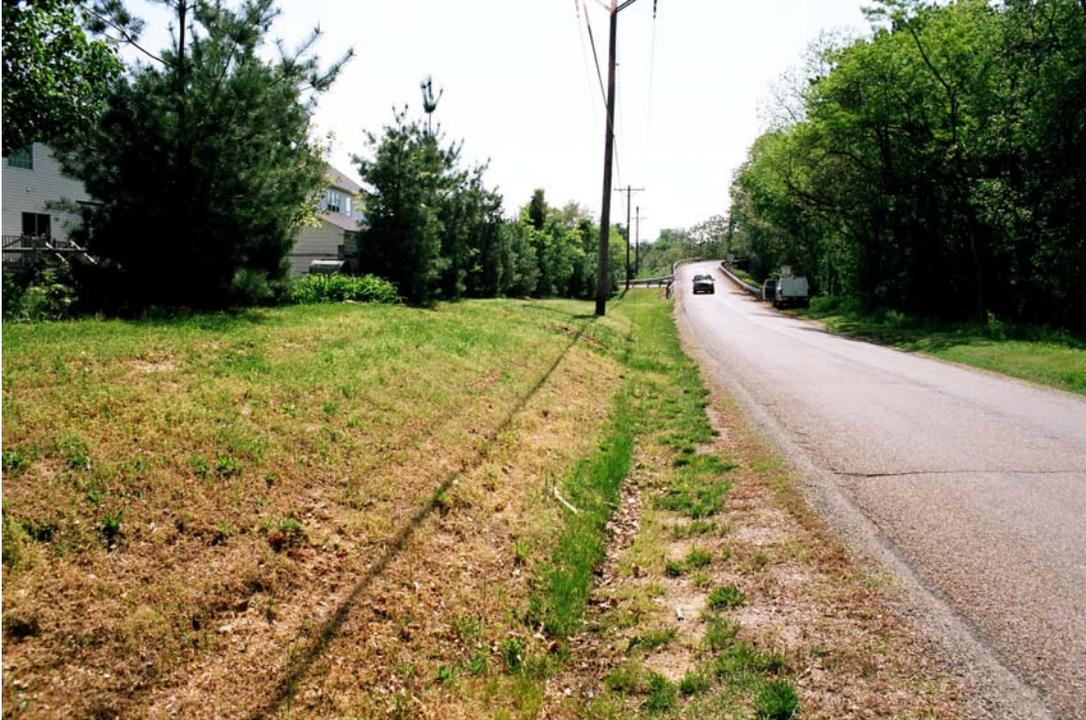
Photograph 3: Disturbance associated with the Cricklewood Subdivision in the southeast quadrant, facing west.

In the southeast quadrant, the APE initially consists of a sliver take on the northern edge of the Cricklewood Subdivision. This area, which is currently in lawn, was disturbed during the

construction of the development and contains underground utilities (*Figure 2, Photograph 3*). Moving toward the bridge, the APE in the southeast quadrant widens in order to accommodate the realignment of the gas company access road and project-related improvements to the existing stormwater management pond. This portion of the project was disturbed during the construction of this infrastructure. It was graded during the installation of the existing driveway and storm water management pond (*Figure 2, Photograph 4*). In addition, this area contains a natural gas testing station and associated underground gas lines (*Figure 2, Photograph 5*).

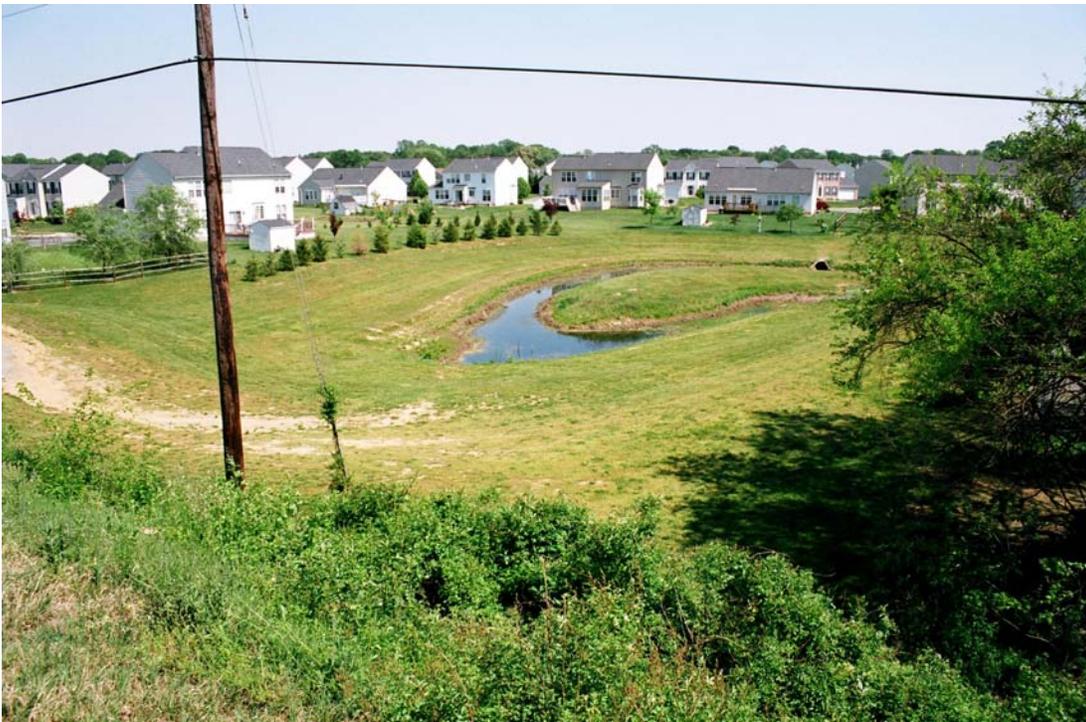
Photograph 4: Disturbance associated with the storm water management pond in the southeast quadrant, facing east.

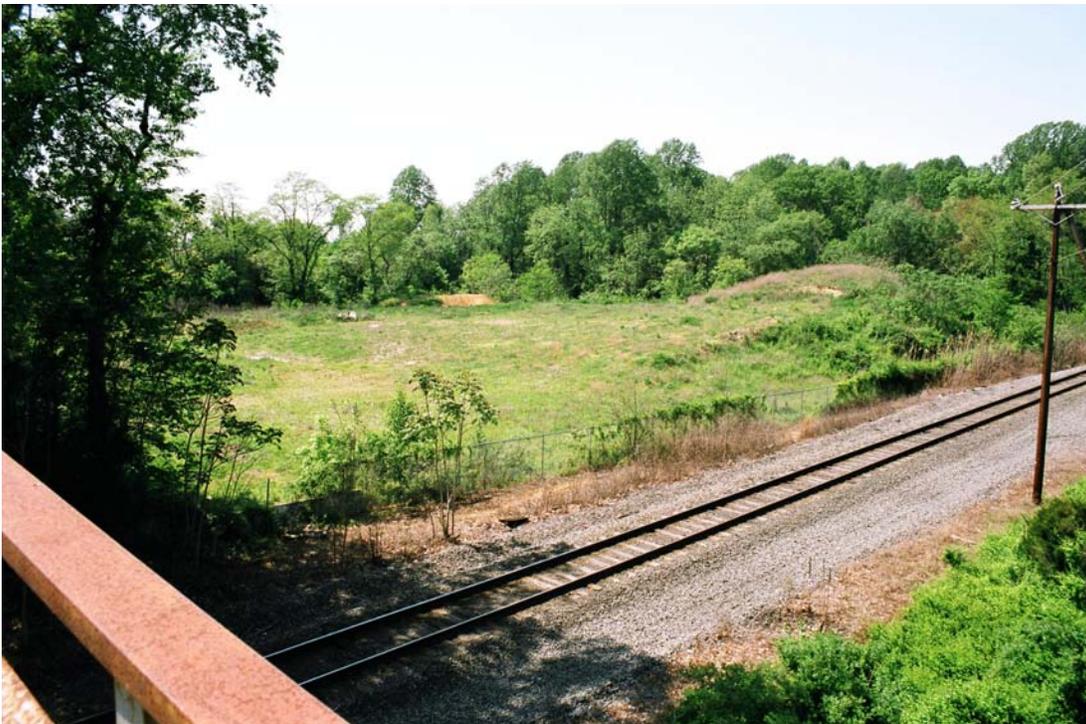
Photograph 6: Landfill in the northwest quadrant, facing northwest.

The landform in the northwest quadrant of the APE also contains two distinct landforms. The area immediately to the west of the railroad tracks lies at the approximate elevation of the east side of the railroad tracks, although it contains the heavily disturbed former Middletown landfill (*Figure 2, Photographs 6 and 7*). The landform to the west of the landfill rises back to an upland position, and is mostly contained within an agricultural field (*Figure 2, Photograph 8*).

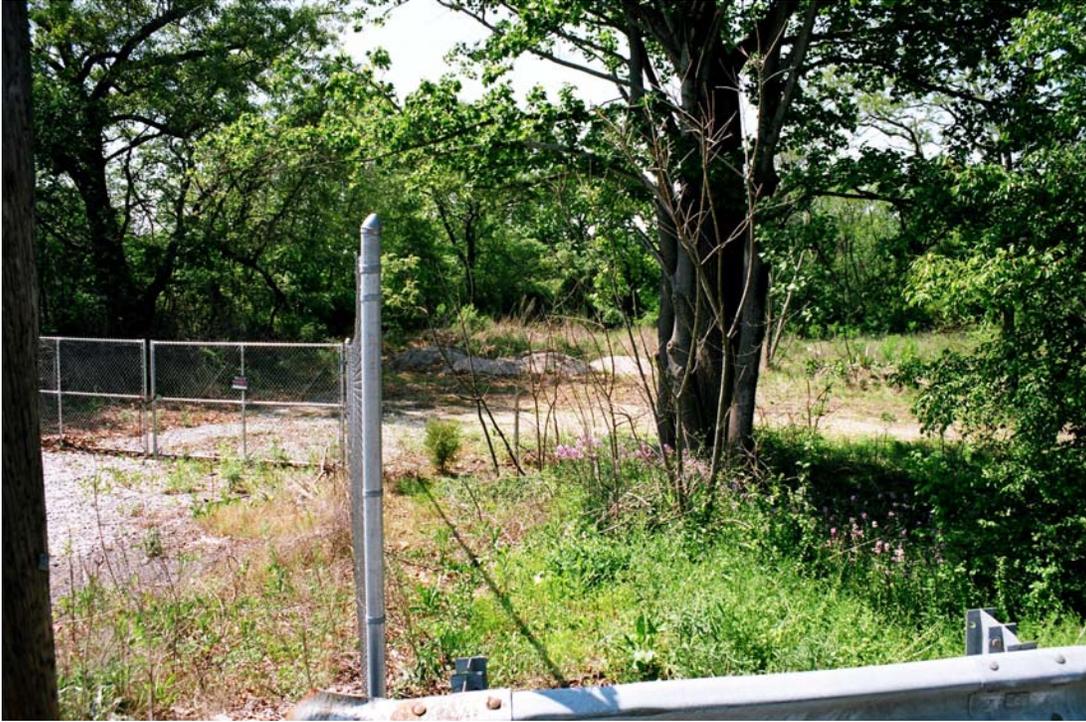
Photograph 7: Landfill in the northwest quadrant, facing northwest.

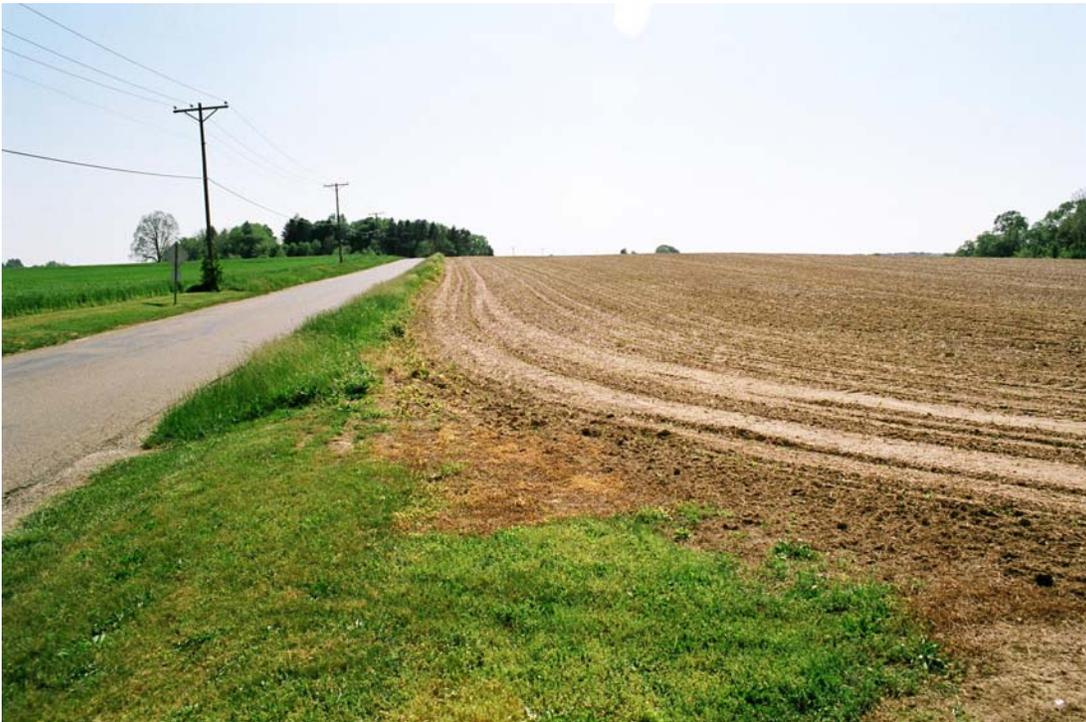
Photograph 8: Agricultural field in the northwest quadrant, facing west.

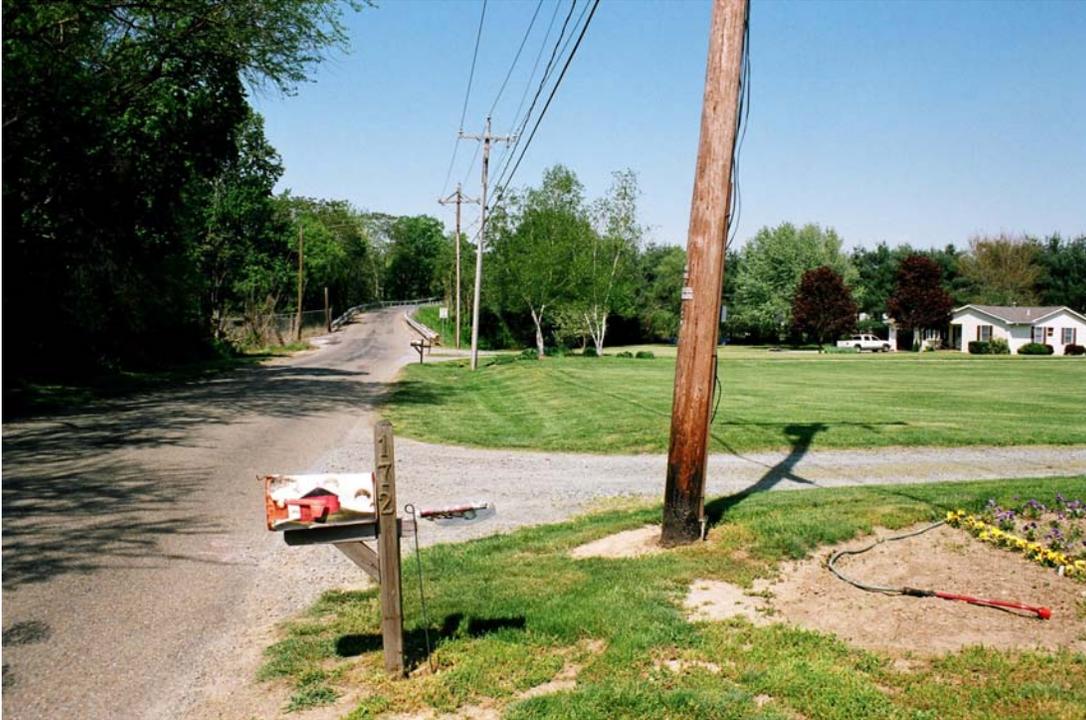
Photograph 9: Lawns in the southwest quadrant, facing northeast.

In the southwest quadrant in the area near the bridge, the APE is contained mostly within the existing disturbed fill slope associated with St Anne's Church Road. Moving to the west, the APE is located within the front lawns of three residential properties; localized disturbances associated with three driveways, landscaping beds, and an underground gas line was noted (*Figure 2, Photograph 9*). West of the residential properties, the APE consists of an agricultural field (*Figure 2, Phototograph 10*).

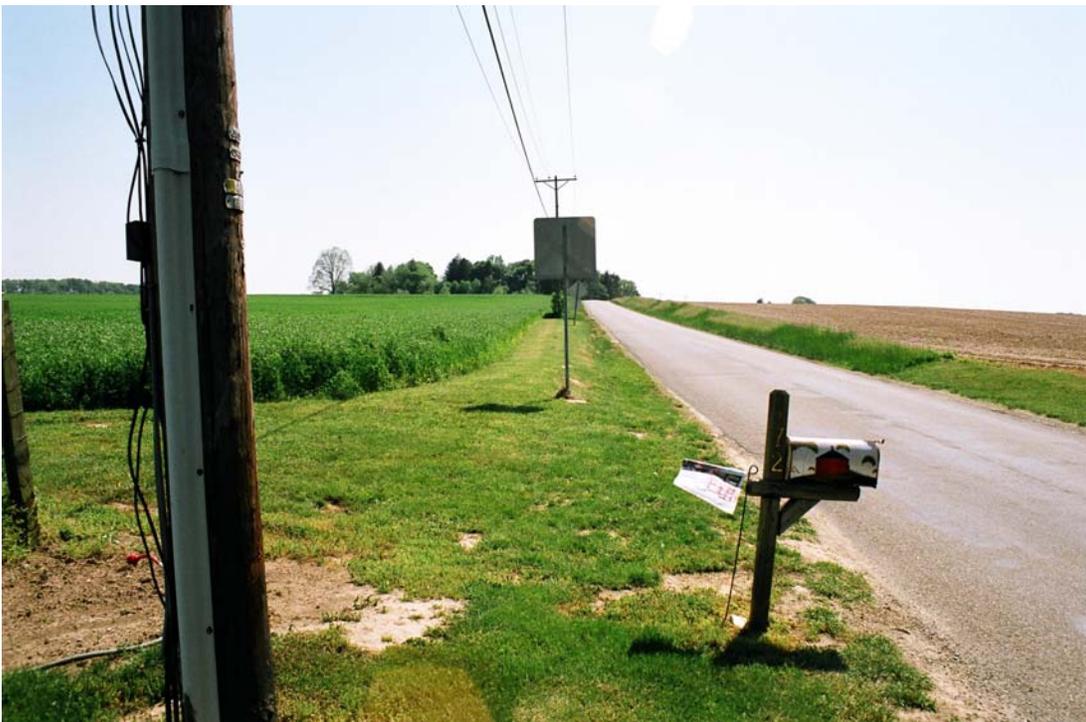
Photograph 10: Agricultural field in the southwest quadrant, facing southwest.

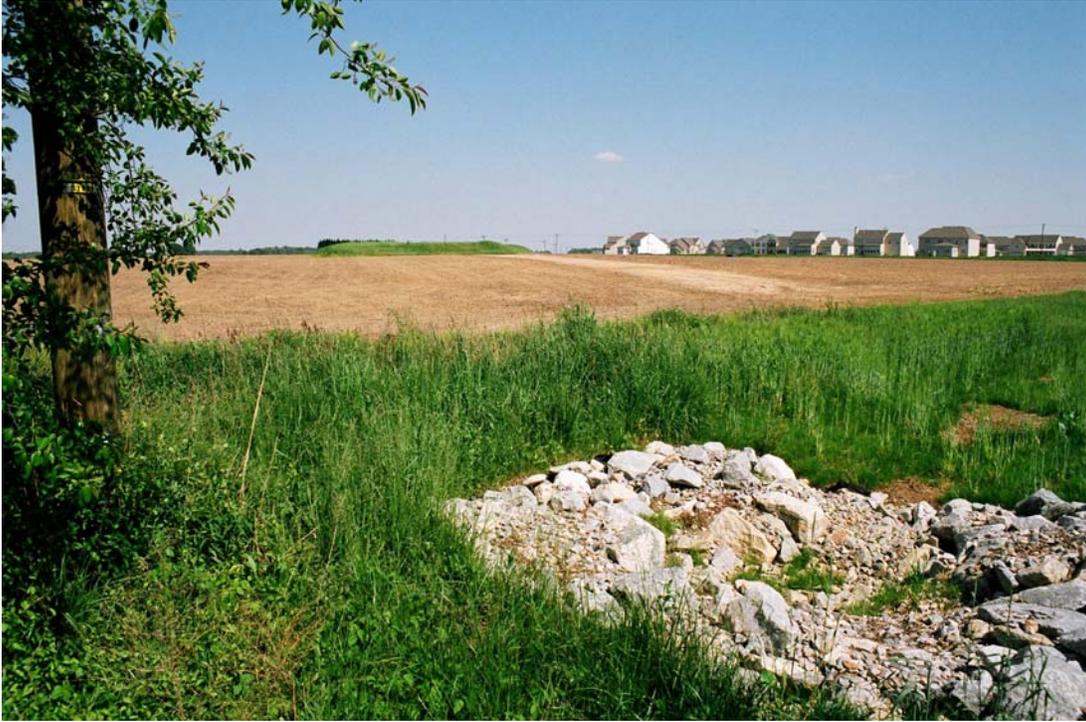
Photograph 11: View of southern portion of Levels Road Culvert APE, facing east.

The project is located in Appoquinimink Hundred, New Castle County, Delaware approximately 5000 feet south of the intersection of S.R. 15 and S.R. 301 and approximately 130 feet to the east of the existing Levels Road (S.R. 15) (*Figure 1*). The proposed project involves constructing a culvert that will carry the headwaters of Deep Creek beneath the proposed new alignment of Levels Road. Disturbances associated with the temporary realignment of the stream channel and the construction stockpile and staging area are included within the archaeological APE (*Figure 3*). The entire APE associated with the culvert replacement is situated on an upland landform that currently serves as an agricultural field (*Figure 3, Photographs 11 and 12*).

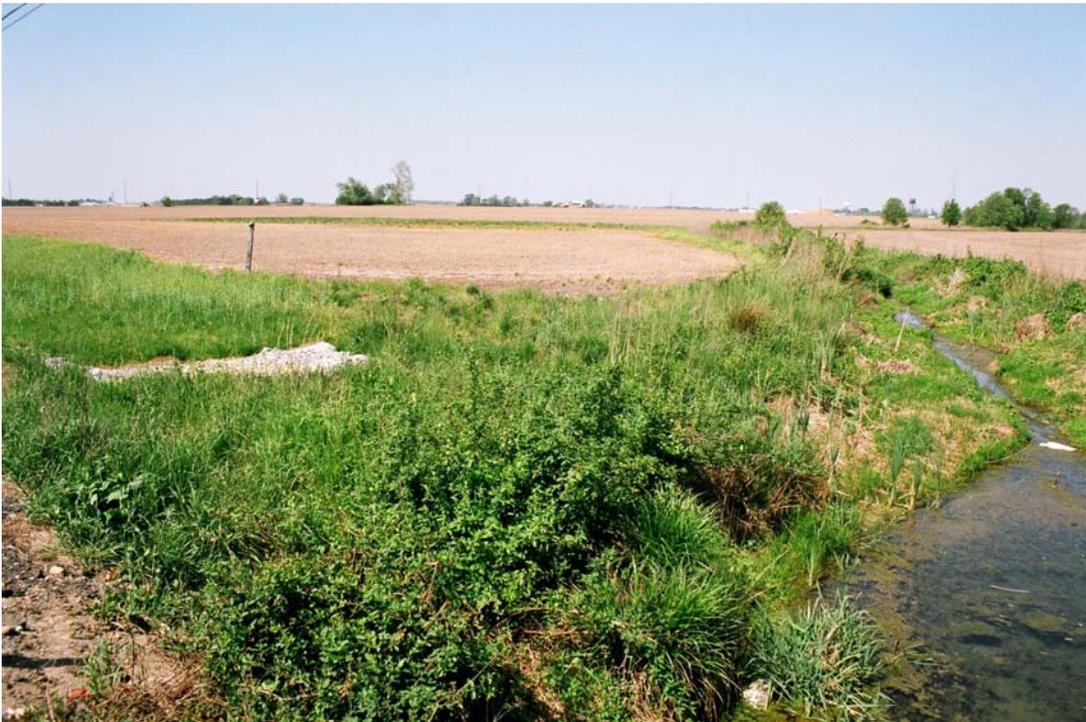
Photograph 12: View of northern portion of Levels Road Culvert APE, facing east.
