IV. Survey Results

A. Architectural Resources: Cauffiel Estate

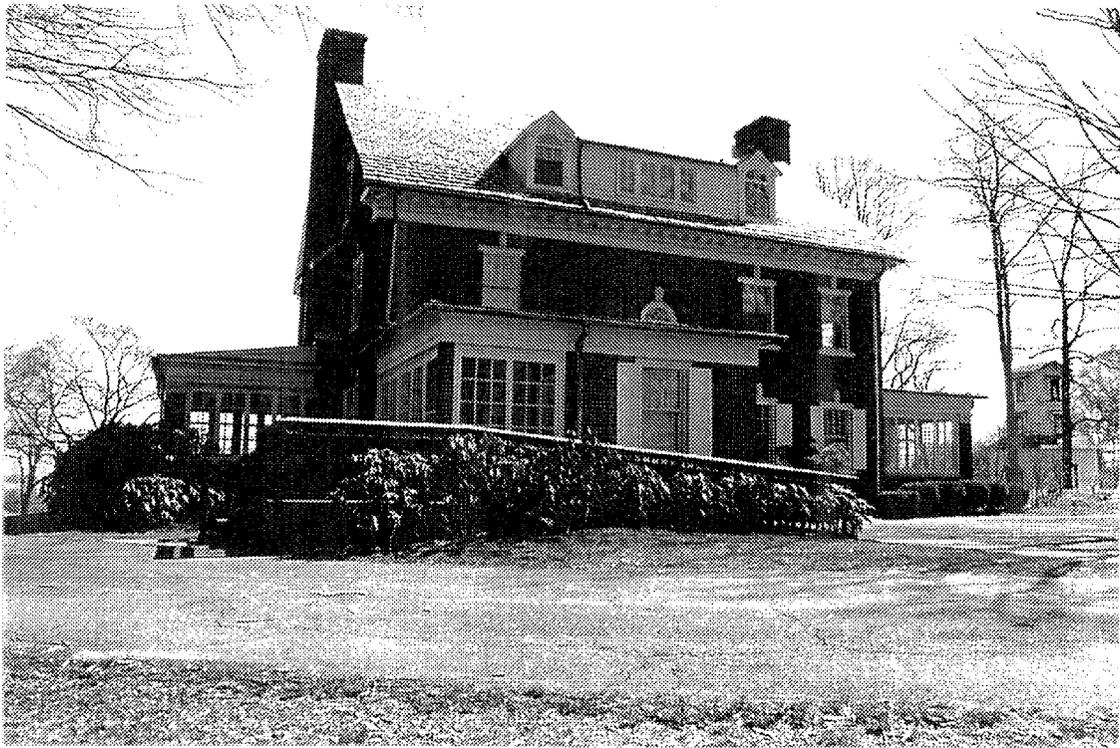
Photograph 4: Cauffiel Estate main house, rear (west) façade, facing east.

A long driveway leads from Philadelphia Pike to the Cauffiel Estate. This driveway forms a circle around the main house. The main house (*Photographs 4, 5, and 6*), designed by a Wilmington architect named Clarence R. Hope, was constructed c. 1928 for Daniel Cauffiel, the chief real estate officer for the DuPont Company. Mr. Hope is also noted for designing The Nurses Home in Wilmington, among other structures. Originally, an older house was situated where the main house now stands. This older house, built c. 1880 for Charles B. Lore, a judge and politician from Wilmington, was moved closer to the carriage house so the present building could be constructed. In the 1940's the Lore house was torn down.

The Cauffiel house is an excellent example of Colonial Revival architecture, and is a particularly good rendition of Georgian Revival. Identical wings, which appear to be part of the original construction, flank the symmetrical rectangular main building. An addition on the rear (west side) of the house and a ramp for handicap accessibility are recent alterations. The main house is five bays wide and two rooms deep with evenly-spaced window and door placement. Constructed of brick in a Flemish Bond pattern, the structure is two and one-half stories high. The house has a water table, giving the appearance of a raised basement. Greek Doric columns support a small portico with an iron railing accenting its roof line, and small dentils adorn the cornice. The door, topped by a transom and bordered by side lights and pilasters, is protected by the portico. The windows are eight

panes, divided by Georgian muntins, over a single pane. Shutters complete the windows, which are crowned by jack arches with keystones. Three gabled dormers extend from the slate-covered gabled roof. Two additional gabled dormers, connected by a shed dormer, accent the rear facade. A modillioned cornice traverses the roof line. A chimney, inlaid with a rounded arch window, rises from each gabled end. In addition, an arched window with tracery decorates the rear of the house.

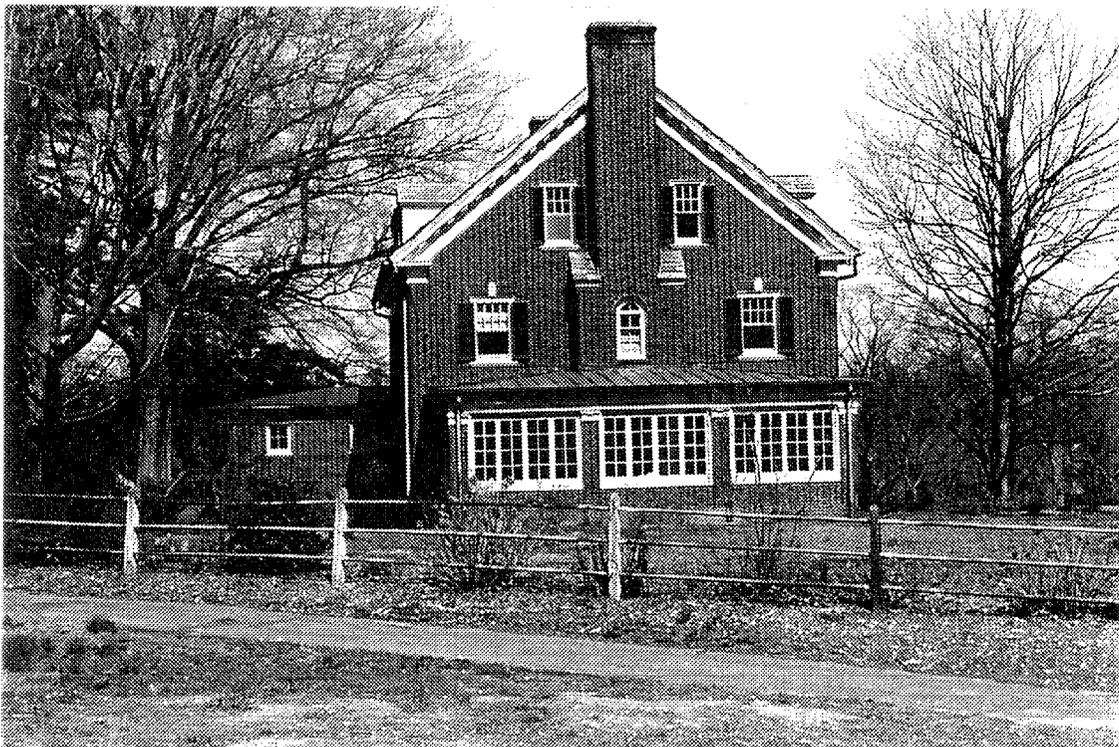
Photograph 5: Cauffiel Estate main house, south gable end, facing north.

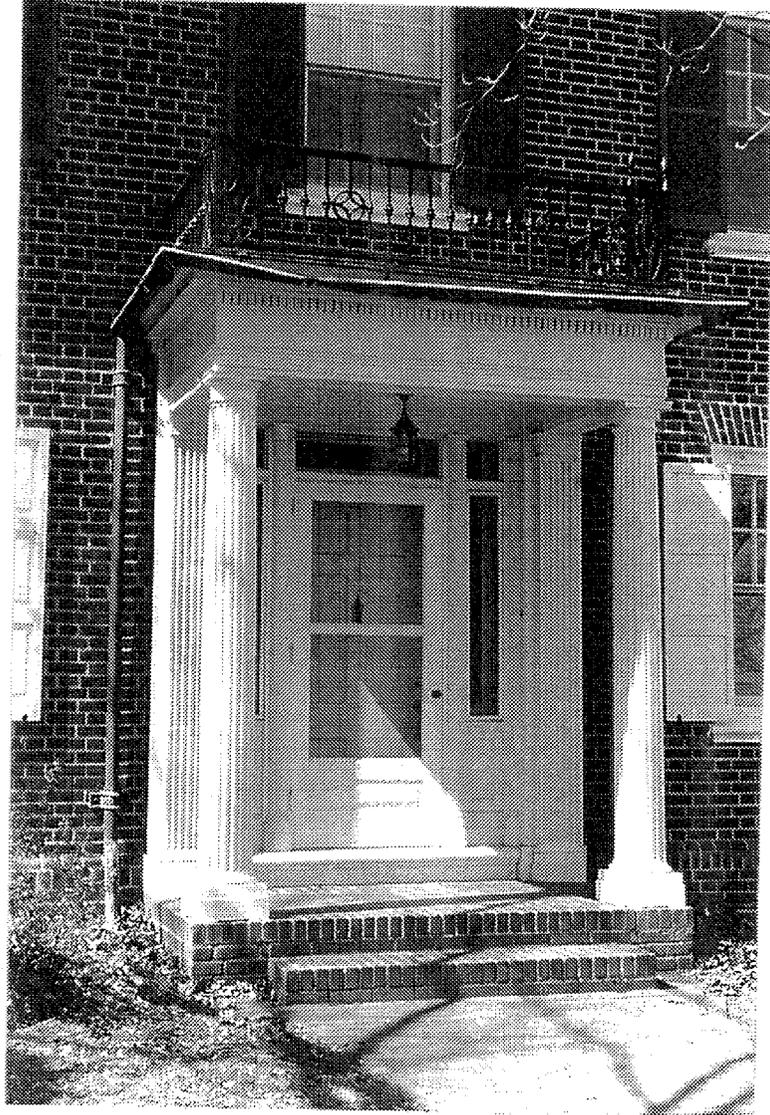
Photograph 6: Cauffiel Estate main house, entrance portico, facing west.

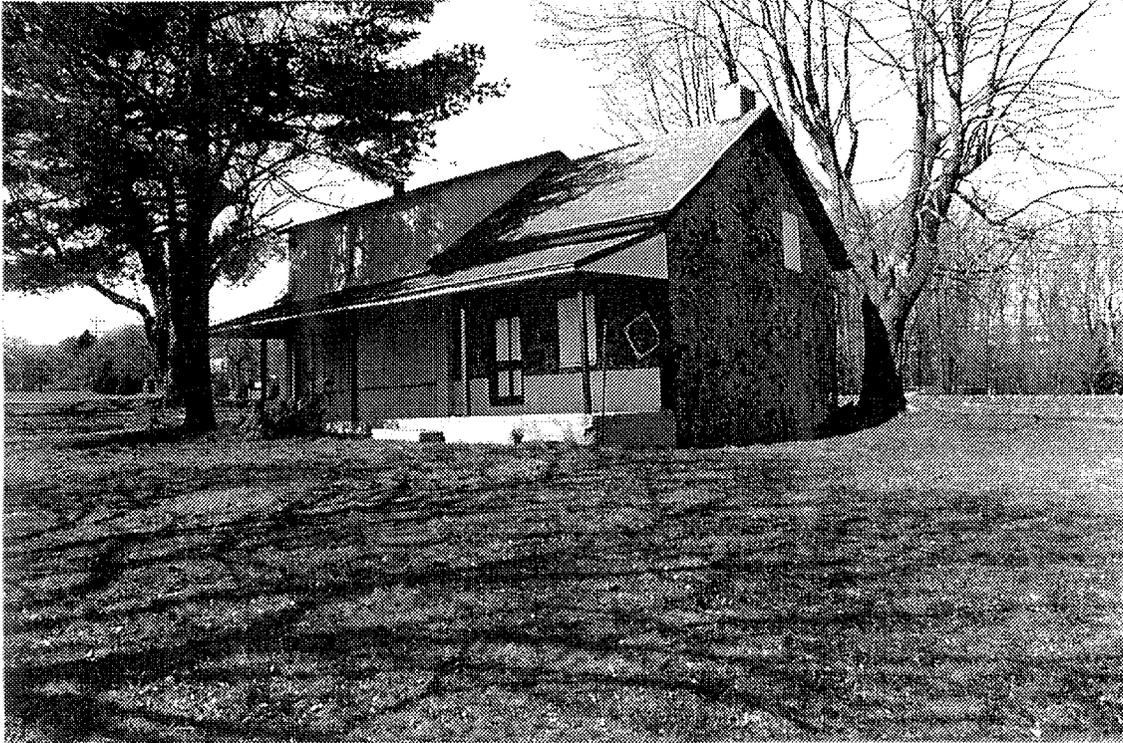
Photograph 7: Log house, east façade and north gable end, facing south.

A log and stone house, called the Sarah Brooks House, is situated on the parcel close to Philadelphia Pike (*Photographs 7 and 8*). Sarah Brooks inherited this property c. 1759 from her father Thomas Cartmell. The house was built in two sections, one of logs, the other, of stone. The log section was constructed first and is now covered with vertical board and batten siding. At the junction of the log and stone sections, small pieces of the logs are currently exposed. The logs appear to be round, not hewn, and V-notched. The ends of the logs protrude over one another, instead of meeting flush. This is a very early method of log construction, and may be indicative of initial Swedish settlement (Early American Architecture, 1987, p. 12-13, p.504). Early land records do suggest that the land now occupied by the Cauffiel Estate was originally owned by Swedish settlers (Duke of York Record, (120), c. 1670, p. 95).

The side-gabled roof is covered with asphalt shingles. Large shed dormers were added during the twentieth century to create additional living space on the second floor. The entire structure is one and one-half stories high, two bays wide and one room deep. The log section is nearly square and is situated on a raised stone foundation. An exterior chimney made of concrete blocks was added to the gabled end of this section in the twentieth century. The stone addition, also almost square, bears a date stone that reads "1806". Uncoursed granite rubble stones were used to construct the addition, with large rectangular stones used as corner quoins. An interior chimney rises near the gabled end of the stone addition. A porch, situated on the east facade of the house, appears to be a much later addition. It has a concrete floor and a shed roof with exposed rafter ends. It also seems that the foundation was exposed at one time and reinforced with poured concrete. The board and batten siding was added in the late nineteenth century when the property was owned by Charles Lore. Like the main house, the Sarah Brooks House is oriented east, facing the Delaware River. The log and stone house, evaluated at fair to poor condition, has not been occupied for the last several years, and the windows have been boarded up. A c.1910 garage and storage shed were situated near the house when the State of Delaware obtained the property in 1993, but have since been torn down.

Although every effort was made to ascertain the construction date of the log section of the house using exterior visual inspection, it remains unclear whether it was built in the late seventeenth century by Swedish settlers, or in the mid-eighteenth century, when Sarah Brooks acquired the property. Establishing the exact date will require a detailed inspection of the building, or analysis of tree ring data from a log sample. Both of these methods will require removal of the board and batten siding, which could compromise the structural integrity of the building.

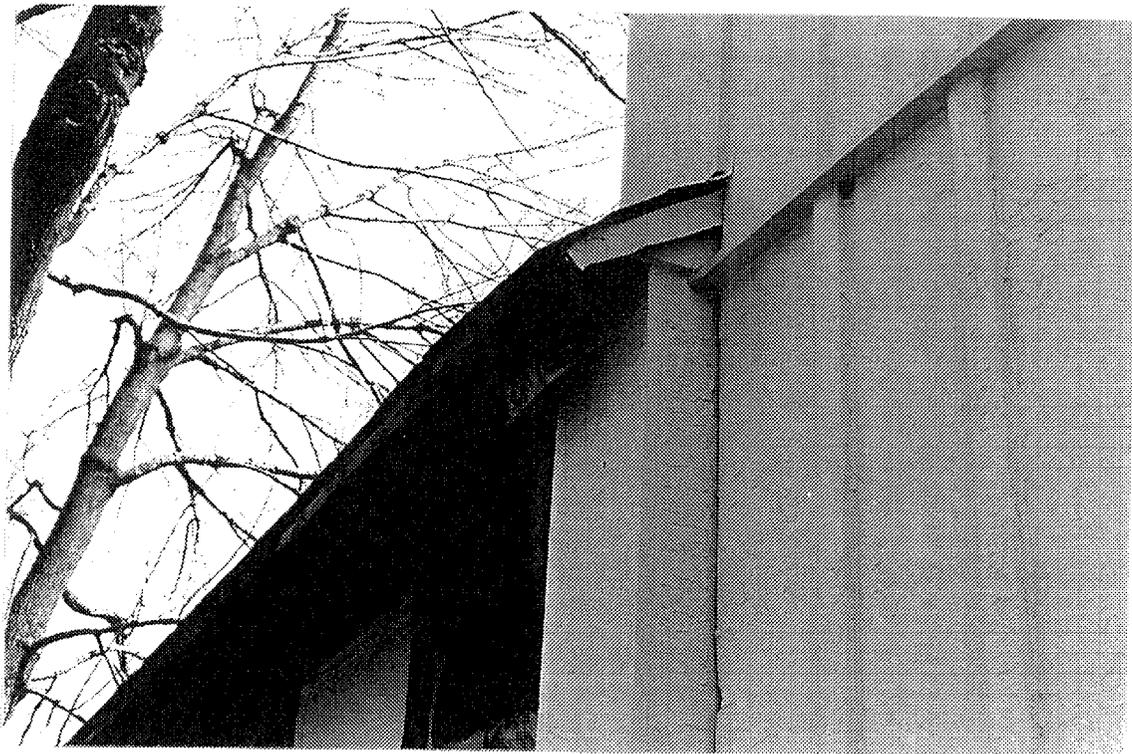
Photograph 8: Log house, exposed log end, facing north.

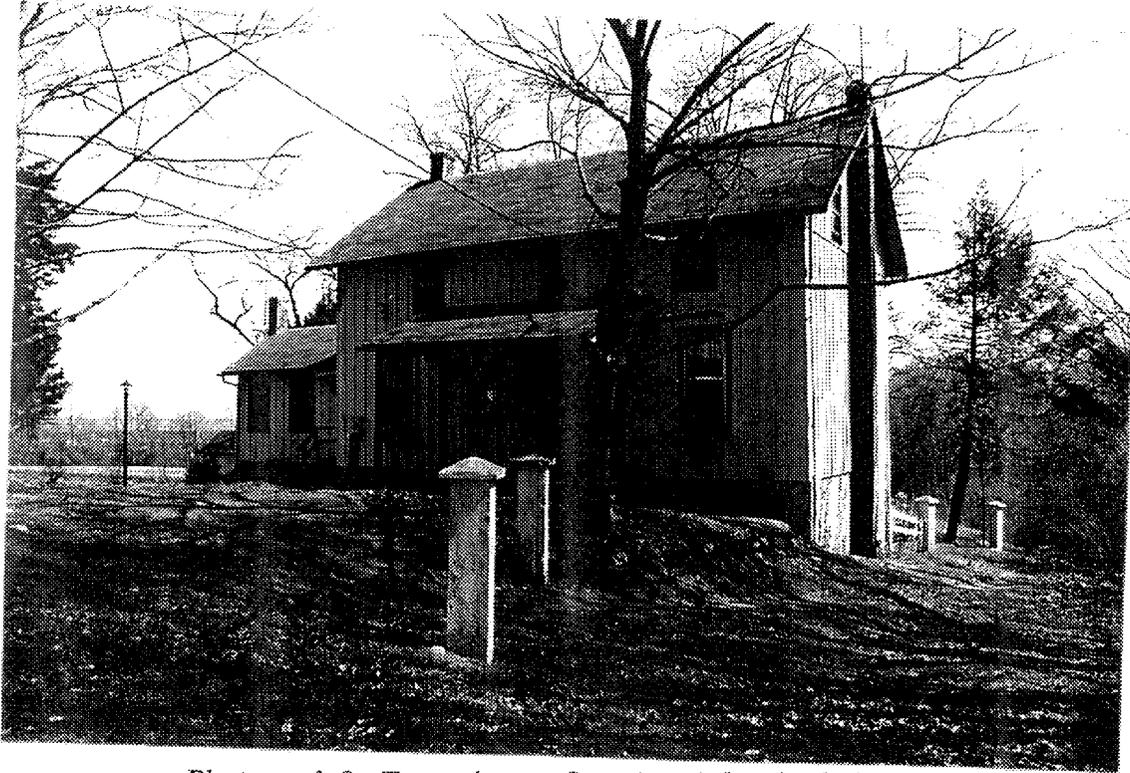
Photograph 9: Tenant house, front (west) façade, facing east.

The tenant house (*Photograph 9*), originally a barn built c.1870, was converted to a residence c.1880 by Charles Lore. Situated southeast of the main house, the tenant house was built on the raised stone basement of the barn, which was originally for stabling animals. Like many barns, it was built into the side of a hill, or banked. As a result, the house is two and a half stories on the east side (back), and one and a half stories on the west side (front). The house, covered with vertical board and

batten siding, is four bays wide and one room deep. A window, a door, a second door, and a window on the first-floor front of the house, as well as three attic windows on the half-story front of the house, are placed asymmetrically. The windows are two over two panes per sash. The roof is covered with asphalt shingles. A small addition is situated on the north side of the house that may have been used for extra hay storage. There is a small front porch supported by wooden posts with scroll sawn Gothic bracket supports. A screened porch on the second floor, rear of the house provides a view of the Delaware River. The window and door surrounds are simple in style. The house was converted from a barn to a folk house, known as an I-house, that has some Gothic style ornamentation. It is in excellent condition.

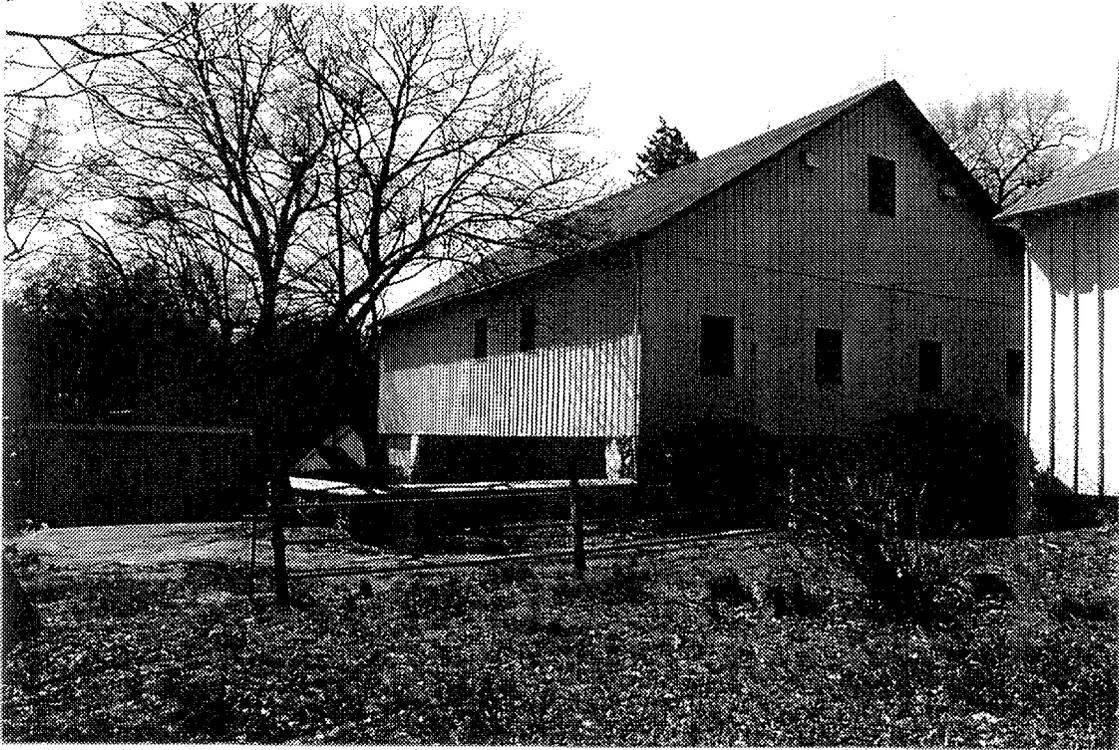
Photograph 10: Bank barn and garage, facing south.

The barn on the property is a typical Pennsylvania Barn (*Photograph 10*), with a banked earthen ramp and a cantilevered forebay. It was built c.1880 during the period when the property was owned by Charles Lore. It is rectangular in shape, four bays wide, and four piles deep. The basement, used for the stable, is made of stone. The upper floor is made of timber frame sheathed with board and batten siding. Unlike many barns it has a considerable number of windows that are probably later alterations. There are three windows on the bank side (east side), four windows across the north gabled end, and a single window near the roof line. There are also three windows across the ramp side (west side) of the barn. The windows are six over six with simple surrounds. There is a large door on the ramp side, as well as doors under the forebay to access the stables. The barn has a very deep forebay supported by an extension of the massive stone basement wall. There is a hay door in the forebay side of the barn. The barn yard is enclosed by a stone fence. The roof is covered with asphalt shingles. *Photograph 10* also shows the garage, which was built c.1910. It is on the left of the photograph, in the background. It is constructed of brick with wooden doors.

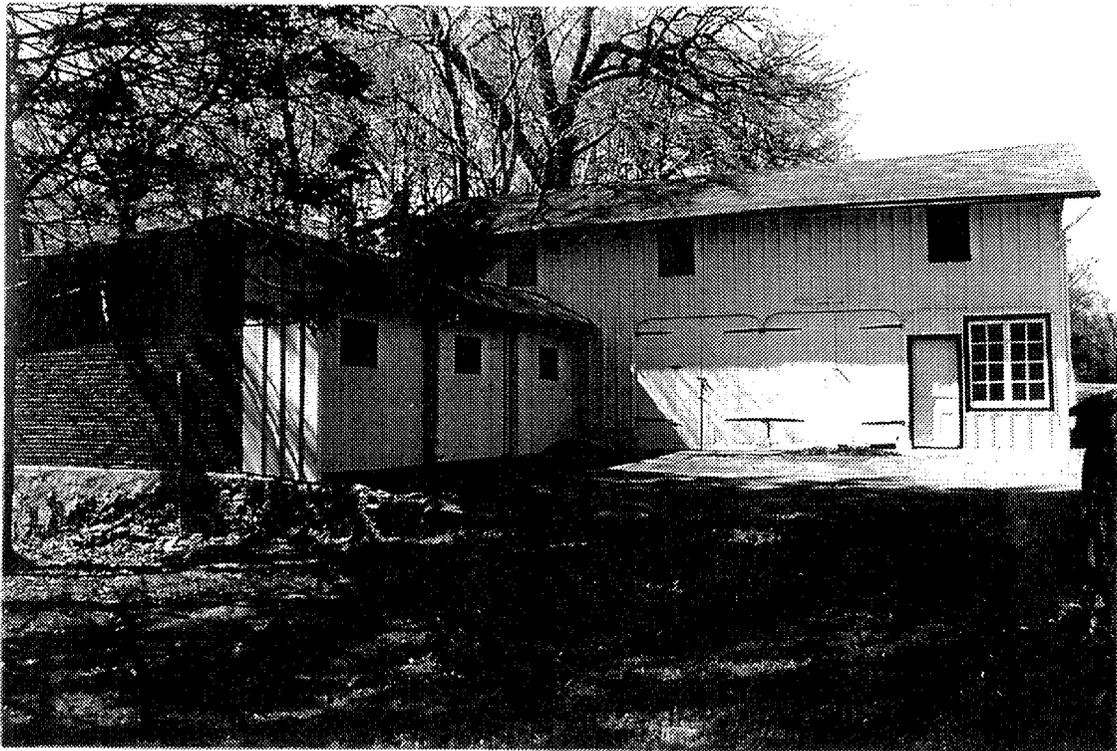
Photograph 11: Carriage house with garage addition, facing west.

There is also a carriage house on the Cauffiel Estate (*Photograph 11*). It was built c. 1880 during the period that the property was owned by Charles Lore, and it has a garage addition from c.1910 when Daniel Cauffiel owned the property. The carriage house section is built of frame and covered with vertical board and batten siding. It is narrow and rectangular in shape, and has two sets of large side-by-side hinged doors on the eave side. There is evidence of a third large door immediately adjacent to the other two, that now has a door and window opening. The windows in the carriage house have small segmental arches over each. The roof is gabled, has overhanging eaves, and is covered with asphalt shingles. It is two stories tall. The second story served as a storage area, as evidenced by a second story hay door. The attached garage addition is perpendicular to the carriage house and forms an overall L-shape. The garage section is one story, with doors for three cars. There is a second garage on the estate that has very similar characteristics and was also built c. 1910. The only difference between it and the garage addition to the carriage house, is that it has doors for two cars. Both garages are constructed of brick with wooden doors. They have slightly pitched roofs covered with asphalt shingles.

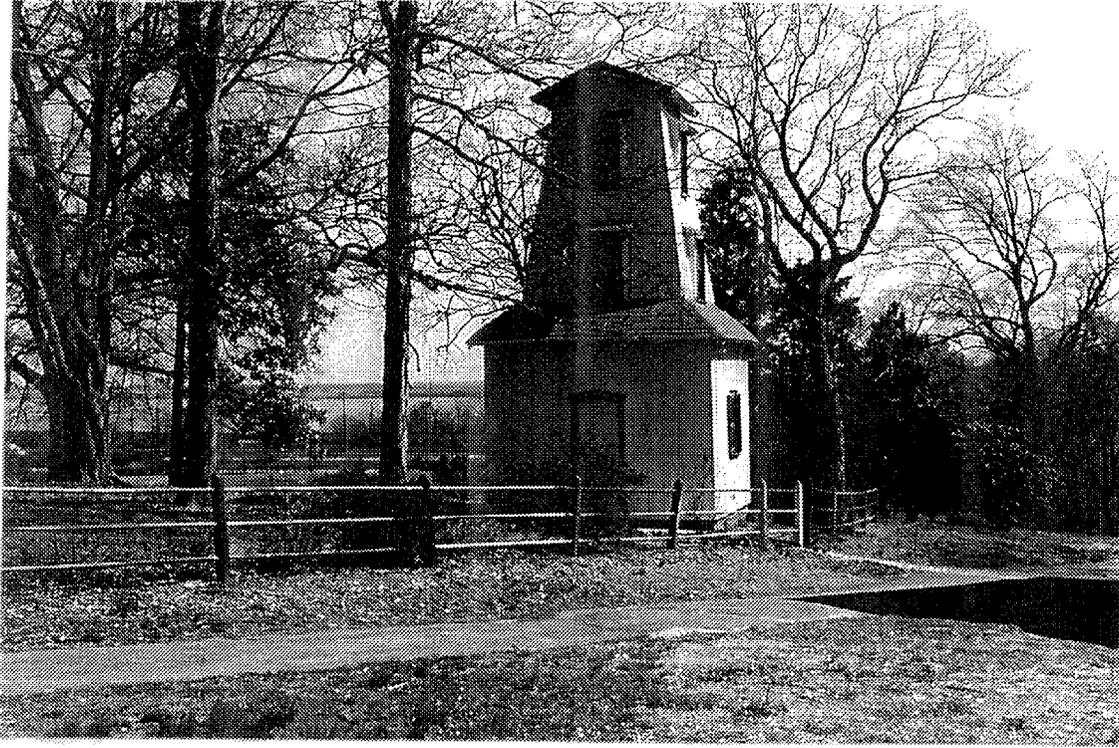
Photograph 12: Pump house, facing east.

The pump house is among the most unique resources on the Cauffiel Estate (*Photograph 12*). It is three stories tall and covered with vertical board and batten siding. It also was built c. 1880 for Charles Lore. The base of the pump house is nearly square in shape, while the upper part is tapered. Its design is similar to that of a windmill. There is a low-pitched gabled roof over the upper section that is covered with asphalt shingles. The base has a hipped roof that is an angled continuation of the upper part. Both roofs are supported by exposed rafter-ends. The windows in the base have simple

surrounds with shutters, while the door has a small triangular pediment above it. The windows in the upper section have rectangular hoods over each that are supported by modillion-like brackets. The windows in the upper section have simple surrounds. According to a previous Delaware Cultural Resources Survey form (N-9554) the pump house system remains in the building, but it has been dismantled.

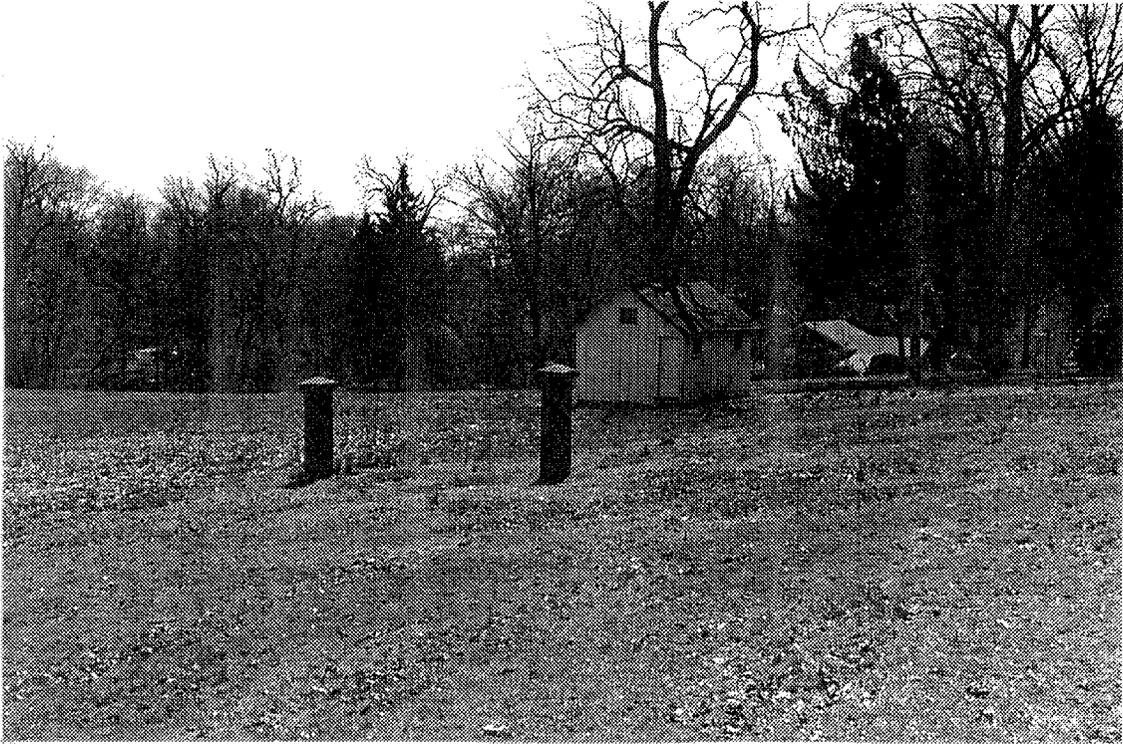
Photograph 13: Chicken coop and cement gate posts, facing south.

There is a small outbuilding on the property that is rectangular in shape and may have served as a chicken coop (*Photograph 13*). The building was built in the late nineteenth century during the time the property was owned by Charles Lore. The building has a gabled roof covered with asphalt shingles. There is a door and window in one gabled end, two small windows along the eave sides, and a small window in the other gabled end. The building is frame construction covered in vertical board and batten siding. The barn and related outbuildings are all in excellent condition.

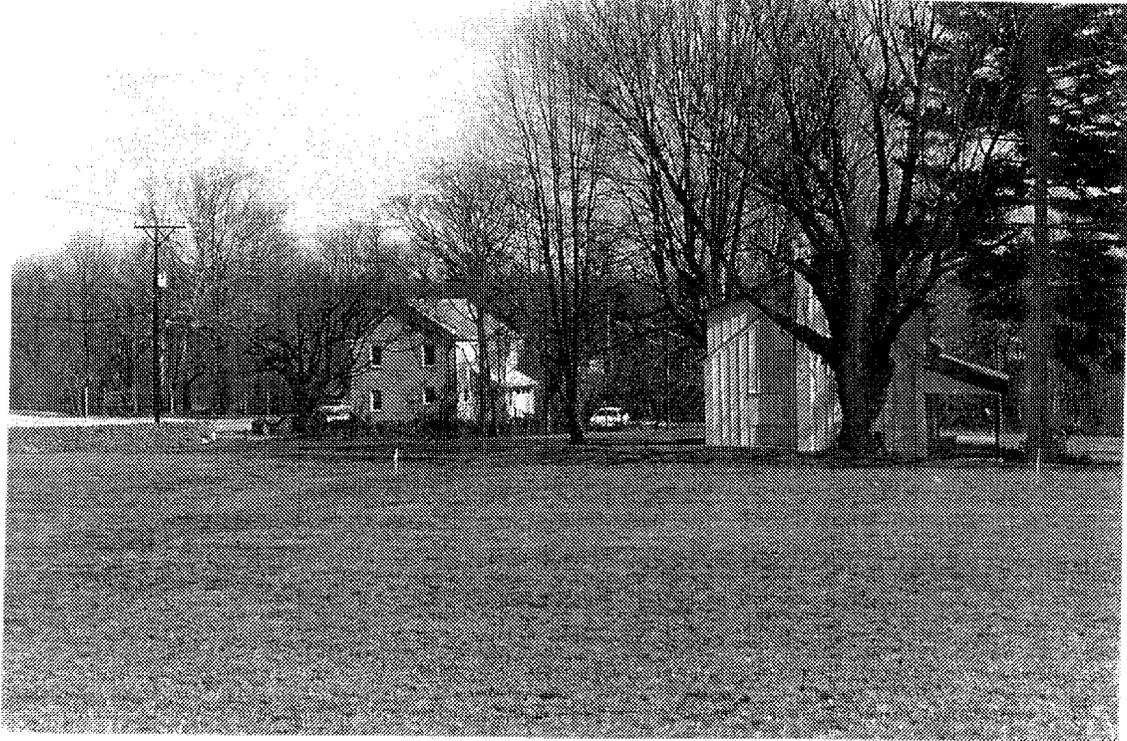
Photograph 15: Log house and office building, facing north.

The former residence/office building on the property is rectangular in shape, two stories high, three bays wide, and two rooms deep (*Photograph 15*). The roof has asphalt shingles with a small central chimney. It is covered with aluminum siding and there is a pent roof along the eave side. The windows are mostly two over two, except for two larger multi-pane windows in the front on each side of the door. Originally, the building was most likely a residence that was converted to commercial use in the mid twentieth century. It is located very close to Philadelphia Pike near the log/stone house. It was originally on the parcel of land that contains the trolley and railroad remnant features, but currently is on its own parcel. It is owned privately by a real estate holding company. The building was probably built prior to 1849, as evidenced by its appearance on a map in the 1849 Atlas of New Castle County by Rea and Price (*Figure 6*).

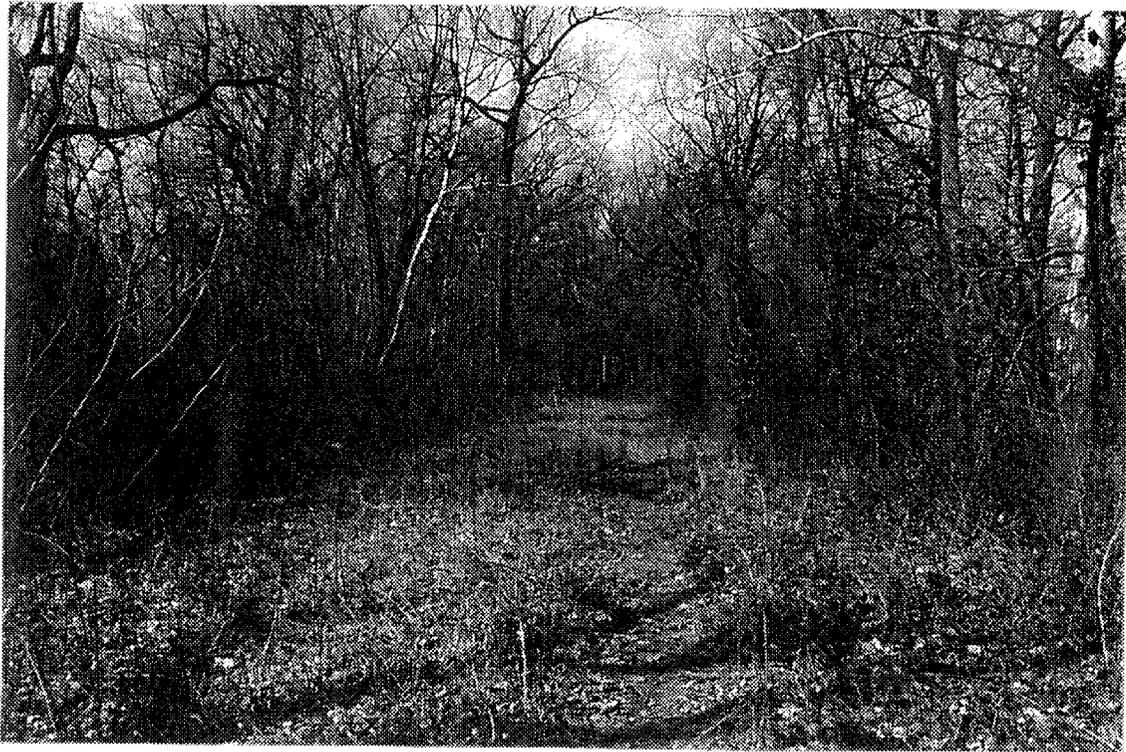
Photograph 16: Railroad right-of-way, now a walking path, facing east.

At one time the Bellevue Quarry Company operated a railroad that crossed the Cauffiel Estate. It is now abandoned and filled with water and known as Lake Bellevue. The quarry mined Brandywine Bluestone, which was floated down Stoney Creek and then shipped by barge on the Delaware River. A large proportion of the stone was used to build the Delaware Breakwater. A small branch railroad was constructed to the quarry c.1870, which ran parallel to Stoney Creek. The Wilmington, Philadelphia, and Baltimore railroad carried most of the shipments of the stone after the branch line was built. Some of the railroad bed is visible on the Cauffiel Estate and a section of the bed is now a walking path (*Photograph 16*). There is a bridge abutment clearly visible along the walking path where the railroad crossed a small tributary of Stoney Creek (*Photograph 17*). The railroad bridge now carries the walking path over the creek. The abutment is constructed of crudely cut granite stone, dry laid in uneven courses. The railroad bridge is made of poured concrete.

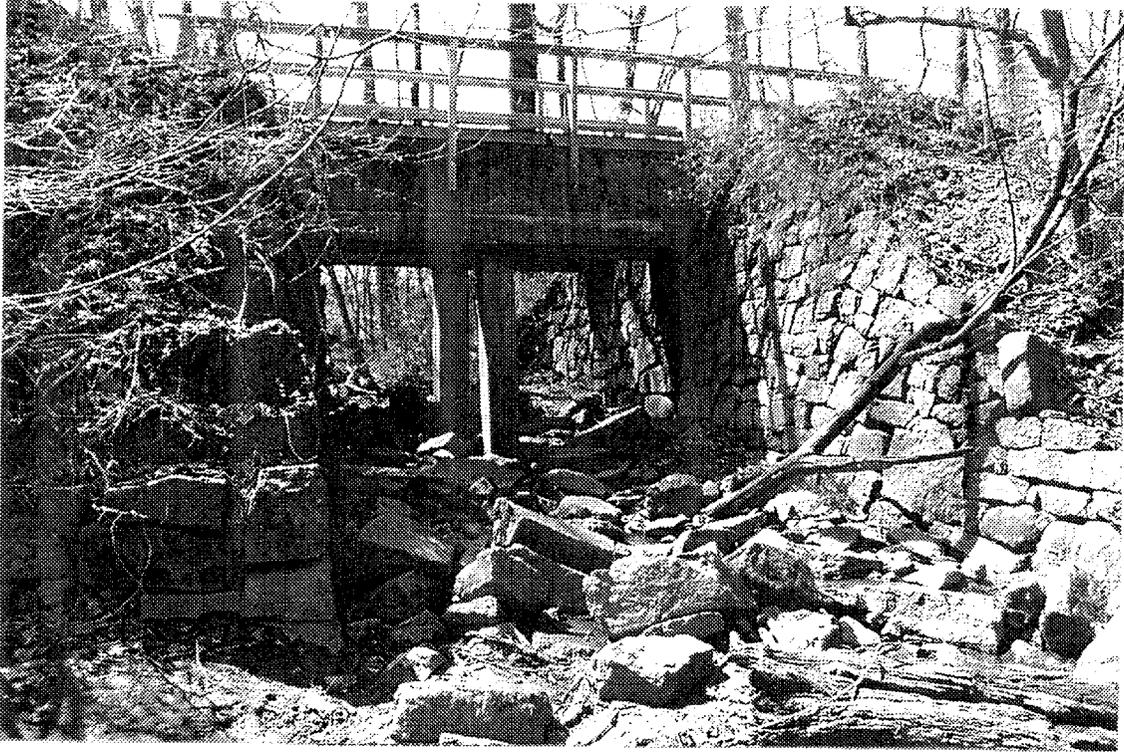
Photograph 17: Railroad bridge abutment, facing south.

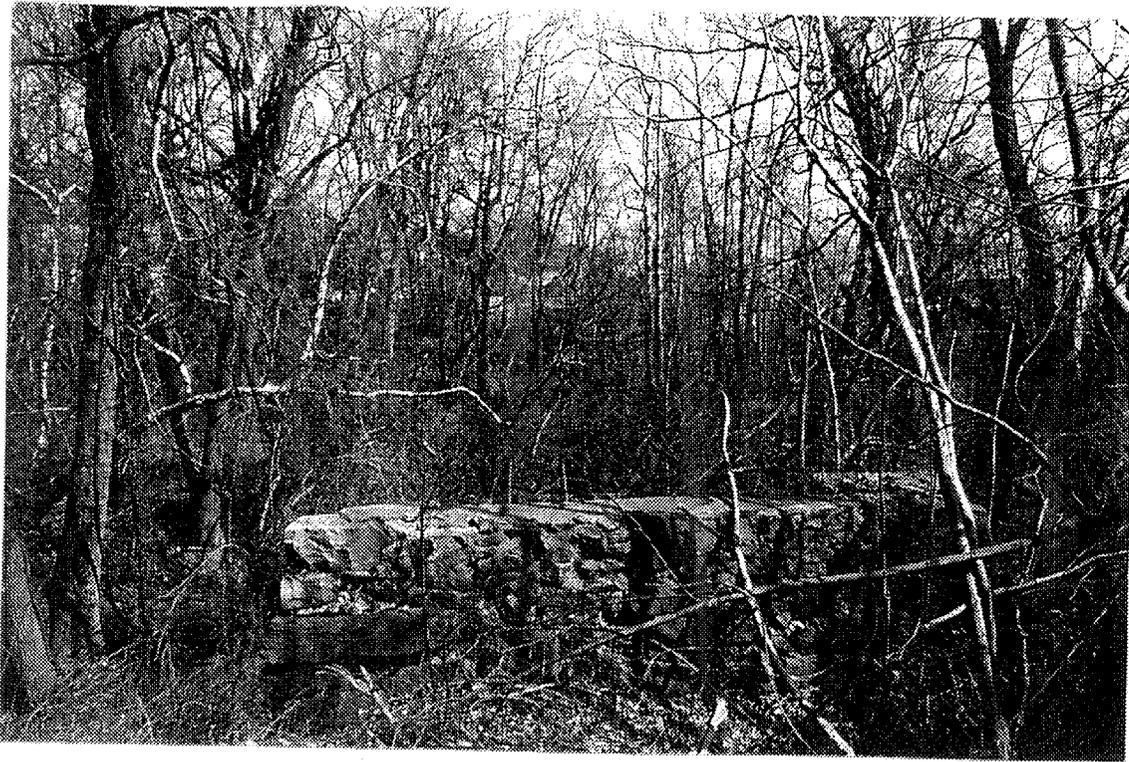
Photograph 18: Trolley bridge abutment, facing south.

The trolley line was built c. 1900 and ran from Wilmington to Darby, Pennsylvania, where riders then connected to trolleys to Philadelphia. Relic features associated with this transportation line include a set of bridge abutments and footings for piers (*Photographs 18 and 19*), which carried the trolley over the railroad, a small tributary of Stoney Creek, and Stoney Creek. These remnants, made of mortared, square-cut granite stones, are not as easily visible as the railroad bridge. The abutments

are situated in the woods, parallel to a walking path, and the piers are most visible in Stoney Creek itself.

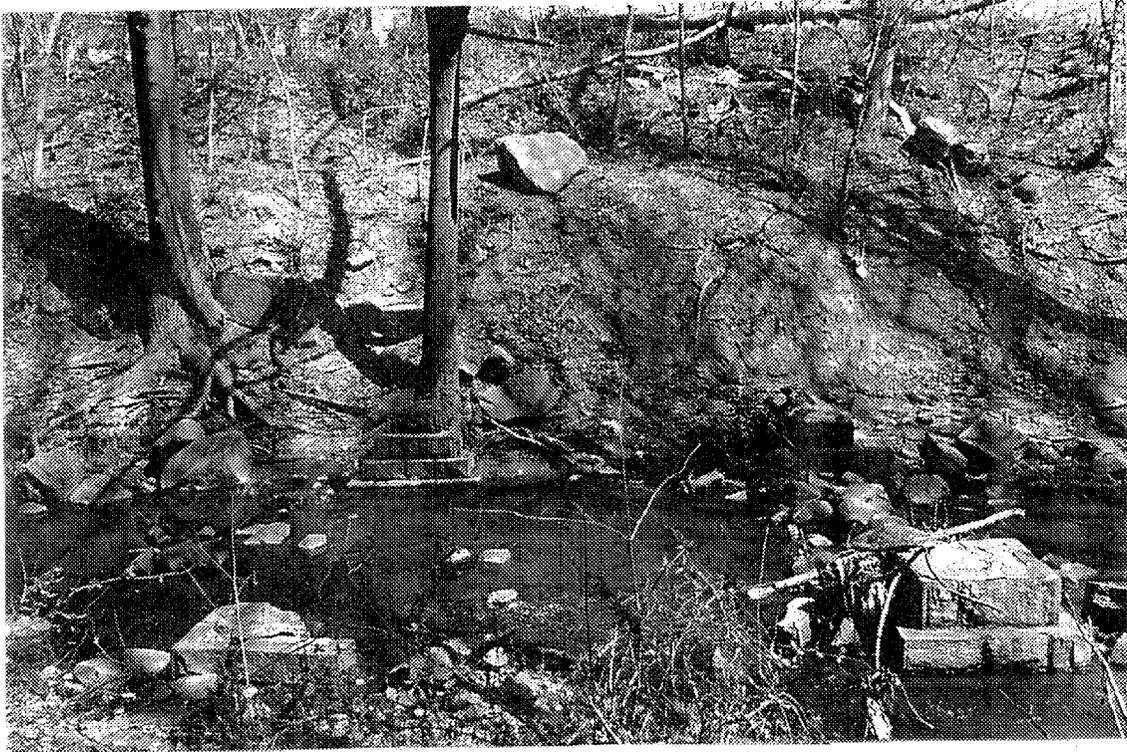
Photograph 19: Trolley bridge footings, facing north.

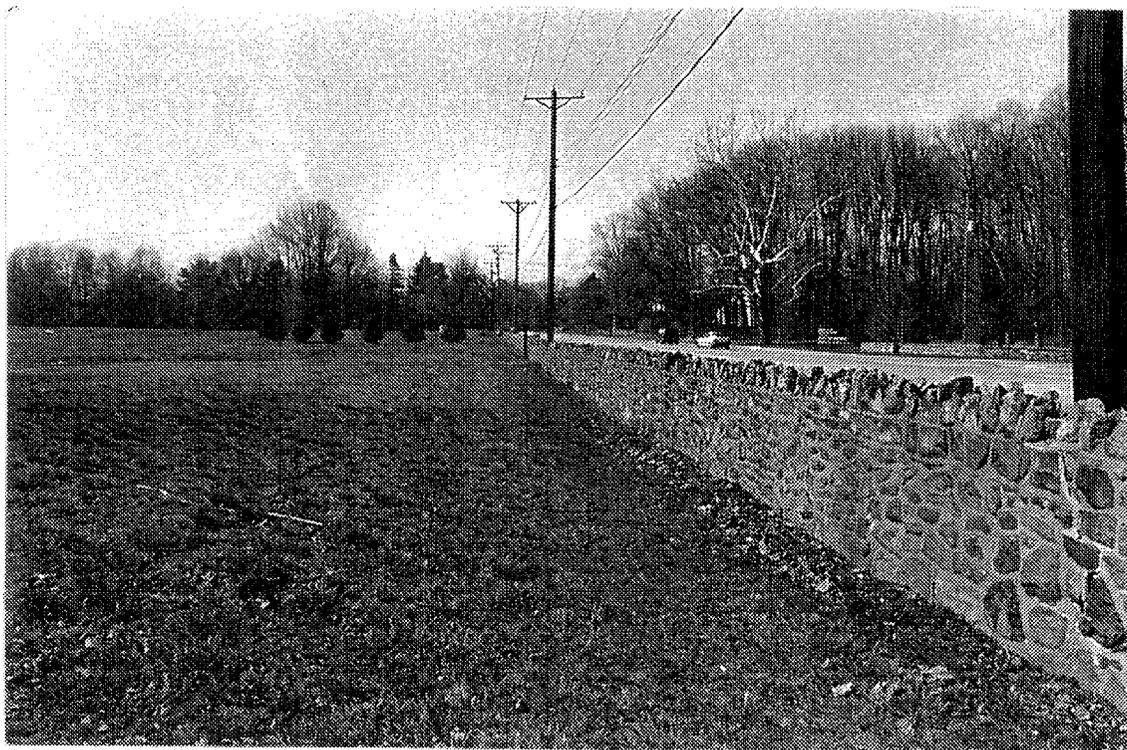
Photograph 21: Stone wall along Philadelphia Pike, facing south.

The current landscape of the estate also provides an opportunity to observe elements of the agricultural history of the property. The barn and outbuildings are obvious reminders of the property's agrarian origins. Along Philadelphia Pike is a mortared stone wall laid in uneven courses (**Photograph 21**). Less obvious indicators of the farm landscape are the scattered cement gate posts that once held gates and fences that allowed access to, and divided, fields, pastures, and orchards (**Photographs 22 and 23**). Orchards are mentioned as having been in the landscape of the property as early as 1759 when Thomas Cartmell willed the property to Sarah Brooks. Orchards are also mentioned in a biography of Charles Lore, and Daniel Cauffiel planted an orchard on the estate. The clustering of the majority of buildings in a small area of the estate signifies an effort to preserve the open land. As a result of this, many open areas exist on the property as well. These include: Stoney Creek, which is scattered with large boulders and small waterfalls (**Photograph 24**); a small area of wetlands; the tributary streams that have eroded the land resulting in changes in elevation; and the flatland and meadows closer to the river. The remnants of the railroad and trolley provide vestige elements that show the overall evolution of the cultural landscape on the estate. In summary, the landscape evolved from the log/stone house possibly being built by early Swedish settlers, to the construction of most of the farm outbuildings in the late nineteenth century when Charles Lore owned the property, to the construction of Daniel Cauffiel's Colonial Revival home in 1928. Interspersed are the remnants of the quarry rail line built in the late nineteenth century and the trolley remnants from the early twentieth century.

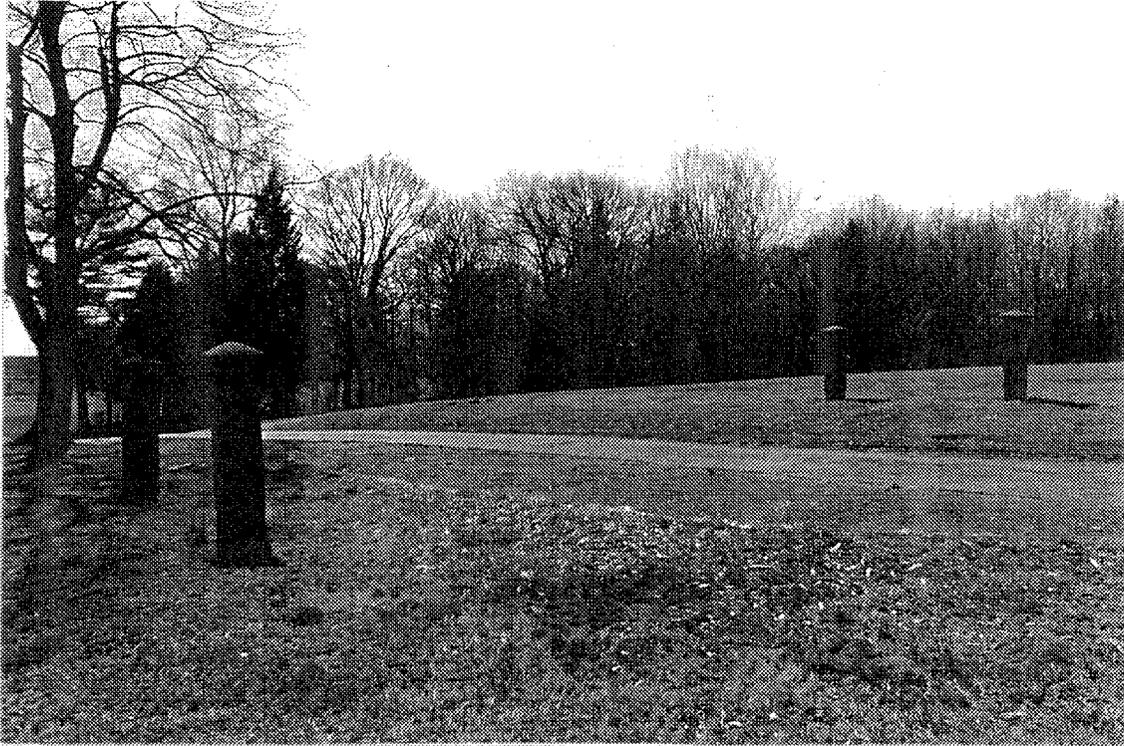
Photograph 22: Cement posts at driveway entrance, facing east.

on file at the Delaware Public Archives, shows the Lore house on the southern boundary of the property near the carriage house/garage (**Figure 9**). A garage and shed near the log/stone house were also removed due to their dilapidated condition. Early land records indicate that a mill, built by Swedish settlers in the 17th century, stood on or near Stoney Creek. No evidence of this mill has been found along the creek. In addition, there are no longer any orchards, cattle, cultivated fields or other types of agricultural practices currently taking place on the estate. Gates and fences have also been removed, except for the gateposts.

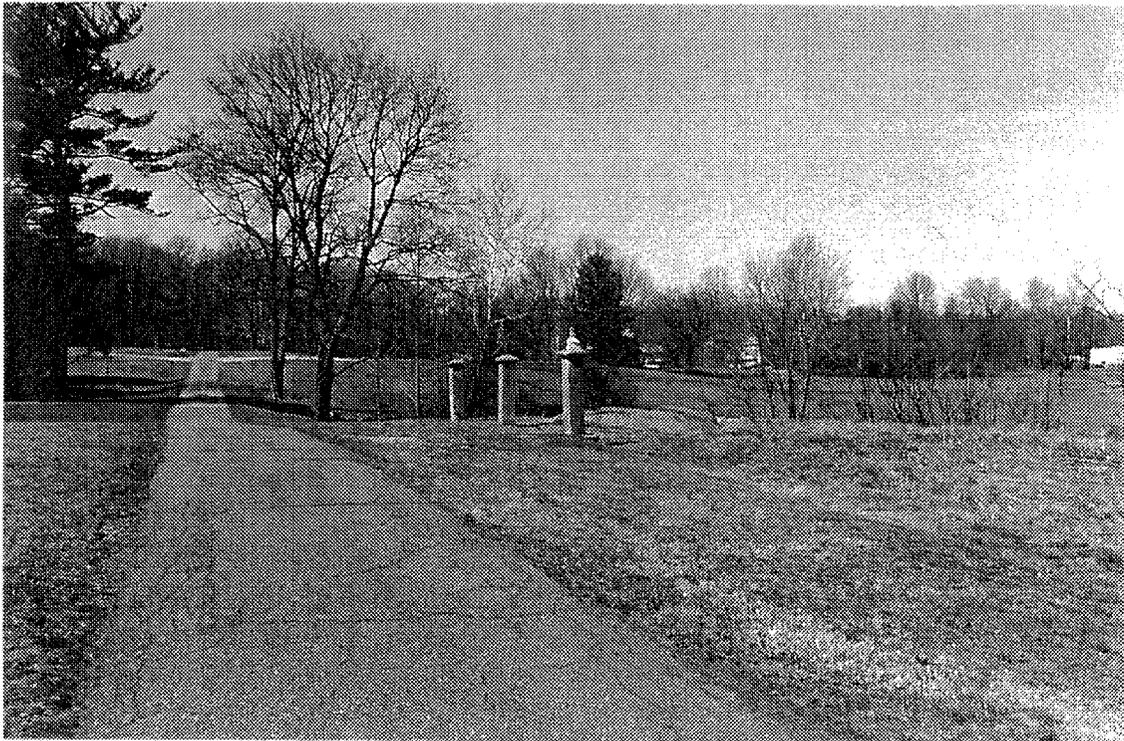
Photograph 23: Driveway and cement gate posts, facing west.

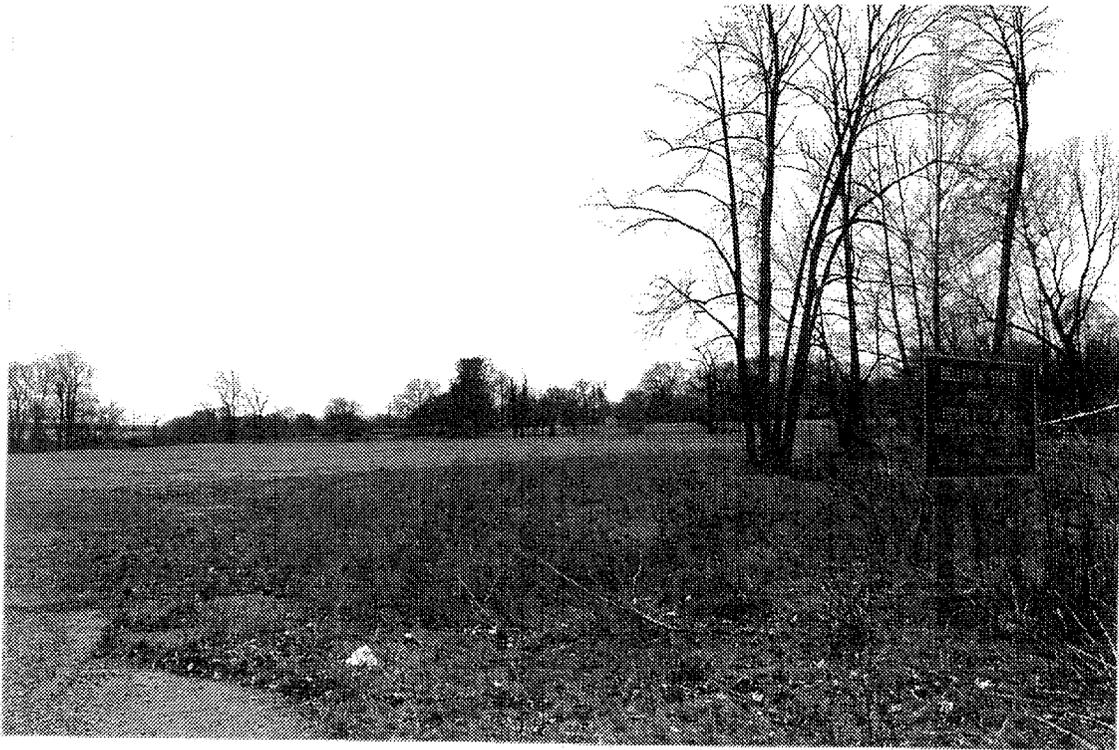
Photograph 25: State Aquatic Center construction zone, facing east.

The historic integrity of the Cauffiel Estate has been retained. The estate displays a mix of architectural styles from earlier folk house types to Colonial Revival. There are some elements that detract from the overall integrity of the property. The log/stone house for example, has been altered by the addition of shed dormers and the board and batten siding. Both of these changes can be reversed, and they represent relatively minor alterations to the house considering its age and potential importance as an example of early Swedish log construction. Also, the former residence/office building has been covered with aluminum siding and windows in the front have been enlarged. The building does still retain its basic shape and form. All the other resources on the property, especially the main house, are in excellent condition and have retained their historic integrity. Intrusions do occur to the overall landscape caused largely by the Delaware Aquatic Center construction (**Photograph 25**) and the addition of rip-rap and piping (**Photograph 26**).

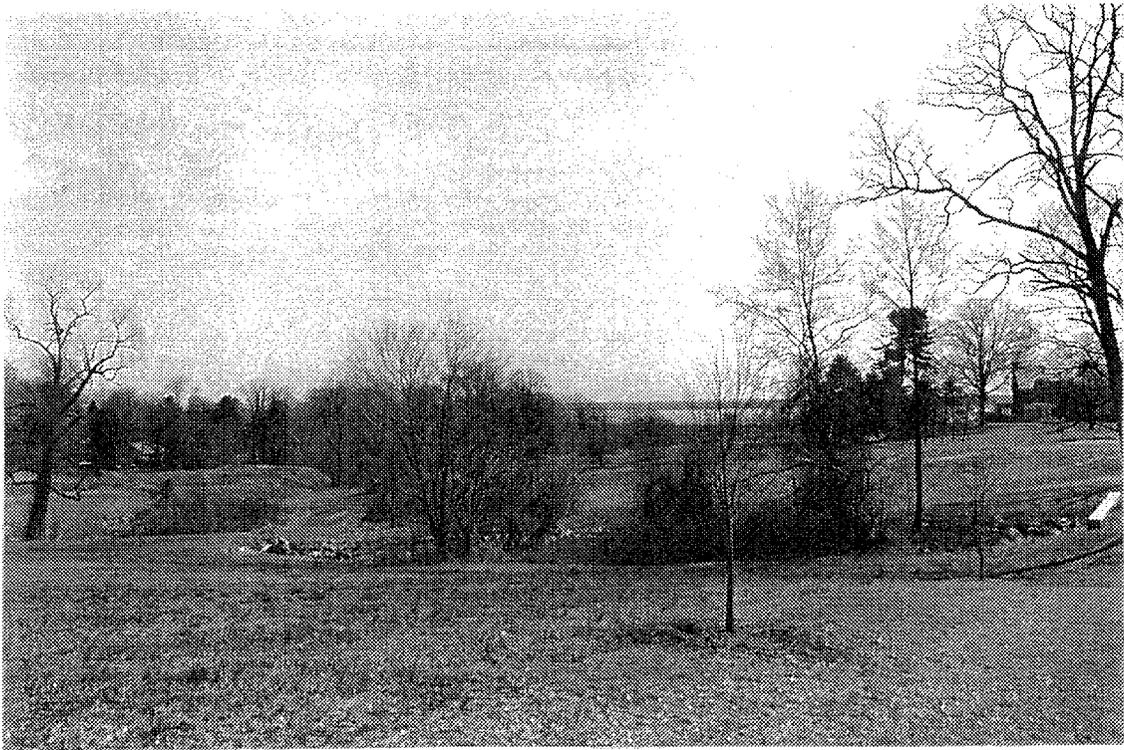
Photograph 26: Piping installation and rip-rap, facing east.
