CULTURAL RESOURCE SURVEY  
PROPERTY IDENTIFICATION FORM

1. HISTORIC NAME/FUNCTION: Chipman Family Cemetery/Cemetery
2. ADDRESS/LOCATION: Lowe's Lakeview Campground, South Side of Chipmans Pond Road
3. TOWN/NEAREST TOWN: Laurel vicinity?
4. MAIN TYPE OF RESOURCE:      building       structure       site       object   
    landscape       district
5. MAIN FUNCTION OF PROPERTY: Cemetery
6. PROJECT TITLE/ REASON FOR SURVEY (if applicable):  
Bridge 362 at Chipmans Pond

a) **Report title:** Bridge 362 at Chipman's Pond Historic Architectural Resource Survey and Determination of Eligibility

CULTURAL RESOURCE SURVEY  
STRUCTURE - BRIDGE/CULVERT  
DRAFT FORM

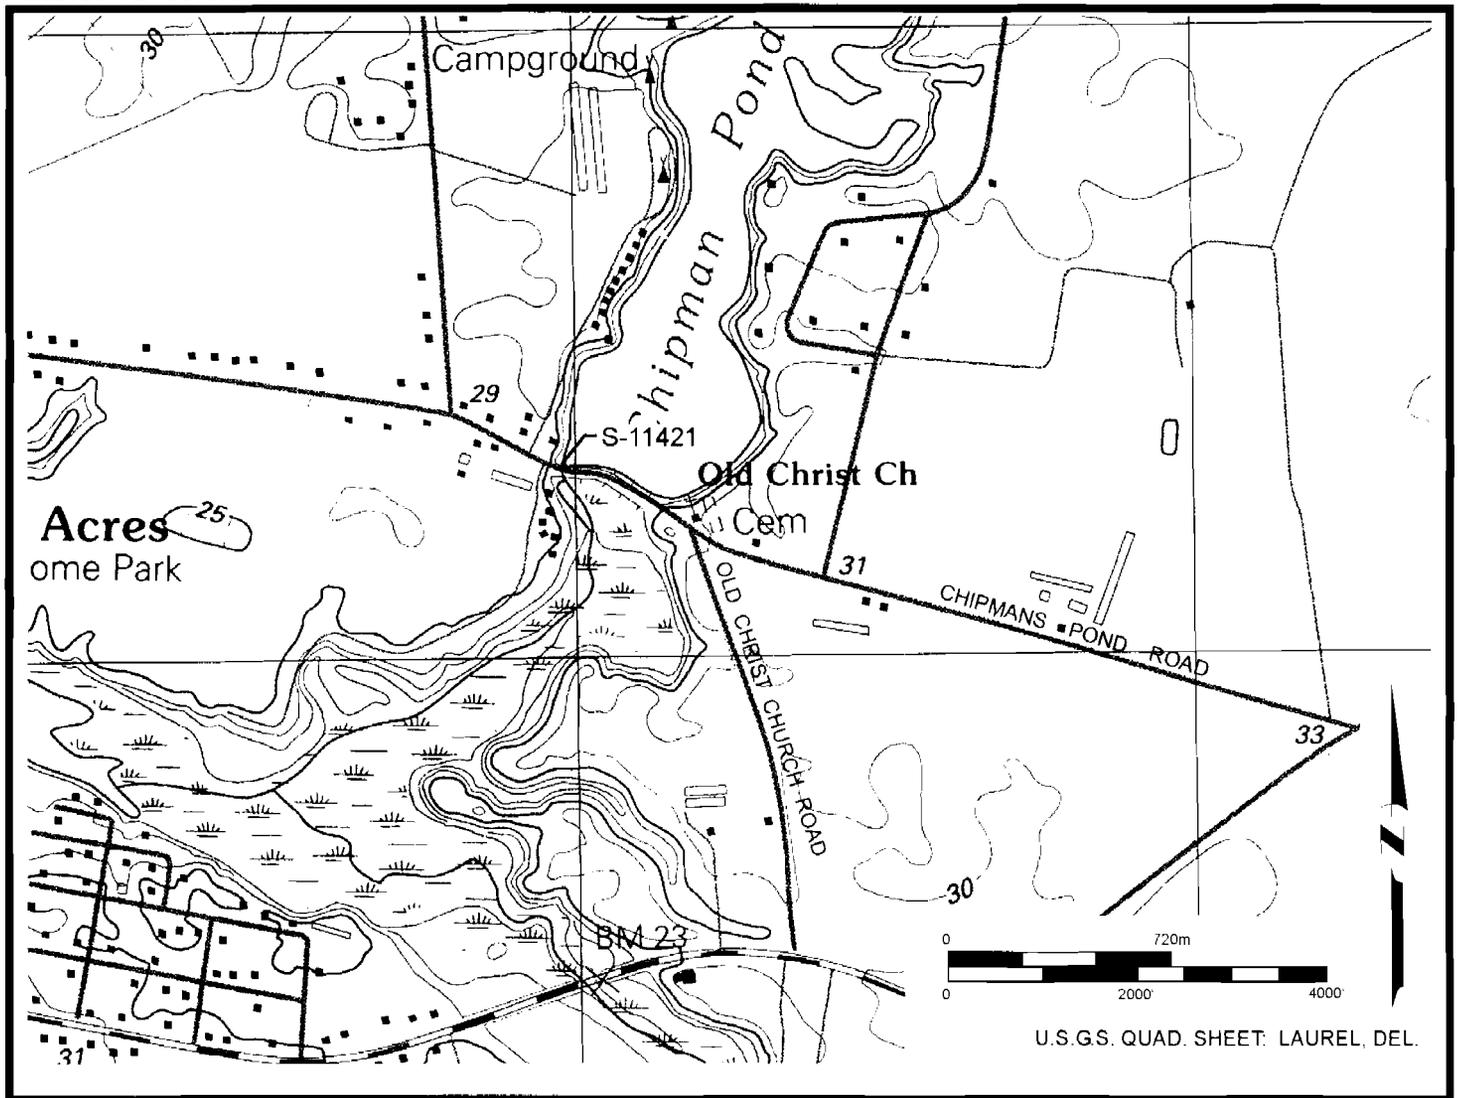
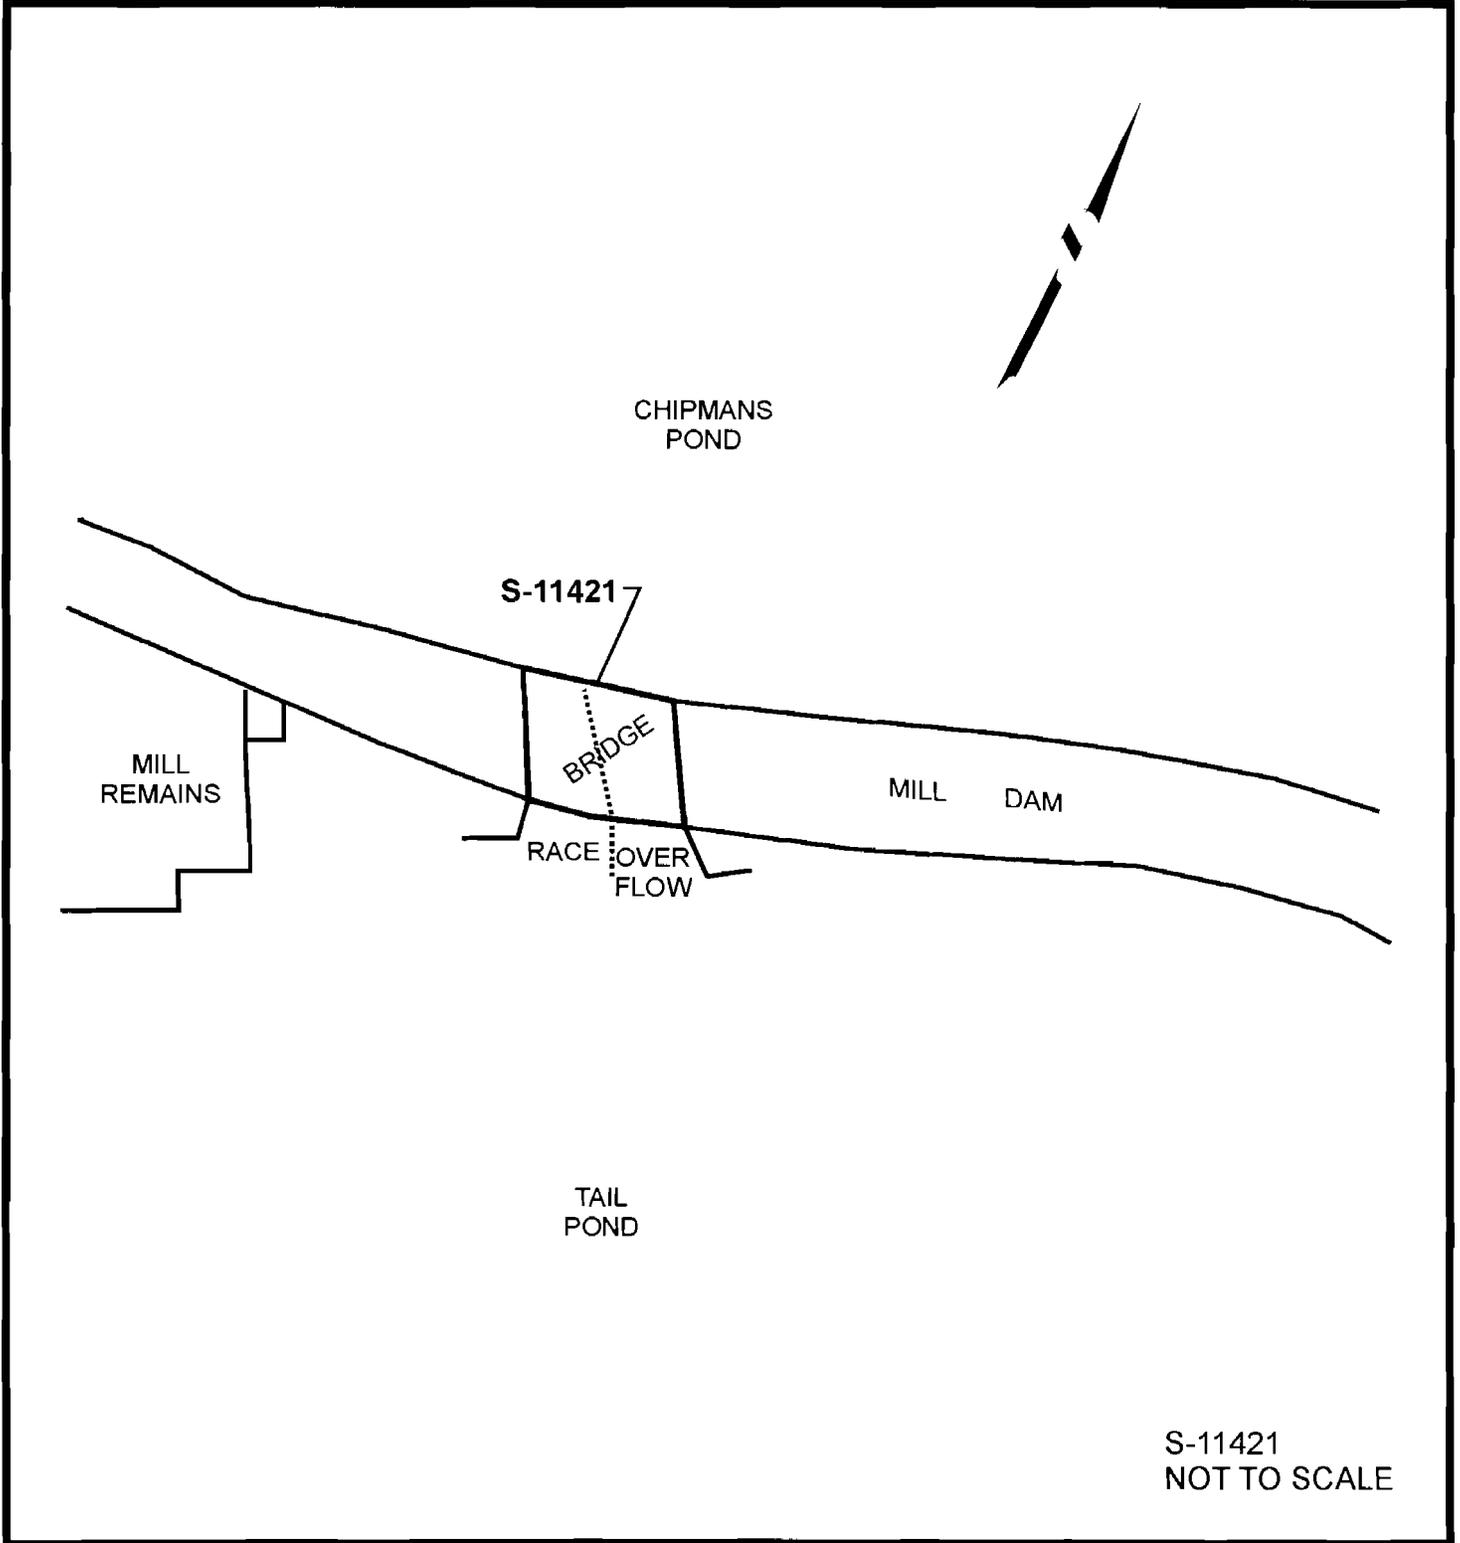
TWO-SPAN, REINFORCED CONCRETE SLAB BRIDGE APPROXIMATELY 17 FT IN LENGTH. THE WEST SPAN IS 7 FT LONG, THE EAST SPAN 10 FT LONG, THE BRIDGE IS WIDER AT THE WEST END (23.5 FT) THAN THE EAST END (21.0 FT). THE BRIDGE IS PART OF THE DAM FOR CHIPMANS POND. IT SPANS THE MILLRACE + SPILLWAY. THE CONCRETE SPILLWAY EXTENDS ABOUT 26 FT TO THE SOUTH.

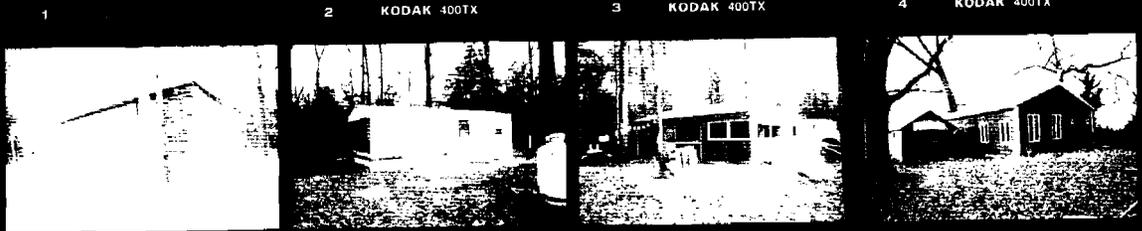
1 5-11419 1A  
2 2A  
3 3A  
4 4A  
5 KODAK 400TX 6 KODAK 400TX 7 KODAK 400TX

Frame #	CRS #	Description of view
1	S-11419	Front (E) and S sides of the toilet facility (S-11419.006), facing NE.
2	S-11419	Front (E) and S sides of the toilet facility (S-11419.006), facing E.
3	S-11419	Front (N) and W sides of S-11419.005, facing SE.
4	S-11419	S-11419.003 and S-11419.004, facing NW.
5	S-11419	Front (E) and S sides of S-11419.004, with S-11419.003 in the background, facing NW.
6	S-11419	Rear (W) and N sides of S-11419.004, facing SE.
7	S-400	Millrace and overflow of S-400, facing NE.
8	S-14121	Elevation view, facing SE.
9	S-188	Facade and E side, facing NW.
10	S-188	Rear (N) and W side, facing SE.
11	S-5873	Chipman Potato House, facade and W side, facing SE.
12	S-5873	Chipman Potato House, rear (S) and E side, facing NW.
13	S-5873	Farmhouse, facade and W side, facing NE.
14	S-5873	Farmhouse, facade and E side, facing NW.
15	S-5873	Garage and carriage barn, facing N from the road.
16	S-5873	Farmhouse, W side and rear ell, facing E.
