4.0 SURVEY RESULTS

4.2 Summary and NRHP Evaluations of the Resources Within the APE

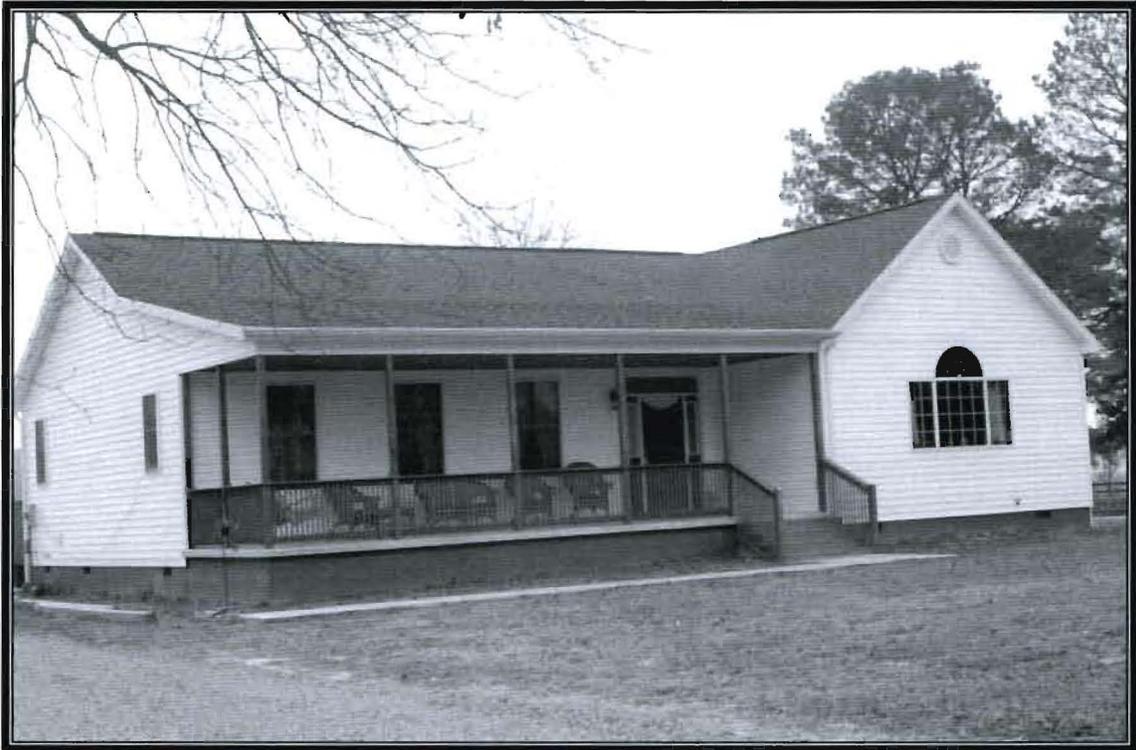
Photograph 1. House associated with CRS S-5876, facing southwest.

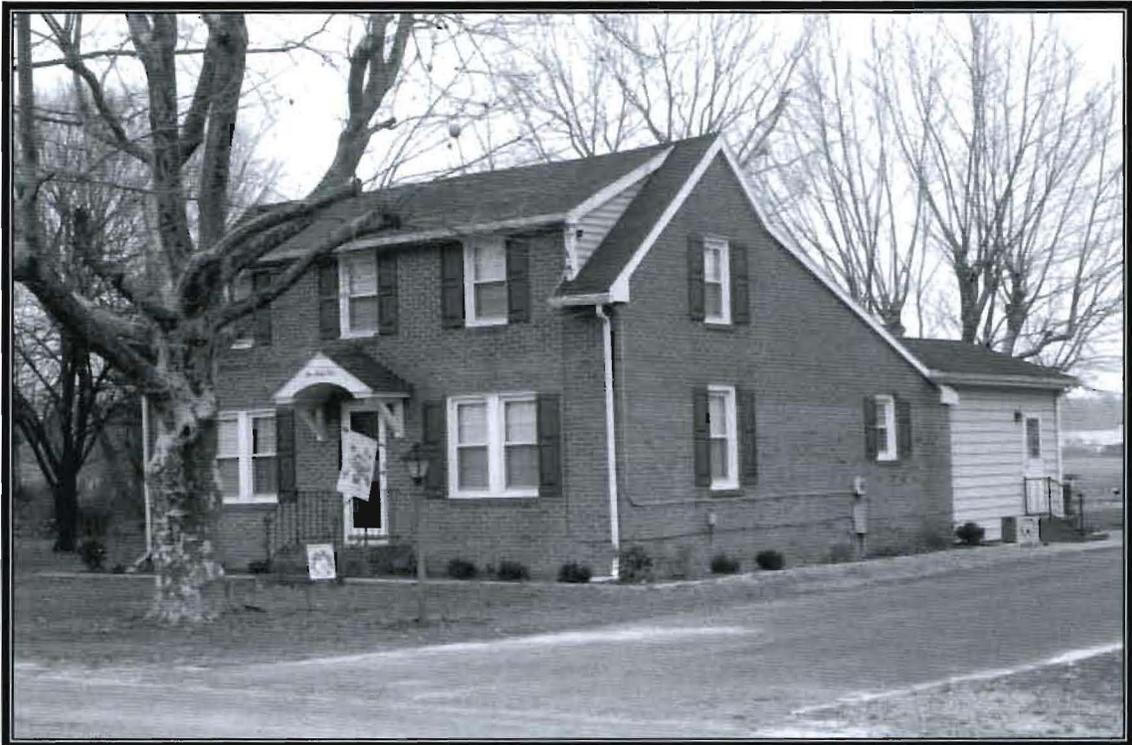
The house built on Chipman and Lowe Lot #3 is a two-story high, three-bay wide Cape Cod style residence dating to ca. 1952 (Photograph 2). The house features a brick-faced exterior, prominent three-bay wall dormer, six-over-six double-hung wood

sash windows, a saltbox roof, pediment arch sheltering the door, and a one-story rear addition. Walter Elwood Chipman and Carlton W. Lowe platted four residential lots on March 2, 1949 (Sussex County Plat Books 1949:Book 2, Page 14); the lots were subdivided from a larger farm. The subdivision of an "edge" of farmland located along a road was common in rural areas. At one time, the four lots consisted of this house, an identical one next to it, and a small store next to the second house. The neighboring house burned down in the late 1970s. The store was moved across the road and is now resource S-5880. The current store for Lowe's Lakeview Campground was built on the fourth lot in 1967 (Jamie Givens, personal communication 2005).

Photograph 2. Chipman and Lowe Lot #3 (S-5878) facade and east side, facing northwest.

Because of their ubiquity and simple nature, the levels of significance and integrity required for a Cape Cod style house to be evaluated as NRHP eligible should be high. Generally, it is difficult for an individual example to be NRHP eligible, unless it is an exceptional example of the distinctive characteristics of the property type, an early example, or a transitional example. This house does not rise to these levels of historical significance. It is a typical and undistinguished Cape Cod style house, built in great quantity following World War II.

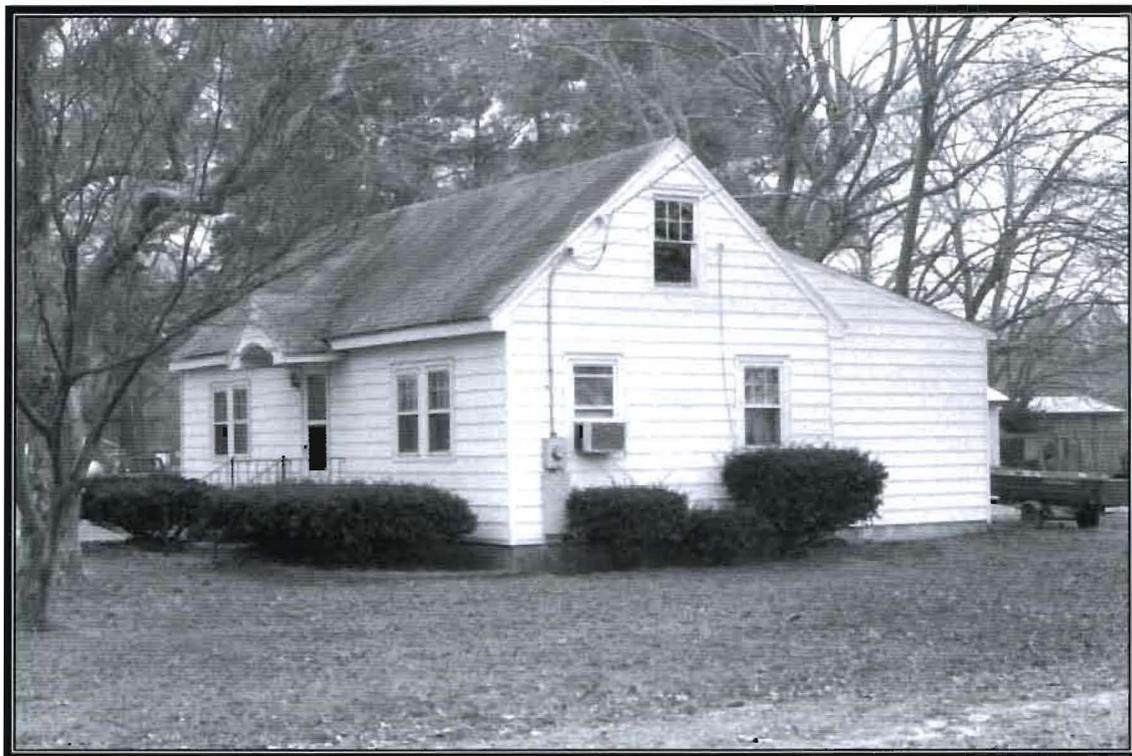
S-5880 is a one-and-one-half-story, three-bay by two-bay frame, vernacular style house (Photograph 3). It has the shape and massing of a Cape Cod style residence, but it lacks the architectural style's characteristic roof dormers. At the rear is a one-story, shed roof extension. The house is a rental property. According to the owner, the building originally was located across Chipmans Pond Road and functioned as a broom factory or store. It was moved to its current location and has served as a residence since the mid-1950s (Jamie Givens, personal communication 2005).

Photograph 3. Broom Store/Rental House (S-5880) facade and west side, facing southeast.

The Broom Store/Rental House is not eligible for NRHP listing for many of the same reasons that the Chipman and Lowe Lot #3 (S-5878) was evaluated as not eligible. The house, a small and rather undistinguished example of a Cape Cod style residence does not illustrate a significant contribution to the history of suburbanization, as is required under NRHP Criterion A (National Park Service 1991:12). It is a solitary house that was moved to its current location in the mid-1950s. It does not convey post-World War II housing trends, which were characterized by suburban subdivisions, including strip development along farm fields. It is not related to the agricultural history of the area, and its 50-year use as a residential property removes the ability to convey its former commercial function as a broom factory. There is no evidence it was ever the residence of a Chipman or a Lowe; the house has long been a rental property (Jamie Givens, personal communication 2005). Architecturally, the house lacks character-defining elements of the Cape Cod style, such as dormers. It is not an exceptional example displaying distinctive characteristics of the architectural type, an early example, or a transitional example. Its material and construction do not convey important information contributing to our understanding of history or prehistory. The house is not significant under NRHP Criteria A, B, C, or D.

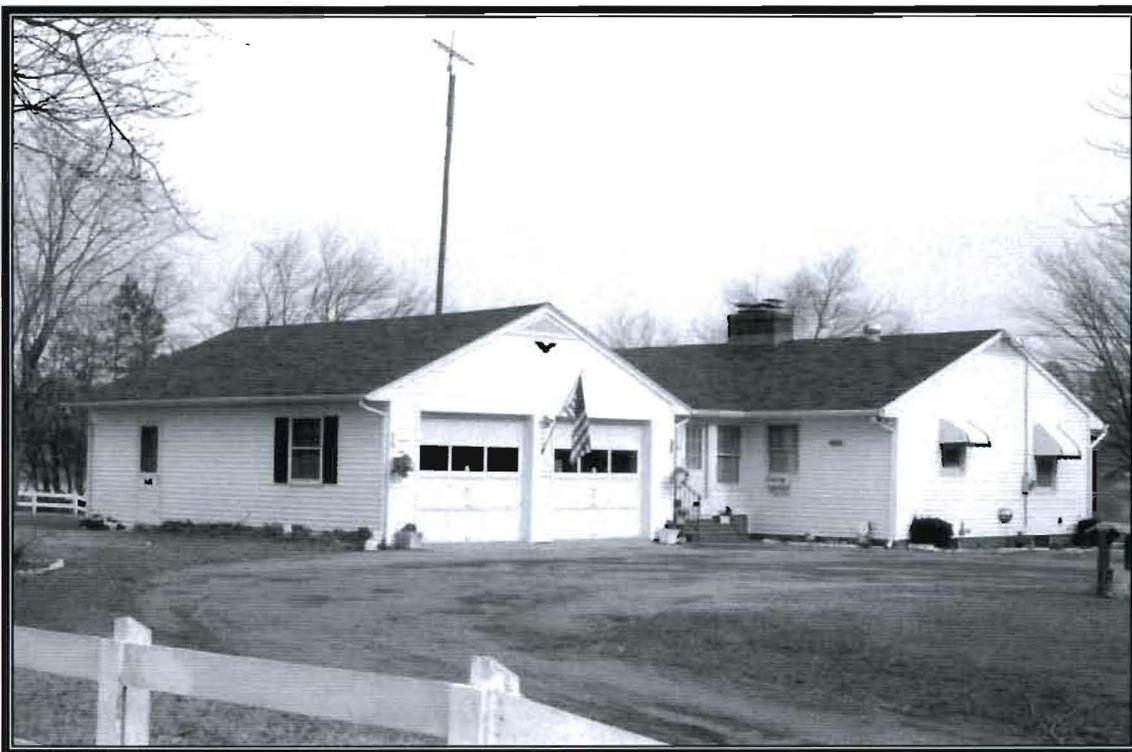
The Carlton Lowe House is a U-shaped, single-story residence whose facade faces Chipmans Pond (Photograph 4). The house dates to the early 1950s, but it was extensively damaged by a fire in the 1980s, and has been substantially rebuilt on both

Photograph 4. Carlton Lowe House (S-11418) south side and garage, facing northeast.

the interior and exterior. It was constructed by Carlton Lowe, the last owner of Chipmans Gristmill and the founder of Lowe's Lakeview Campground, which is located across the road. Historically, a store was located on the site where the house now sits (Jamie Givens, personal communication 2005; Sturges Lowe, personal communication 2005).

The Carlton Lowe House lacks integrity. According to both, Lowe's grandson and his widow (Jamie Givens, personal communication 2005; Sturges Lowe, personal communication 2005), the house was extensively damaged by fire in the 1980s. The original design, materials, workmanship, and feeling of the house were changed as a result. Because of a loss of integrity, the resource is not eligible for NRHP listing.

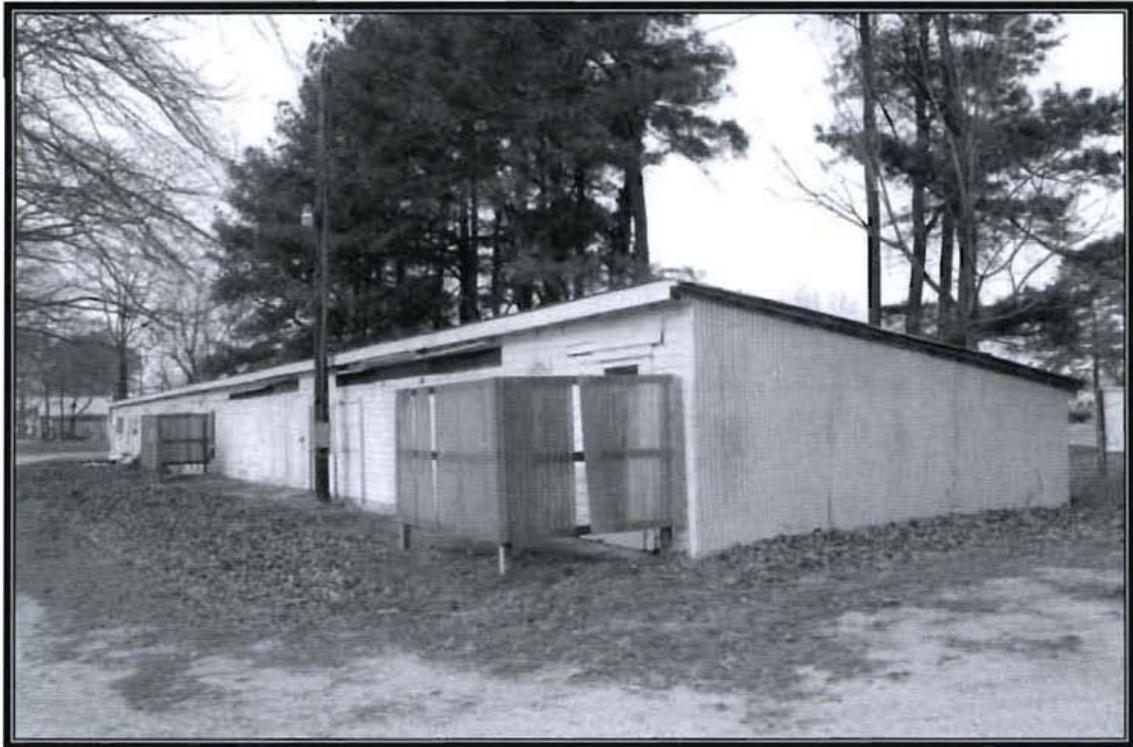
Photograph 5. Lowe's Lakeview Campground (S-11419), south and east sides of the shower house, facing northwest.

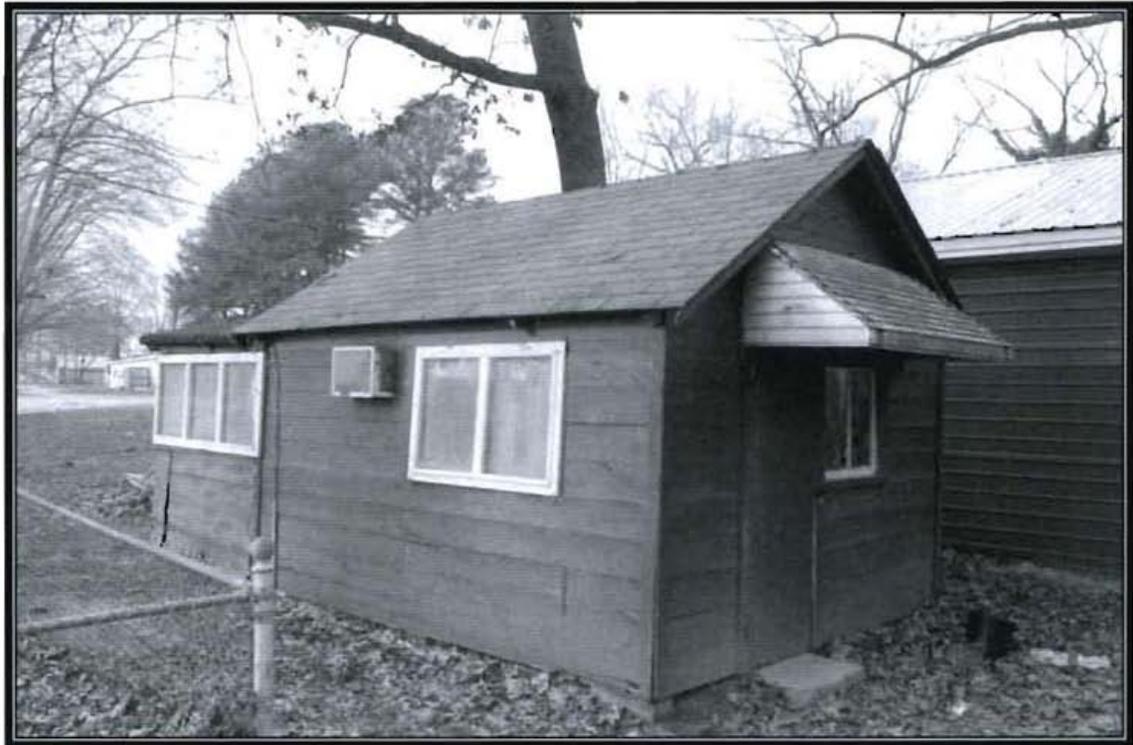
Photograph 6. Lowe's Lakeview Campground (S-11419), facade and south side of the unaltered Red Cabin, facing northwest.

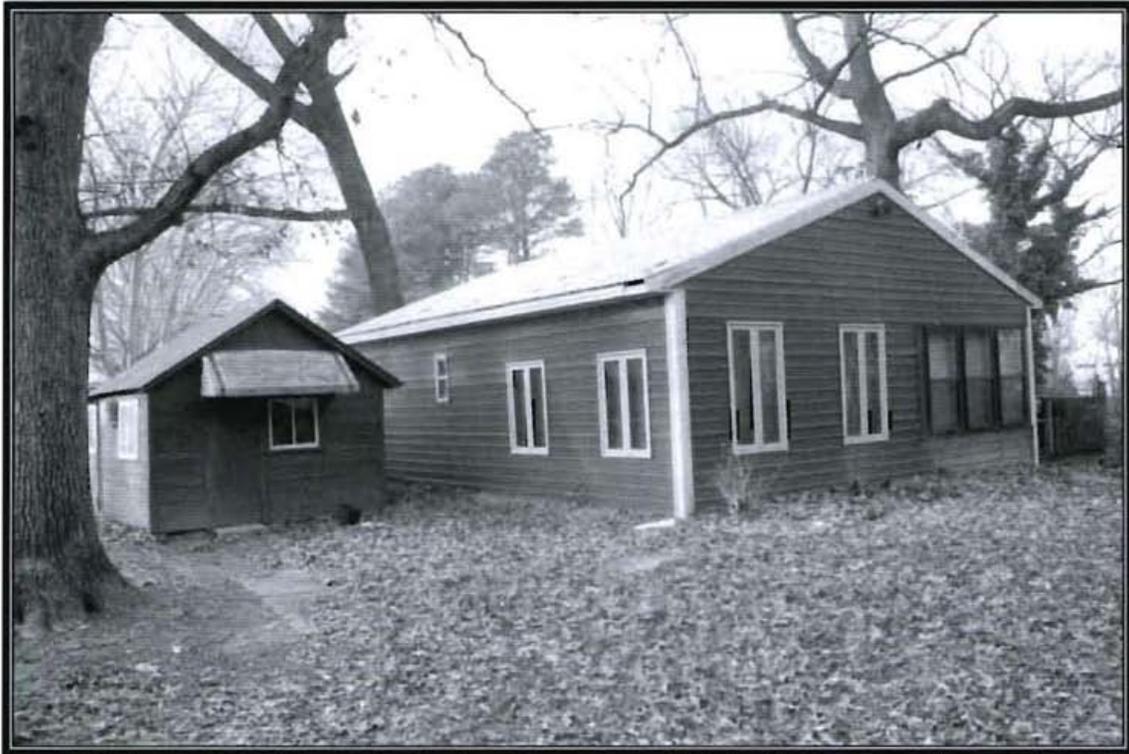
Photograph 7. Lowe's Lakeview Campground (S-11419), comparison of the unaltered Red Cabin to one of the altered Red Cabins, facing northwest.

Adding to the lack of a cohesive design are the alterations the cabins have undergone. This is most pronounced in the Red Cabins. Two of the three have been doubled in size and have been completely reoriented in the arrangement of doors and windows. The third, original Red Cabin serves to highlight the extent of the alterations to the other two. By contrast, the White Cabins are much more original. Three of the four are virtually unaltered from their original appearance. But three cabins that are part of a larger site do not convey the historic sense of Lowe's Lakeview Campground.

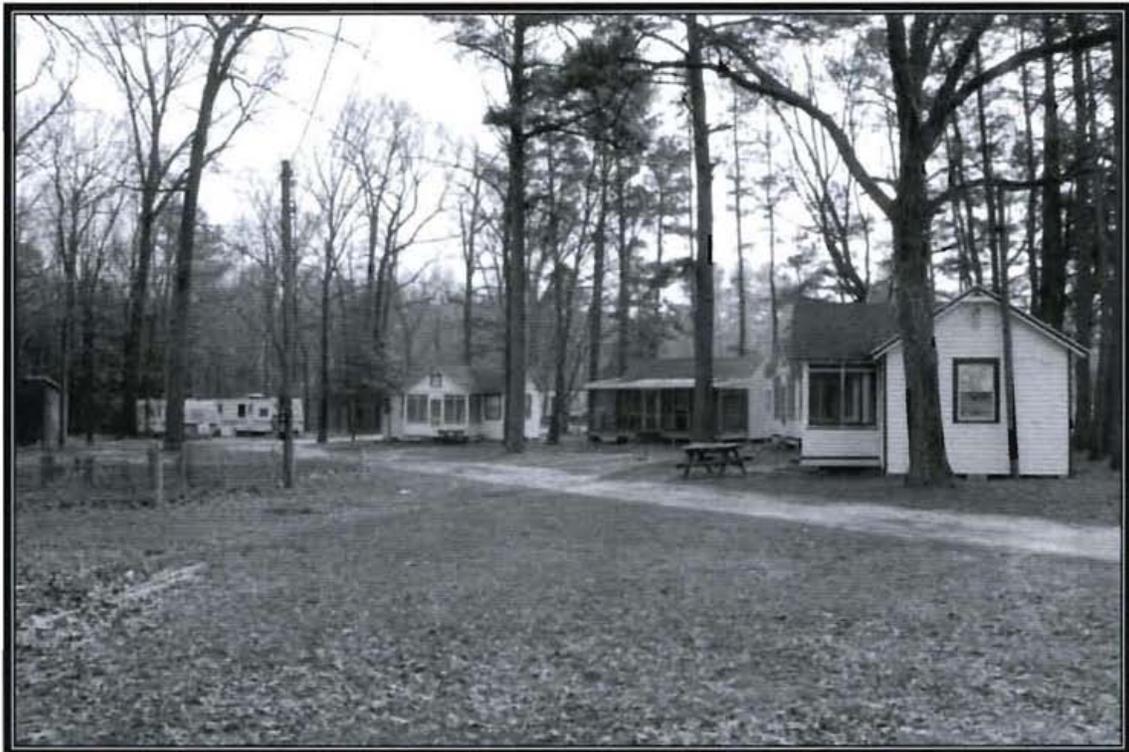
Photograph 8. Lowe's Lakeview Campground (S-11419), arrangement of the White Cabins and the shower facility, facing south.

Lowe's Lakeview Campground is not eligible for NRHP listing. Although clearly associated with automobile travel, the resource lacks the design elements necessary to convey that association. The best examples of cabin courts feature cottages arranged, often in a semicircle, in proximity to a combination manager's office/residence/restaurant/store, often with gasoline pumps in front. Lowe's arrangement lacks the central building and gas pumps. Historically these functions were located across Chipmans Pond Road, but they are no longer extant. They were replaced in the 1950s by the Carlton Lowe House (S-11418). Their loss further compromises the integrity of the resource. Additionally, the buildings that remain do not appear to have been arranged as part of a design. Rather, the shower building (which was a chicken house), Red Cabins, and White Cabins seemed to have been placed randomly, where space allowed, without a sense of how the buildings related to one another. The White Cabins, which were moved to the location in the 1950s, are somewhat of an exception. The four buildings look to have been consciously placed in a semicircle around the open area and toilet facility.

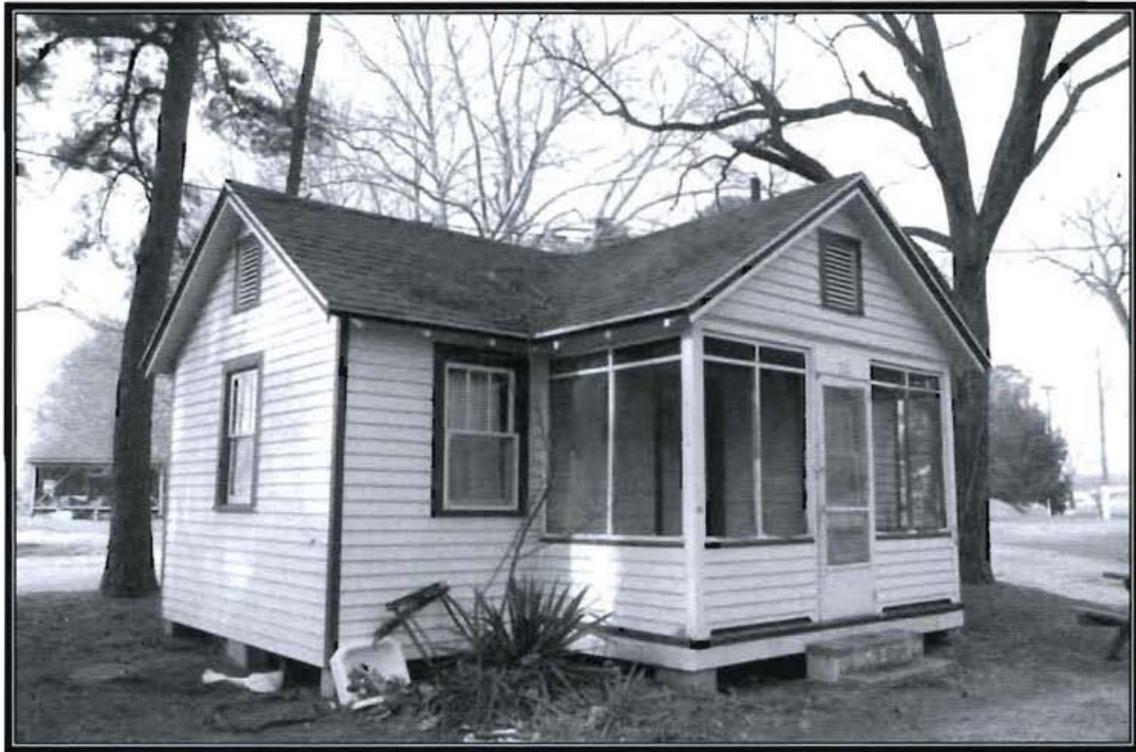
Photograph 9. Lowe's Lakeview Campground (S-11419), representative view of one of the unaltered White Cabins, facing northwest.

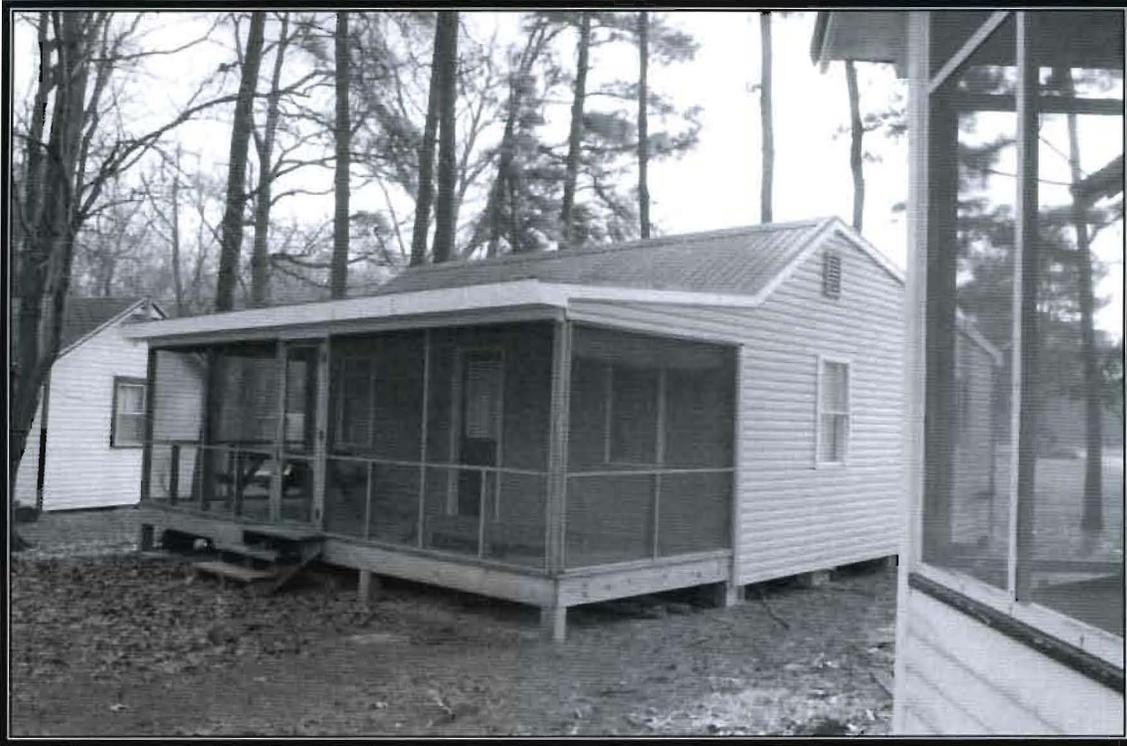
original porch replaced with a full-width one, and new siding and windows emplaced (Photograph 10). The toilet facility is a one-story, four-bay frame and block building (Photograph 11). Initially, it was a pump house for the chicken house. It then served the same function for the shower house before being converted to a toilet (Jamie Givens, personal communication 2005).

Photograph 10. Lowe's Lakeview Campground (S-11419), facade and west side of the altered White Cabin, facing southeast.

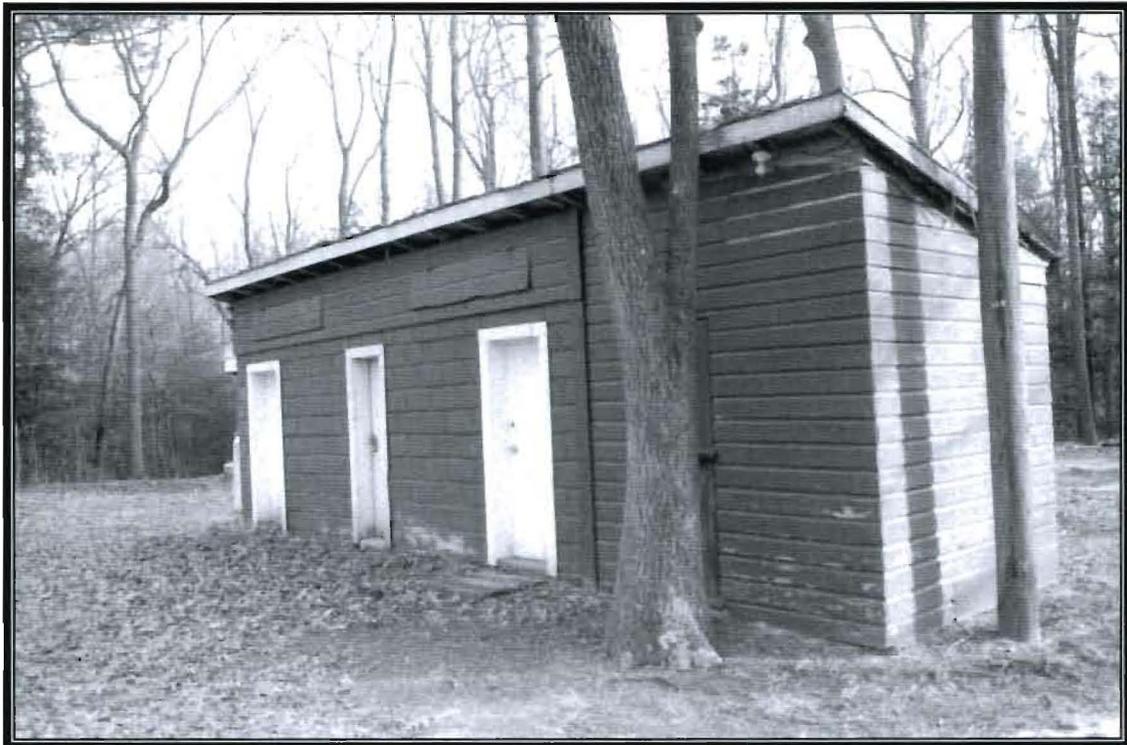
Photograph 11. Lowe's Lakeview Campground (S-11419), facade and west side of the toilet facility, facing southeast.
