**ARCHITECTURAL RESOURCE SURVEY
ROUTES 273-72-2 INTERSECTION**

Newark, Delaware

March 1999

Philip E. Pendleton
The Cultural Resource Group
Louis Berger & Associates, Inc.
East Orange, New Jersey

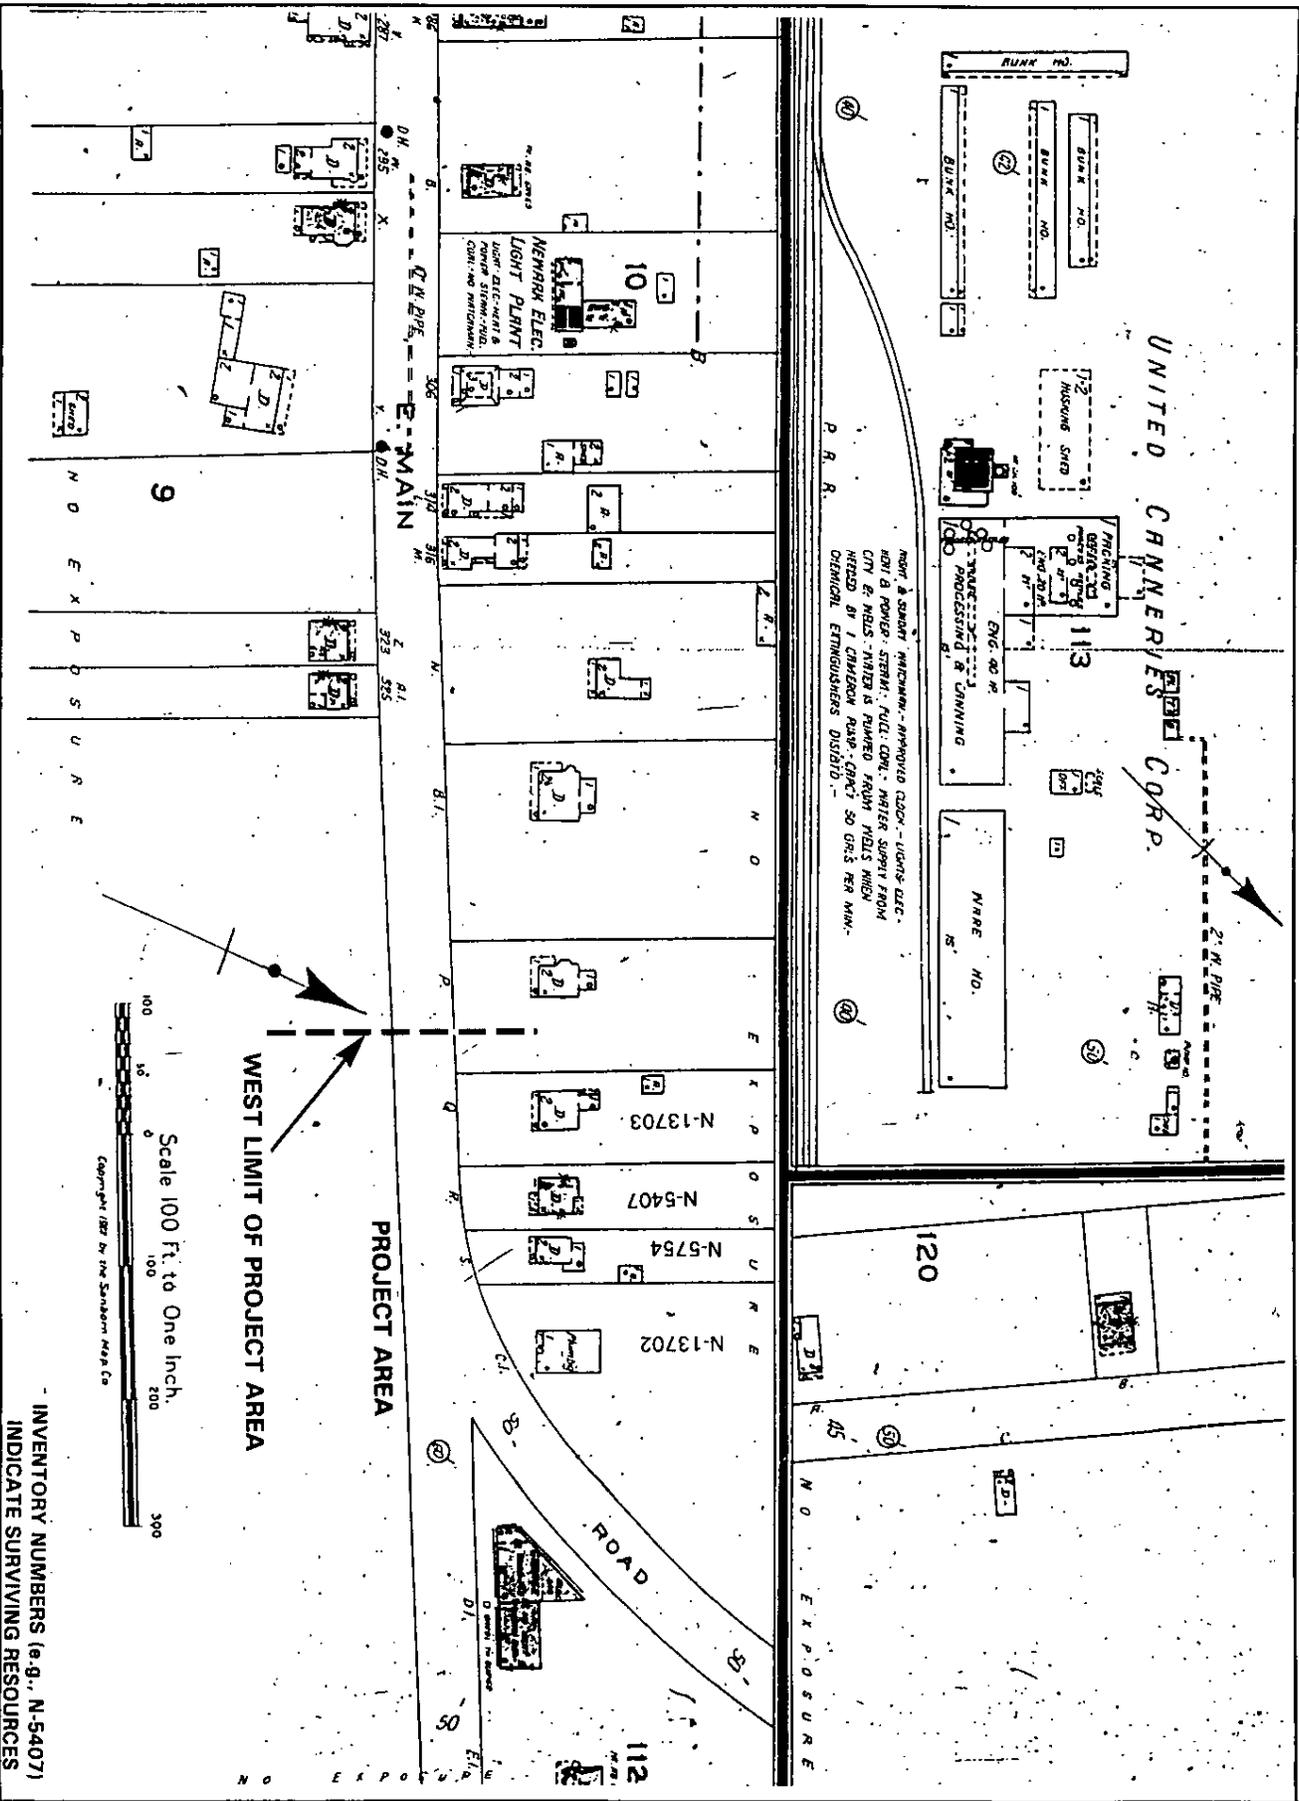
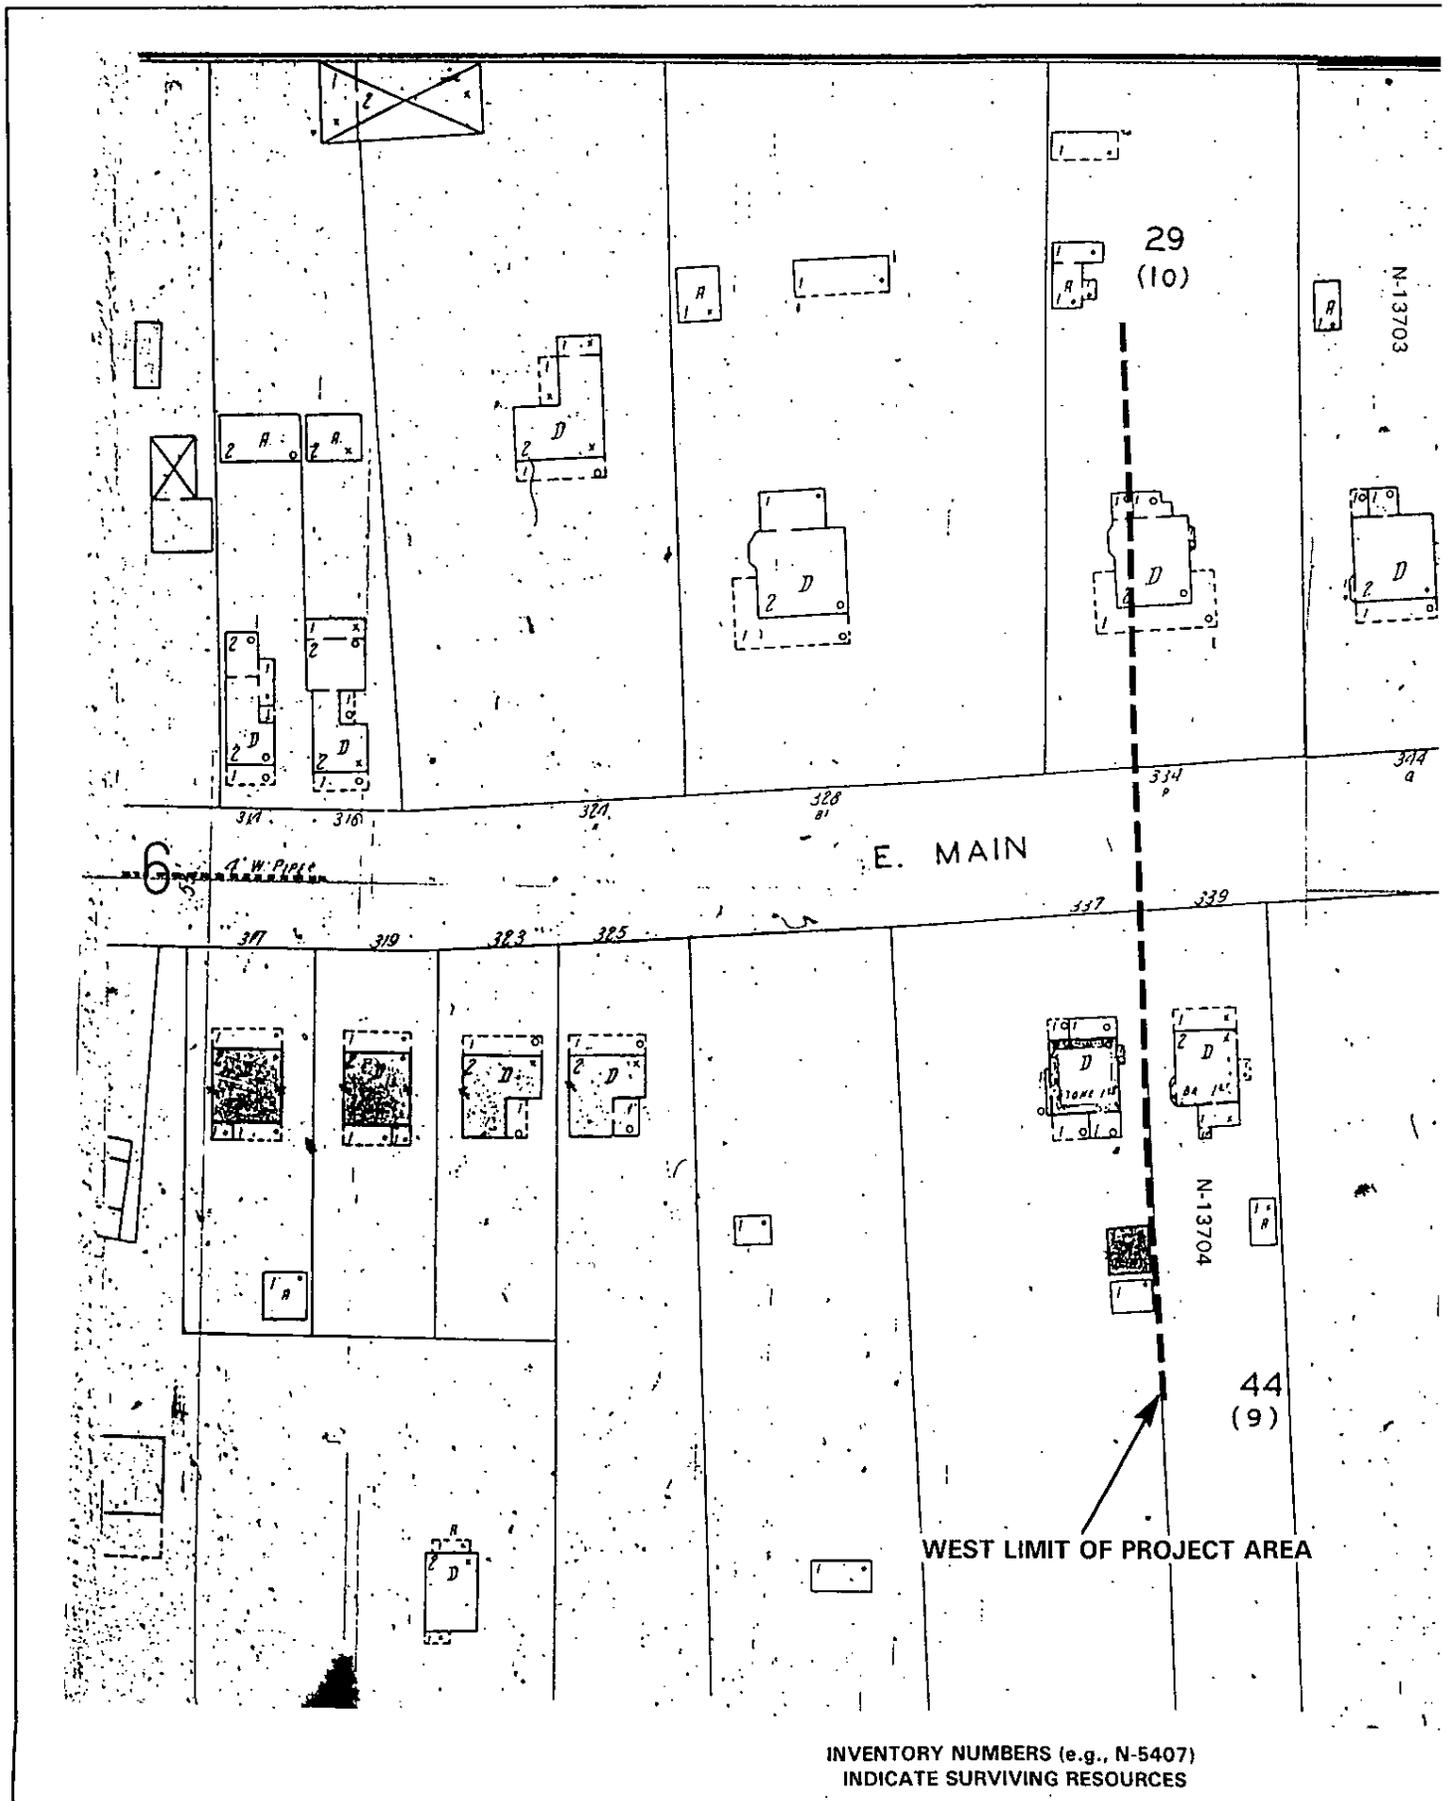
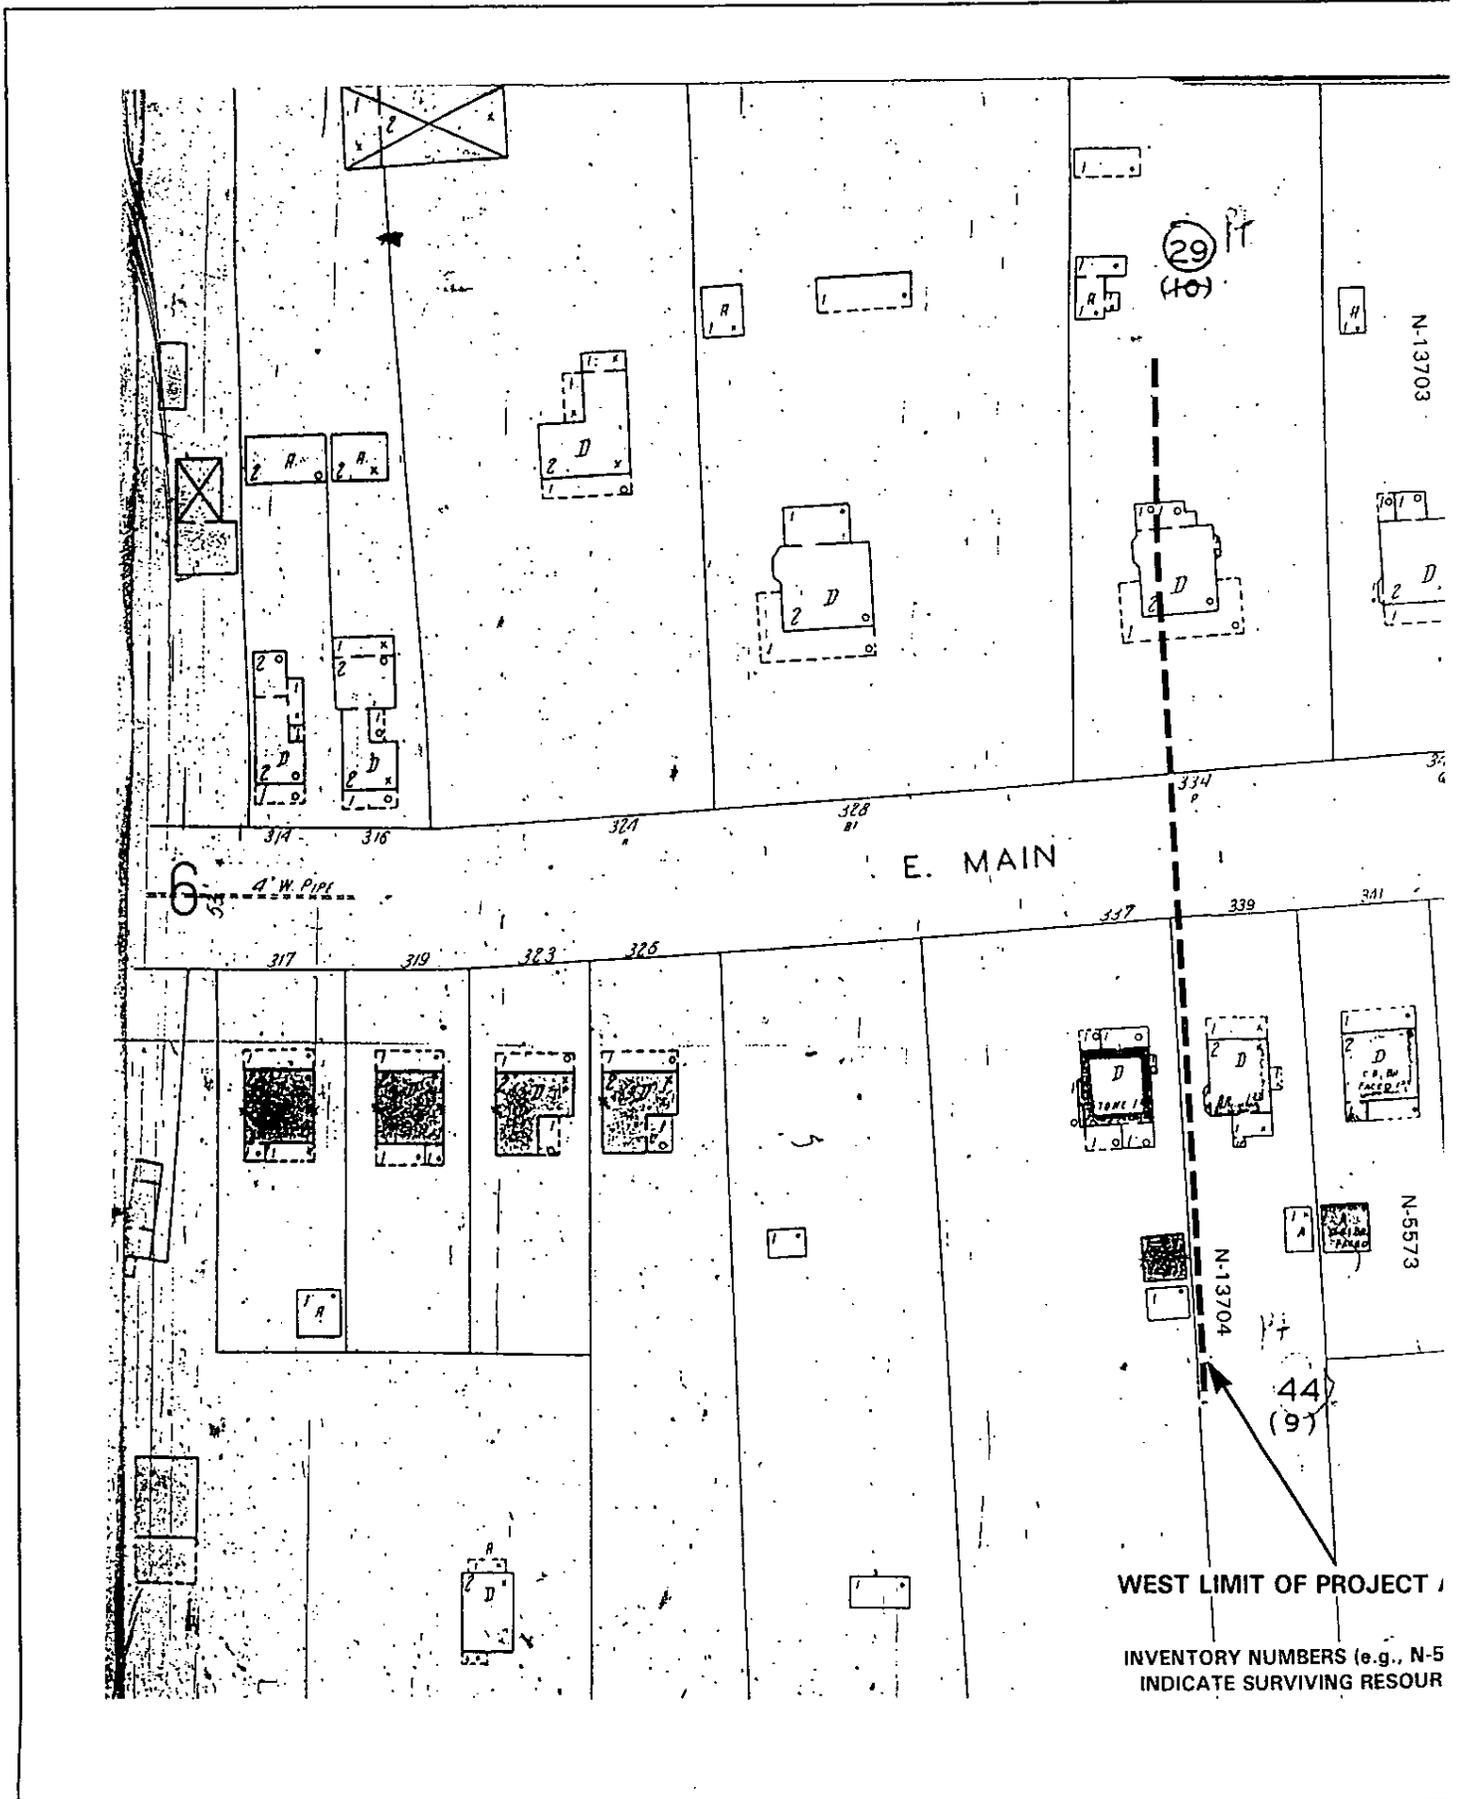
FIGURE 5: Project Area Detail (West Portion) in 1922

INVENTORY NUMBERS (e.g., N-5407)
INDICATE SURVIVING RESOURCES

Evaluation: The house was depicted on the Sanborn maps of 1922, 1929, and 1949 (see Figures 5-7) (Sanborn Map Co. 1922, 1929, 1949). The house represents an undistinguished example of the mass-market housing of that period. It fails to demonstrate integrity of design, materials, and workmanship due to the extensive alteration it has undergone. Lacking architectural distinction or important historical associations, this property does not meet the criteria of historic significance for National Register eligibility.

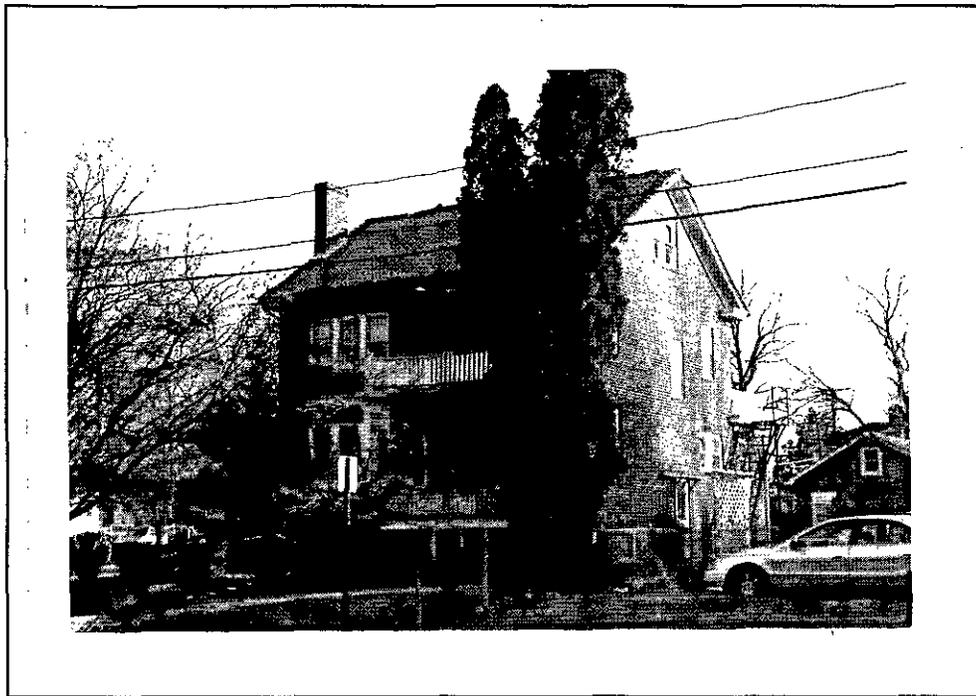
PLATE 1: 349 East Main Street (N-5406), Looking Southeast

Description: The house at 349 East Main Street, previously documented on a CRS inventory form, stands at the corner on the south side of Main Street and on the west side of Washington Street. It is a two-story, gable-roofed building with a tile roof, brick walls and foundation, a two-story wooden entry porch on a brick foundation, and a brick end chimney. The garage is a gable-roofed structure with three bays and is built of rock-faced concrete block with a roof covering of asphalt shingle.

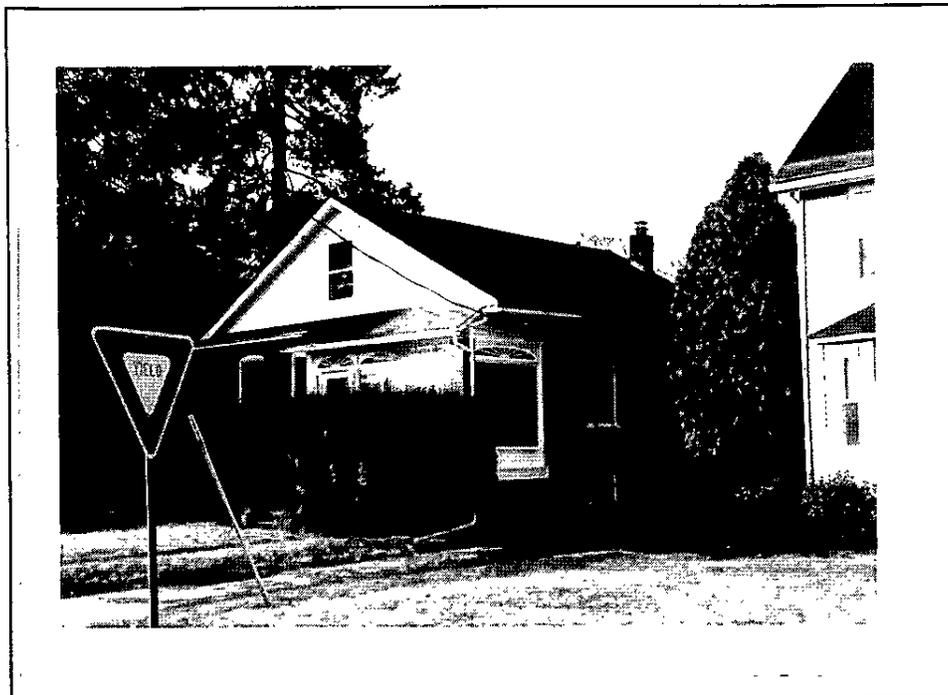
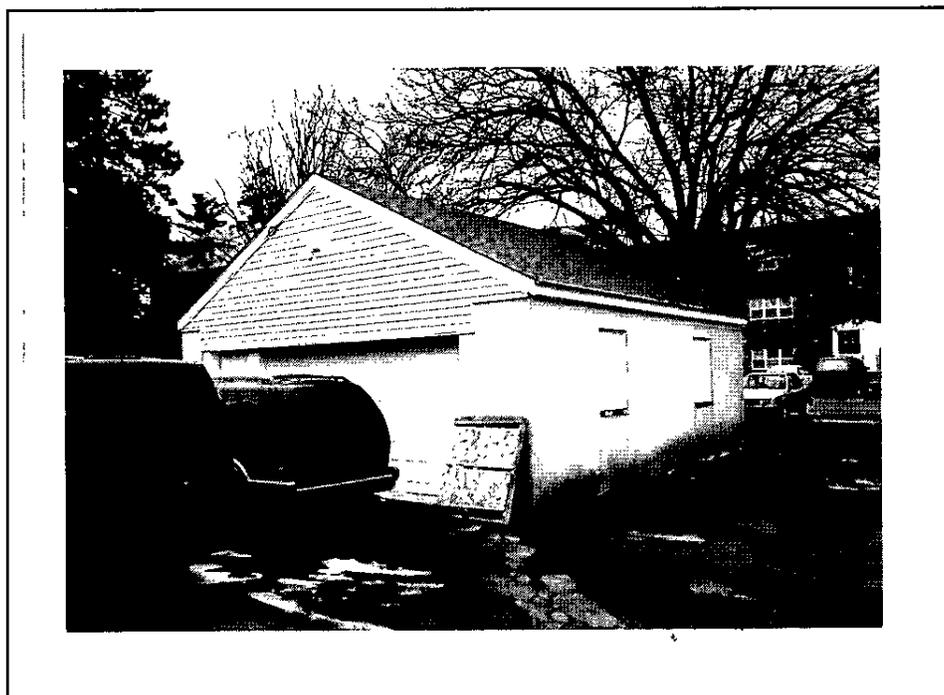
PLATE 3: 352 East Main Street (N-5407), Looking West

Description: The house at 352 East Main Street, previously documented on a CRS inventory form, is located on the north side of the street immediately to the west of the intersection with the Old Capitol Trail and Washington Street. A one-story, front-gabled structure incorporating a front sunroom or enclosed porch, it has a roof covered in asphalt shingle, weatherboarded gables, brick walls and foundation, and a small brick chimney at the rear. A stylistic touch is given to the modest house by the fanlight and sidelights at the

Evaluation: The house was depicted on the Sanborn maps of 1922, 1929, and 1949. A garage of similar dimensions to the property's present one was shown on the 1929 and 1949 Sanborn maps, but in a different location, suggesting that it was either moved or replaced (see Figures 5-7) (Sanborn Map Co. 1922, 1929, 1949). The house represents an undistinguished example of the mass-market housing of that period. As alterations have been relatively limited, the property does demonstrate integrity of design, materials, and workmanship. As it does not possess qualities of architectural distinction or important historical associations, however, this property does not meet the criteria of historic significance for National Register eligibility.

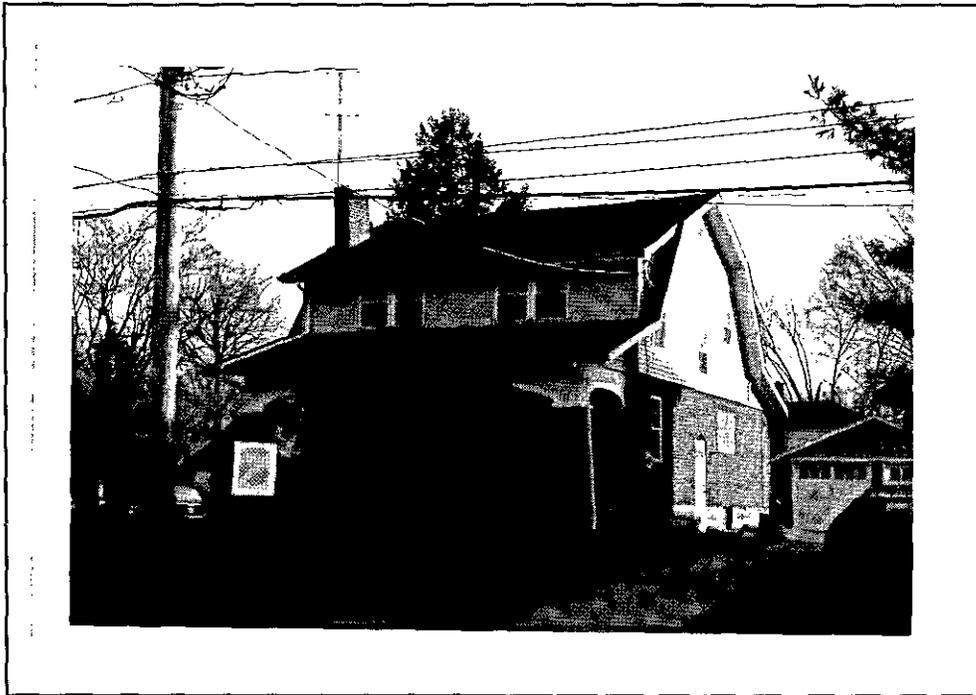
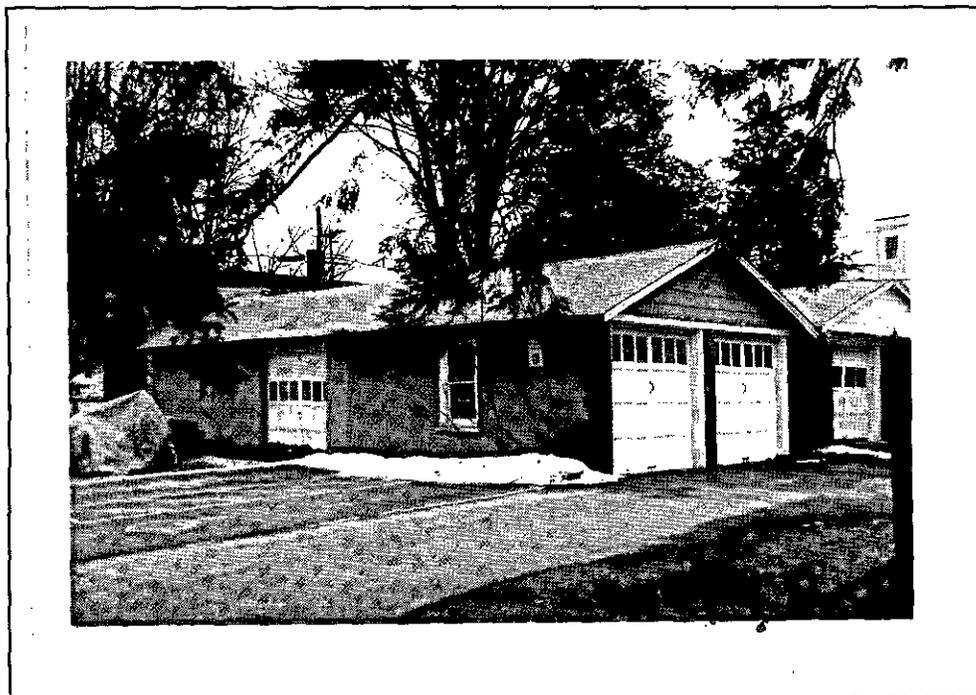
PLATE 5: 341 East Main Street (N-5573), Looking Southeast

Description: The house at 341 East Main Street, previously documented on a CRS inventory form, is situated on the south side of the street approximately 50 meters (or 165 feet) west of the intersection with the Old Capitol Trail and Washington Street. It is a one-and-a-half-story, gambrel-roofed structure with a foundation of concrete, first-story walls of brick, upper-story walls of frame clad in vinyl siding, and a brick end chimney. A shed-roofed dormer extends across the front of the gambrel. On both front and rear, the roof extends beyond the gambrel structure with shed roofs, the front one sheltering a broad, brick-skirted porch supported by concrete foundation, brick pillars, and concrete arches. The rear roof slope shelters an integral lean-to. The roof is covered with asphalt shingle. A former bay window on the west elevation has been removed and filled in with brick. The original section of the garage is a front-gabled structure with two bays, stucco walls, gable infill of asbestos shingle, and roof cover of asphalt shingle. The garage was extended to the rear in recent years.

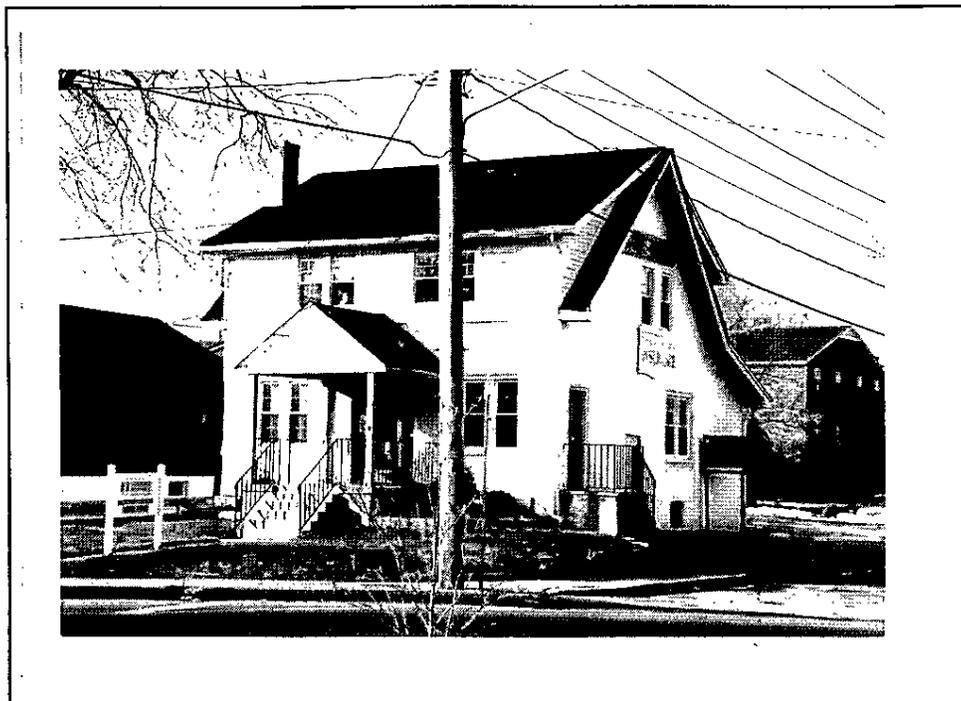
PLATE 9: 366 East Main Street (N-6167), Looking Northwest

Description: The house at 366 East Main Street, previously documented on a CRS inventory form, is situated on the northwest side of the Old Capitol Trail approximately 60 meters (or 200 feet) northeast of its intersection with East Main Street and Washington Street. The address designation "East Main" for the property has apparently been retained due to longstanding use. It is a one-and-a-half-story, gable-roofed structure with a foundation of stone masonry, walls of concrete block coated in stucco, and a roof covering

Evaluation: The house was depicted on the Sanborn maps of 1929 and 1949, indicating that it was built sometime during the years 1922-1929 (see Figures 5-7) (Sanborn Map Co. 1922, 1929, 1949). The house represents an undistinguished example of the mass-market housing of that period. It fails to demonstrate integrity of design, materials, and workmanship due to the alteration it has undergone. Lacking architectural distinction or important historical associations, this property does not meet the criteria of historic significance for National Register eligibility.

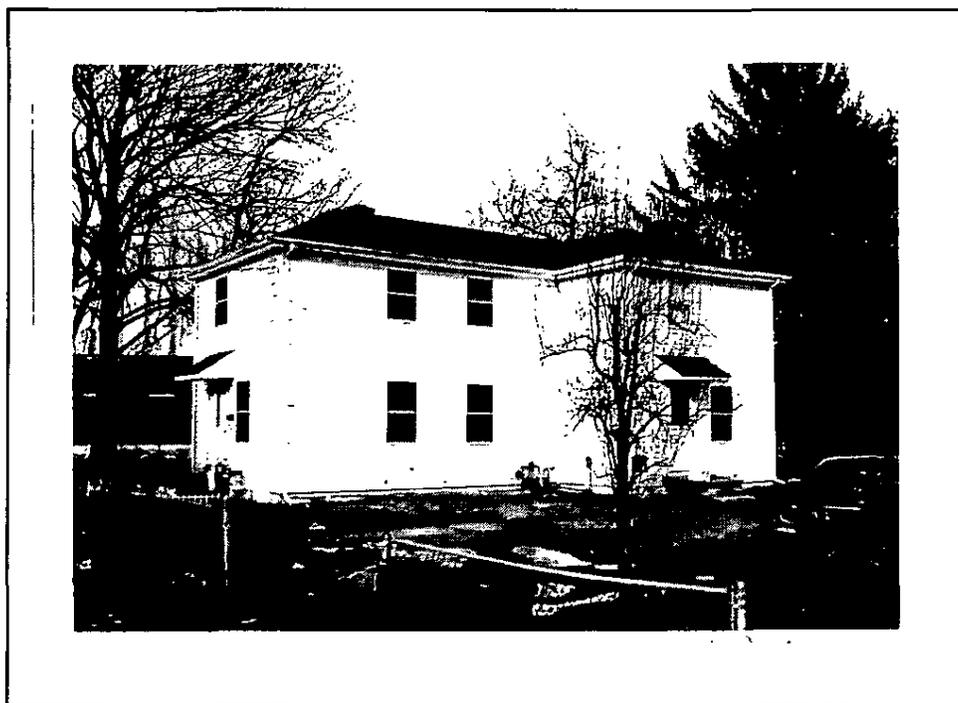
PLATE 14: 9-11 McKean Place (N-13705), Looking North

Description: The house at 9-11 McKean Place stands on the eastern edge of the George Read Village development, adjacent to the parking lot of the Newark branch of the New Castle County Library. Like its fellow Village houses, it was evidently originally designed as a duplex apartment building, with a hipped roof; an L-shaped plan; an entry in each wing-end elevation, each entry with a small shed-roofed hood and a concrete stoop; and two brick chimneys. The foundation is concrete, the walls are of frame clad in vinyl siding, and the roof covering is composed of asphalt shingle.

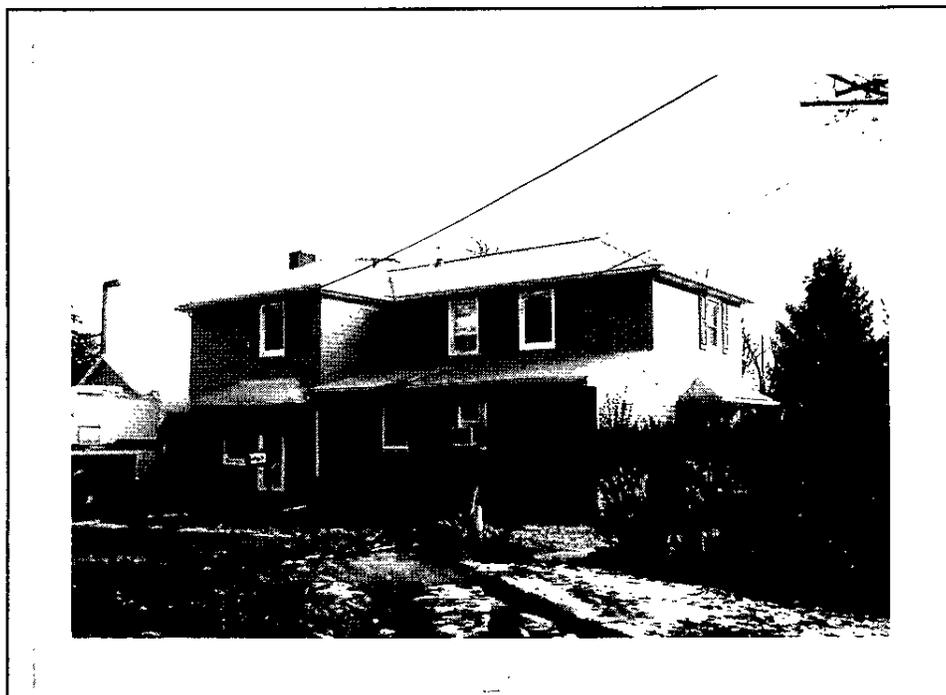
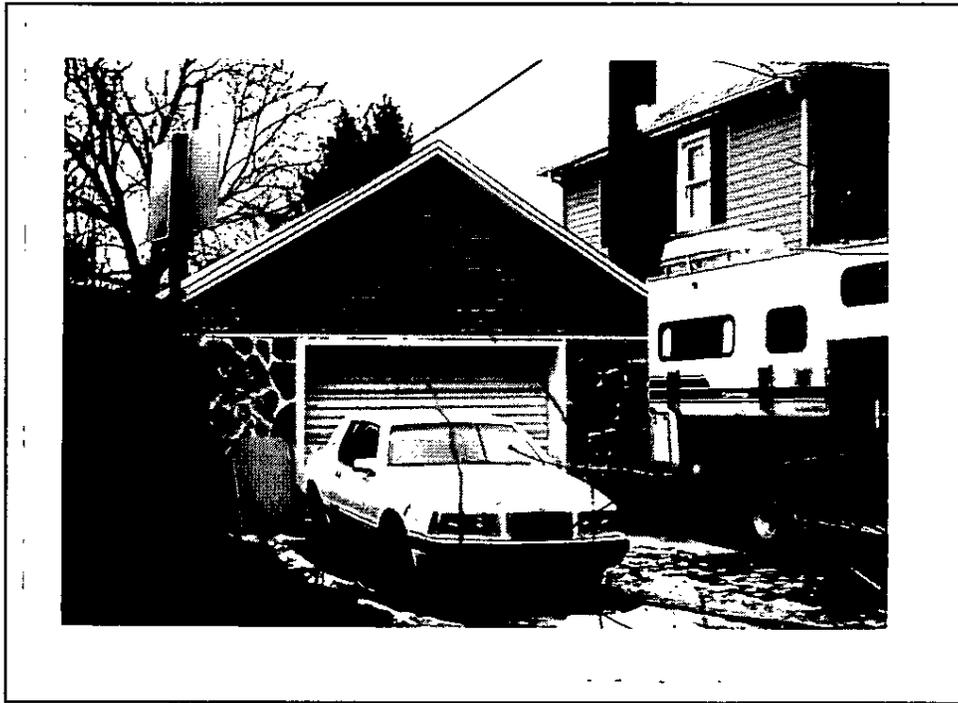
PLATE 18: 401-403 Delaware Place (N-13708), Looking East

Description: The house at 401-403 Delaware Place stands on the eastern edge of the George Read Village development, adjacent to the parking lot of the Newark branch of the New Castle County Library. Like its fellow Village houses, it was evidently originally designed as a duplex apartment building, with a hipped roof; an L-shaped plan; an entry in each wing-end elevation, each entry with a small shed-roofed hood and a concrete stoop; and two brick chimneys. The foundation is concrete, the walls are of frame clad in vinyl siding, and the roof covering is composed of asphalt shingle. Aside from the application of vinyl siding, alterations made in recent years include the conversion of the building into a single-family residence, the addition of a one-story lean-to along the northwest elevation, and the replacement of the door hoods with ones of a larger, hip-roofed design. The garage, which is probably less than 50 years old, is a front-gabled structure with a single bay, stone facing on the front, lateral walls clad in stucco, and gable infill of vinyl siding.

Evaluation: The current New Castle County assessment provides a construction date of 1943 for this house, apparently the year in which the overall George Read Village development was built (New Castle County Department of Land Use). The property represents an undistinguished example of wartime mass-market housing construction. Having been converted for single-family occupancy, and received various other exterior modifications, the property fails to demonstrate integrity of design, materials, and workmanship. Lacking architectural distinction or important historical associations, this property does not meet the criteria of historic significance for National Register eligibility.
