APPENDIX A: Delaware CRS Forms

CULTURAL RESOURCE SURVEY
PROPERTY IDENTIFICATION FORM

CRS # S-10124
SPO Map 14-15-10
Hundred Georgetown
Quad Harbeson
Other 1-35-15-123

building	<input checked="" type="checkbox"/>	structure	<input type="checkbox"/>	site	<input type="checkbox"/>	object	<input type="checkbox"/>
landscape	<input type="checkbox"/>	district	<input type="checkbox"/>				
5. MAIN FUNCTION OF PROPERTY: Dwelling
6. PROJECT TITLE/ REASON FOR SURVEY (if applicable):
Route 9/Road 319 Intersection Improvements Project

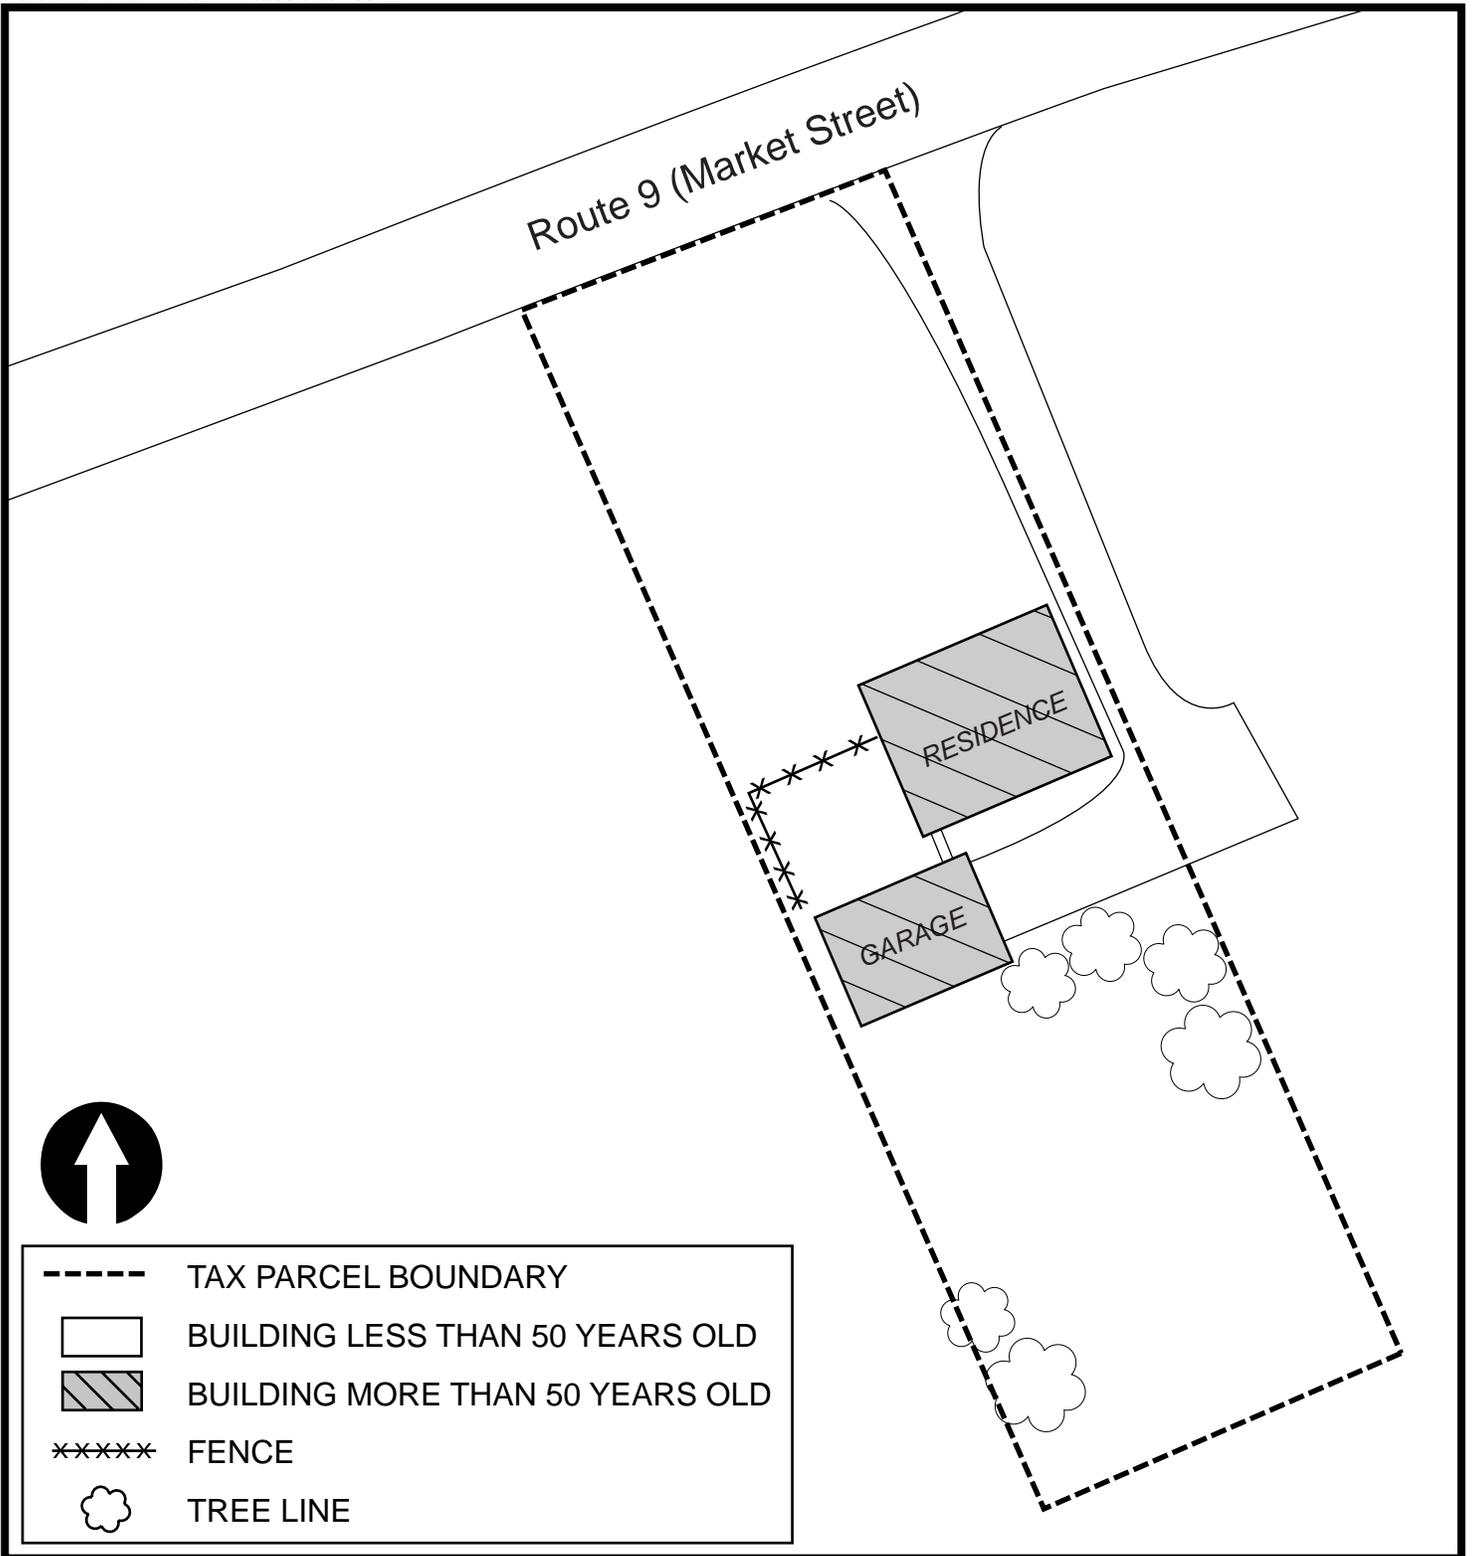
4. SITE PLAN:

11. OTHER COMMENTS: Gravel drive to the west of house; paved drive to the east of house leads to rear. To the rear of the house and slightly west is a one-story gable-roofed garage, connected to the house by a breezeway; a tall, solid, L-shaped fence connects the end of the garage to the west facade of the house.

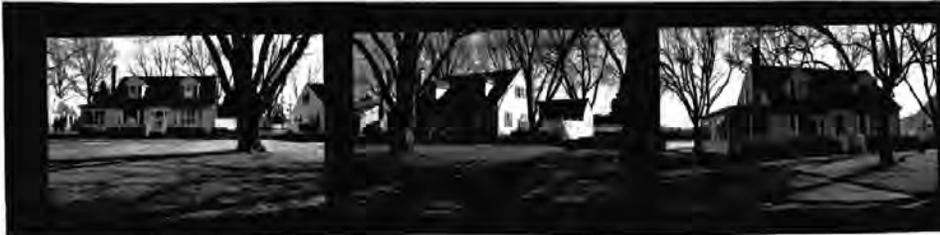
CRS # S-10124 Date 3/19/2004 Photo Roll # 1 Surveyor Jennifer M. Holl/Katie Diehl

Description (1) elevation of front façade, facing south; (2) lateral view of residence, facing southeast;
(3) lateral view of residence, facing southwest
