State Bridge Number 494

HABS/HAER INVENTORY

Road 395 over Waterway
Fenwick Island, Sussex County, Delaware

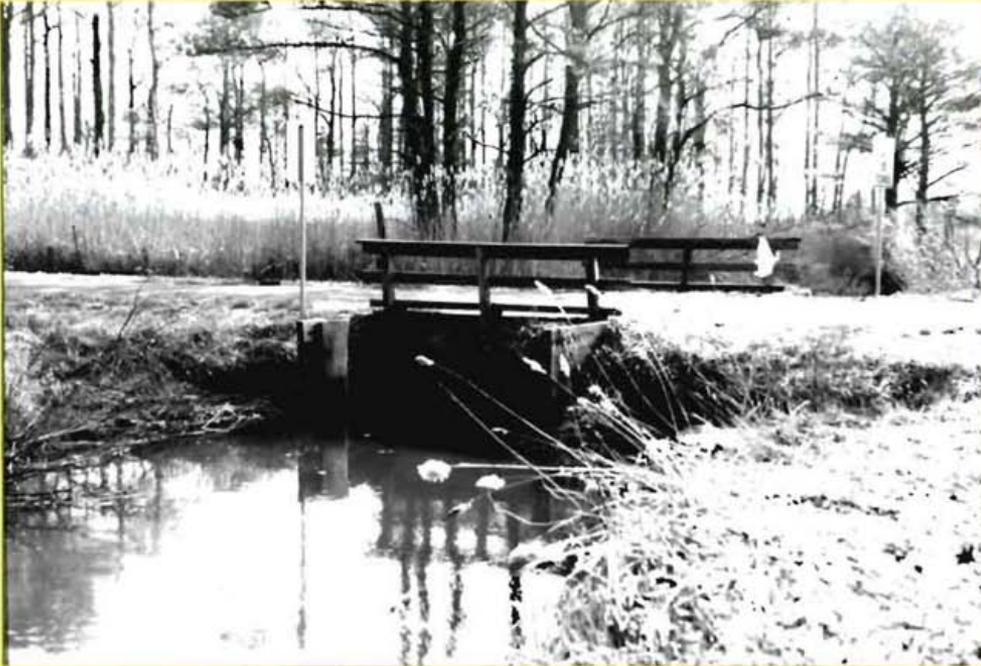
5B:12-18

State Highway Bridge Number 494 is a 10'-6" timber girder span, carrying two lanes of traffic with a deck width of 23'-0". It rests on timber bents comprised of 15" diameter pilings supporting a 12" x 12" beam. The straight wing walls are constructed of 4" x 10" planks. The deck consists of 4" x 10" planks secured to 6" x 14" girders. The parapet comprises a simple wooden rail, with posts at each portal and mid-span, horizontal rails in between, and capped with a flat board. The bridge retains much of its original fabric.
