**Carter Road Architectural Supplement**  
**Prepared by Michael C. Hahn, AICP and Nathaniel Delesline**  
**Delaware Department of Transportation**  
**800 Bay Road, P. O. Box 778 Dover, Delaware 19903**  
**May 2010 (Final)**

K-7641, Dwelling  
578 Sunnyside Road  
(Pin: 1913020600)  
Construction date: circa 1956

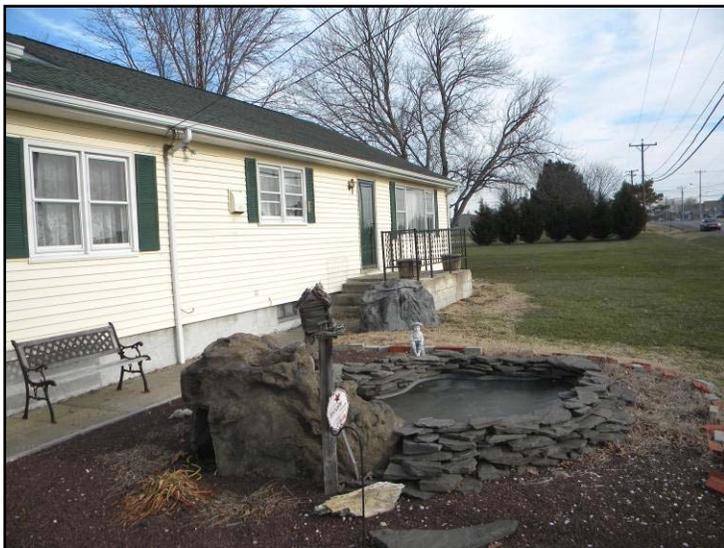
**Description:** The resource at 578 Sunnyside Road is a one-and-a half story, side gable dwelling with an extended porte-cochere continuing from the west roofline elevation. The building footprint with concrete driveway is located at the western end of the 2.18 acre tax parcel. The property is surrounded by grass yards and a dense wooded area to the

The main dwelling fronts Sunnyside Road and is oriented towards the south. The landscape immediately surrounding the dwelling is a flat grassy yard with a variety of modern ornamental plantings. Landscape features include a small modern fishpond in the front yard and a row of Leyland Cypress trees situated to the east and west ends of the immediate property lines for privacy screening. A poured concrete drive provides vehicular access to the porte-cochere, which is able to cover two vehicles and a small walkway leading to the side entrance of the dwelling.

The vinyl-clad dwelling consists of four bays on the front façade. It is accessed by a central concrete block entrance stoop with metal hand rail. The main entrance features a modern six-recessed panel metal door. The entire structure is situated atop a raised concrete-block foundation and finished or parged in stucco. There appears to be a basement or larger crawl space within the main block.

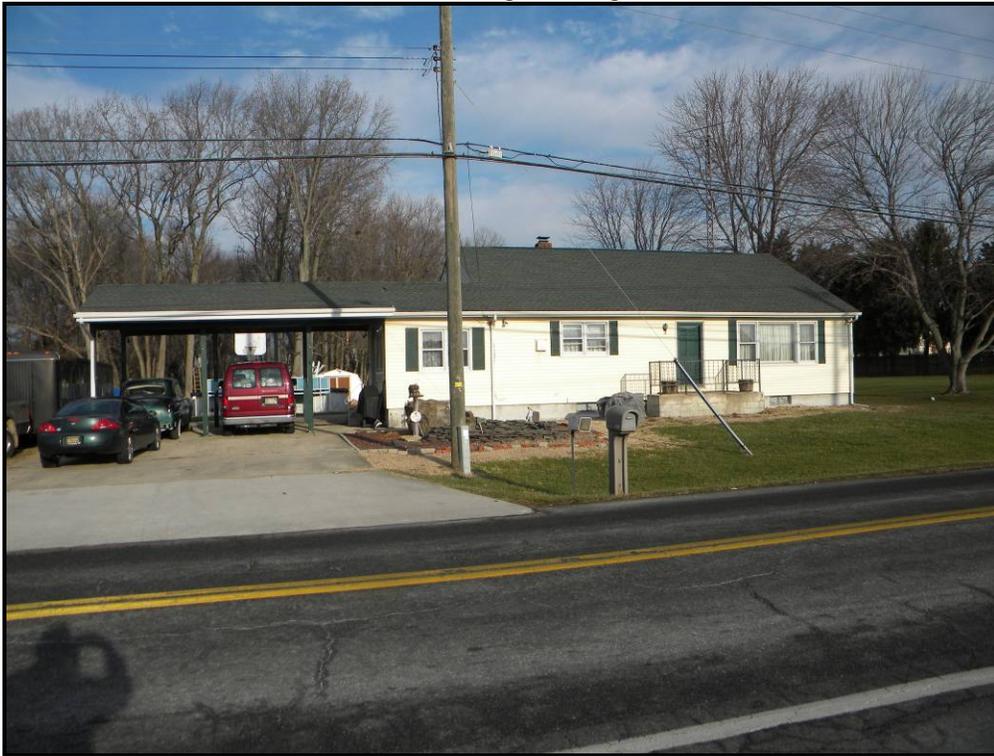
The east elevation features two bays. Fenestration is regular and symmetrical, consisting of one-over-one, double-hung vinyl sash windows with decorative, louvered vinyl shutters. The gable-end is adorned with a plane cornice with closed cornice returns at the eaves. The ½ story at each gable end is marked with a single one-over-one, double-hung vinyl sash with vinyl shutters. A louvered air vent is situated at the top peak.

Front and east side of dwelling looking northwest.

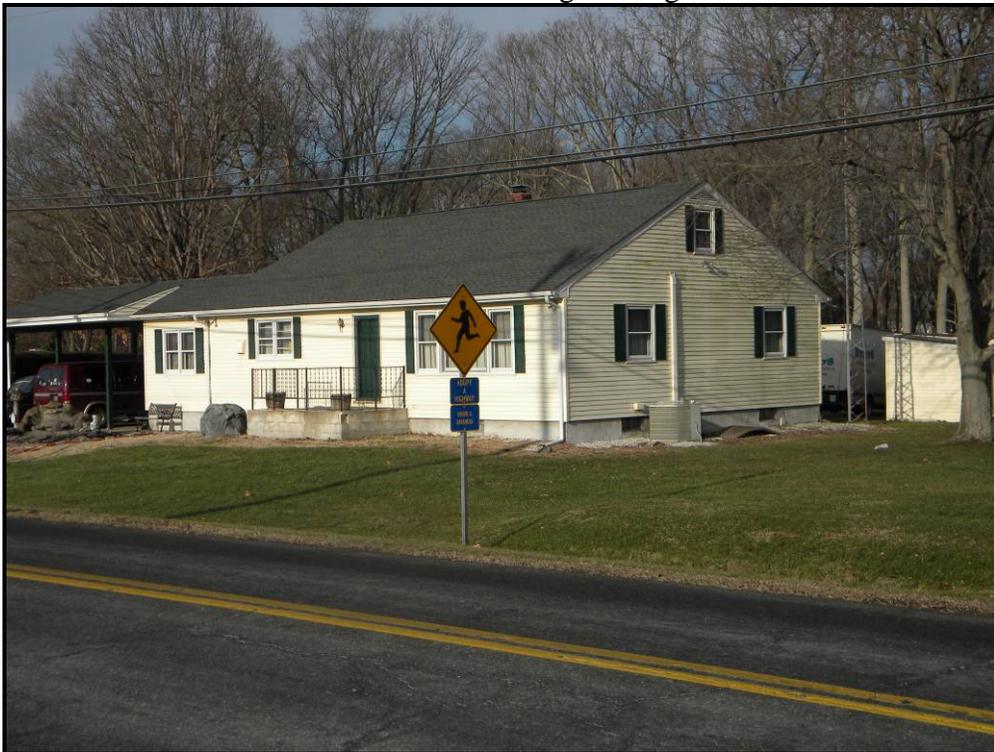
The five-bay north (rear) elevation features regular and symmetrical fenestration. Vinyl windows are one-over-one, double-hung sash trimmed with decorative, louvered vinyl shutters. Two windows feature six-light grille inserts. A bulkhead entry to the basement is situated between the first and second bays. The entry is composed of Bilco metal doors atop a concrete block frame. An interior, brick chimney rises mid-slope, just off-center. A large television antenna tower is situated atop a concrete pad at the northeast corner of the elevation.

Rear of dwelling looking south.

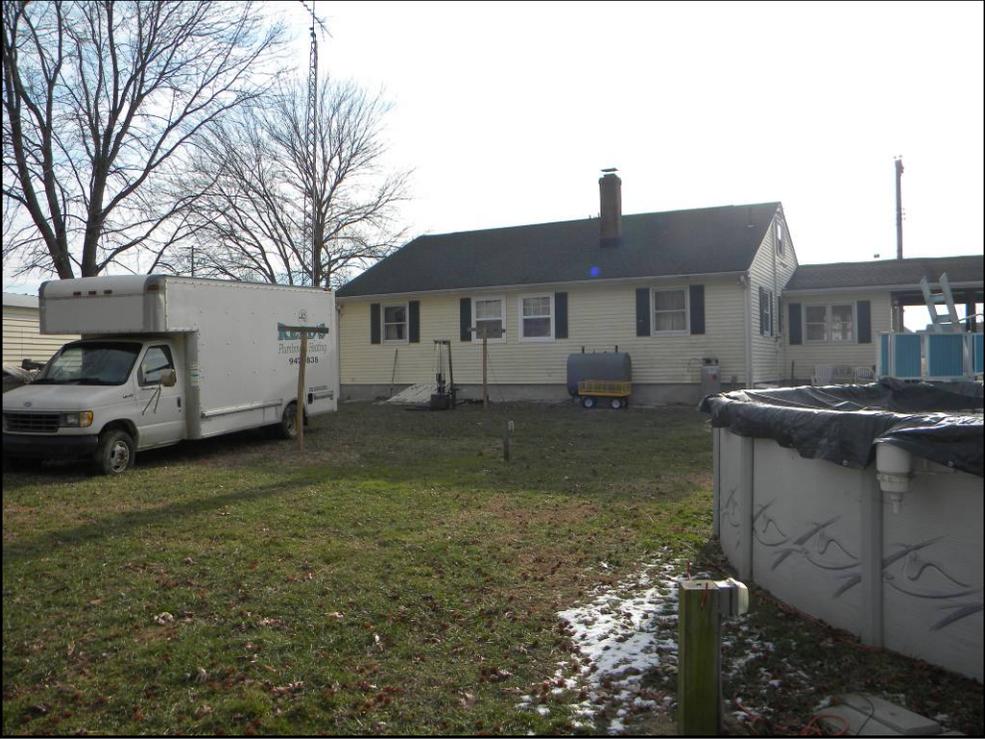
The west elevation consists of four bays with a modern addition that houses as a side entrance. The two light, flat panel side entry door is accessed by poured-concrete steps. Fenestration is irregular and asymmetrical and consists of single and paired one-over-one, double-hung, vinyl sash windows. The windows are trimmed with decorative louvered vinyl shutters. Supported by metal posts, the porte-cochere extends from the roofline of the gable end.

West end looking east and showing porte-cochere.

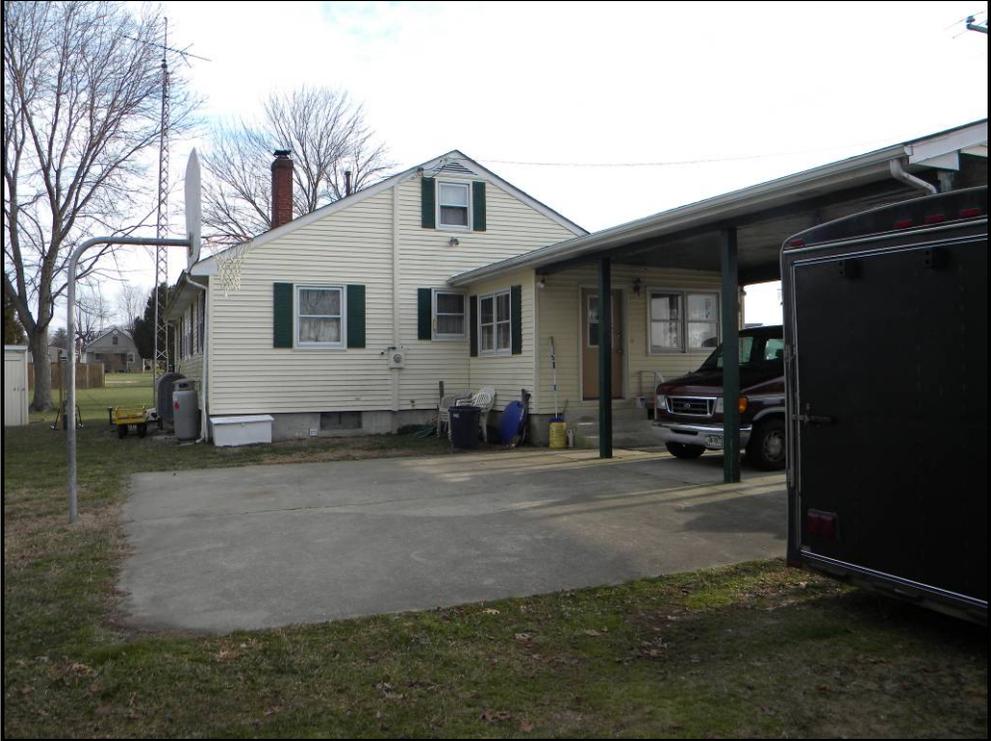
There is also a vinyl clad one-story storage shed located toward the rear on the property and closer to the dwelling on the east. In its form, the storage shed outbuilding appears to be an older chicken house, but the building has been added onto and altered with additional plywood access doors for storage of motorized equipment. Its construction date is estimated to be the late 1940's, by evidence of lightning rods still evident on the ½ gable flat (minimal pitch) roofline sheathed in metal and asphalt shingles. Before the circa 1956 main dwelling was erected, the surrounding landscape consisted of smaller farms and strip roadside residential homes. It is possible that the outbuilding was moved and relocated to its current location or dates to the early 1960's. It remains as a remnant outbuilding since it was not evident until it was identified between the 1961 and 1968 aerial views of the property.

Rear of storage shed or former chicken house. Also, the east end and partial rear of main dwelling.

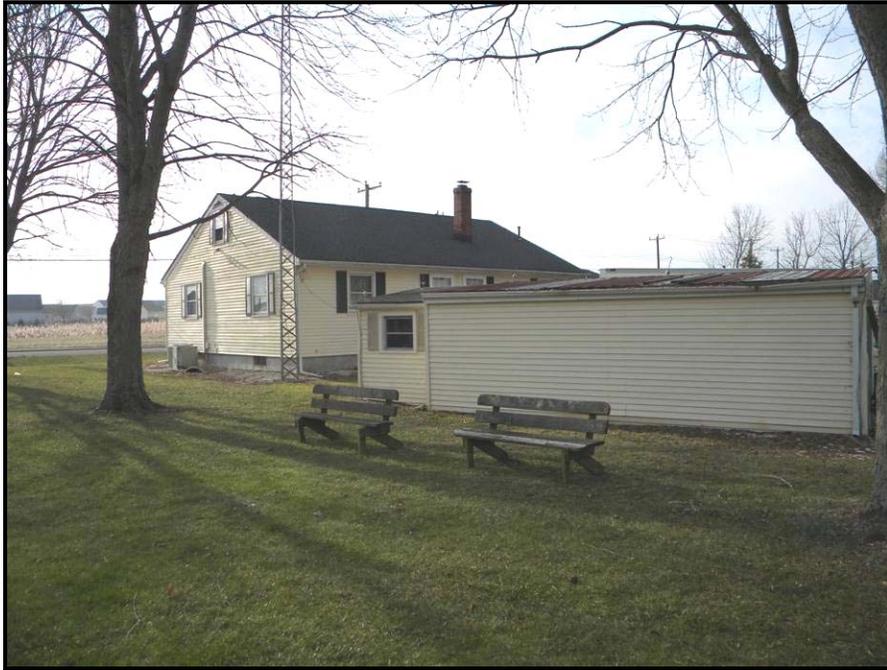
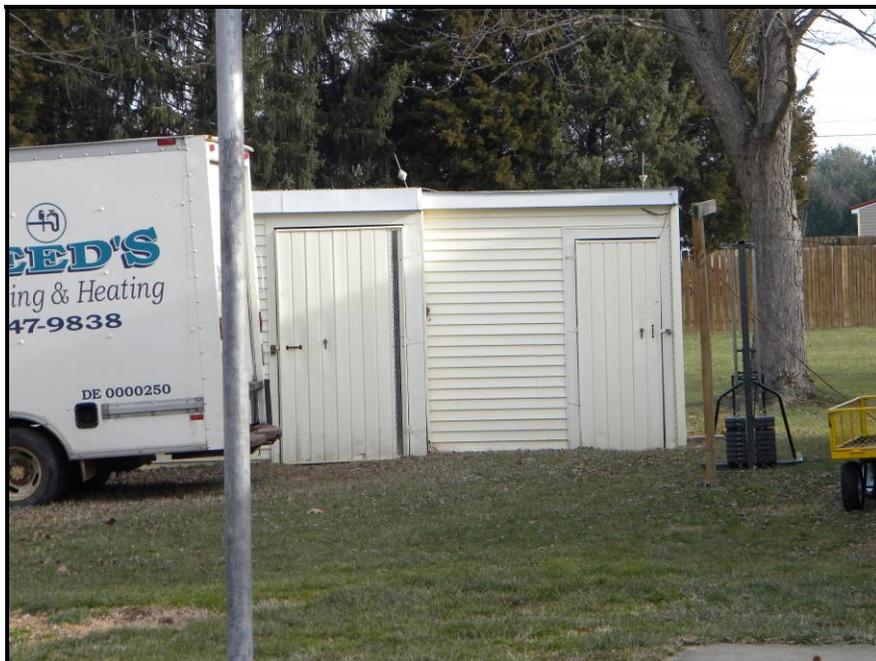
Partial front of storage shed or chicken House – attached addition on right

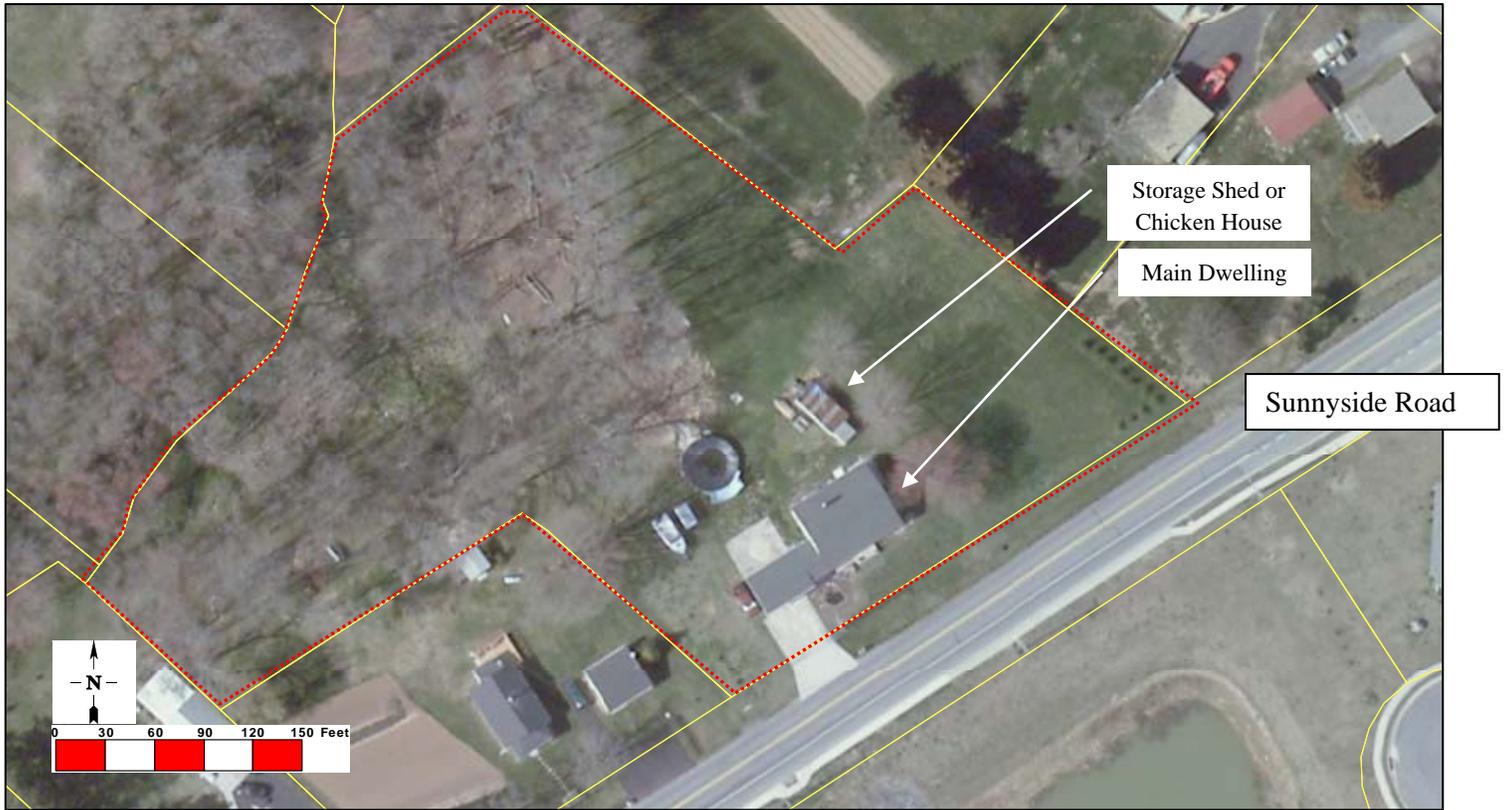
2007 Aerial from DeIDOT Geomedia. The property (K-7641) delineated in dashed red

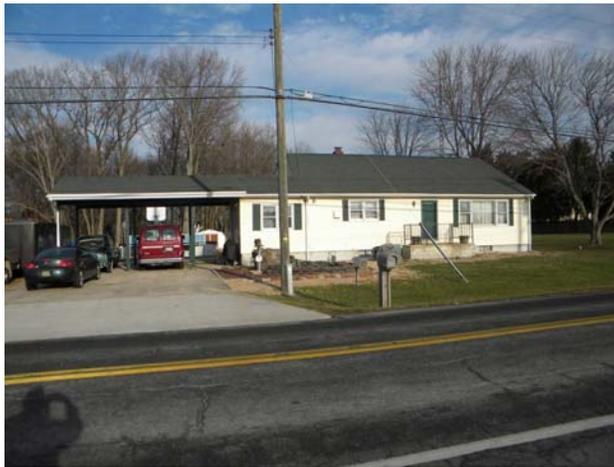
CRS# K-7641 Date 01/14/2010 Photo Roll# 1 of 3 Surveyor Michael C. Hahn

Description: View of front façade and east side looking north.

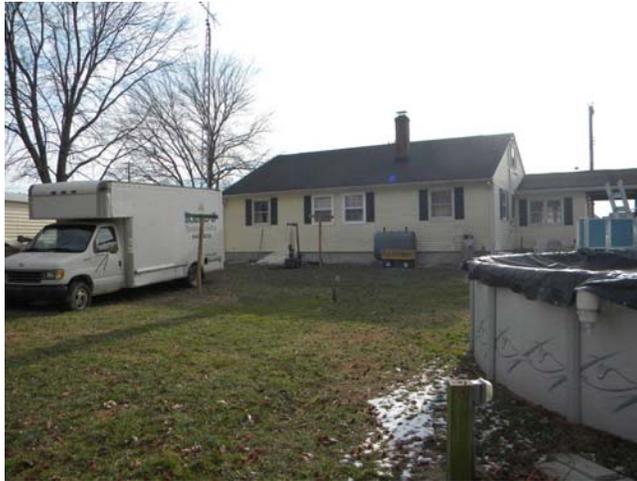
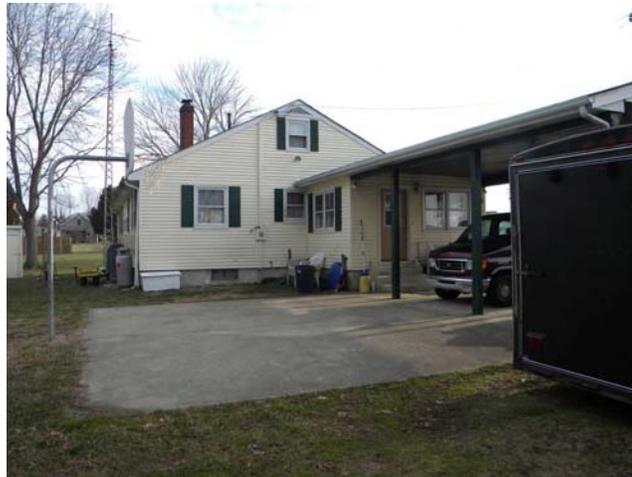
CRS# K-7641 Date 01/14/2010 Photo Roll# 2 of 3 Surveyor Michael C. Hahn

Description: View of rear looking south; view of west side gable looking east.

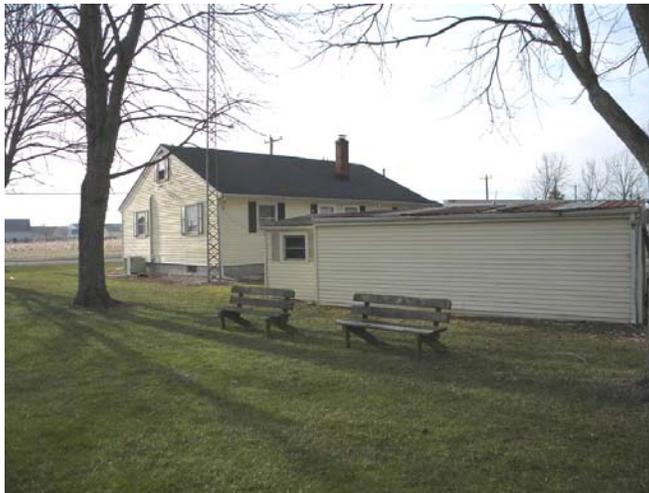
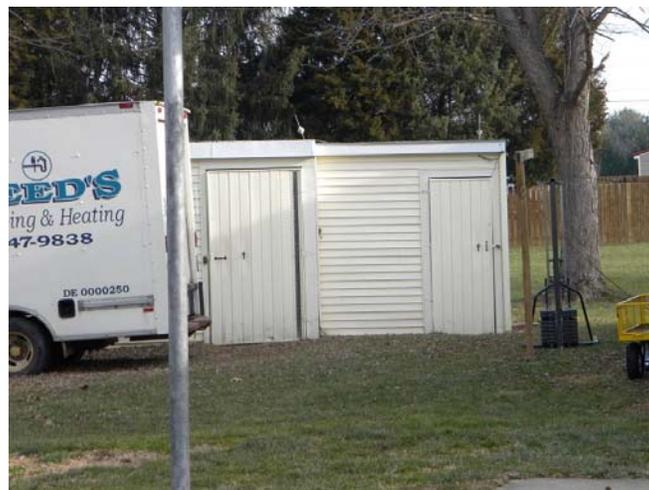
CRS# K-7641 Date 01/14/2010 Photo Roll# 3 of 3 Surveyor Michael C. Hahn

Description: View of rear and east side gable and rear of outbuilding; front of outbuilding.
