**ARCHITECTURAL RESOURCE SURVEY
CENTERVILLE ROAD (SR 273)
SR 259 TO SR 80**

New Castle County, Delaware

**Louis Berger & Associates, Inc.
East Orange, New Jersey**

The Delaware Department of Transportation

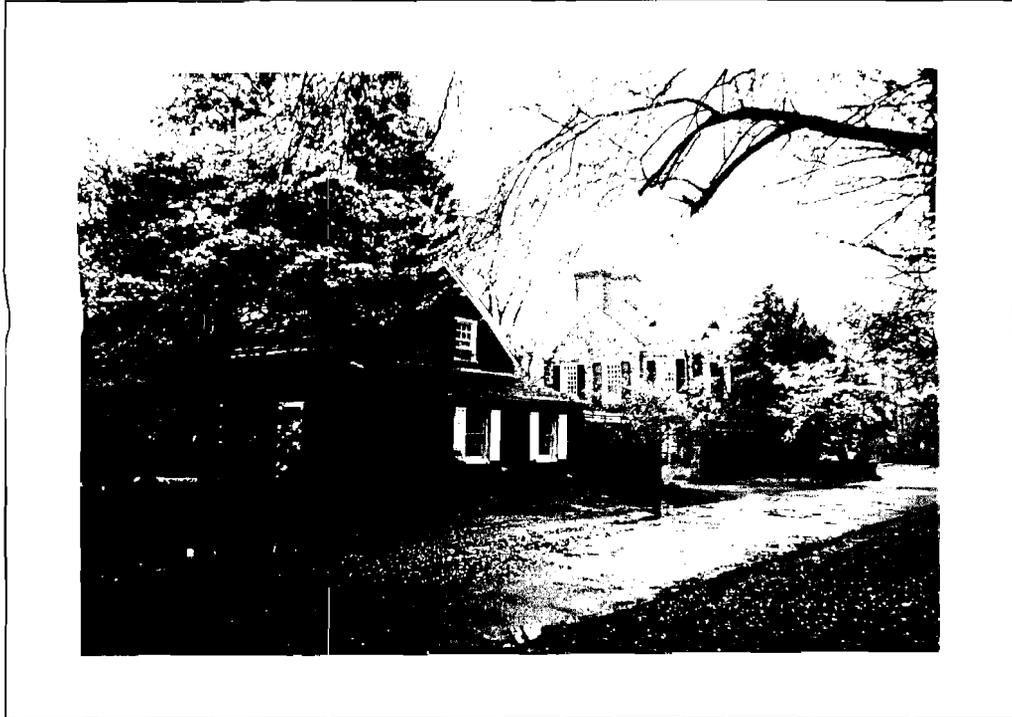
PLATE 31: William A. Worth House, View to South

Evaluation: This house was built by William A. Worth and Jane R. Worth in 1937. In 1994, the house was sold to the Intercollegiate Studies Institute by the heirs of Jane R. Worth (NCC Deed 1849-55). William Alexander Worth was a prominent industrial figure in Delaware during the early twentieth century, having established the Worth Steel Company in Claymont (north of Wilmington) during the early 1920s. The Worth Steel Company was one of the leading industries in Delaware during the early twentieth century. Worth served as vice-president and treasurer of the company, beginning in 1923 (Bevan 1929:81). The house was his home from its construction in 1937 until his death in 1983 (NCC Will 82093). The house and outbuildings possess a high degree of integrity of location, setting, design, materials, and feeling. The William A. Worth House is best evaluated for National Register eligibility as a contributing element in the proposed Centerville Road Historic District, which is described in the Summary and Conclusions chapter of this report.

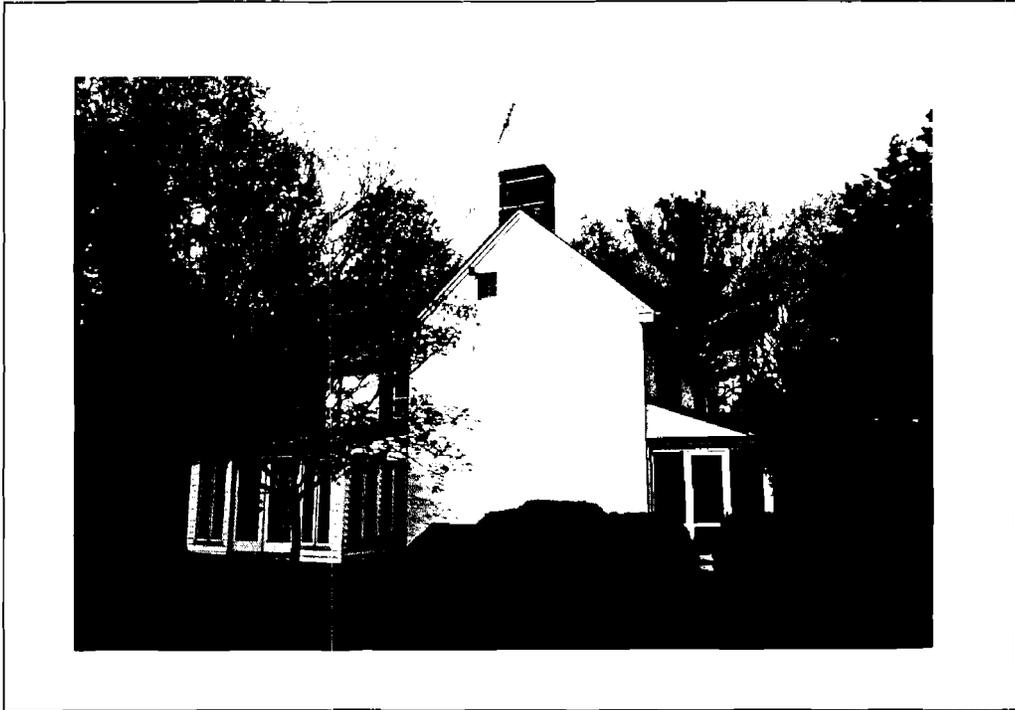
PLATE 36: William A. Dickson House, View to East

The William A. Dickson House meets National Register Criterion C, as it represents the distinctive characteristics of a early nineteenth-century stone I-house. Although the house and existing outbuildings at the William Lowther Farm possess integrity of location, physical and documentary evidence shows that several of the historic outbuildings which were associated with this property are no longer extant, including a stone barn and stable, and a mill operation. These demolitions, as well as the construction of a new garage and the construction of the Deborah B. Halsey Wilson House west of the William Dickson House, have diminished the property's integrity of setting, feeling, and association. Additions and alterations to the house throughout the twentieth century have diminished the property's integrity of design, materials, and workmanship. The William A. Dickson House does not meet National Register Criteria with regard to integrity. The house must be considered a non-contributing element in the proposed Centerville Road Historic District, as it does not date to the period of significance of the district (Urbanization and Early Suburbanization: 1880-1940 \pm) and is not representative of the themes and styles characteristic of the district (Settlement Patterns and Demographic Change/Commuter Suburbs; Early Twentieth-Century Revival Styles). The Centerville Road Historic District is described in the Summary and Conclusions chapter of this report.

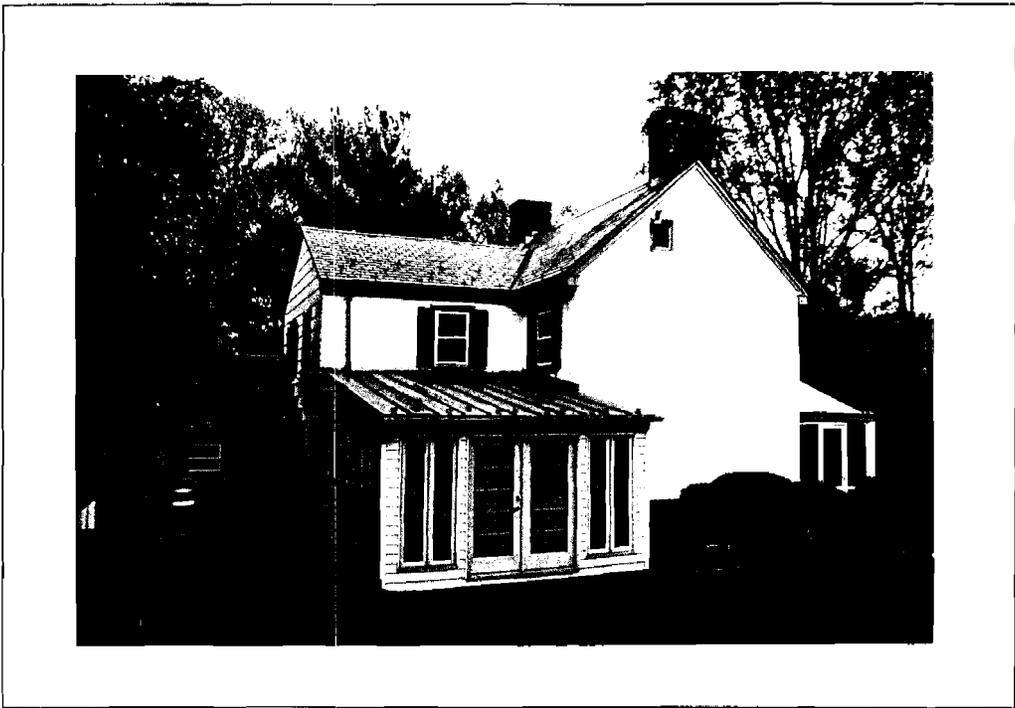
PLATE 37: William A. Dickson House, View to Southeast

Description: This property consists of a single dwelling, a garage, a springhouse, and a shed. The dwelling is a 2-story, 3x1-bay, side-gabled stone I-house dating from the late eighteenth century (Plates 36 and 37). The plan, which was originally rectangular, has been made irregular by additions which appear to range in date from the mid-nineteenth to the late twentieth centuries. The oldest section is constructed of uncoursed stone, covered with a thin layer of stucco. The principal facade, which faces south, has a one-story, screened-in porch with shed roof. The first- and second-story windows consist of wooden 6/6 double-hung sashes. The main entrance is a central door, flanked by two evenly spaced windows. The windows are set into openings having wooden frames constructed of 4-inch-wide rough-hewn timbers. The roof covering consists of slate. The main section has two interior gable-end chimneys constructed of brick.

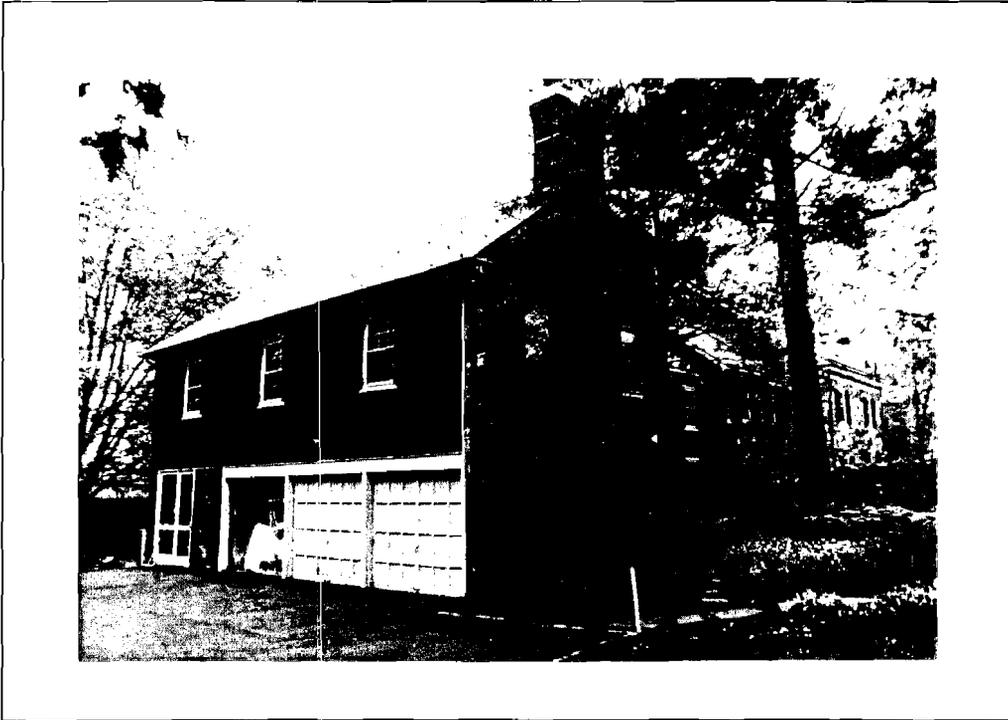
PLATE 41: Deborah B. Halsey Wilson House, View to Northwest

Description: This 2-story stone Colonial Revival-style house with an irregular plan is situated west of the William A. Dickson House at the end of a drive opposite Hillside Road (Plates 41 and 42). The materials and construction of this house are similar to those of the William A. Worth House. It is a side-gabled structure with its primary facade facing east. The building consists of five distinct sections: a 2-bay main or entrance section which has a 1-bay gabled wing attached to its north gable, and two side-gabled sections and one cross-gabled garage attached to its southern gable. Attached to the south elevation gable of the main section is a 2-bay wing, to which is attached another 2-bay wing. The cross-gabled garage is two bays wide. Windows consist primarily of 6/6 wooden double-hung sashes with 4-inch wooden surrounds; however, the main section has 9/6 double-hung windows on its first story. All first-story windows have recessed panel shutters, and the second-story windows have louvered shutters. Massive stone lintels and keystones identical to those on the William A. Worth House suggest that the same builder constructed both buildings. The roof, which is pierced by four brick chimneys, is clad with slate. A front entrance on the east elevation of the main section has a fanlight transom. Two shed-roofed, screened-in porches extend westward from the west elevation. A datestone set in the north elevation gable reads: "R.E.W. -1939- D.B.H.W."

Evaluation: The title history of this property is identical to that of the William A. Dickson House. The house was built in 1939 after Deborah B. Halsey Wilson purchased the land (NCC Deed 40-339). J. Seth and Barbara Cruice currently own this property (NCC Deeds Z-83-173 and 902-78). Although it is a fine example of early twentieth-century Colonial Revival architecture, it does not possess the high-style architectural qualities which distinguish other local examples of this relatively common architectural style, such as the neighboring William A. Worth House, and does not appear to meet National Register Criteria A, B, or C. The house may, however, be considered a contributing element in the proposed Centerville Road Historic District, which is described in the Summary and Conclusions chapter of this report.

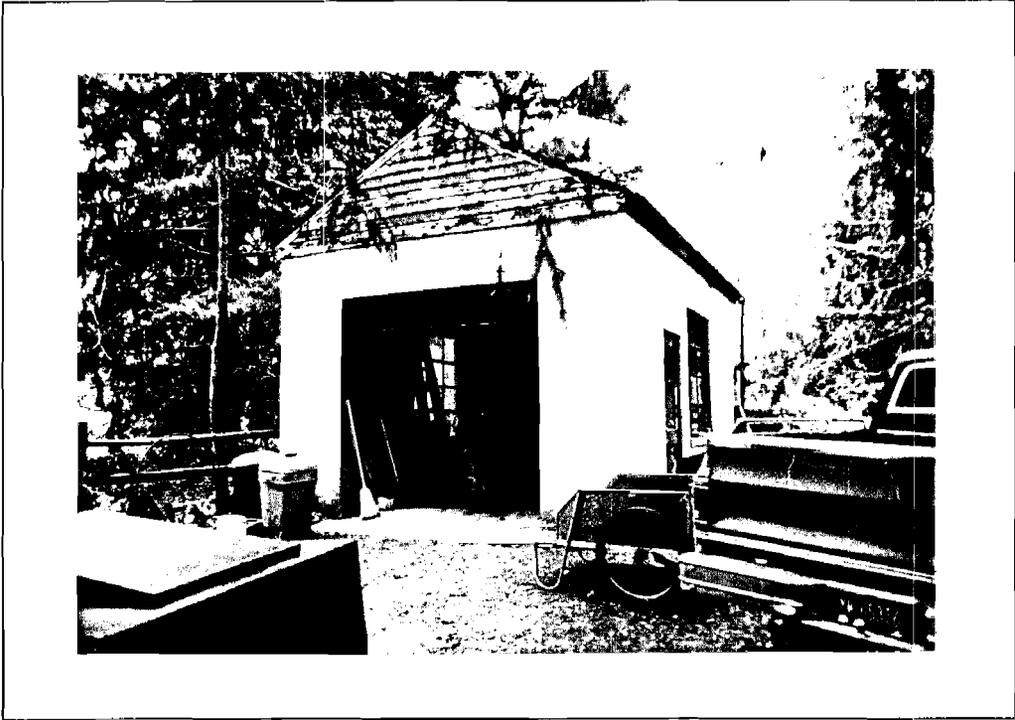
PLATE 43: Deborah B. Halsey Wilson House Garage, View to South

South of the house lies a 1x2-bay, front-gabled, concrete-block garage on a concrete slab, with an asphalt-shingled roof (Plate 43). This garage dates from the mid-twentieth century. An in-ground concrete pool is situated near the north elevation of the house (Plate 44). A stone wall leading from the house to the pool has a datestone embedded in it which appears to have come from a building historically associated with the William A. Dickson House. It reads: "W^D S 1792." This appears to refer to William and Susanna Dickson, owners of the land during the late eighteenth century (NCC Deed M-3-419). North of the pool is a small frame shed with board and batten siding dating from the mid- to late twentieth century (Plate 45).

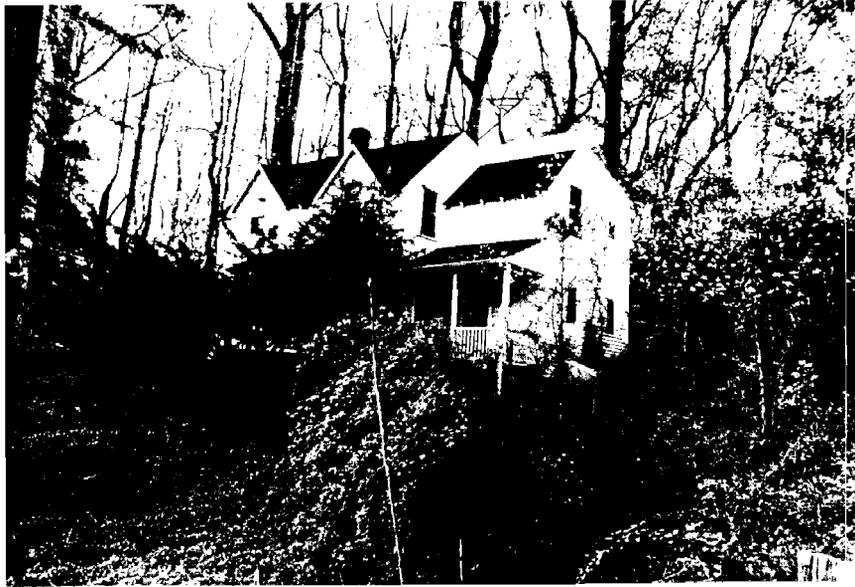
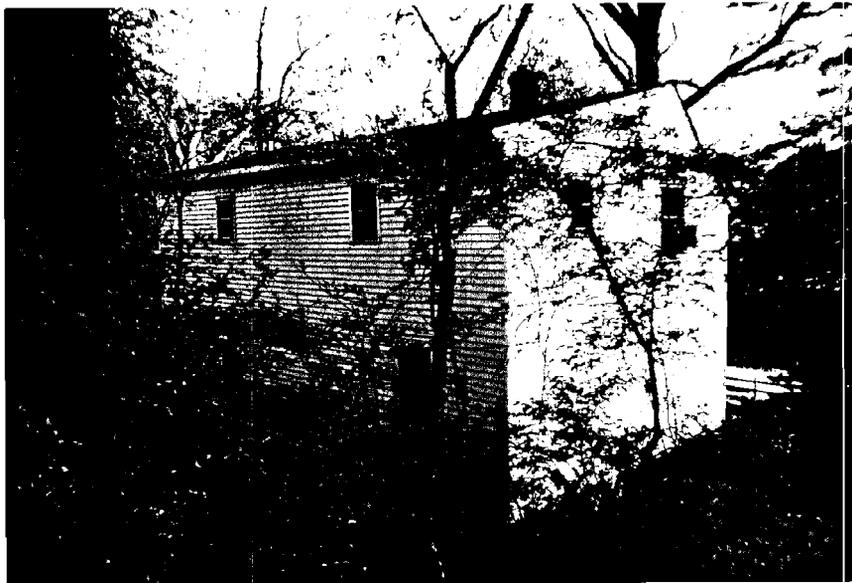
PLATE 46: Westbrae Tenant House, View to North

Description: This property consists of a dwelling and a garage. The house, which is set on a hill, consists of an original 3x2-bay, 1½-story side-gabled main block with a one-bay addition at the east gable end (Plates 46 and 47). The original section is frame, set on a stone foundation, with its principal elevation facing south. The first story of this elevation has a central entrance with a brick stairway and porch, covered by a shed roof. Windows on each side of the entrance have 6/6 wooden sashes. The roof is clad with asphalt shingles, and is pierced by a central interior ridge chimney. The 1x2-bay frame addition has a combination of 1/1 and 6/6 wooden sash windows. The rear of the house (north elevation) has a shallow roof pitch due to what appears to have been a late twentieth-century addition which raised the roof, creating a half story. Windows on the north elevation consist of a combination of late twentieth-century-style wooden 1/1 and 6/6 windows. The entire house is clad with vinyl siding.

Evaluation: According to the previous cultural resource survey form for this property, this dwelling was built as a tenant house associated with the mansion house of Frank and George Rhoads (Westbrae; see below) in the early twentieth century (DESHPO Cultural Resource Survey Form No. 522). George and Frank Rhoads sold this property to Walter Pyle in 1918 (NCC Deed Q-27-82). Walter Pyle was an owner of the prominent C. and W. Pyle Leather Goods Company in Wilmington at the turn of the century (Conrad 1908:386; DESHPO Cultural Resource Survey Form No. 521). Walter Pyle died in 1919, leaving the property to his son, Walter Pyle, Jr. (NCC Will N-4-131). In 1936, Walter Pyle, Jr., heir of Walter Pyle, Sr., sold the house back to George A. Rhoads (NCC Deed B-40-533). Upon the death of George Rhoads, the property was sold to Frank and Amalia Manegold, and then by Amalia Manegold to Robert K. Beste in 1956 (NCC Deeds Q-42-37 and Q-57-18). Beste sold the property to its present owners, Peter and Jeanne Huang, in 1980 (NCC Deed Z-111-24). This property does not possess sufficient architectural or historical significance to be eligible for the National Register of Historic Places. Furthermore, extensive alterations and additions have greatly diminished the property's integrity of design, materials, and workmanship. Due to these extensive alterations, the Westbrae Tenant House would be considered a non-contributing element in the proposed Centerville Road Historic District, which is described in the Summary and Conclusions chapter of this report.

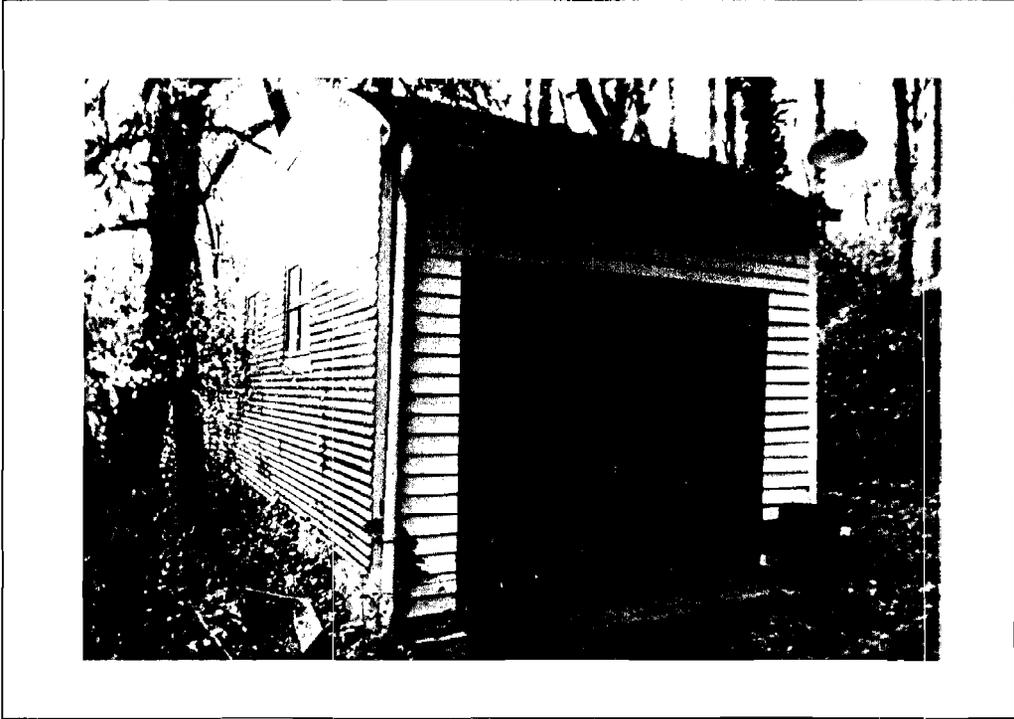
PLATE 48: Westbrae Tenant House Garage, View to Northwest

A garage, which is constructed from a metal quonset hut with one curved side clipped to create an entrance bay, lies southwest of the house near Hillside Road. It appears to date from the mid-twentieth century (Plate 48).

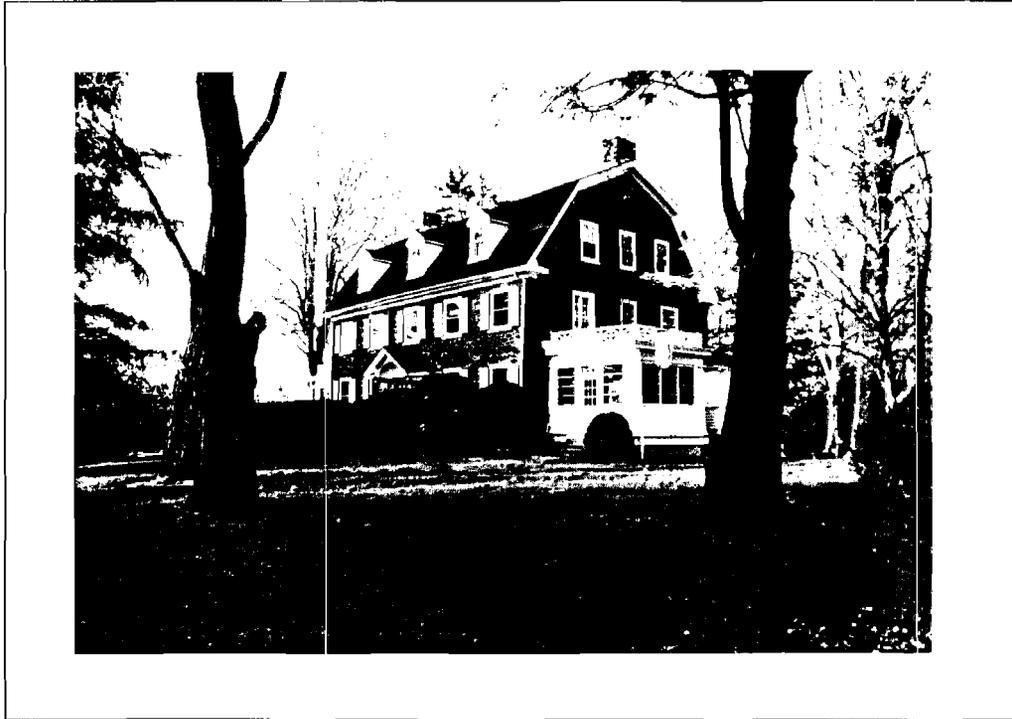
PLATE 49: Westbrae, View to Northeast

Description: This property consists of a large dwelling, three garages, and a pool. The dwelling is a large 2½-story, stone Dutch Colonial Revival-style house dating from the early twentieth century (Plates 49 and 50). It is a 5x3-bay, side-gabled stone house with stone interior end chimneys which rise above a gambrel roof. The roof is clad with cedar shingles. Most windows are 6/1 double-hung wooden sashes with elaborate molded wooden sills and stone lintels with keystones. Both roof slopes have three pedimented dormers. The principal facade faces west, and has a central-gabled portico entrance with concave ceiling. Both gable ends of the house have one-story enclosed porches with flat roofs which have decorative wooden balustrades. The porch roofs are supported by round wooden columns of the Tuscan Doric order. The east elevation has a central porte cochere which has a flat roof surrounded by a balustrade. The porte cochere roof is supported by two Doric-order columns. Centered on the porte cochere roof is a small arched window with leaded panes. A datestone on the south gable wall reads: "C.F.R. 1907."

1908:386; DESHPO Cultural Resource Survey Form No. 521). When the land was sold back to George Rhoads in 1937, he developed a small spring water business on part of the property, which became known as Westbrae Springs. Westbrae is a good example of the early twentieth-century Dutch Colonial Revival style, possessing integrity of location and a high degree of integrity of design, materials, workmanship, feeling, and association. The house is eligible for the National Register of Historic Places as a contributing element in the proposed Centerville Road Historic District, which is described in the Summary and Conclusions chapter of this report.

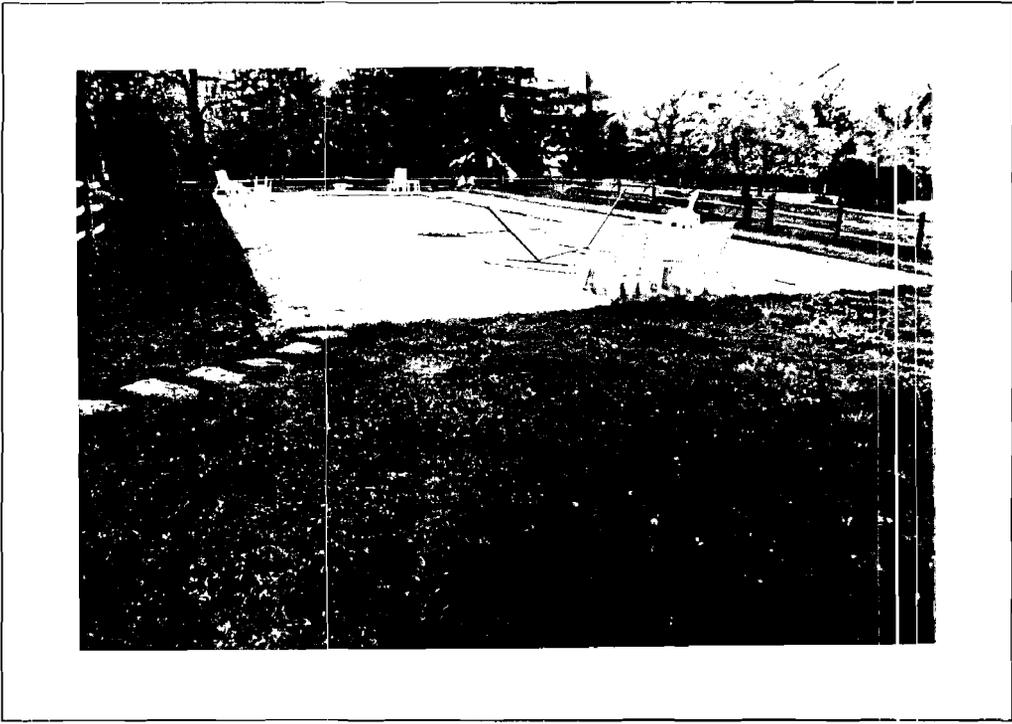
PLATE 51: Westbrae Pool, View to West

Northwest of the house is an in-ground concrete pool (Plate 51). East of the house stands a 1x2-bay, front-gabled frame garage with a combination of vertical beaded-board and plywood siding (Plate 52). The roof is clad with asphalt shingles. This garage, which appears to date from the early twentieth century, is in poor condition. Southwest of this garage is a 1½-story, gabled garage with an L-plan (Plate 53). The building appears to have been constructed in two phases. A 3x1-bay section, which appears to date from the early twentieth century, has a stone foundation, central stone chimney, and gambrel roof, with a single dormer on both its northern and southern roof slopes. A one-story ell attached to the north elevation of this garage has a brick chimney. This ell appears to date from the mid-twentieth century. Both sections are clad with a combination of german siding and asphalt shingles. Windows consist of a variety of fixed-pane sashes and 2/2 and 6/6 double-hung. The interior of the half story of the main section appears to be finished, and may have been used as living quarters at some time. A steel quonset-hut garage identical to the one on the Westbrae Tenant House property is situated east of this garage (Plate 54).
