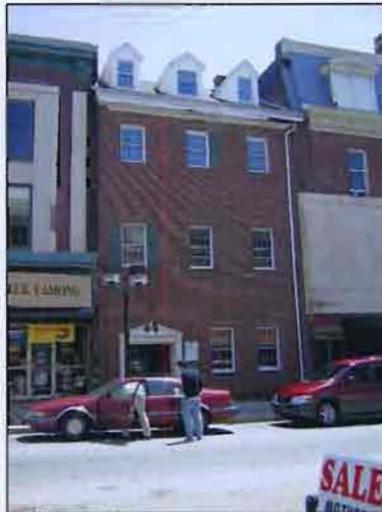
Figure 55: 606 N. Market Street

Description: single brick dwelling built c. 1750 (Figure 55).

However, the façade of the building has been extensively rehabilitated, and the present eligibility of the building may be in question.

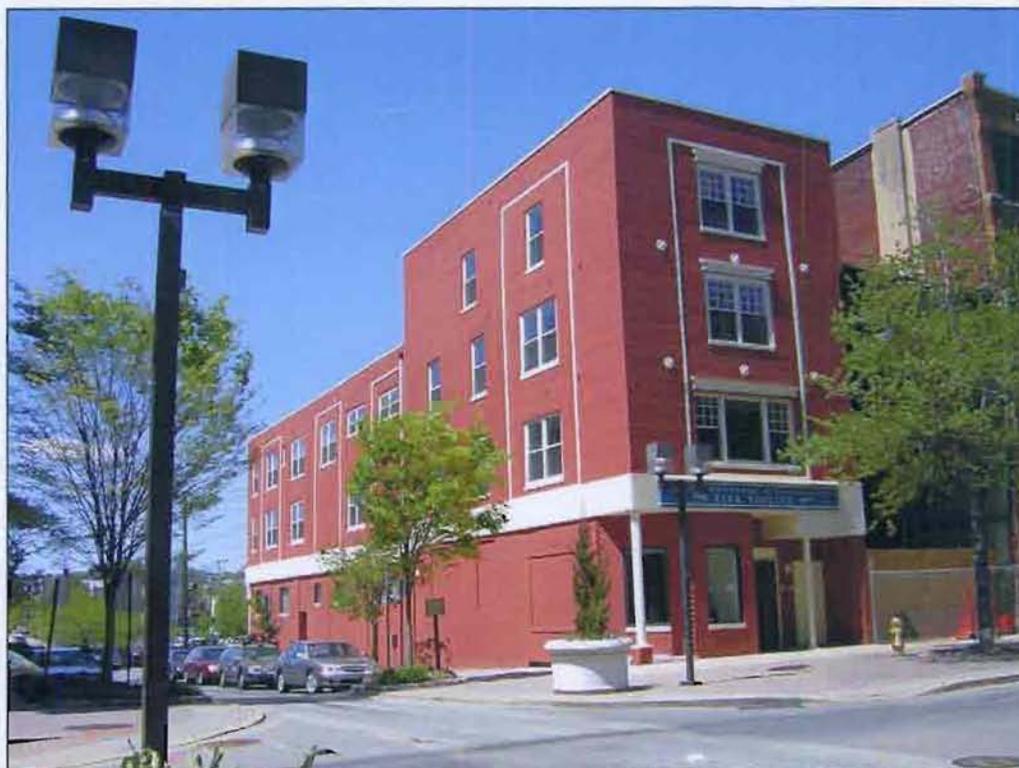
Figure 56: 601-603 N. Market Street

- *601 N. Market Street.* (no CRS Number). This four-story, early 20th-century red brick commercial building has been recently renovated (Figure 56). Exterior changes to the building were largely cosmetic and existing materials were replaced in-kind.

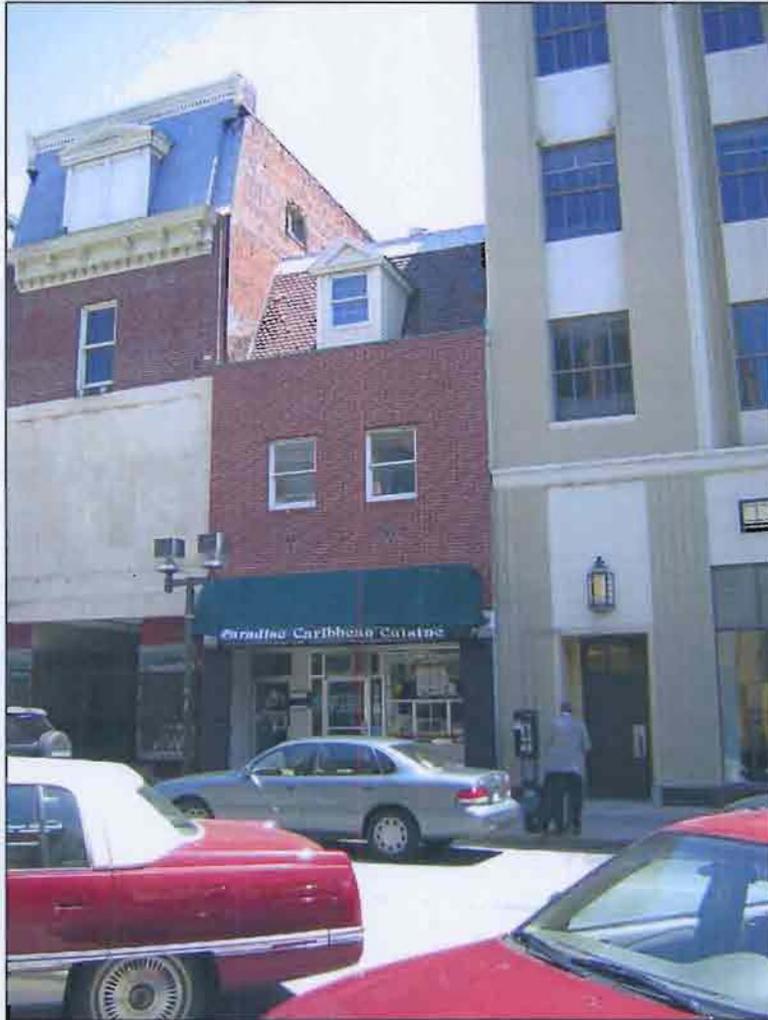
Figure 57: 602 N. Market Street, Main Elevation

- *602 N. Market* (CRS Number: 2158). This two-bay, two-story brick, mid-19th-century commercial/residential building has a gabled dormer (Figure 57). However, the front elevation has been heavily altered with non-compatible brick facing.
- *603 N. Market* (no CRS Number). This three-story brick, commercial building has a heavily altered façade (Figure 56). The façade of this vacant building was removed recently, revealing a ca. 1930s relief depicting a reclining figure.

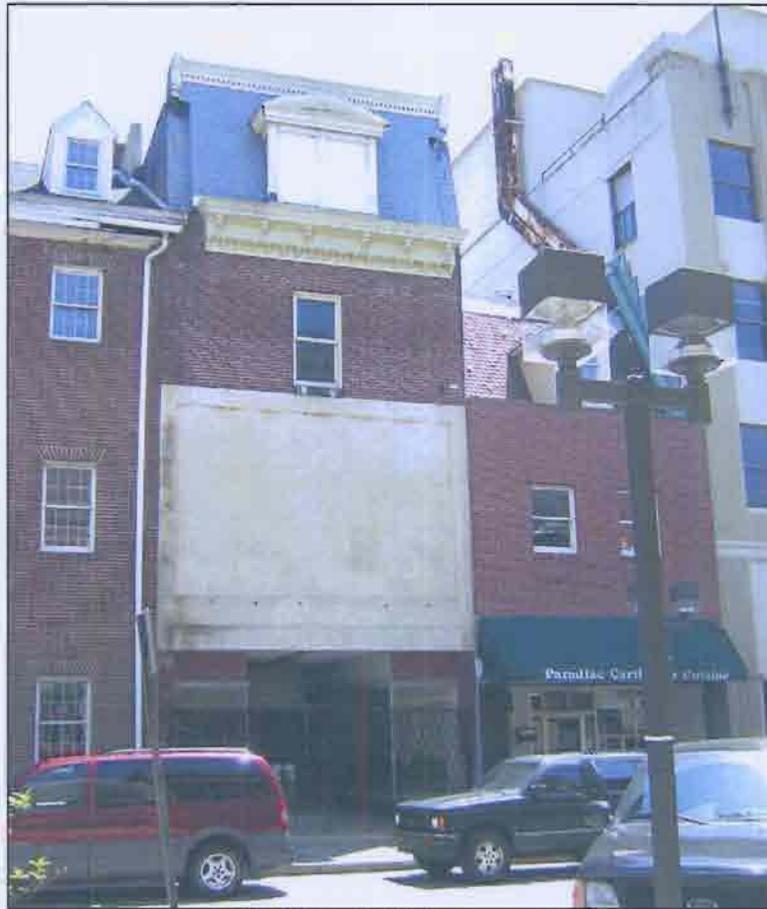
Figure 58: 604 N. Market Street, Main Elevation

- *604 N. Market (CRS Number: 751).* This one-bay, three-story brick Second Empire-style commercial/residential building is vacant (Figure 58). The building, which once housed Livingstons Credit Clothing, dates to 1870 – 1900. It has a slate-shingled mansard roof over a tripartite molded cornice with projecting central section. The first and second stories have been extensively altered for a shop front. [Note: this CRS number also has been assigned, mistakenly, to the Line House on Kennet Pike, far beyond downtown Wilmington].
- *2 E. 7th Street (614-620 N. Market) (no CRS Number).* This substantial, early 20th century commercial/office building has a round corner bay (Figure 59).
- *617-627 N. Market (no CRS Number).* This large, two-story, mid-20th century brick commercial building is vacant for renovation (Figure 60).

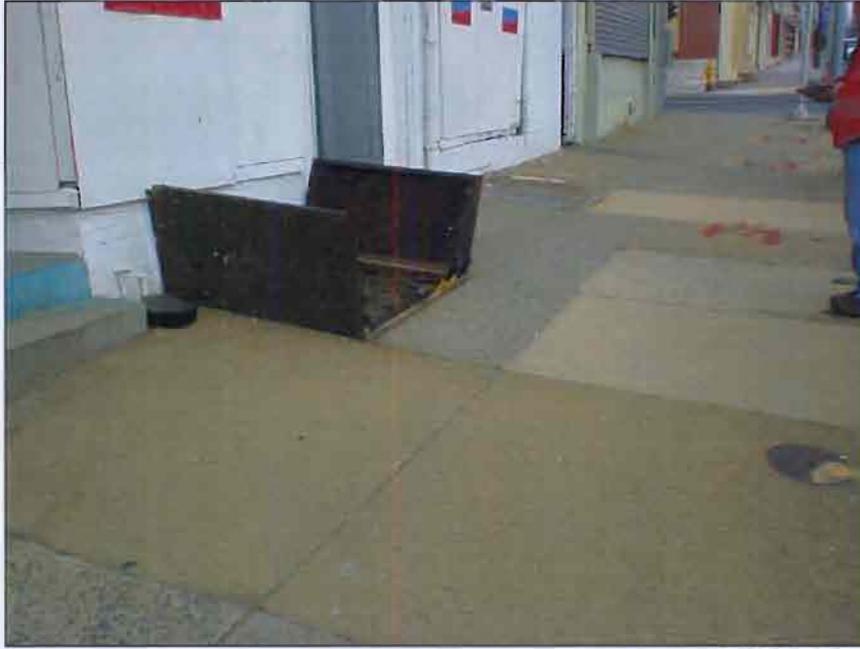
Figure 61: Sidewalk Entrance to Typical Subterranean Vault (123 N. Market Street)

Typically, these vaults are located beneath the sidewalks fronting the buildings on Market Street. The vaults within the APE are designed to be accessed in one of two ways. The first example includes having the vaults be accessible via the sidewalks, from which staircases extends down to the actual vault areas. These accessible openings are covered by double-leaf metal doors (Figure 61). Sidewalk vault doors have historically been constructed of cast-iron or other metals. The extant sidewalk vault doors are constructed of metal; however, historic

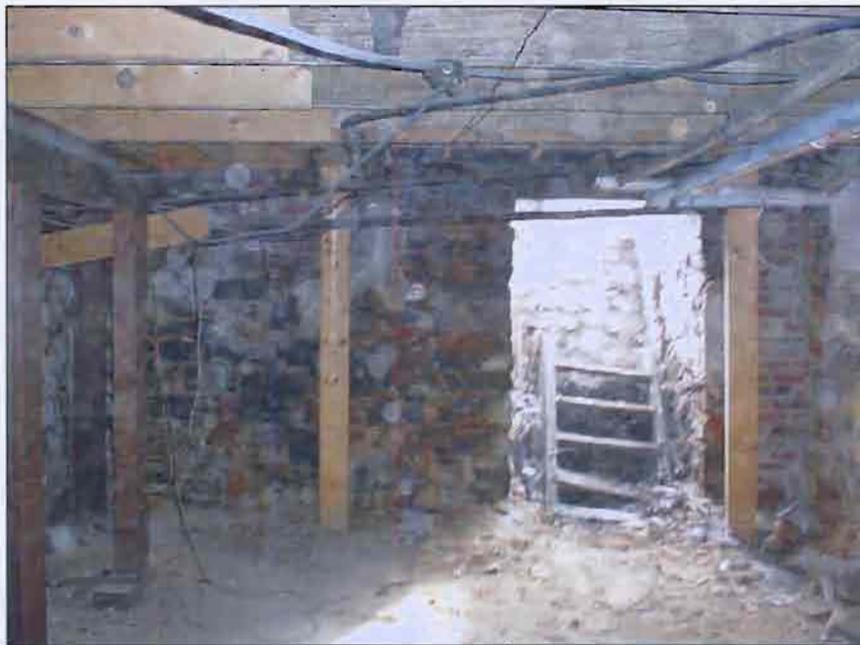
All of these spaces share similar features and characteristics. The interiors are austere with none possessing any notable construction or ornamented features (Figure 62). The walls are of masonry construction executed in either brick or fieldstone, with a few vaults having parged walls. In most cases, the concrete slab base of the sidewalk structure forms the roof of the vaults. The concrete slab is supported by exposed timber, steel or concrete beams. The slab is really a component of the street and sidewalk support system itself and not that of the associated building. Typically, multiple timber beams would have originally supported most of the vault roofs, and many of these spaces still contain timber beams. Other vaults contain modern steel or concrete I-beams that perhaps replaced earlier timber supports. Portions of some of the vaults contain spaces that have vaulted ceilings constructed of brick (Figure 63). Physical evidence, supported by the existence of shoots or sealed openings, suggests that these spaces were historically used for coal storage.

Figure 62: Interior View of Typical Subterranean Vault (123 N. Market Street)

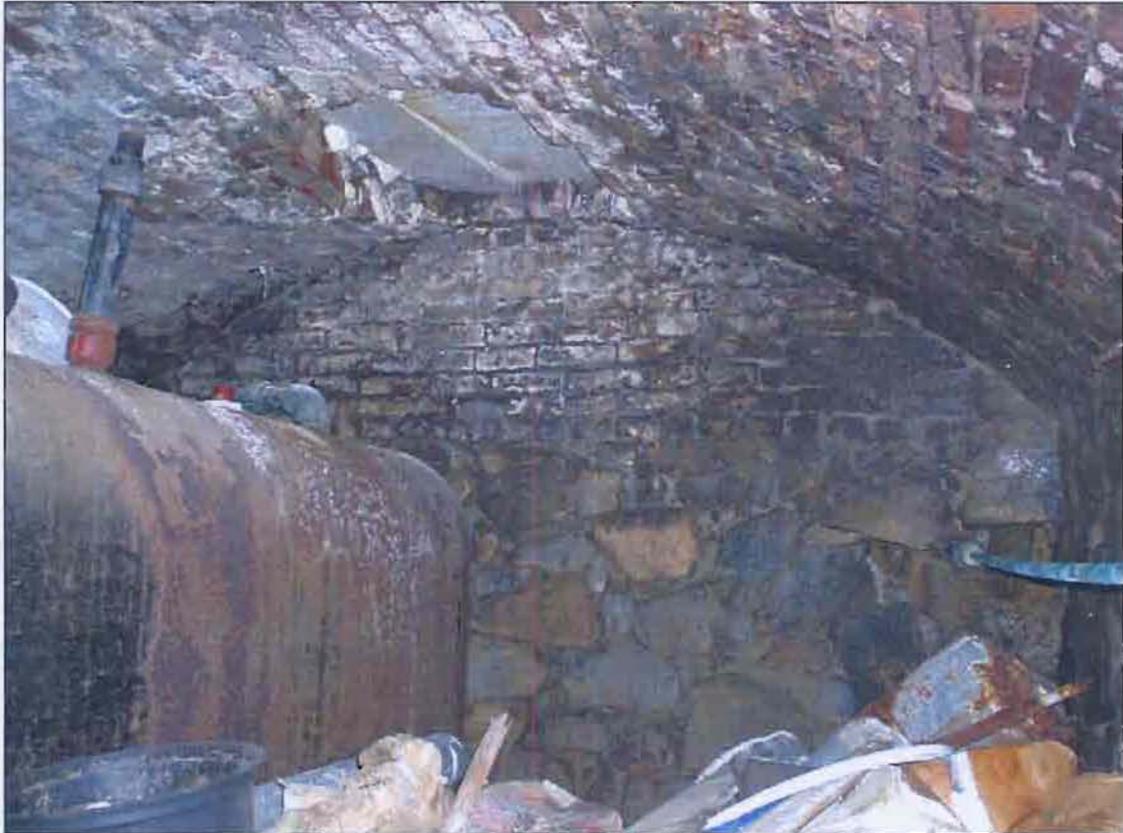
Figure 63: Interior View of Storage Space with Vaulted Ceiling (423 Market Street)
